**2007/2008 Annual Inspection
Report**

**LITTLE VERMILION BAY
SEDIMENT TRAPPING
PROJECT (TV-12)**

State Project Number TV-12
Priority Project List 5

June 6, 2008
Vermilion Parish

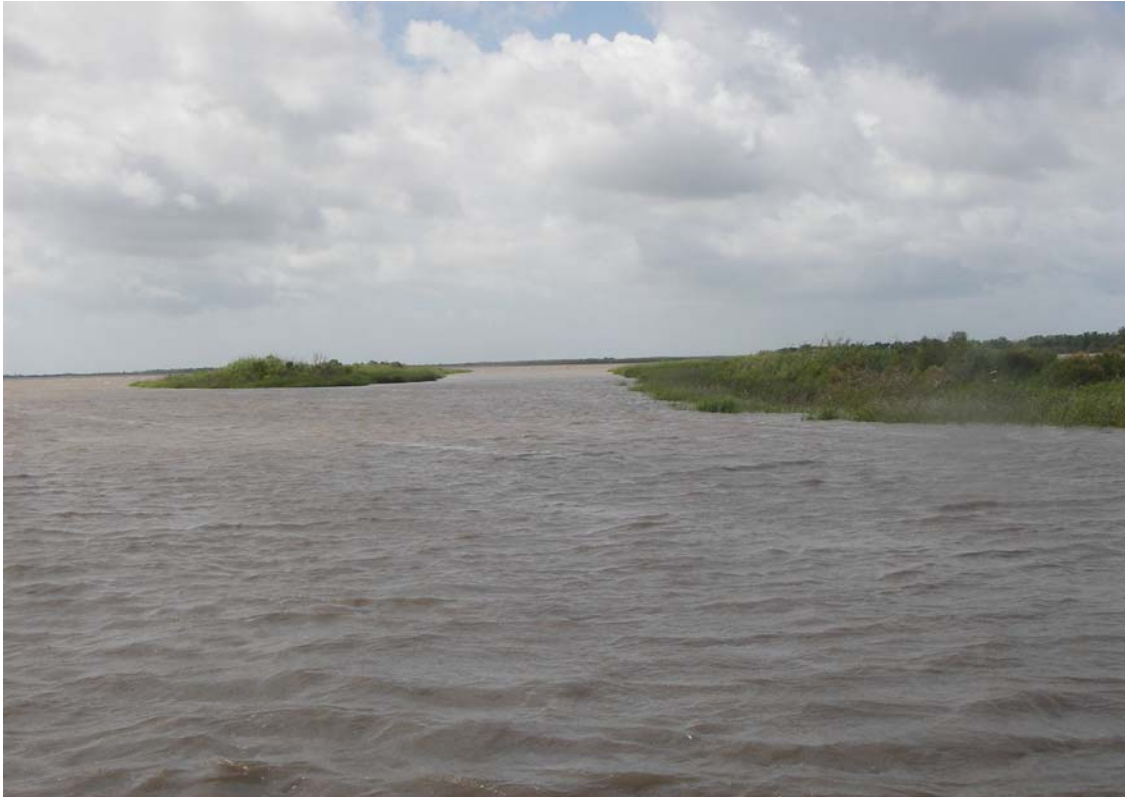
Photo 1—typical terrace

The terraces are in excellent condition. Water elevation was not available at the time of this inspection. Staff gauges will need to be re-established in the area. Erosion continues on the southwestern most terraces but vegetation is still evident and the terrace is still functioning as protection to the terraces to the north. The terraces nearest Freshwater Bayou have begun to show significant erosion on the northern side due to the continual widening of the opening to Little Vermilion Bay. (Photos: Appendix B, Photo 1-2)

- Installation of a staff gauge

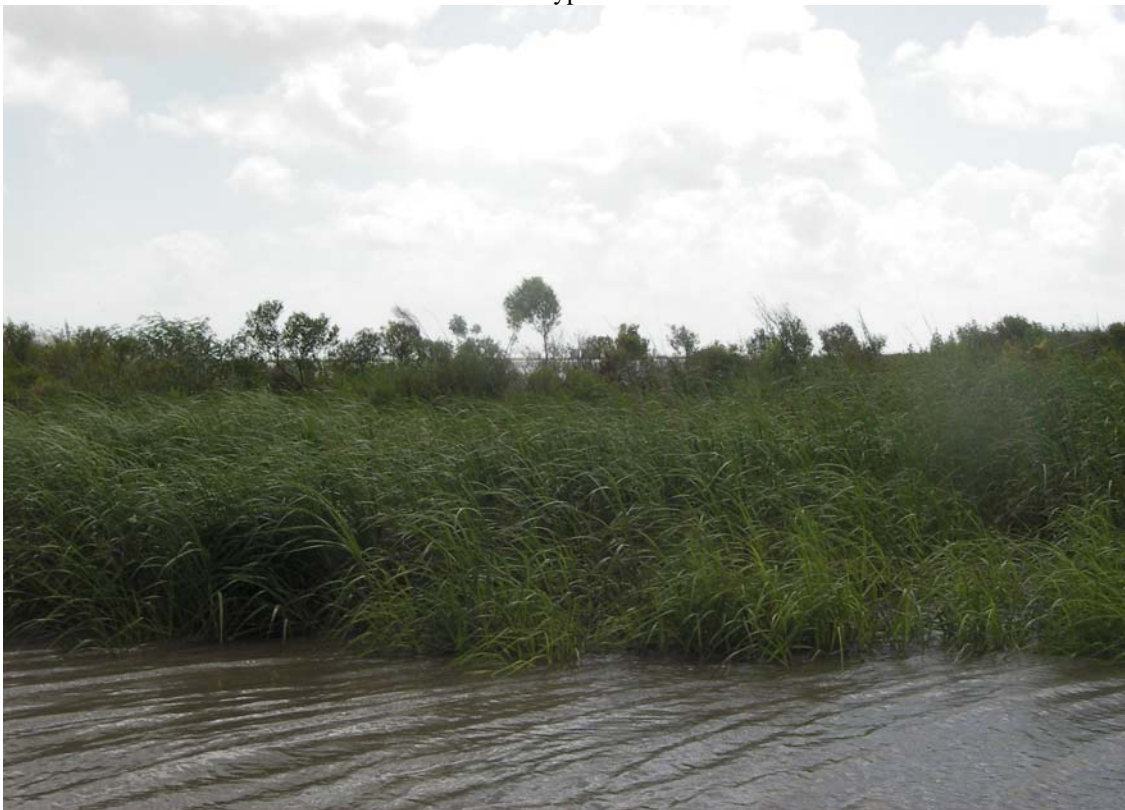
Photo 2—typical vegetated terrace

Vegetation has expanded 40-60 feet from the original plantings. No maintenance needed at this time.
