**2007/2008 Annual Inspection
Report**

**MARSH ISLAND HYDROLOGIC
RESTORATION PROJECT
(TV-14)**

State Project Number TV-14
Priority Project List 6

February 28, 2008
Iberia Parish

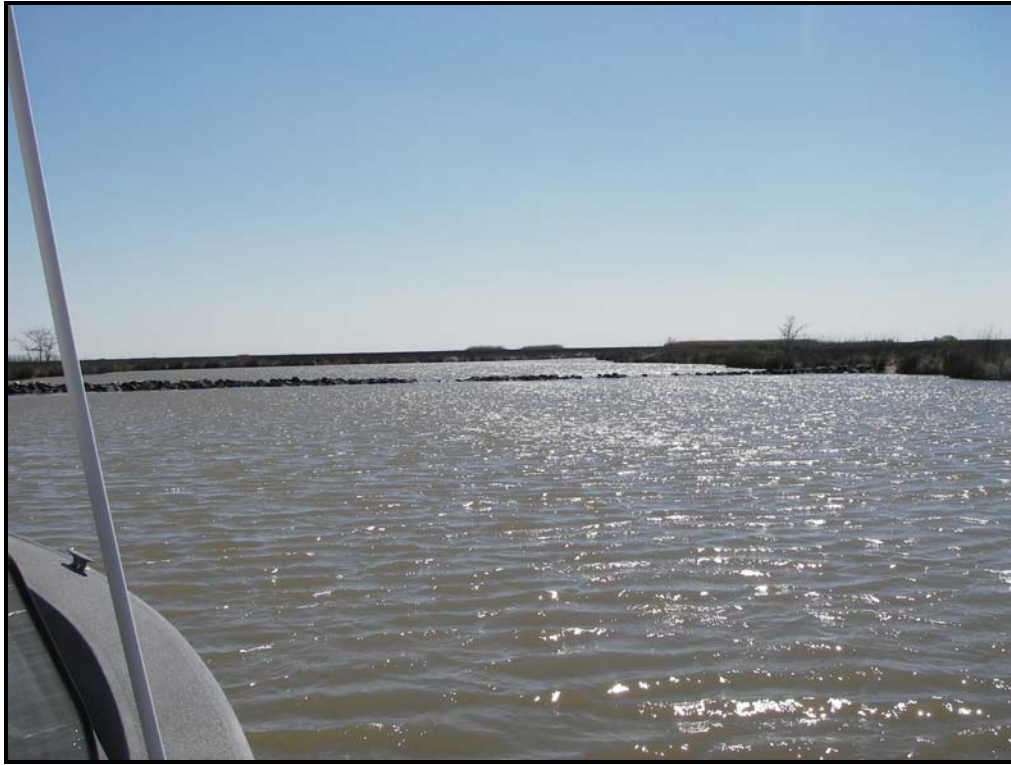
As per the results of the 2006 inspection there is some erosion on each end where the rock plug ties back into the adjacent marsh. Damages were determined to be related to Hurricane RITA. This condition will allow for additional erosion and eventual “flanking” of the canal closure. As a result of the inspection of Closure No. 1, LDNR and COE agree that corrective actions will be required this year. The marsh on each end of the closure should be paved with 12” of 30# stone to make this area “hard” and less subject to erosion and thereby prevent eventual flanking of the structure. This proposed work is currently included in our maintenance project for repair of Hurricane RITA damages. (Photos: Appendix B, Photo 1).

Photo 1, Closure No.1, Note low areas of stone in center of structure.

Item	Condition	Physical Damage	Corrosion	Photo #	Observations and Remarks
Steel Bulkhead / Caps	N/A				
Steel Grating	N/A				
Stop Logs	N/A				
Hardware	N/A				
Timber Piles	N/A				
Timber Wales	N/A				
Galv. Pile Caps	N/A				
Cables	N/A				
Signage / Supports	N/A				
Rip Rap (fill)	Good	Minor		1	Some erosion on each end of rock plug, marsh paving will be required to prevent further erosion.
Earthen Embankment	N/A

- Closure No. 1 – bank paving on each end of closure.
- Closure No. 2 – extend rock dike east end, bank paving each end of closure.
- Closure No. 5 – replace staff gage.
- Closure No. 6 – extend rock dike to close breach, bank paving each end of closure.

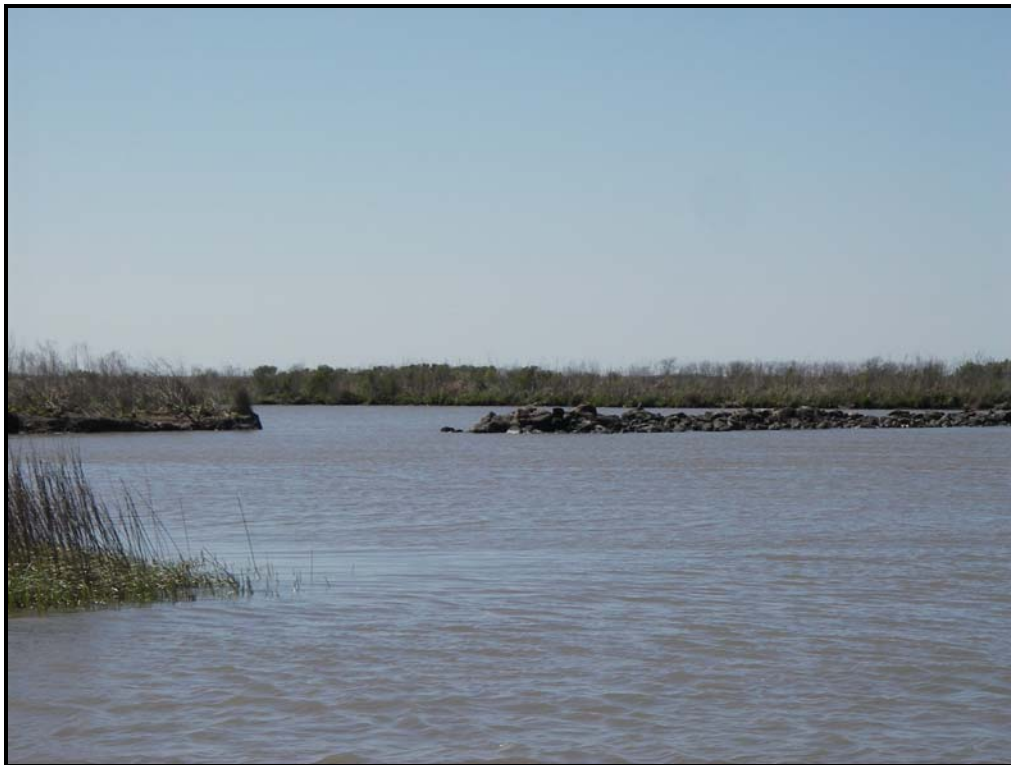
It was observed that extensive erosive damage by Hurricane RITA's surge to each end of the closure had occurred, especially on the east end, where there is now a major "flanking" cut that allows a water connection to the bay. The original rock structure that was constructed is still in good condition. LDNR and COE agree that maintenance will be required at this time. The closure dike needs to be extended on the east end to cut off and fill the flanking channel that was caused by Hurricane RITA. On the west end, the area that suffered erosion needs to be adjusted with some new stone paving. As a preemptive effort, the "new" ends of the closure dike should be paved and made "hard" as described for Closure No. 1. (Photos: Appendix B, Photo 2).

Photo 2, Closure No.2, View showing "flanking" cut on east end.

Item	Condition	Physical Damage	Corrosion	Photo #	Observations and Remarks
Steel Bulkhead / Caps	N/A				
Steel Grating	N/A				
Stop Logs	N/A				
Hardware	N/A				
Timber Piles	N/A				
Timber Wales	N/A				
Galv. Pile Caps	N/A				
Cables	N/A				
Signage / Supports	N/A				
Rip Rap (fill)	Fair	Moderate		2	Some erosion on east end of rock plug, marsh paving will be required to prevent further erosion. A flanking cut has occurred on the west end of the plug and will need to be extended.
Earthen Embankment	N/A

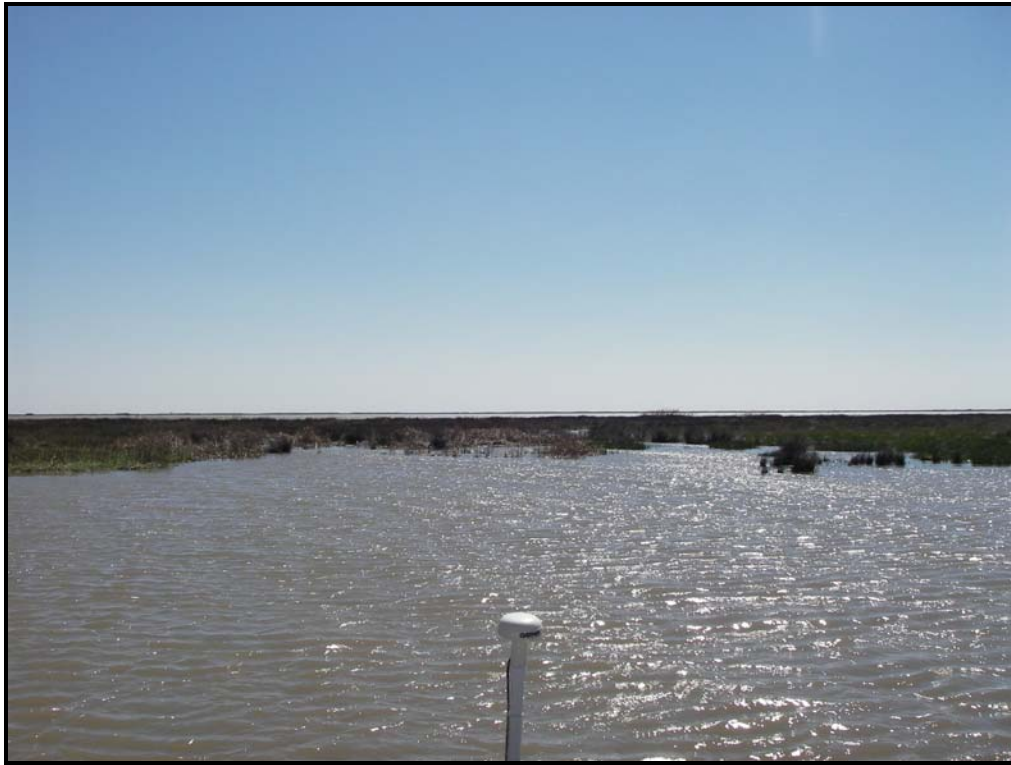
The rock closure dike appears in good condition and the stone appears to not have suffered major displacement. Also, it was observed (and confirmed with aerial photography post Hurricane RITA) that a large open water area has developed within the marsh near the western terminus of Closure No. 3 and that the bankline between that point and the eastern end of Closure No. 2 has eroded very severely and such that the "landbridge" between Vermilion Bay on the north of Marsh Island and the northwestern portion of Lake Sand proper is now narrow and may become subject to breaching thus allowing an undesirable water connection between the two bodies of water. LDNR and COE agree that this area is in poor condition and should be considered for maintenance at some point in time. It is recommended that an additional reach of shoreline protection dike be constructed, an estimated 1,500 to 1,800 linear feet, to connect the western end of Closure No. 3 to the eastern end of Closure No. 2. This reach of bank has been recently surveyed and the estimated cost for rock dike and flotation is approximately \$800,000. LDNR and COE agreed that due to this area being of concern but not yet critical status; and budget constraints, this maintenance work would be undertaken at a later time. (Photos: Appendix B, Photos 3 & 4).

Photo 3, Area between West End of Closure No.3 and East End of Closure No.2, showing narrow section of marsh requiring shoreline protection.

Item	Condition	Physical Damage	Corrosion	Photo #	Observations and Remarks
Steel Bulkhead / Caps	N/A				
Steel Grating	N/A				
Stop Logs	N/A				
Hardware	N/A				
Timber Piles	N/A				
Timber Wales	N/A				
Galv. Pile Caps	N/A				
Cables	N/A				
Signage / Supports	N/A				
Rip Rap (fill)	Good			3 & 4	Hurricane RITA eroded the marsh between Str. No. 2 & 3, leaving a narrow piece of marsh, and it is recommended that the shoreline between Str. 3 & 4 (+/- 1,500 to 1,800 L.F.) be armored with a rock dike.
Earthen Embankment	N/A

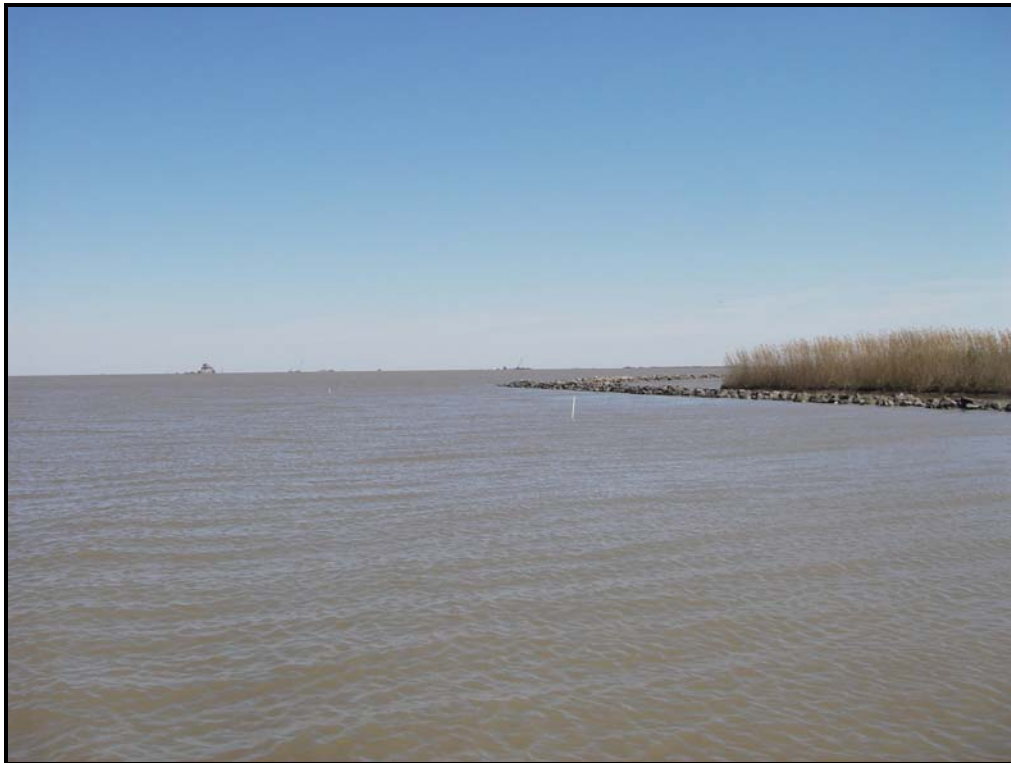
Photo 4, Closure No. 3, View looking east, Lake Sand Dike in the background.

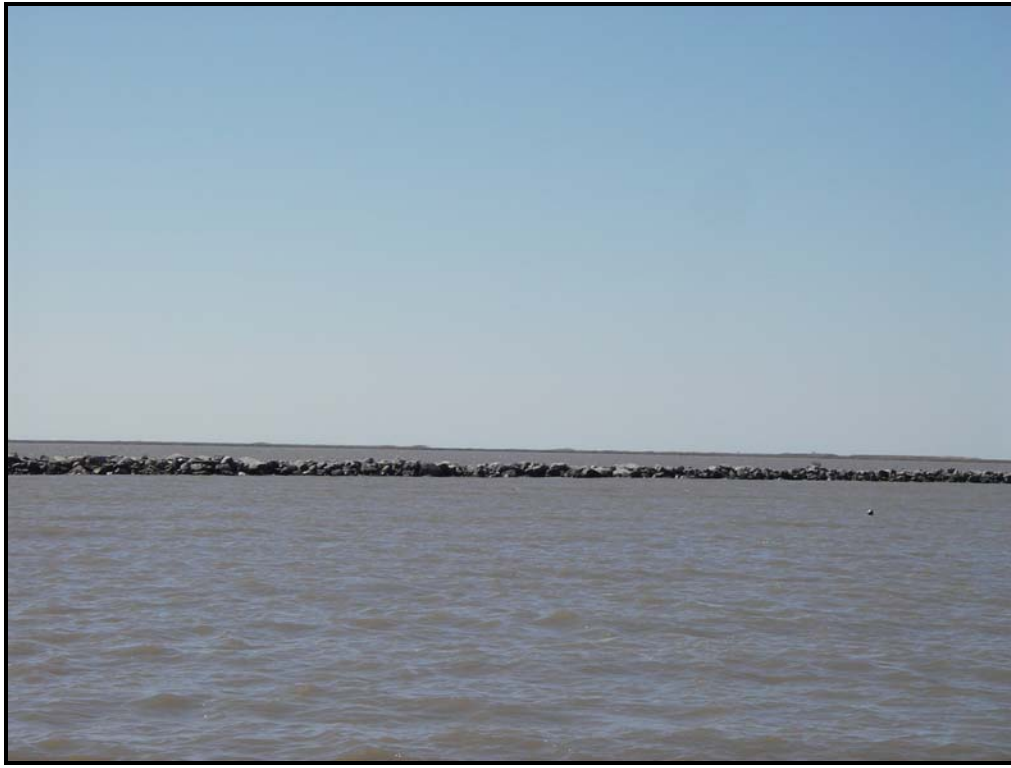
The Lake Sand Dike closure as originally constructed and recently repaired for Hurricane LILI damages, appears in good condition and the stone appears to have not suffered major displacement except for some of the eastern reach where some of the stone, which had existed to +4.0 NAVD88, appears to be a bit low in elevation. This latter reach is several hundred feet in length and the most easterly tie-in bank has been reduced in cross-section for 80 to 100 feet. LDNR and COE agree that this area is deficient and maintenance will be required sometime. The low areas described above in the reach within the old dike that was to +4.0 elevation will need to be restored with rock riprap, though bank protection is still being afforded by the existing stone shoreline protection. (Photos: Appendix B, Photo 5).

Photo 5, Typical view of Lake Sand Closure No. 4.

Item	Condition	Physical Damage	Corrosion	Photo #	Observations and Remarks
Steel Bulkhead / Caps	N/A				
Steel Grating	N/A				
Stop Logs	N/A				
Hardware	N/A				
Timber Piles	N/A				
Timber Wales	N/A				
Galv. Pile Caps	N/A				
Cables	N/A				
Signage / Supports	N/A				
Rip Rap (fill)	Good	Minor		5	Several hundred feet of the rock dike on the eastern end has been displaced and will need to be restored to constructed height of +4.0.
Earthen Embankment	N/A

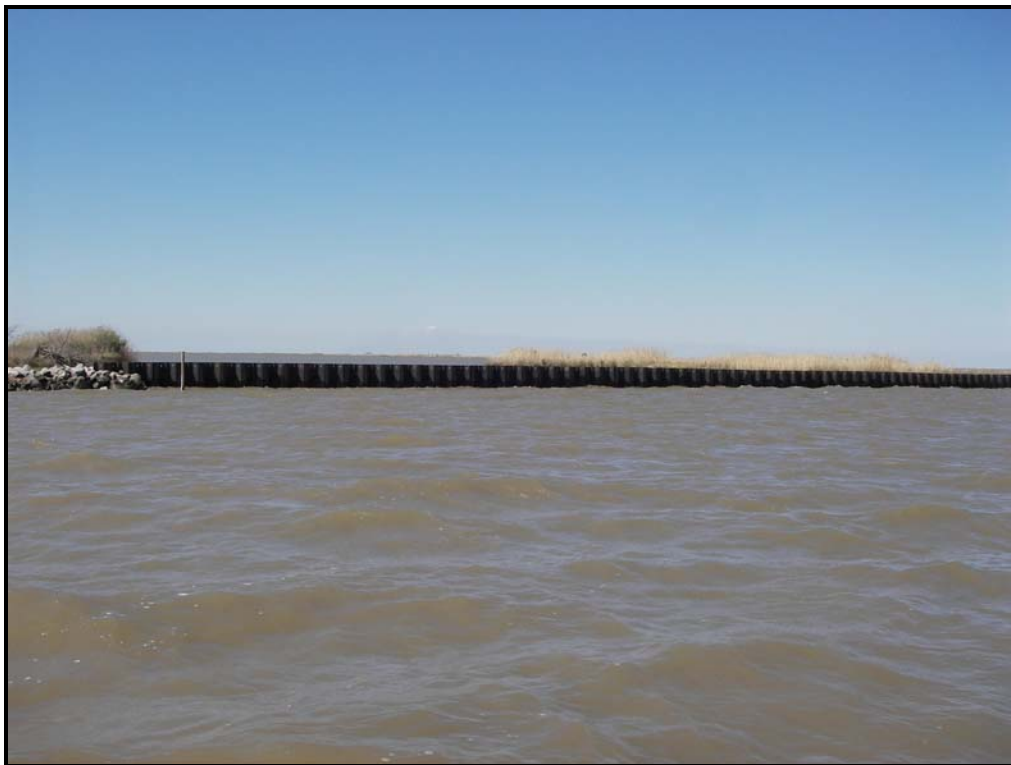
The inspection at Closure No. 5 revealed there had been some degradation of the earthen/marsh areas in the adjacent marsh. The steel sheet pile, rock riprap wingwalls, and stone bank/marsh paving placed as part of the Hurricane LILI repair project is in good condition and were apparently very effective in preventing additional damage by the erosive action of Hurricane RITA. The staff gage needs to be re-set and made plumb to provide accurate readings. This work will be a part of a survey effort to be performed within the next year. The overbank marsh areas paved to make same “hard” and paid for with O & M funding needs to be continually evaluated for its effectiveness. Marsh overbank areas, especially on the

north end of the structure sustained much erosion in areas not protected by the “hard” paving, such that it is possible that the unpaved area to the north end of the closure may not be wide enough to withstand many more years without experiencing storm induced breaching. (Photos: Appendix B, Photo 6).

Photo 6, Closure No. 5. View of center portion of structure showing sheet pile wall.

Item	Condition	Physical Damage	Corrosion	Photo #	Observations and Remarks
Steel Bulkhead / Caps	N/A				
Steel Grating	N/A				
Stop Logs	N/A				
Hardware	N/A				
Timber Piles	N/A				
Timber Wales	N/A				
Galv. Pile Caps	N/A				
Cables	N/A				
Signage / Supports	N/A				
Rip Rap (fill)	Good			6	Staff gage leaning, needs to be re-set. Marsh overbank area on the north needs to be evaluated for possible extended marsh paving.
Earthen Embankment	N/A

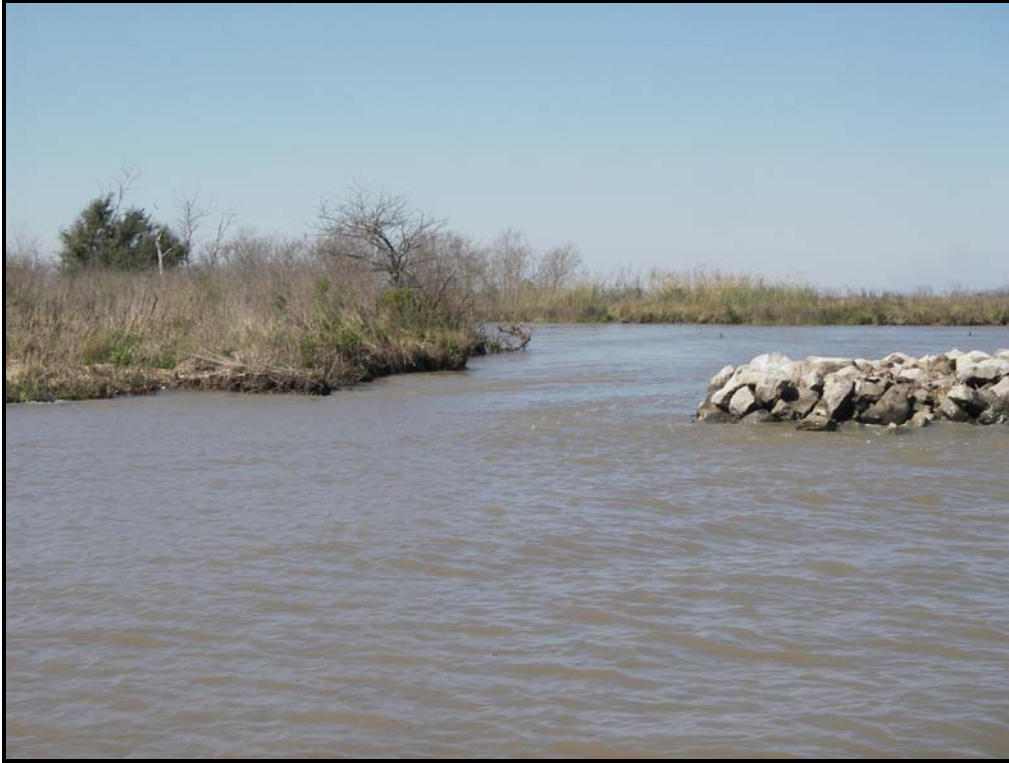
The initially constructed closure at this site still has an excellent cross-section, but the breach on the south end of the closure has been enlarged by Hurricane RITA. The repair of same is included in an upcoming maintenance contract currently being developed. (Note: the breach was discovered approximately one month prior to RITA and was narrow and about two feet in depth). The breach is now larger, post RITA, and approximately one foot deeper in depth. On the north end of the closure, the erosion of the marsh area was sustained at the dike tie-in location, to an extent that it is predicted that “flanking” of the closure has occurred. LDNR and COE agree that this area is deficient and maintenance will be required at this time. The existing flanking channel cut needs to be plugged off by extending the rock riprap closure to the south with stone. Cost will be shared with FEMA such that a channel breach existed pre-RITA. It is the opinion of this office that the cost sharing proportions would be equitable if shared at 1/3 State and 2/3 FEMA as the storm event made the pre-existing flanking breach wider and deeper in about those proportions. Also, as a recommended additional preemptive work, each resulting end of the closure dike will be paved and made “hard” per discussion for Closure No. 1. Again this work is currently being designed for a maintenance contract to be performed this year. (Photos: Appendix B, Photo 7).

Photo 7, Closure No. 6. Note breach on south end of closure stone fill. Breach had begun prior to Hurricane RITA, but was not as wide.

Item	Condition	Physical Damage	Corrosion	Photo #	Observations and Remarks
Steel Bulkhead / Caps	N/A				
Steel Grating	N/A				
Stop Logs	N/A				
Hardware	N/A				
Timber Piles	N/A				
Timber Wales	N/A				
Galv. Pile Caps	N/A				
Cables	N/A				
Signage / Supports	N/A				
Rip Rap (fill)	Poor	Major		7	The existing breach on the southern end has increased in size and depth and needs to be plugged. Some erosion on northern end of rock plug which will need marsh paving to harden this area.
Earthen Embankment	N/A

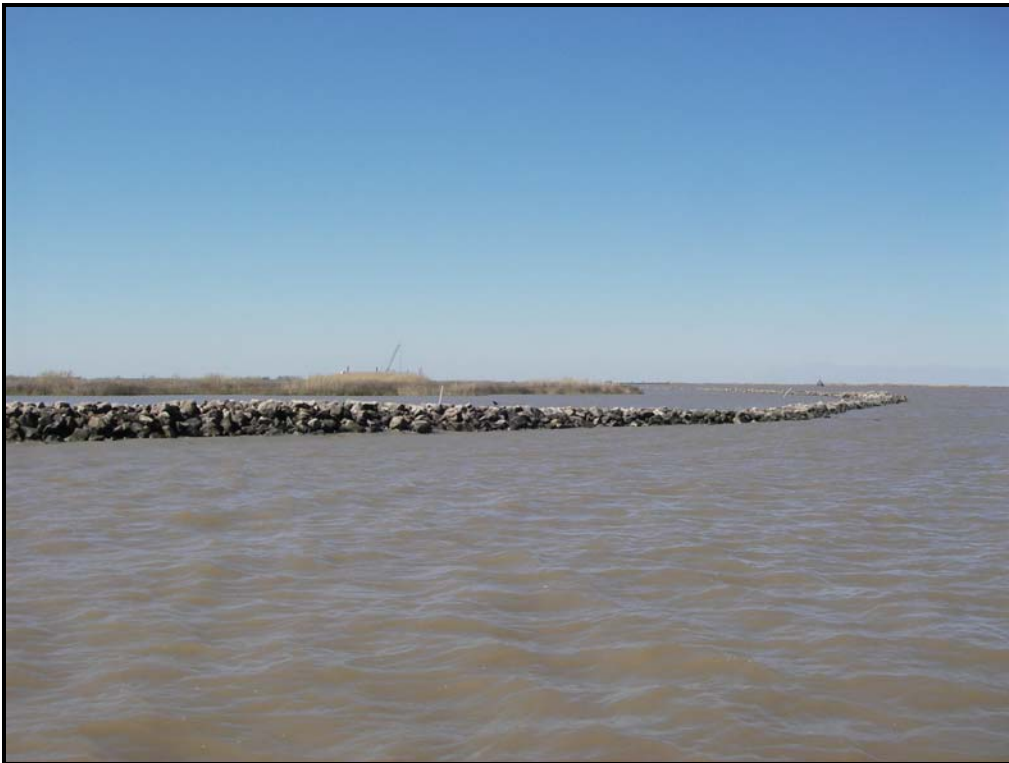
This closure site is in good condition except that the bank areas at both ends of the rock riprap have experienced some minor erosion. The closure tie-ins to the bank, however, appear still adequate at this time. LDNR and COE agree that this area is in good condition and no maintenance will be required at this time. (Photos: Appendix B, Photo 8).

Photo 8, Shoreline protection at Site No. 7.

Item	Condition	Physical Damage	Corrosion	Photo #	Observations and Remarks
Steel Bulkhead / Caps	N/A				
Steel Grating	N/A				
Stop Logs	N/A				
Hardware	N/A				
Timber Piles	N/A				
Timber Wales	N/A				
Galv. Pile Caps	N/A				
Cables	N/A				
Signage / Supports	N/A				
Rip Rap (fill)	Good			8	
Earthen Embankment	N/A

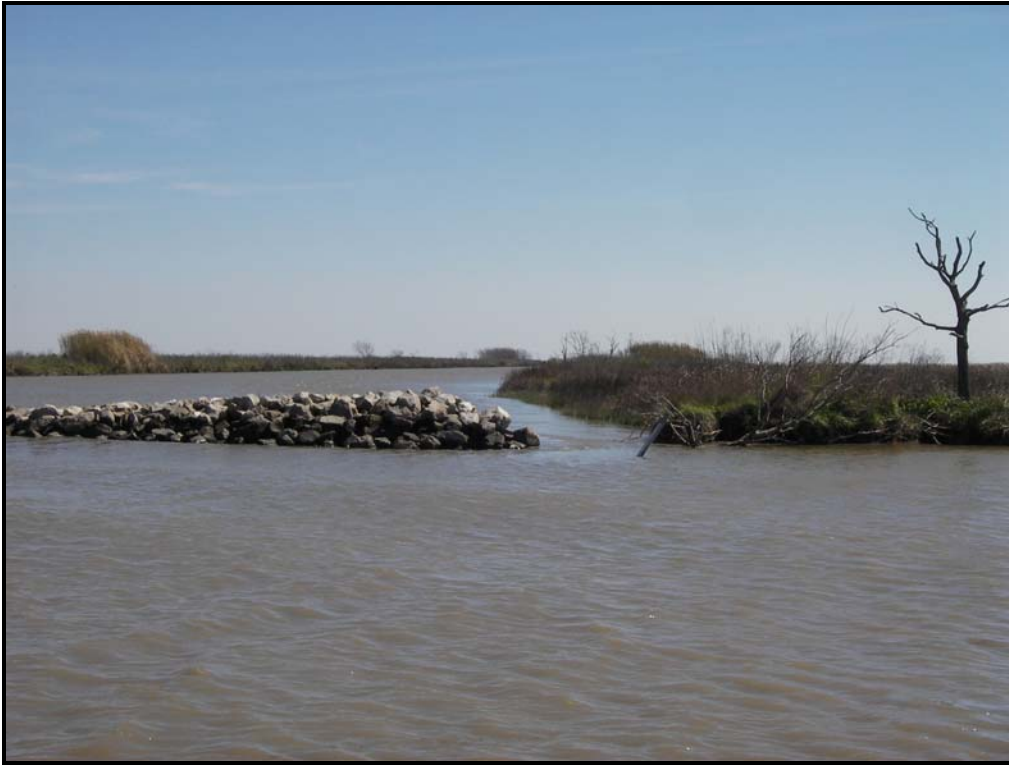
This closure site is in good condition however a very small breach was discovered on the southern end of the rock closure that will need to be addressed. LDWF indicated that Renaissance Petroleum Co., LLC has requested a “Letter of Clearance” to dredge the oilfield canal adjacent to Closure No. 8 and place the spoil material on the eastern shore of the canal up to the southern end of this closure. LDWF will inquire about the possibility of spoil from this dredging project could be used to plug the small breach and also to verify the expected timeline as to when this work will be performed. Should this option not be available, then we will include this work as part of the current proposed O&M maintenance project; however it will entail additional survey, design and permitting efforts. LDNR and COE agree that this project feature requires maintenance at this time. (Photos: Appendix B, Photo 9).

Photo 9, Closure No.8, View looking east showing breach on southern end of rock plug.

Item	Condition	Physical Damage	Corrosion	Photo #	Observations and Remarks
Steel Bulkhead / Caps	N/A				
Steel Grating	N/A				
Stop Logs	N/A				
Hardware	N/A				
Timber Piles	N/A				
Timber Wales	N/A				
Galv. Pile Caps	N/A				
Cables	N/A				
Signage / Supports	N/A				
Rip Rap (fill)	Moderate			9	A breach has occurred on the southern end of the rock plug. A proposed oilfield dredging project may provide a means to closing this breach. If, not then additional surveying, design, & permitting required.
Earthen Embankment	N/A

- Closure No. 8 – fill in the small breach on the southern end of the rock plug.

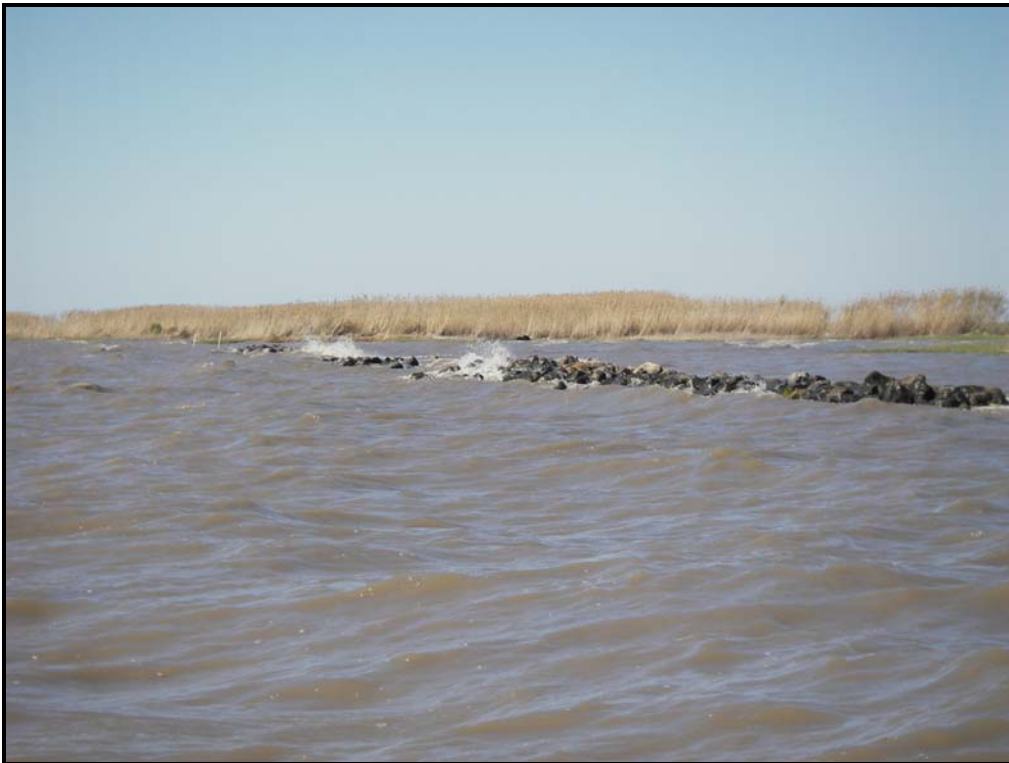
The rock riprap shoreline protection dike constructed on the south shoreline of Marsh Island was noted to now sit out further into the waters of the Gulf as discussed in the last inspection. Conditions that existed pre-RITA were such that the feature was functioning well and that sediment had accreted and a growth of marsh vegetation had extended over the new fill. This rock shoreline feature will still function as a breakwater and extend the life of the earthen pipeline closure to the north. It was discussed that perhaps each end of the current rock riprap dike be extended to the east and to the west, or perhaps construct extensions on each end of the existing stone to the northwest and northeast alignment directions to the shoreline from erosion of the earthen pipeline closure. Conditions at this location need to be evaluated and a design for some east and west extensions of the current dike concluded after some study. (Photos: Appendix B, Photo 10).

Photo 10, Closure No. 9, Along south shore of Marsh Island. Note that shoreline protection dike is now away from the current shoreline post-RITA.

Item	Condition	Physical Damage	Corrosion	Photo #	Observations and Remarks
Steel Bulkhead / Caps	N/A				
Steel Grating	N/A				
Stop Logs	N/A				
Hardware	N/A				
Timber Piles	N/A				
Timber Wales	N/A				
Galv. Pile Caps	N/A				
Cables	N/A				
Signage / Supports	N/A				
Rip Rap (fill)	Poor	Moderate		10	Hurricane RITA has eroded the marsh/sediment behind the rock plug and has exposed the earthen keyway to further erosion. The rock dike needs to be extended on each end and tie back into existing shoreline.
Earthen Embankment	N/A
