**2007/2008 Annual Inspection
Report**

**SEDIMENT TRAPPING AT THE
JAWS PROJECT (TV-15)**

State Project Number TV-15
Priority Project List 9

April 1, 2008
St. Mary Parish

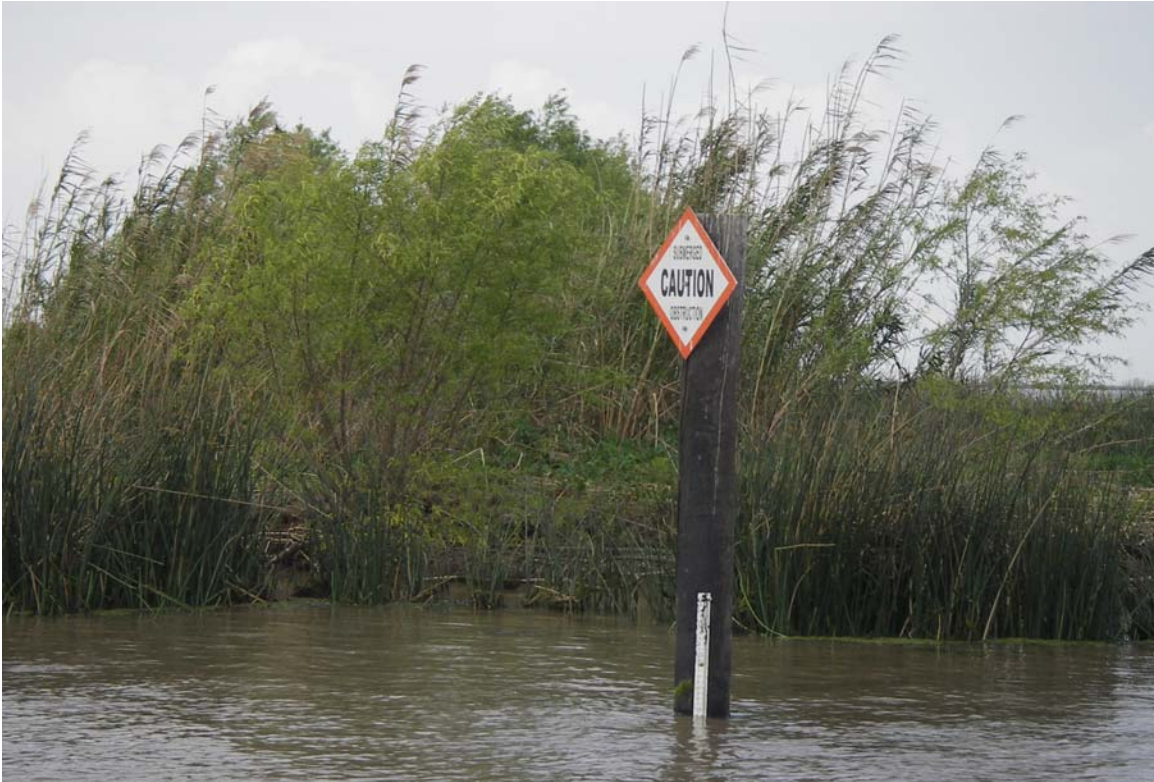
Photo 1—typical terrace and warning sign

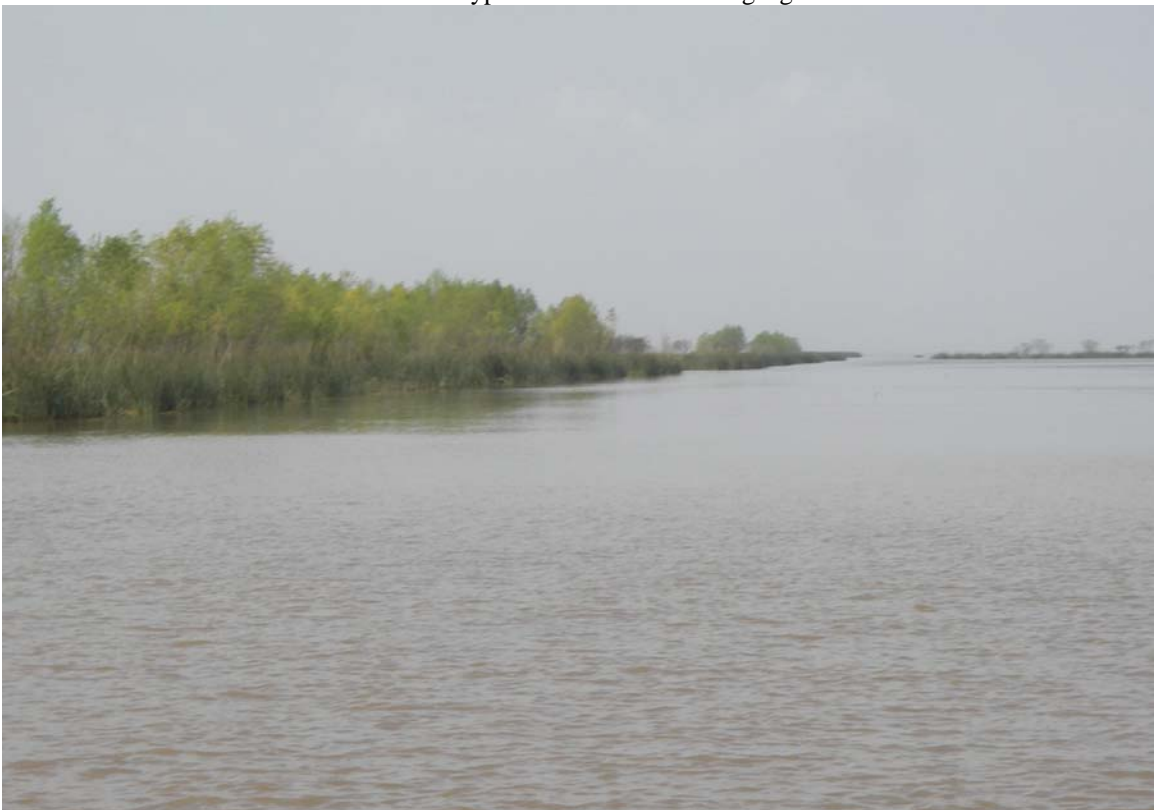
Photo 2—typical terraces

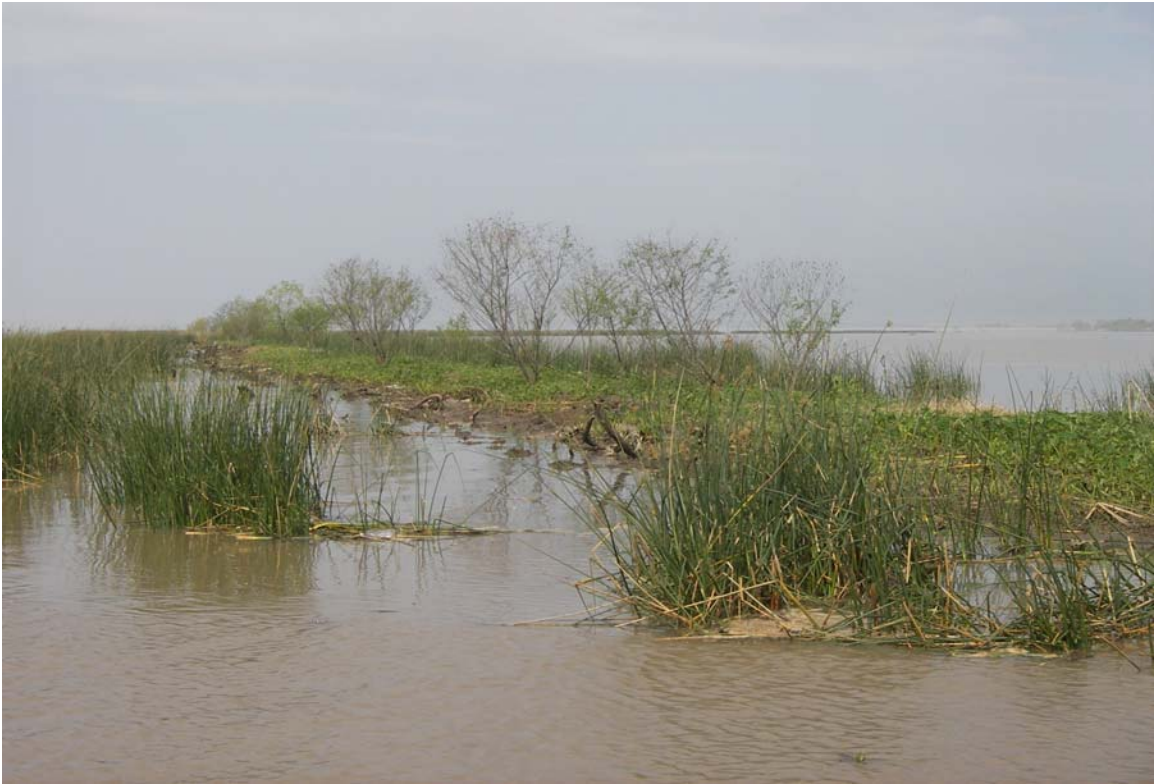
Photo 3—expanding vegetation

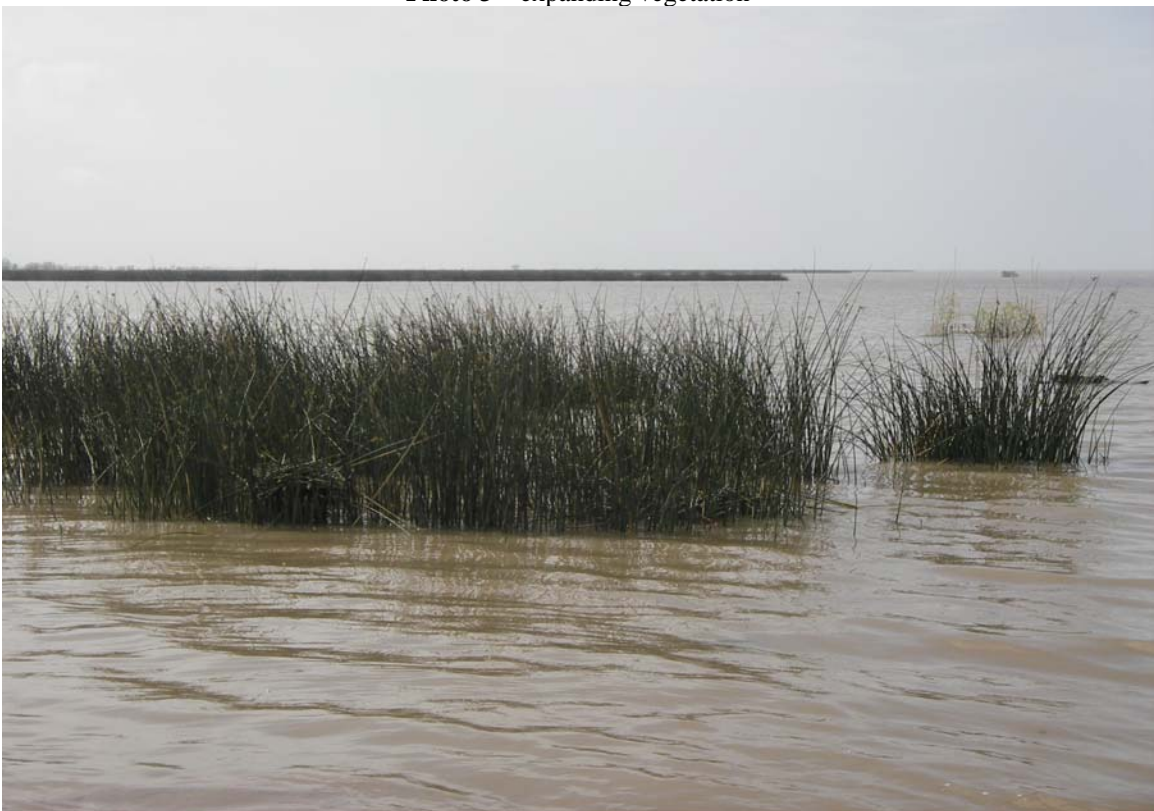
The terraces appear to be in excellent post-construction condition. Settlement on the ends of the terraces, furthest from the main channel of the Jaws, is significant but still functional. Warning signs were all in place and stable. Nutria rats were seen throughout the terrace field, feeding on the vegetation. Since water levels were slightly elevated, submerged and emergent aquatic vegetation between the terraces wasn't as visible as during last year's inspection but still exists. Channels remain

Photo 4—settled end of terrace
