**Coastal Protection and Restoration
Authority of Louisiana**

**2007/2008 Annual Inspection
Report**

**LAKE PORTAGE LAND
BRIDGE PROJECT
(TV-17)**

April 15, 2008
Vermilion Parish

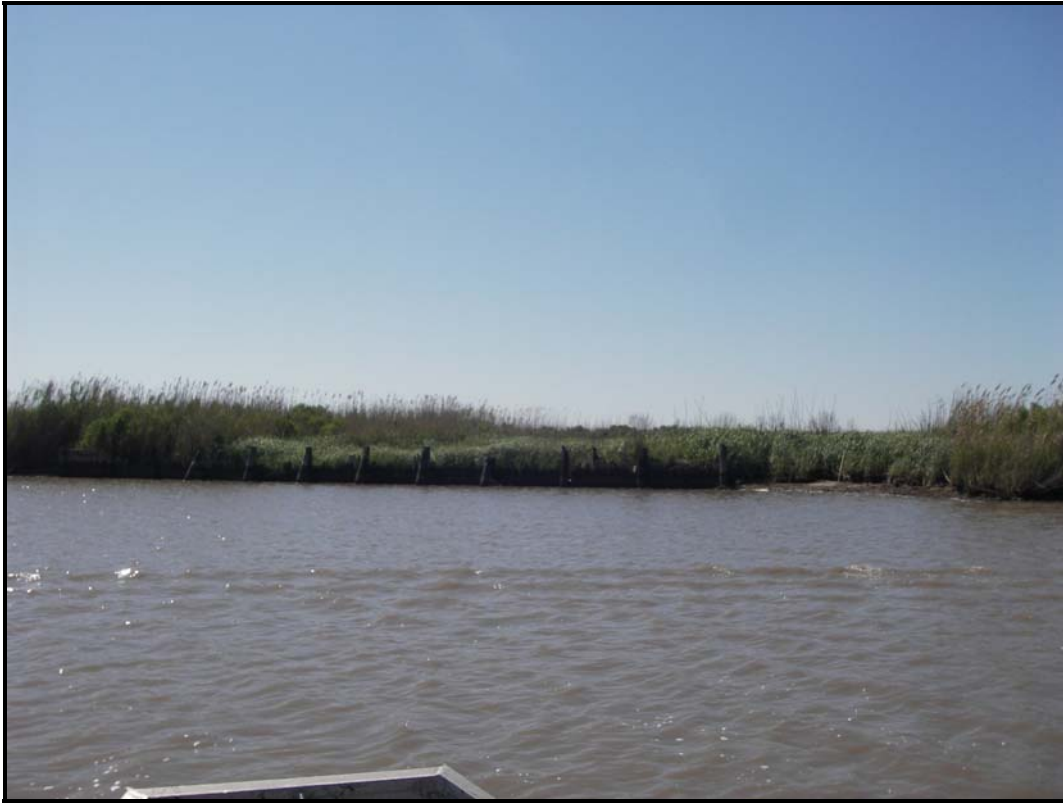
Area 1 is in good condition and vegetation has continued to expand from the containment banks moving towards the center of the channel and is 100 per cent vegetated. Salinity was measured at 1.6 ppt in Lake Portage near the bulkhead. As a result of the inspection of Area 1, LDNR and NRCS agree that no corrective actions will be required this year. (Photos: Appendix B, Photo 1).

Photo 1, Area 1, View looking south at timber bulkhead.

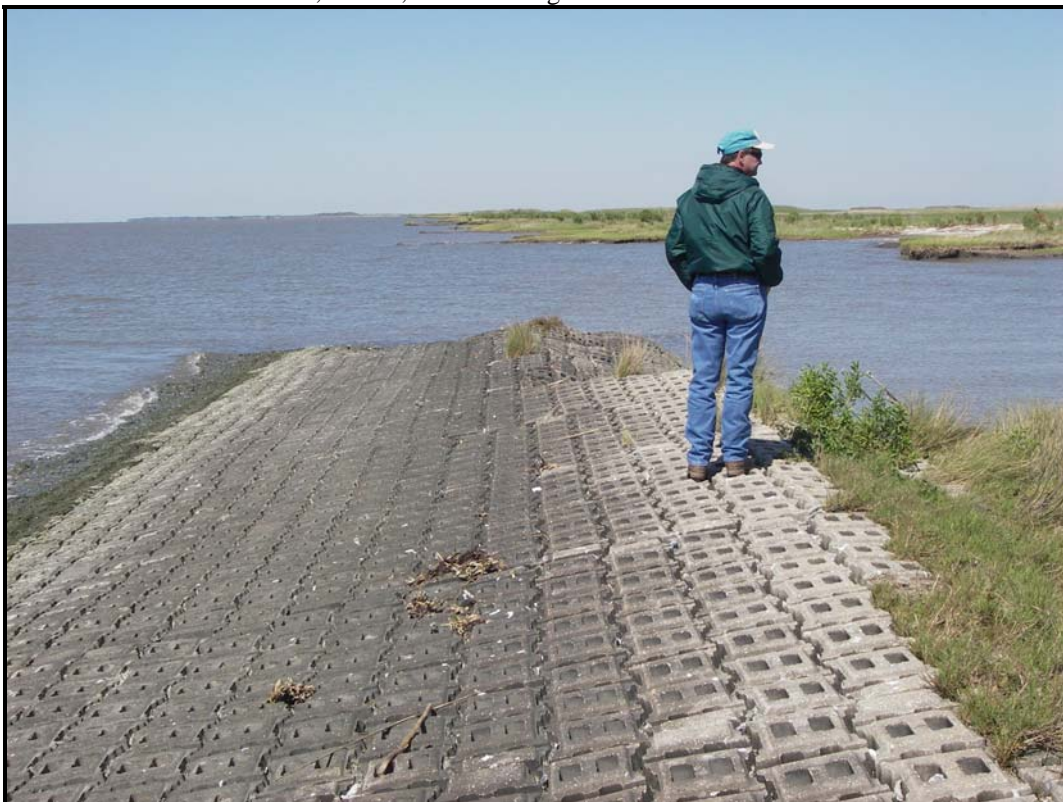
Area 2 is also in good condition and is fully vegetated, such that this reach was preexisting with additional dredge material added through this project to fill in any trenasses. Some erosion at the ends of the concrete mats along the Gulf shoreline has occurred over time and part of the mat system is showing signs of failure. Although the concrete mat system is not a feature to be maintained as part of this project, this area is experiencing erosion that may threaten the integrity of the overall project. Therefore, LDNR and NRCS agree that maintenance will be required at this time. (Photos: Appendix B, Photos 2, 3, 4 & 5).

Photo 2, Area 2, West side of concrete mats.

Item	Condition	Physical Damage	Corrosion	Photo #	Observations and Remarks
Timber Bulkhead / Caps	Good				
Steel Grating	N/A				
Salinity Readings					Area 1 Lake Portage - 1.6 ppt
Concrete Mats	Good			2,3,4	Some erosion each side of concrete mats along Gulf shoreline.
Timber Piles	Good				
Timber Wales	N/A				
Galv. Pile Caps	N/A				
Vegetation	Good			1,5,6	Area 3 fully vegetated, Area 2 existing vegetation, Area 1 fully vegetated.
Signage /Supports	Good				
Rip Rap (fill)	N/A				
Earthen Embankment	Good				
Dredge Spoil	Good				Slight settlement.

Overall, the Lake Portage Land Bridge Project is in good condition and functioning as designed. However, the erosion problem occurring at the Gulf shoreline will need to be addressed. Preliminary survey work to develop an accurate estimate of costs and subsequent CWPPRA funding request will be initiated in FY 2009.

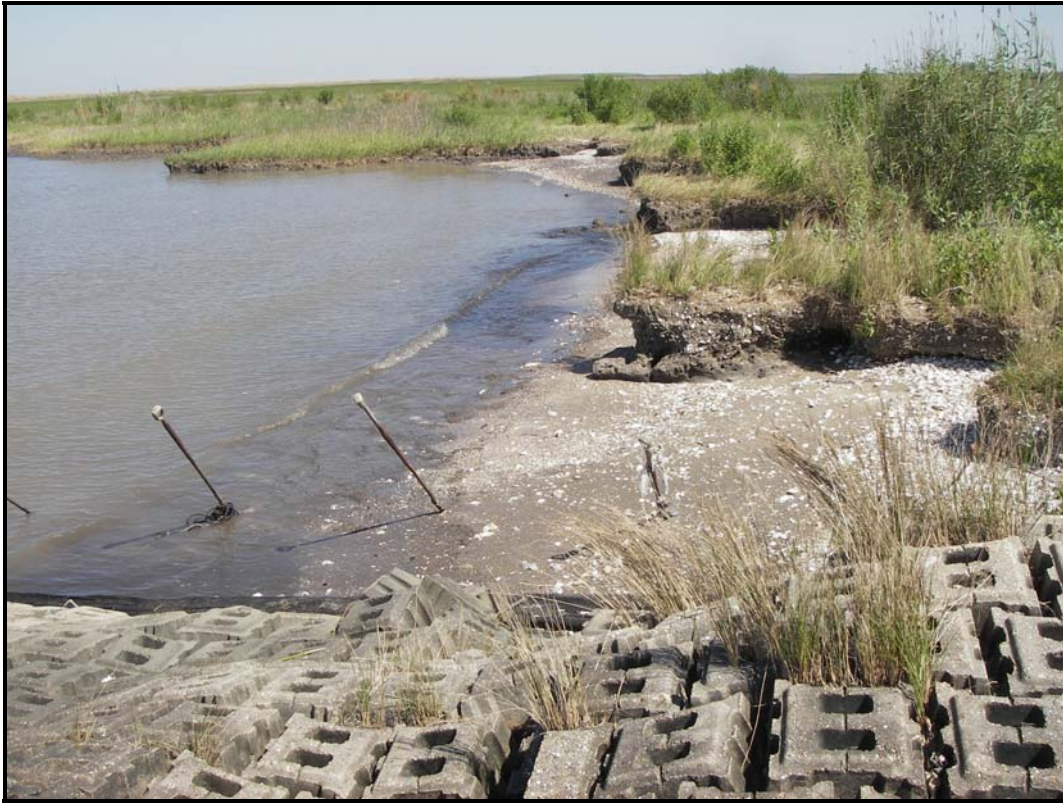
Photo 3, Area 2, Close up view of erosion on west side of concrete mats.

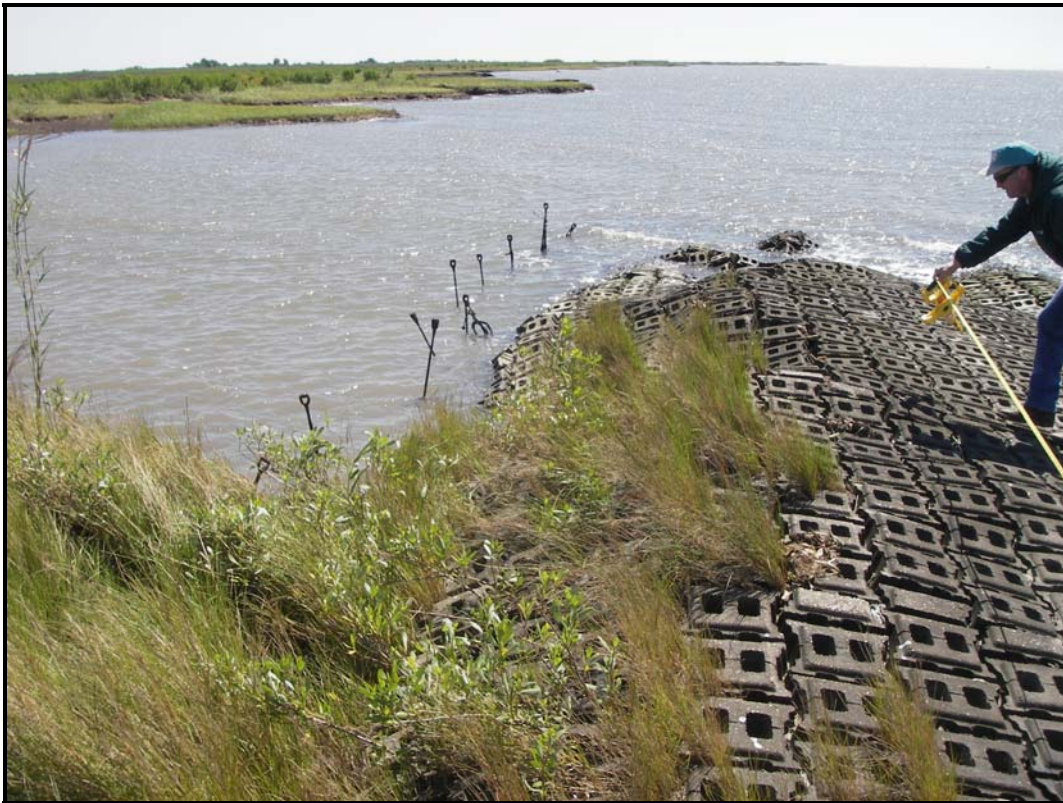
Photo 4, Area 2, East side of concrete mats.

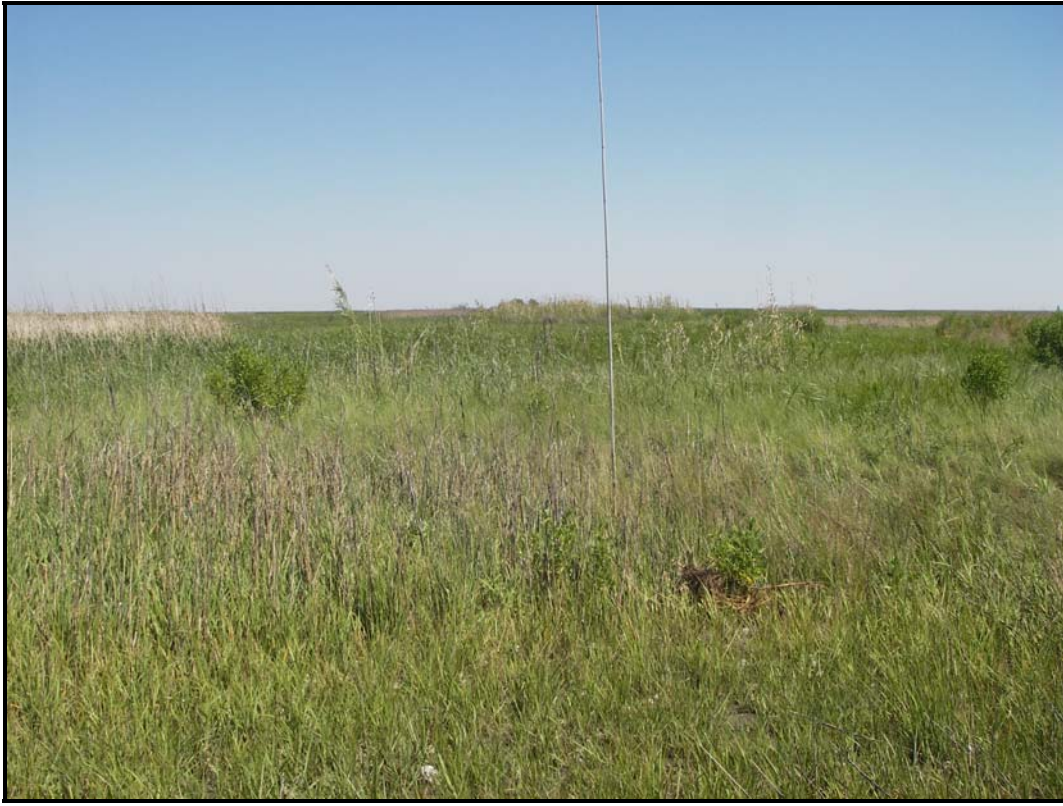
Photo 5, Area 2, View looking north.

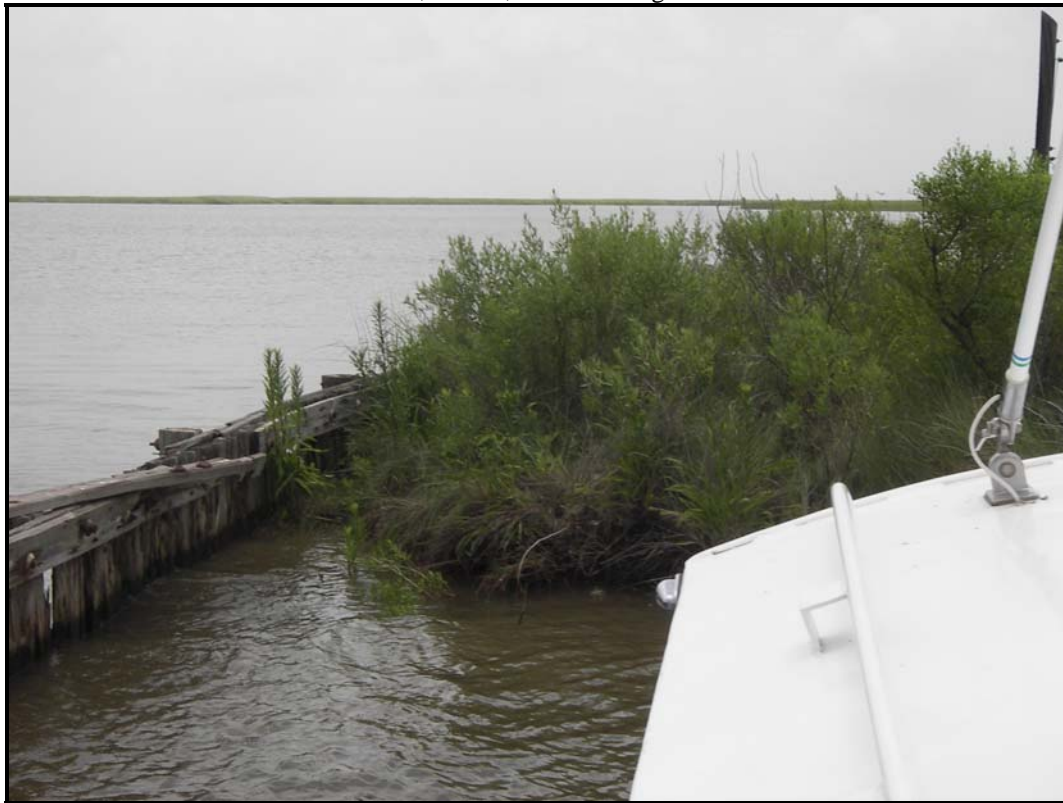
Area 3 also is in good condition. The northern part of this reach is fully vegetated, mainly due to the fact that this reach was constructed first, and has been in place since May, 2003. There is some minor erosion occurring on each side of the northern timber bulkhead which will need to be monitored on future annual inspections. LDNR and NRCS agree that this area is in good condition and no maintenance will be required at this time. (Photos: Appendix B, Photos 6).

Photo 6, Area 3, near bulkhead on north end.
