**State of Louisiana  
Department of Natural Resources  
Coastal Restoration Division**

**2006/2007 Annual Inspection  
Report**

**Bayou Chevee Shoreline Protection  
(PO-22)**

State Project Number PO-22  
Priority Project List 5

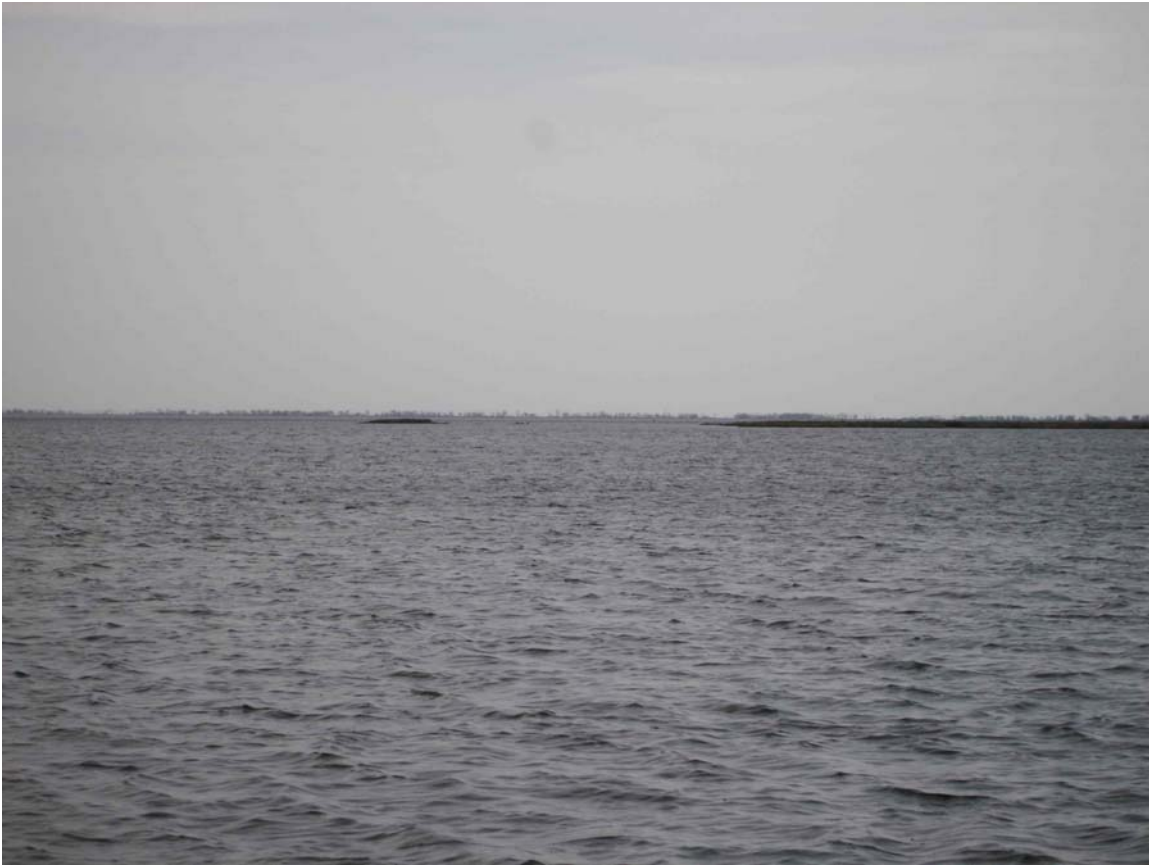
**Photo #1 – Shore Erosion.** Looking east toward Chef Pass. Erosion has separated this point of land from the shore beyond the end of the project area.

There is no need for any maintenance activity at this time. The marsh situation will continue to be monitored. Consider extending the rock dike at the South end to meet Chef Pass.

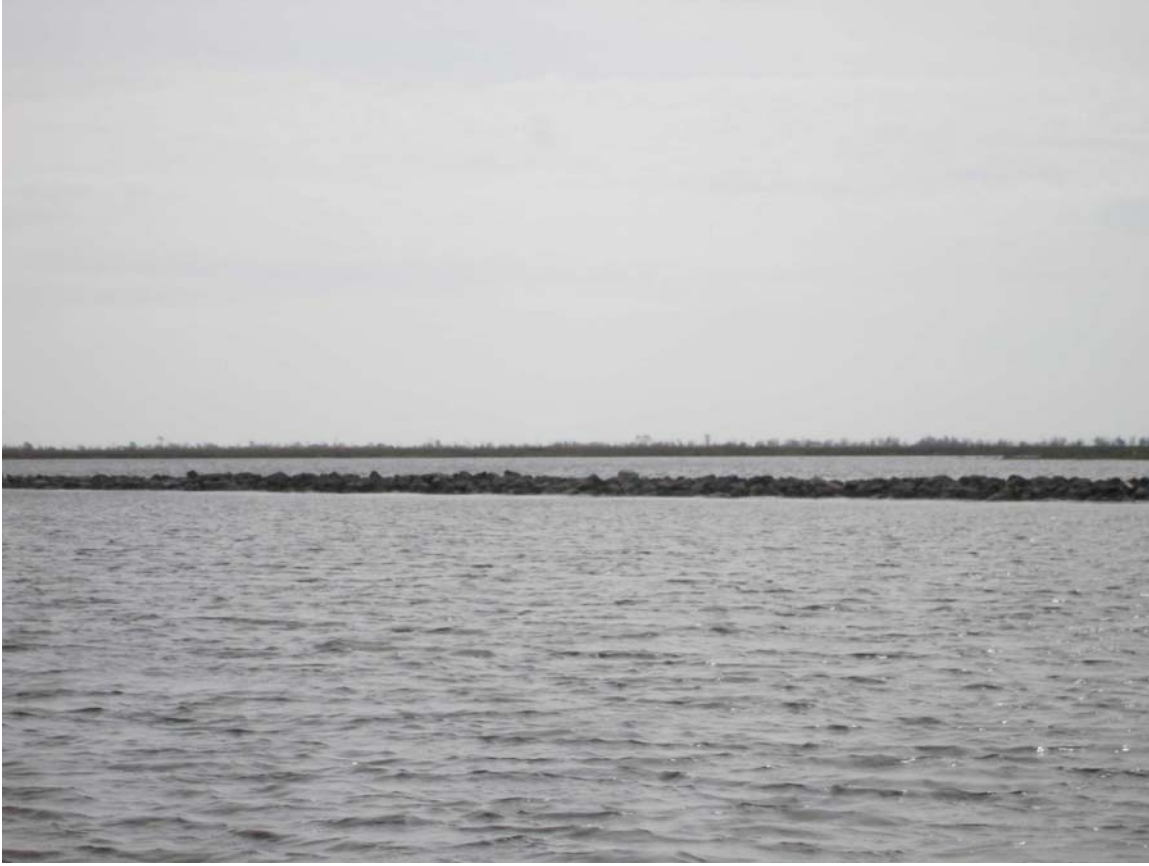
The structures on the North and South Coves appear to be performing as designed. The storm surge damage from Hurricane Katrina to the marsh inside of the project area is still evident. Most of that damage occurred in the South Cove section of the project, near Chef Pass, where the structure ends and leaves a portion of the cove exposed. Erosion of the marsh in this area appears to be continuing (see Photo # 1). This project would be greatly benefited by extending the structure on the South Cove to meet Chef Pass.

**Photo #2 – South Cove Marsh.** Notice the open water behind the rock dike.
