**State of Louisiana  
Department of Natural Resources  
Coastal Engineering Division**

**2006/2007 Annual Inspection  
Report**

**SABINE REFUGE PROTECTION  
PROJECT (CS-18)**

March 22, 2007  
Cameron Parish

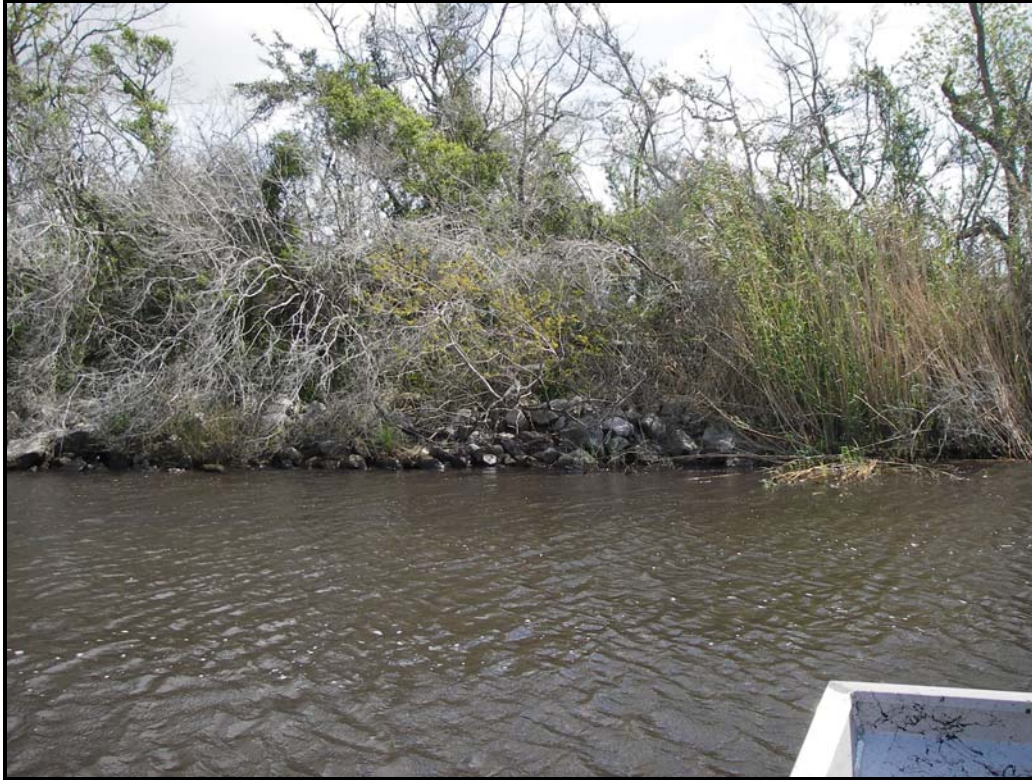
The rock breakwater along the Burton Sutton Canal was inspected along its entire reach. The water level in the Burton Sutton Canal was estimated to be +1.1 NAVD88. The dike is in excellent post construction condition. No need for any maintenance in the foreseeable future. (Photos: Appendix B, Photos 1 - 2)

Photo 1—southern tie-in on Burton Sutton Canal (March 22, 2007)

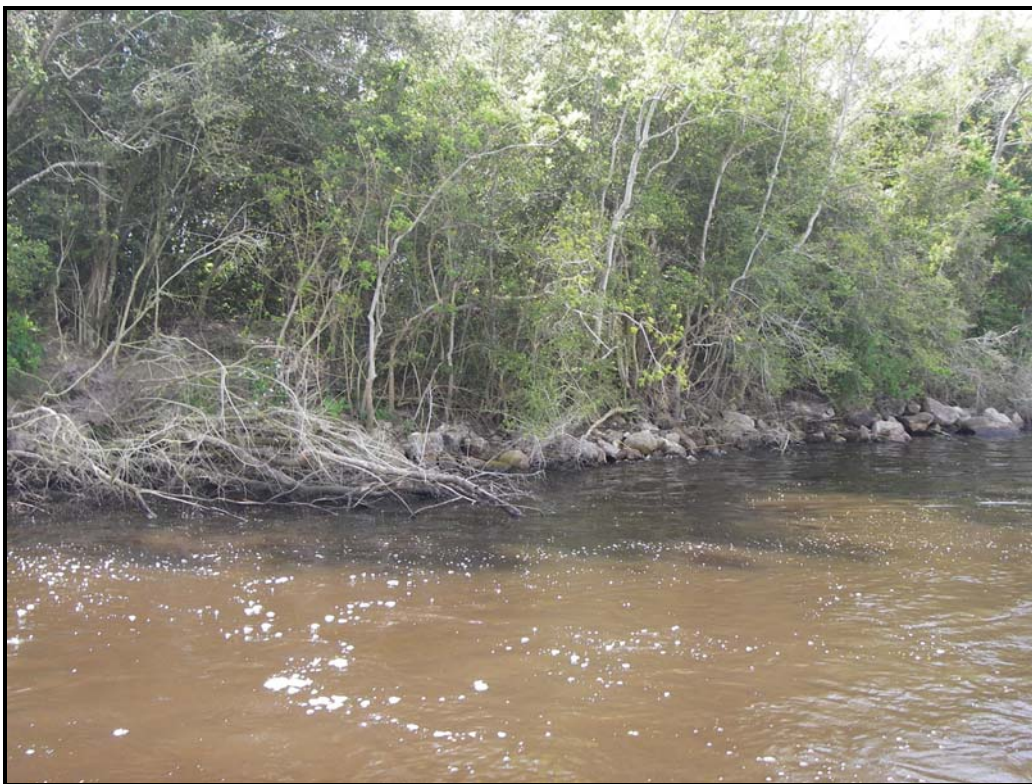
Photo 2—northern tie-in on Burton Sutton Canal (March 22, 2007)

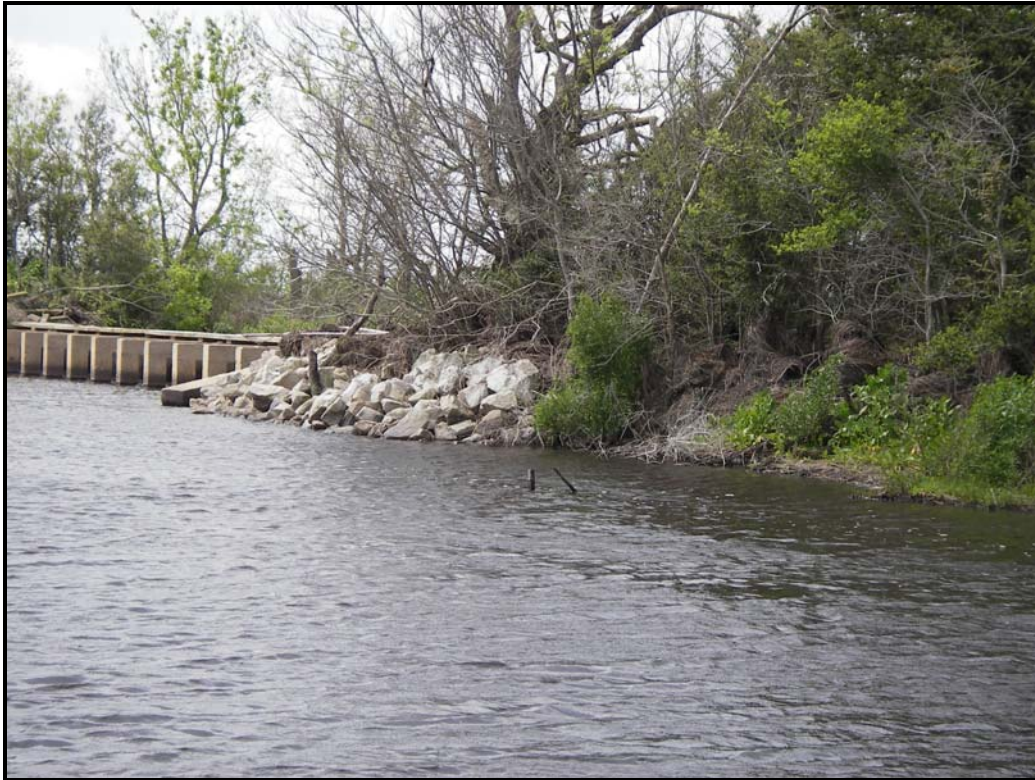
The weirs at Beach Canal Structure No. 2, Northline Canal Structure No. 3, and Stark's Central Canal Structure No. 4 were inspected for rock reinforcement at each wingwall. No maintenance required at any of the structures at this time. (Photos: Appendix B, Photos 3-8).

Photo 3—northern wingwall rock on Beach Canal Structure No. 2 (March 22, 2007)

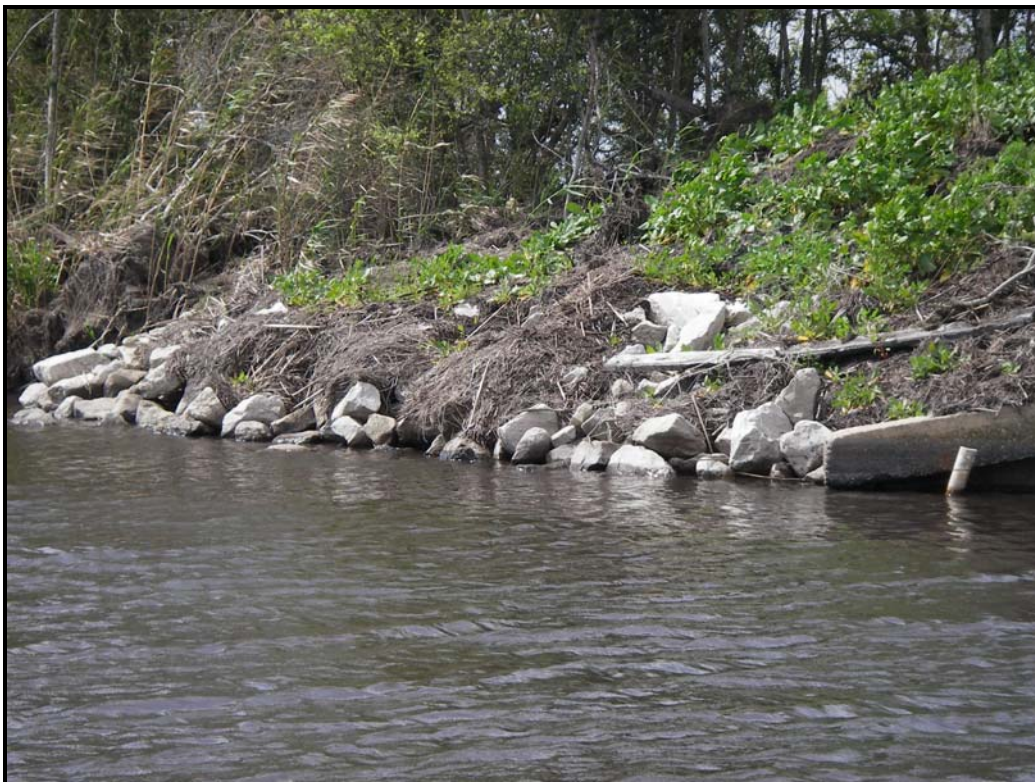
Photo 4—southern wingwall rock on Beach Canal Structure No. 2 (March 22, 2007)

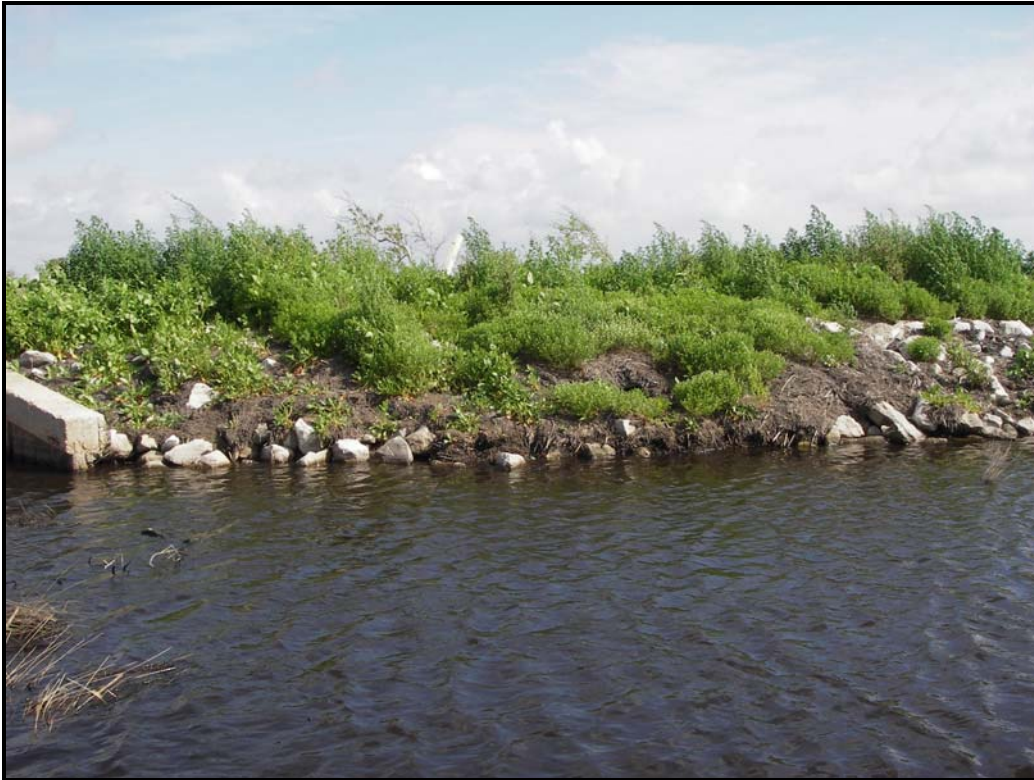
Photo 7 – eastern wingwall rock on Stark's Central Canal Structure No. 4 (March 22, 2007)

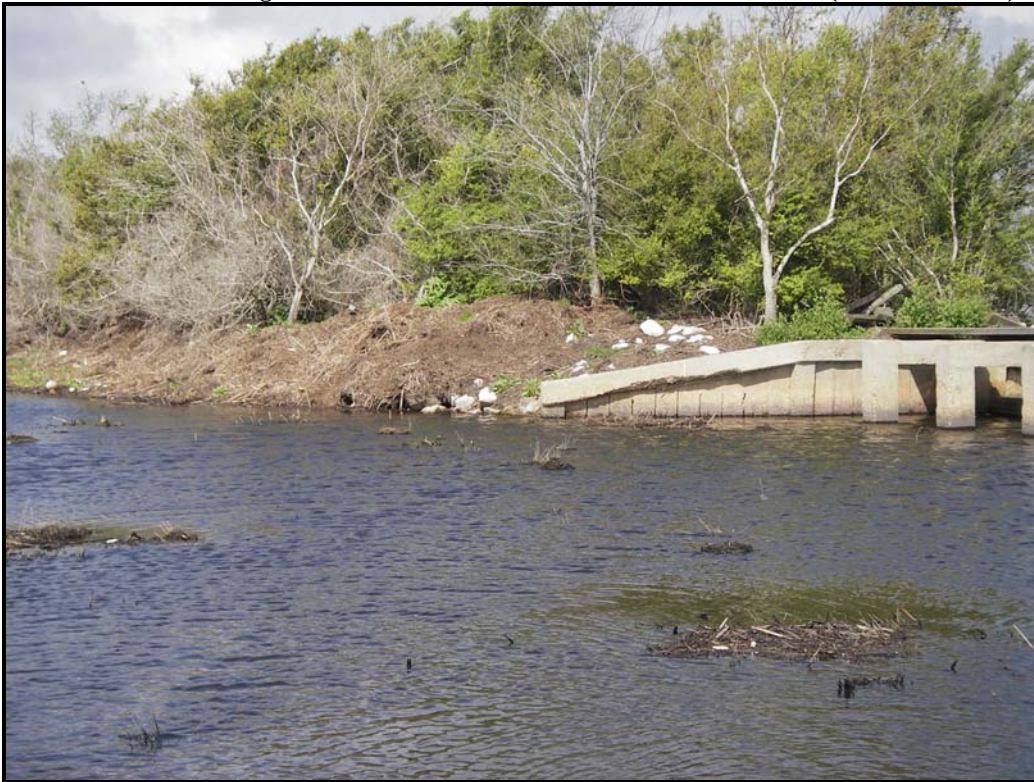
Photo 8 – western wingwall rock on Stark's Central Canal Structure No. 4 (March 22, 2007)

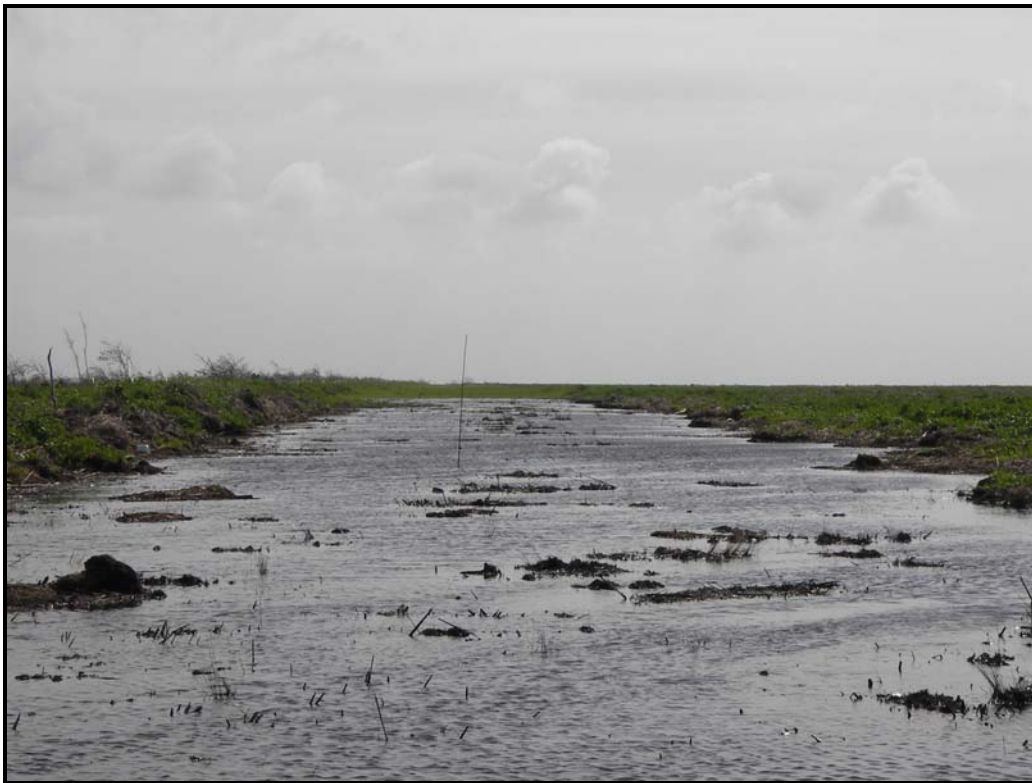
Portions of the Stark's Central Canal were clogged with wrack and debris from Hurricane RITA. USFWS plans to leave this material in place to help control water flow in the refuge. (Photos: Appendix B, Photo 9).

Photo 9 – Central Canal, view looking east, showing canal clogged with wrack and debris from Hurricane RITA which will remain in place. (March 22, 2007)
