**State of Louisiana
Department of Natural Resources
Coastal Engineering Division**

**2006/2007 Annual Inspection
Report**

**SABINE REFUGE STRUCTURE
REPLACEMENT PROJECT
(CS-23)**

March 22, 2007
Cameron Parish

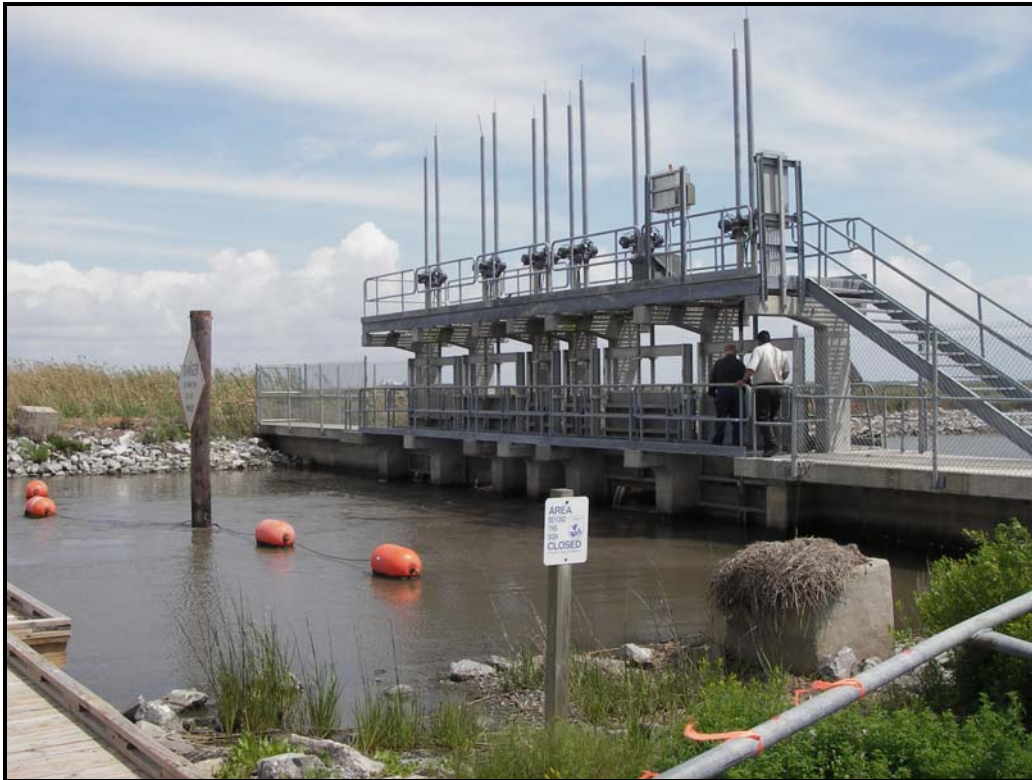
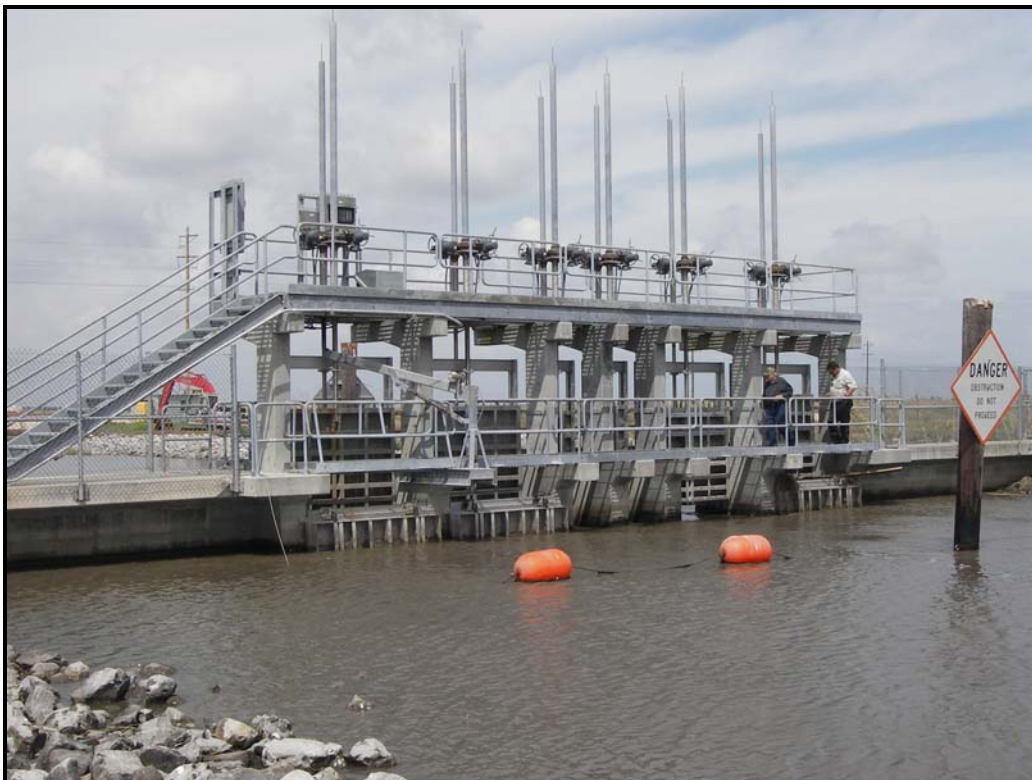
This structure is still not operable due to damage from Hurricane RITA in 2005. The security chain link fence has been replaced as described in the maintenance section above. The trash and debris on and around the structure has been cleaned up by others. The structure will require maintenance work to repair the gates with dual stem operation, repair the actuators,

add reinforcement to flanges, update electrical system, install bird excluder devices, and install lighting. (Photos: Appendix B, Photos 1 - 2)

Photo No.1, Inside view of Hog Island Gully Structure. (2007-03-22)

Photo No. 2, Lake side view of Hog Island Gully Structure. (2007-03-22)

Item	Condition	Physical Damage	Corrosion	Photo #	Observations and Remarks
Steel Bulkhead / Caps	N/A				
Steel Grating	Good				
Gates	Fair	Yes		1 & 2	Alignment problems.
Electrical	Poor	Yes			All electrical components demolished.
Hardware					
Fencing	Good				Chain link fence and posts replaced in June 2006.
Timber Piles	Good				
Timber Wales	N/A				
Actuators	Fair				All actuators will have to be taken apart and serviced.
Cables	Good				
Signage / Supports	Good				
Rip Rap					
Rock Dike	Good				
W.W. Reinf.					
Earthen Embankment	N/A

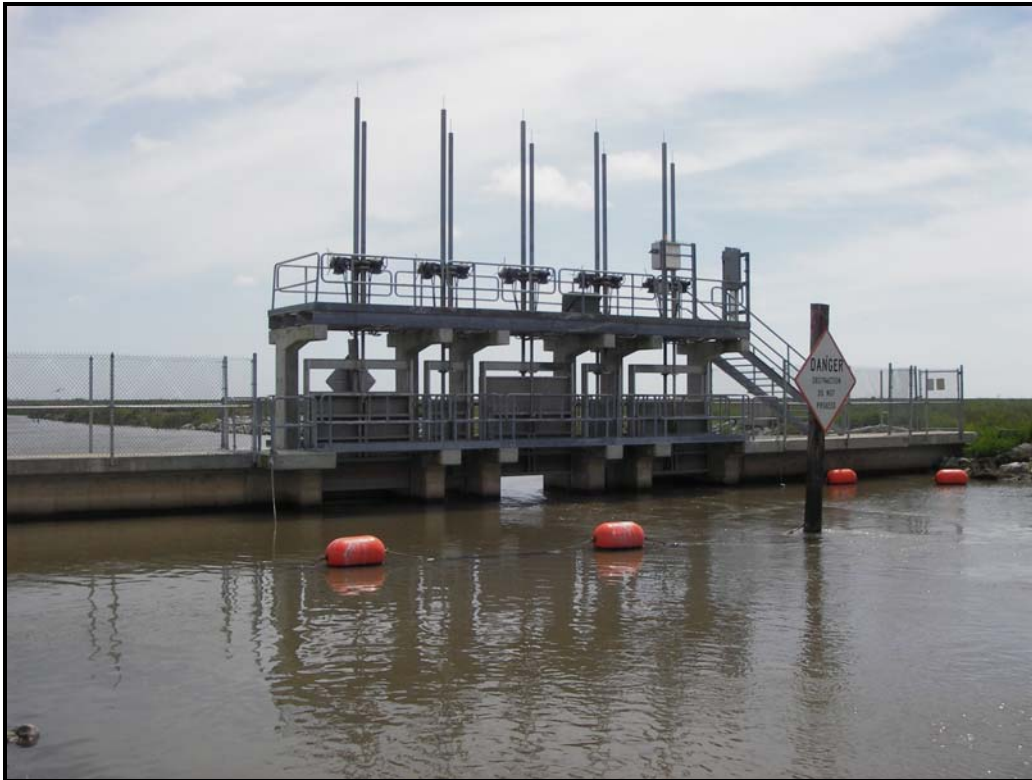
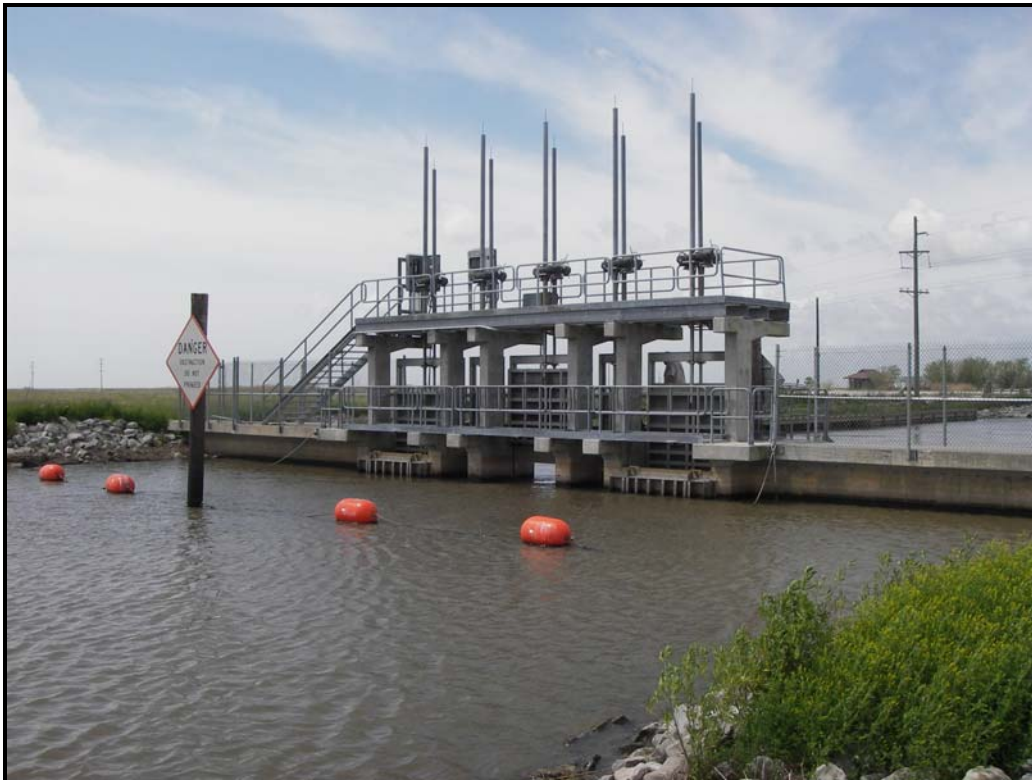
This structure is still not operable due to damage from Hurricane RITA in 2005. The security chain link fence has been replaced as described in the maintenance section above. The trash and debris on and around the structure has been cleaned up by others. The structure will require maintenance work to repair the gates with dual stem operation, repair the actuators, add reinforcement to flanges, update electrical system, install bird excluder devices, and install lighting. (Photos: Appendix B, Photos 3-4).

Photo No. 3, Inside view of West Cove Structure. (2007-03-22)

Photo No. 4, Lake side view of West Cove Structure. (2007-03-22)

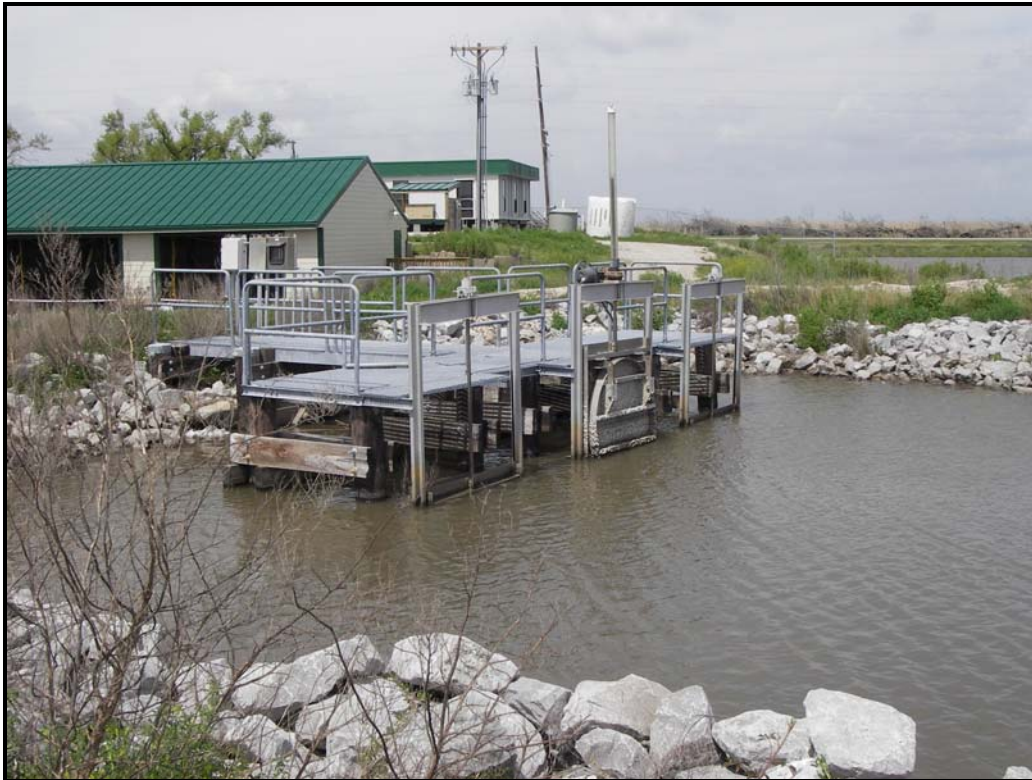
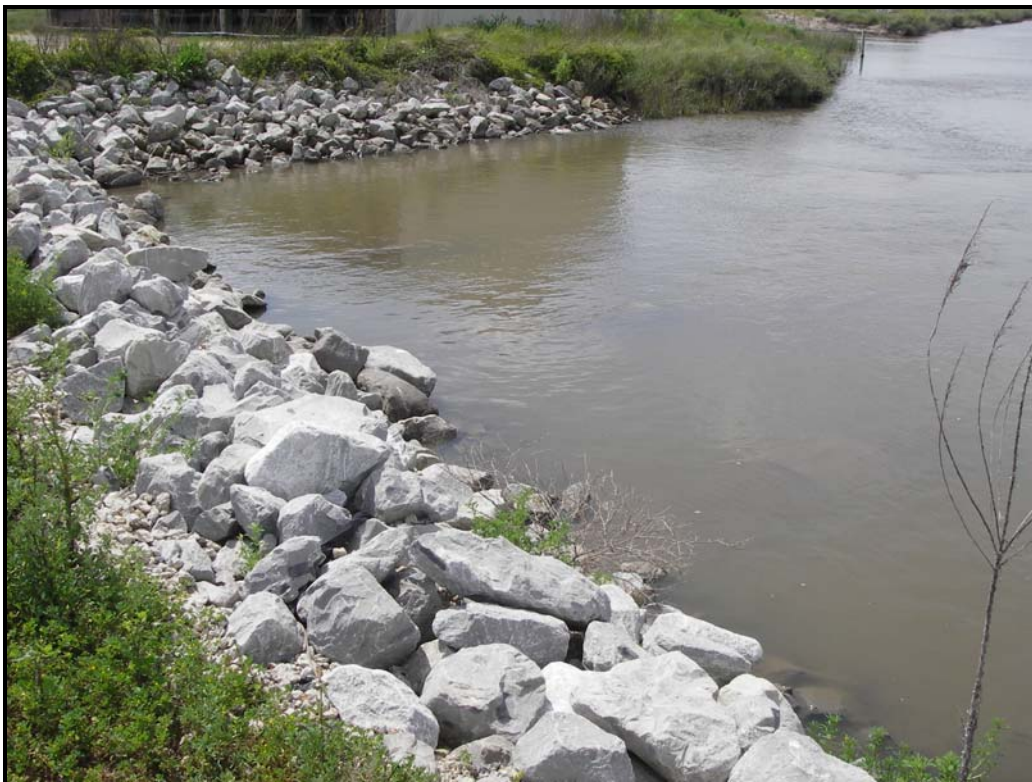
This structure is still not operable due to damage from Hurricane RITA in 2005. The trash on and around the structure has been cleaned up by others. The structure will require maintenance work to replace the electrical controls and repair the actuator on one of the gates. (Photos: Appendix B, Photos 5-6).

Photo No. 5, Inlet side of Headquarters Structure. (2007-03-22)

Photo No. 6, Outlet side of Headquarters Structure. (2007-03-22)
