**State of Louisiana  
Department of Natural Resources  
Coastal Engineering Division**

**2006/2007 Annual Inspection  
Report**

**CAMERON PRAIRIE REFUGE  
PROTECTION PROJECT  
(ME-09)**

November 02, 2007  
Cameron Parish

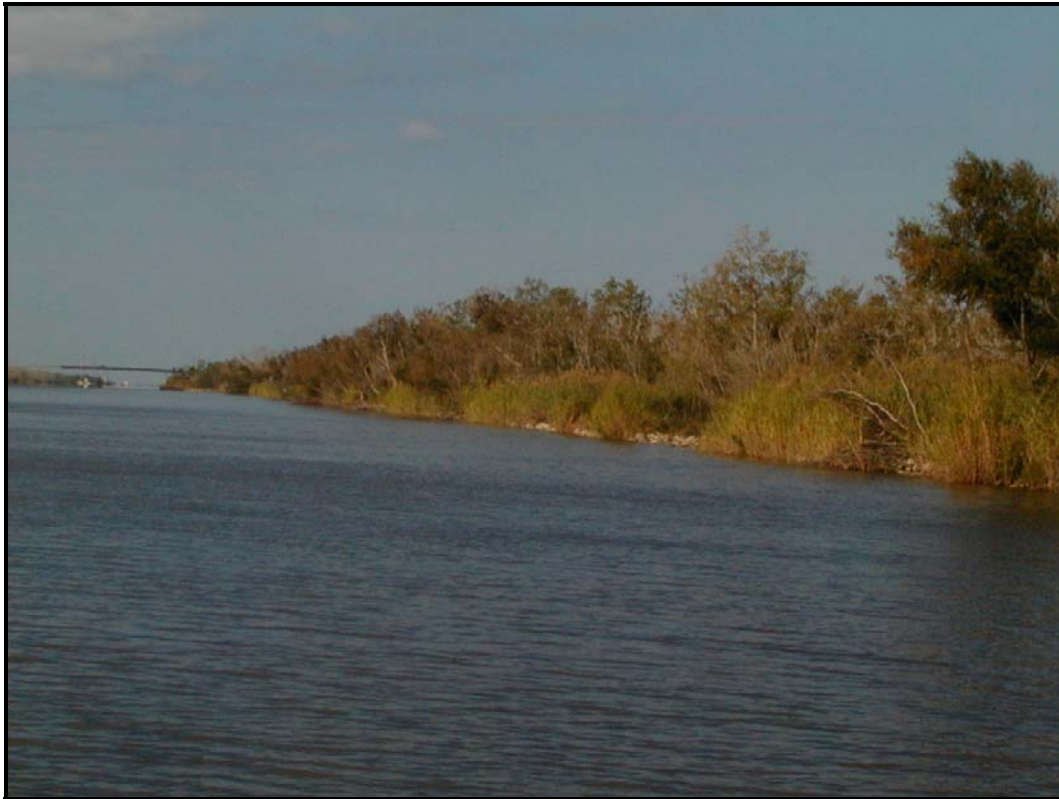
Photo 1, Tie in to North Prong Canal

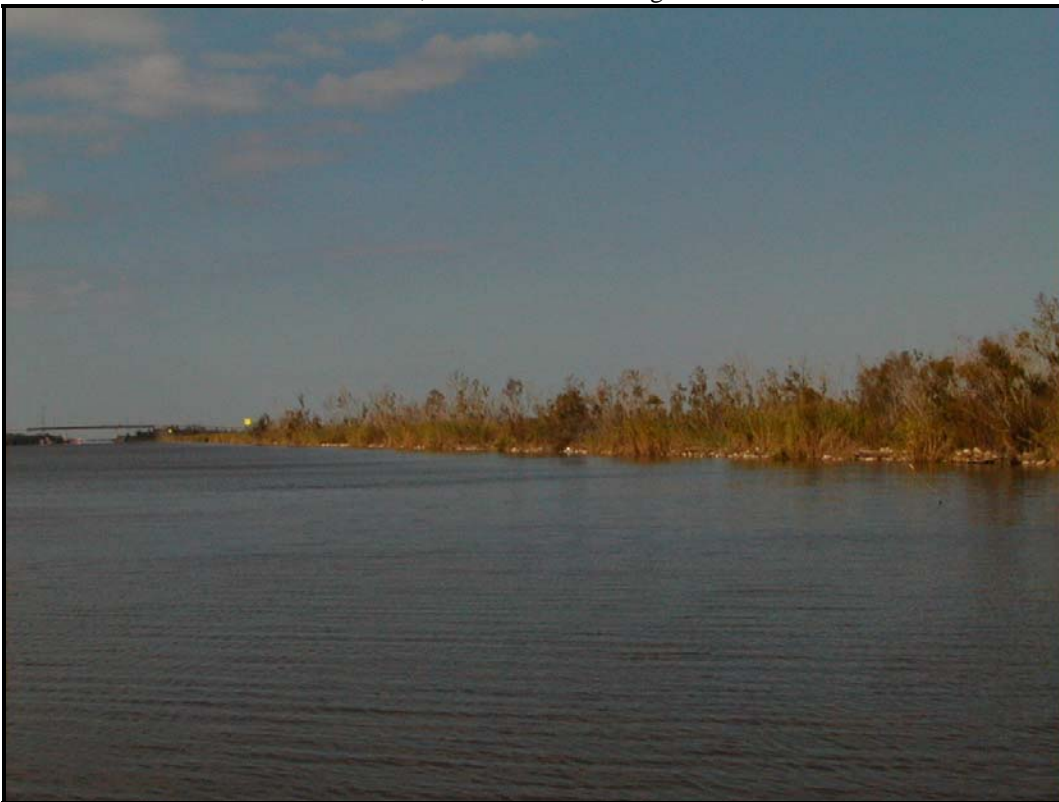
Photo2, Typical foreshore dike section.

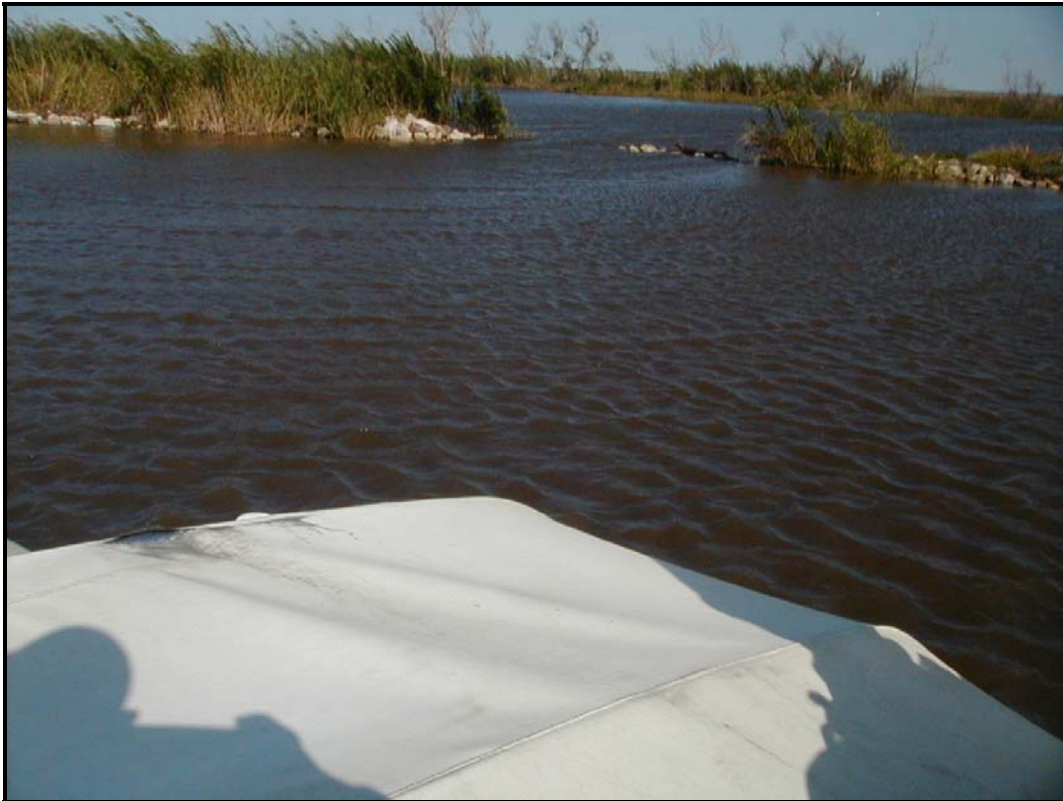
The foreshore rock dike is in excellent post construction condition. There is a short section of dike that is low with some displaced rock. Evidence of increased vegetation behind the foreshore rock dike was noted. No need for any maintenance in the foreseeable future however a staff gage is required. (Photos: Appendix B, Photos 1 - 3)

Photo 3, Low area/displaced rock area along dike.

| Item | Condition | Physical Damage | Corrosion | Photo # | Observations and Remarks |
|---|---|---|---|---|--|
| Rip Rap (fill) (foreshore dike) | Excellent | | | 1,2 & 3 | One area of dike is low with displaced rock. |
