**2006/2007 Annual Inspection
Report**

**Bayou Sauvage Refuge Restoration
Phase I
(PO-16)**

State Project Number PO-16
Priority Project List 1

July 18, 2007
Orleans Parish

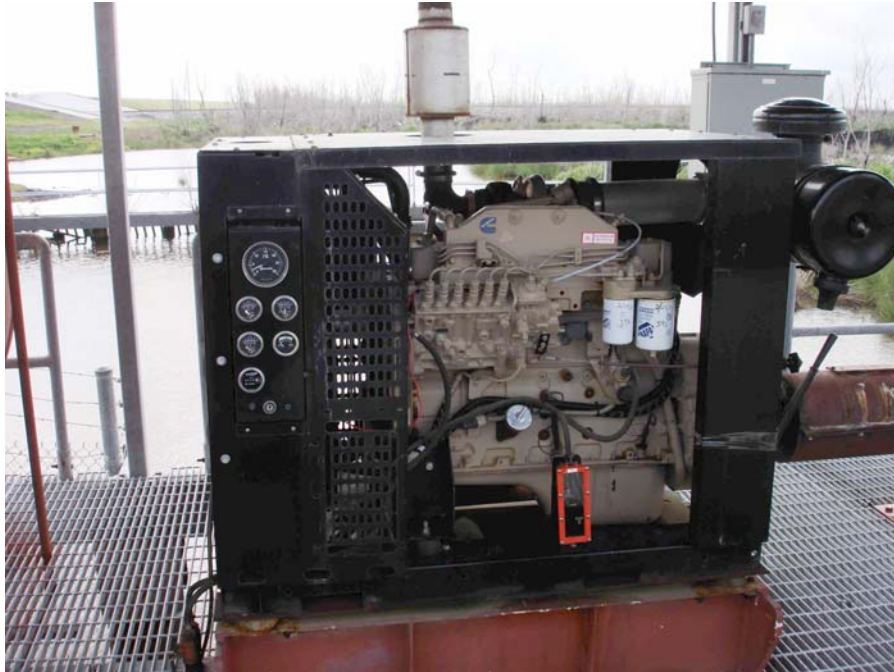
USFWS has replaced the pump and it is fully operational.

Photo #1 – CTU #5. New pump engine.

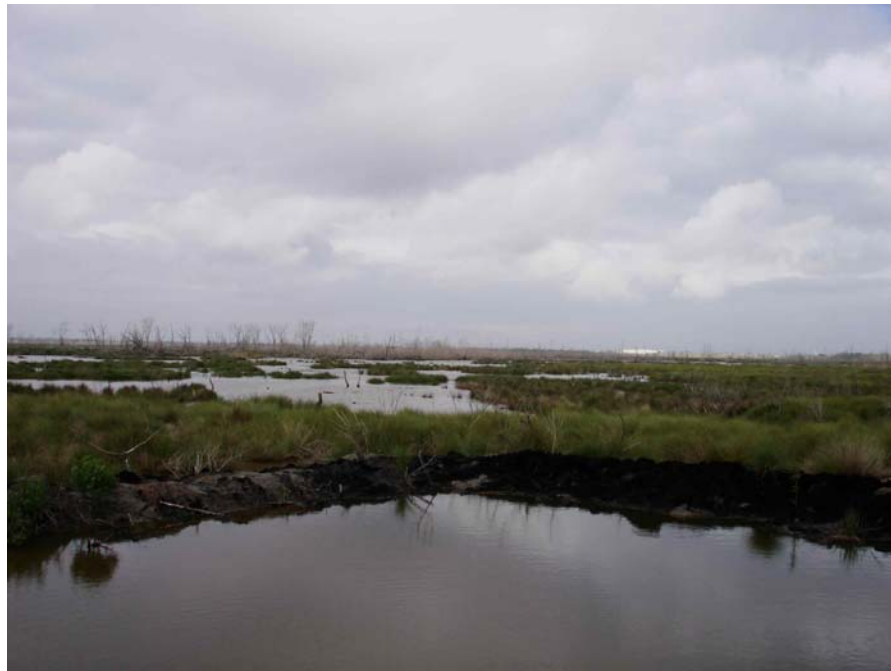
Photo #2 – CTU #5. Marsh beyond pump suction basin.

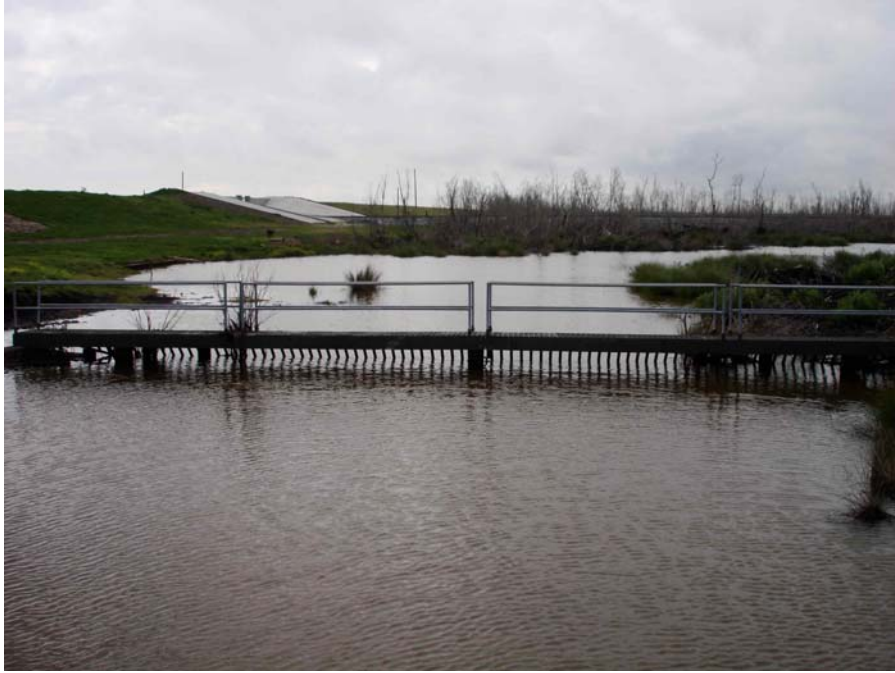
Photo #3 – CTU #5. Bar screen with railroad embankment and floodgate in background.

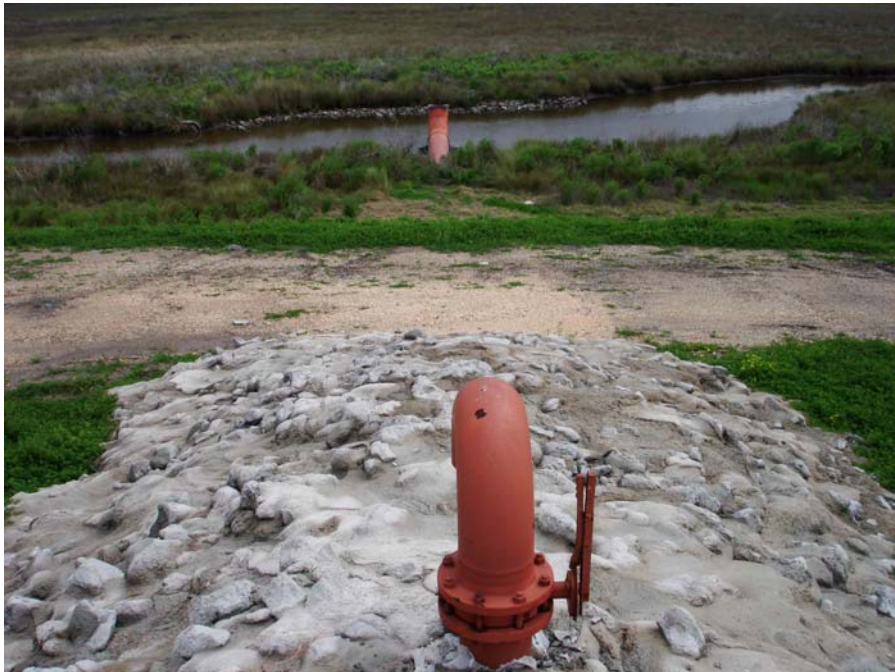
Photo #4 – CTU #5. Pump discharge pipe crossing under levee.

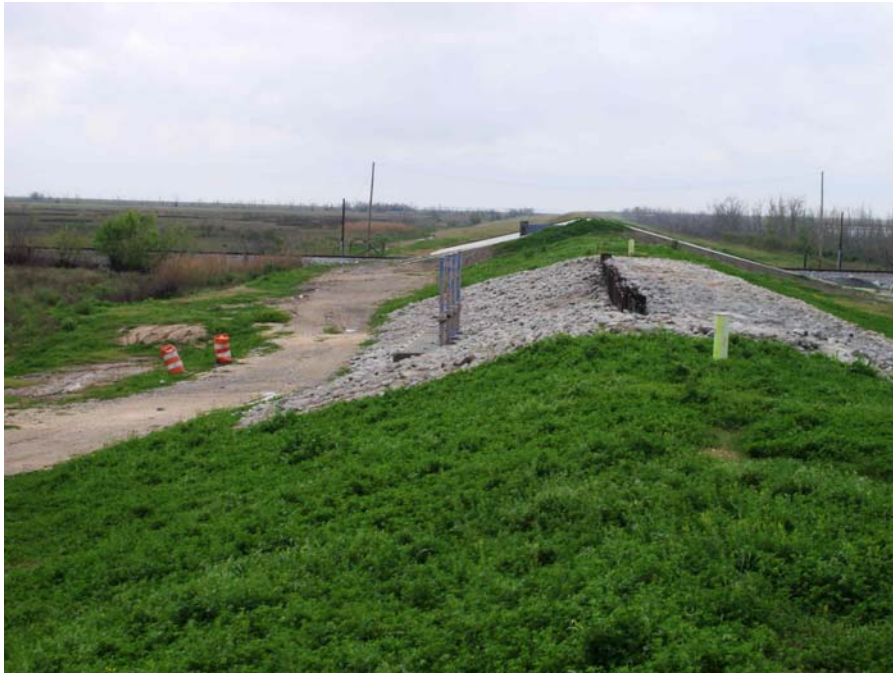
Photo #5 – Near CTU #5. Lake Pontchartrain water inlet valves. Not a project feature.

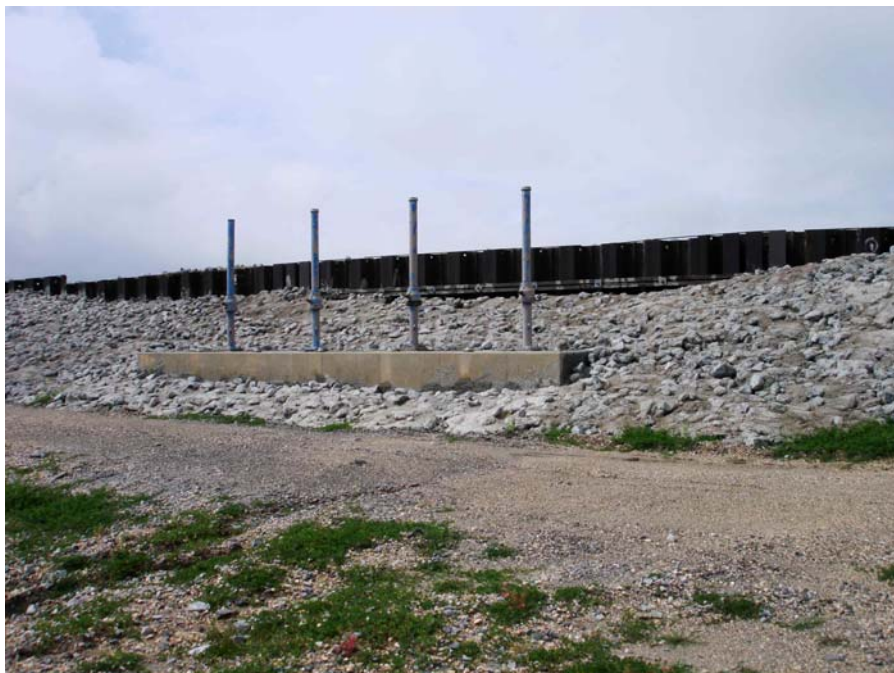
Photo #6 – Near CTU #5. Lake Pontchartrain water inlet valves crossing through levee. Not a project feature.
