**State of Louisiana
Department of Natural Resources
Coastal Restoration Division**

**2006/2007 Annual Inspection
Report**

**Bayou Sauvage Refuge Restoration
Phase II
(PO-18)**

July 19, 2007
Orleans Parish

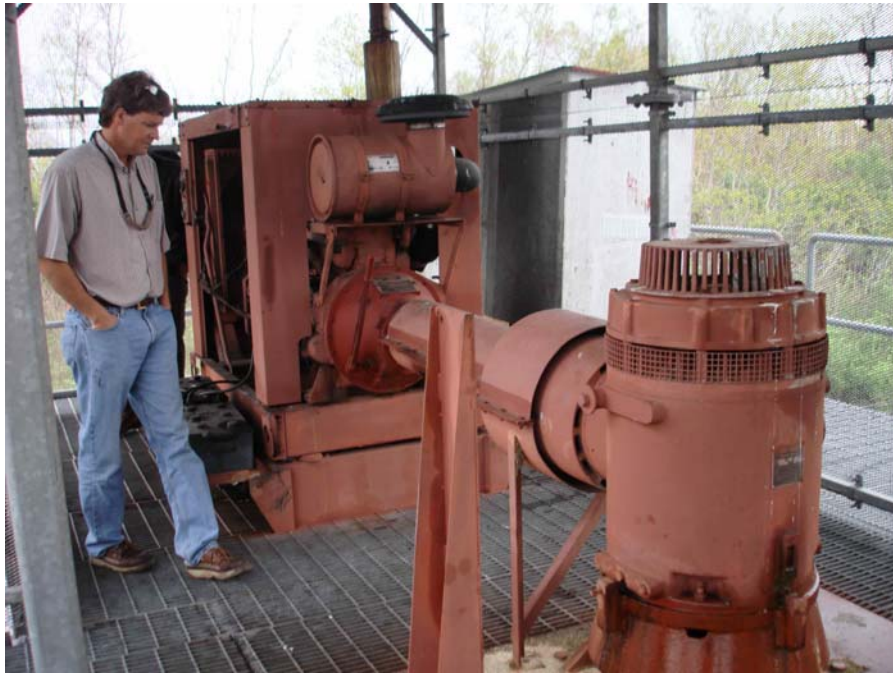
USFWS has recently serviced the pump and it is fully operational.

Photo #1 – Pump #3.

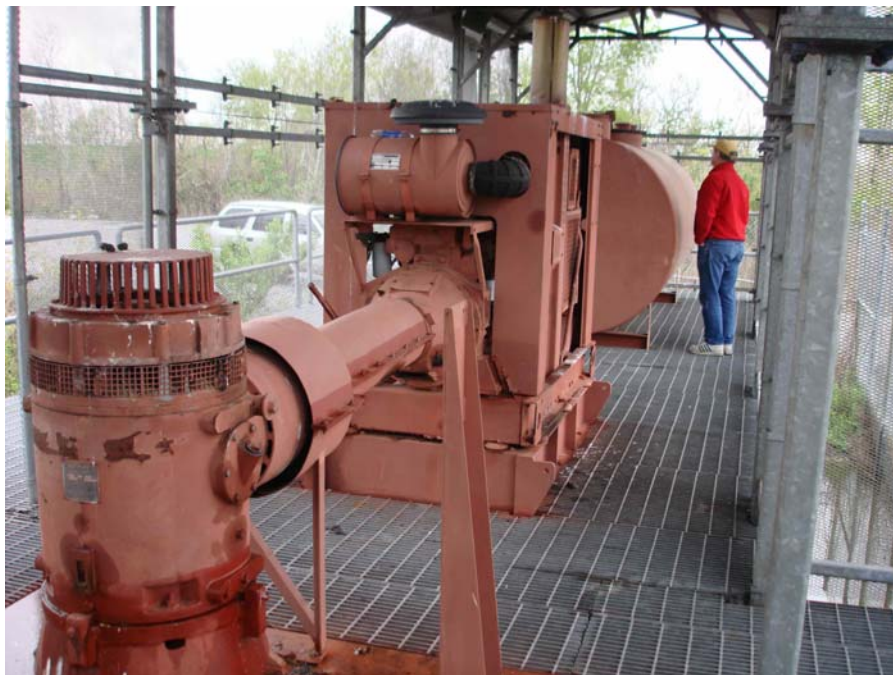
USFWS has recently serviced the pump and it is fully operational.

Photo #2 – Pump #4.

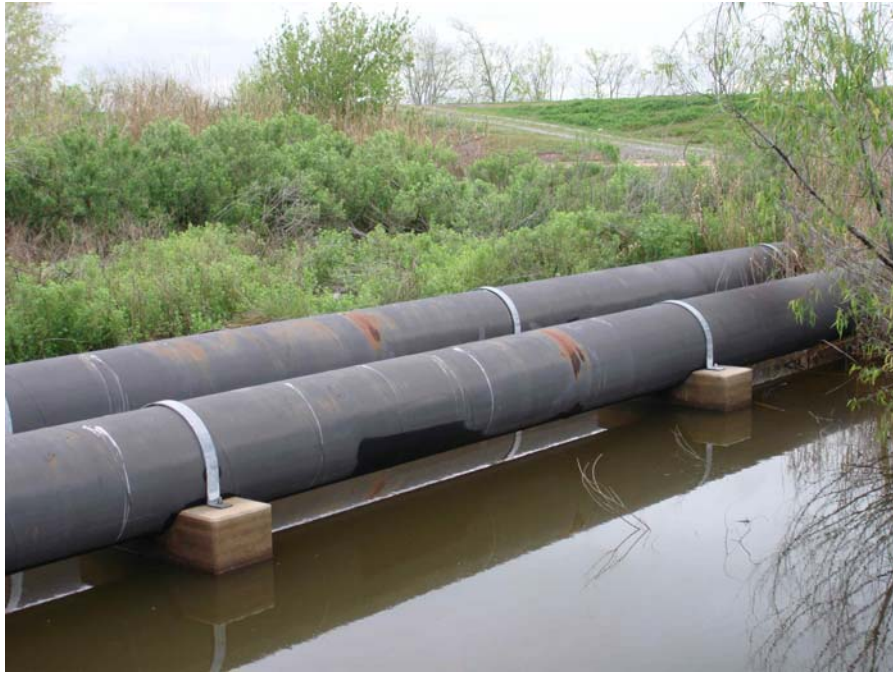
Photo #3 – Outflow. Discharge pipes from pump station to levee.

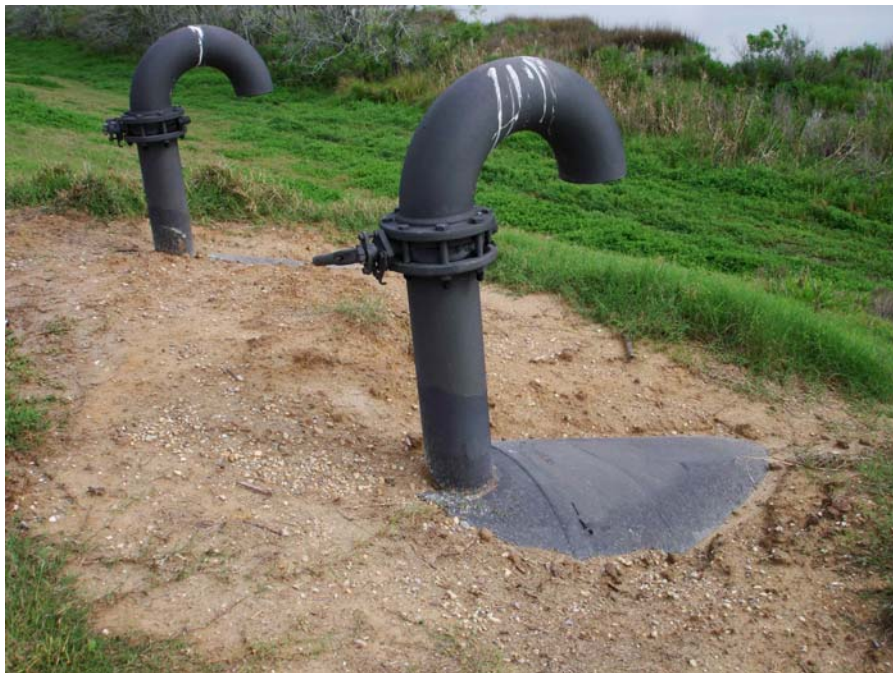
Photo #4 – Outflow. Discharge pipes crossing levee to Lake Pontchartrain

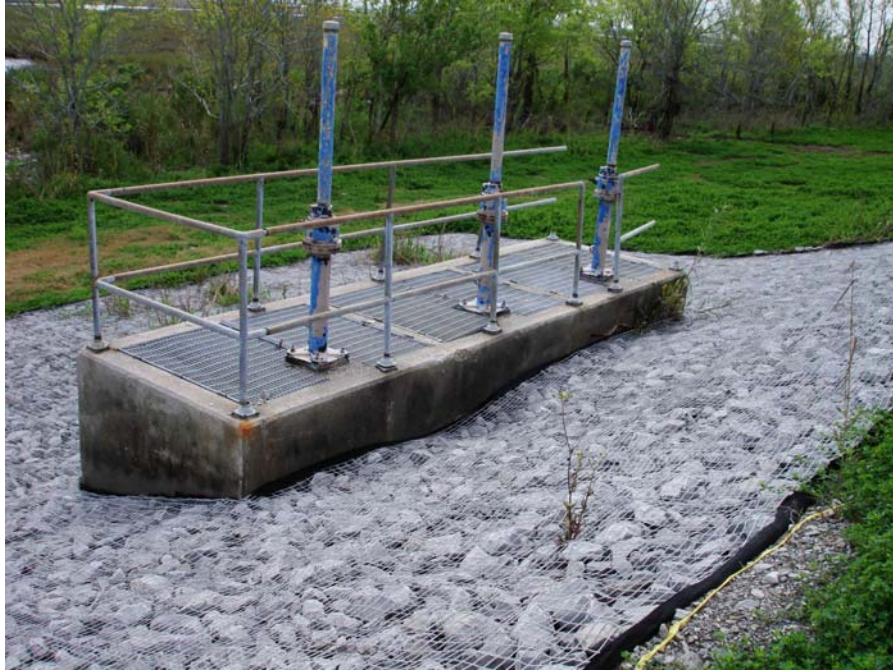
Photo #5 -Valves These valves control drainage from the project area to Lake Pontchartrain. Not a project feature.

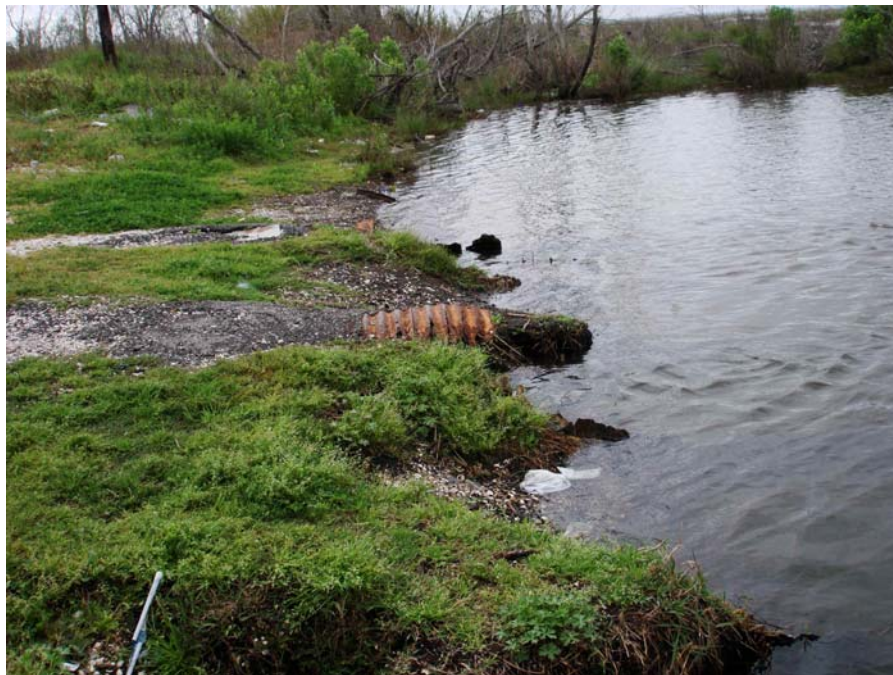
While these culverts are not a project feature, they do affect the flow of water into and out of the project area. It has been noted that these culverts have potentially collapsed, limiting the water exchange south of Hwy 11. This is causing the water in the project area to become stagnant instead of flowing out of, or into, the project area. During pumping operations, the culvert restrictions cause the northern unit to draw down much faster than the southern unit. This means that the northern pump must be shut down to allow water levels to stabilize and then resuming pumping operations until desired result is achieved. USFWS, Pon Dixon, has informed LDNR that they and/or LaDOTD will perform the necessary work to the culverts at no cost to the project. LDNR will continue to monitor.

Photo #6 -
Hwy. 11 Culverts These culverts under Hwy. 11 are collapsing and restricting flow between areas of the project. This causes imbalance of water levels and restricts the ability to use the pumps. Not a project feature.
