**State of Louisiana
Department of Natural Resources
Coastal Engineering Division**

**2006/2007 Annual Inspection
Report**

**BLACK BAYOU HYDROLOGIC
RESTORATION PROJECT
(CS-27)**

November 8, 2006
Calcasieu and Cameron Parishes

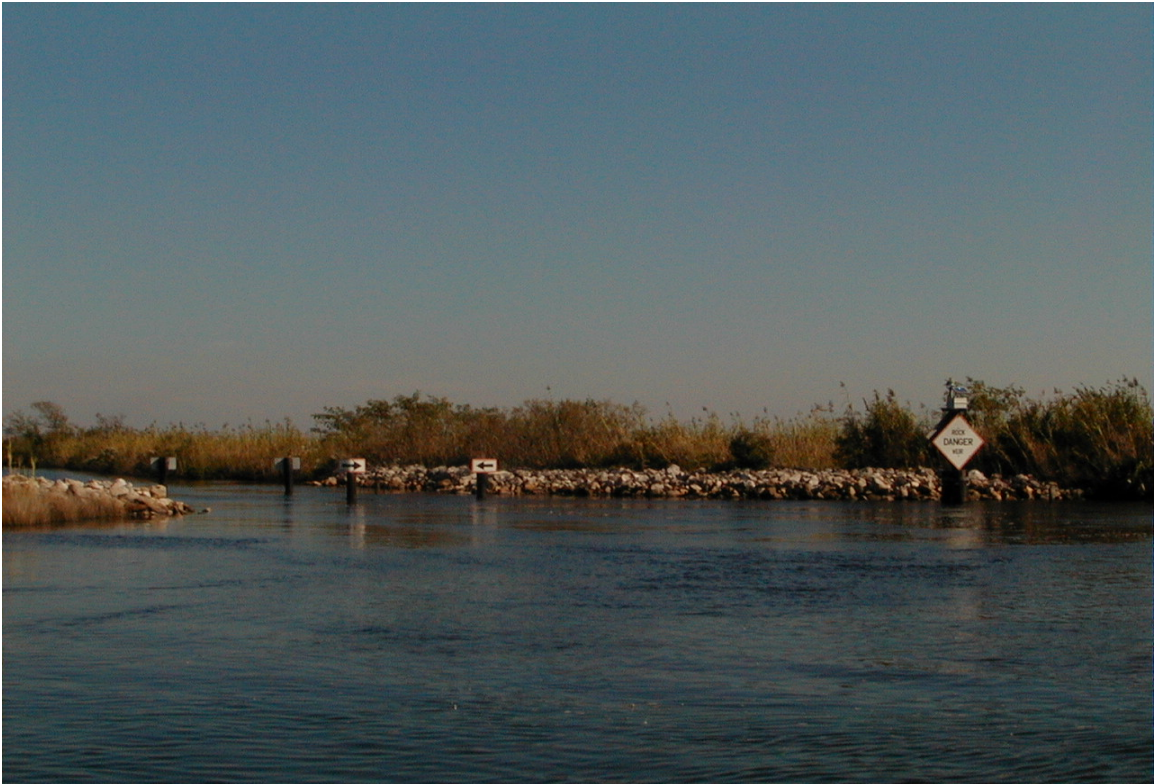
The rock weir is in excellent condition. Signage is stable. There is some slight erosion on the SE bank that will need to be monitored. No immediate need for maintenance at this structure. Conditions of the Navigational Aid Lights were inspected in March '06 and determined to be functioning properly. (Photos: Appendix B, Photos 1-3)

Photo 1—Navigational Aids and signage at Block's Creek

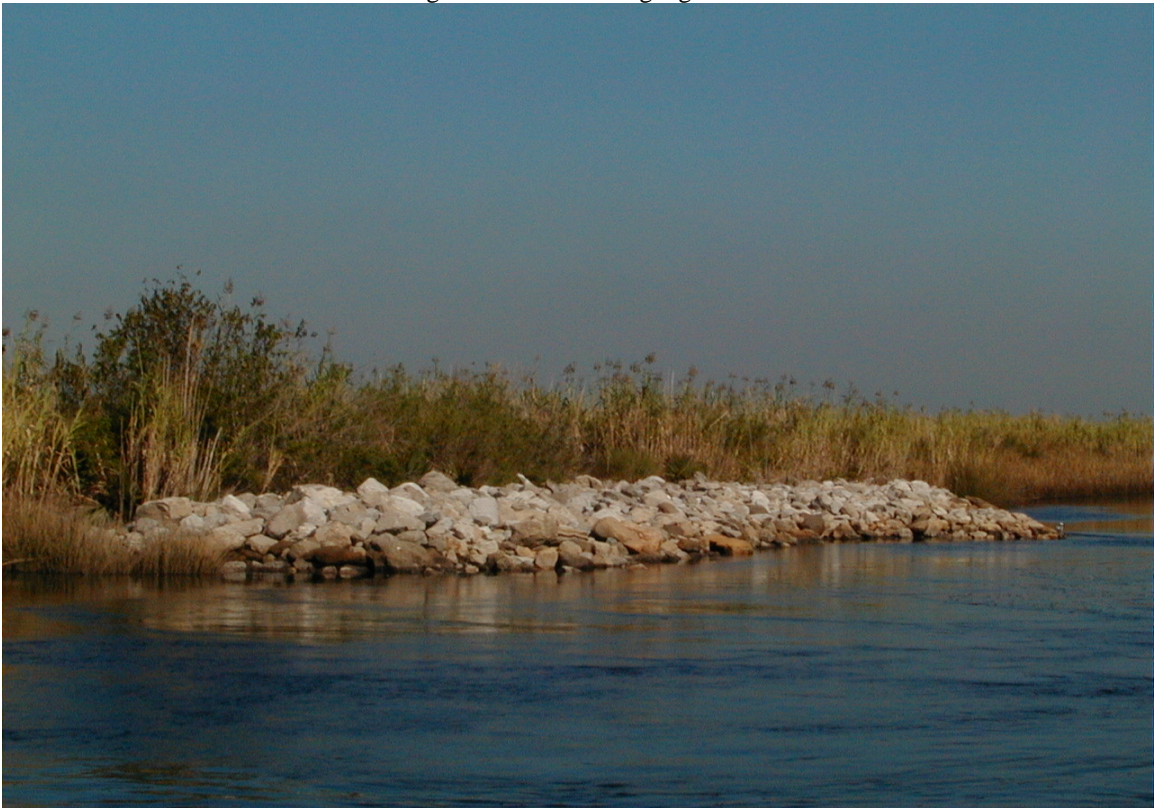
Photo 2—western side of Block's Creek Structure

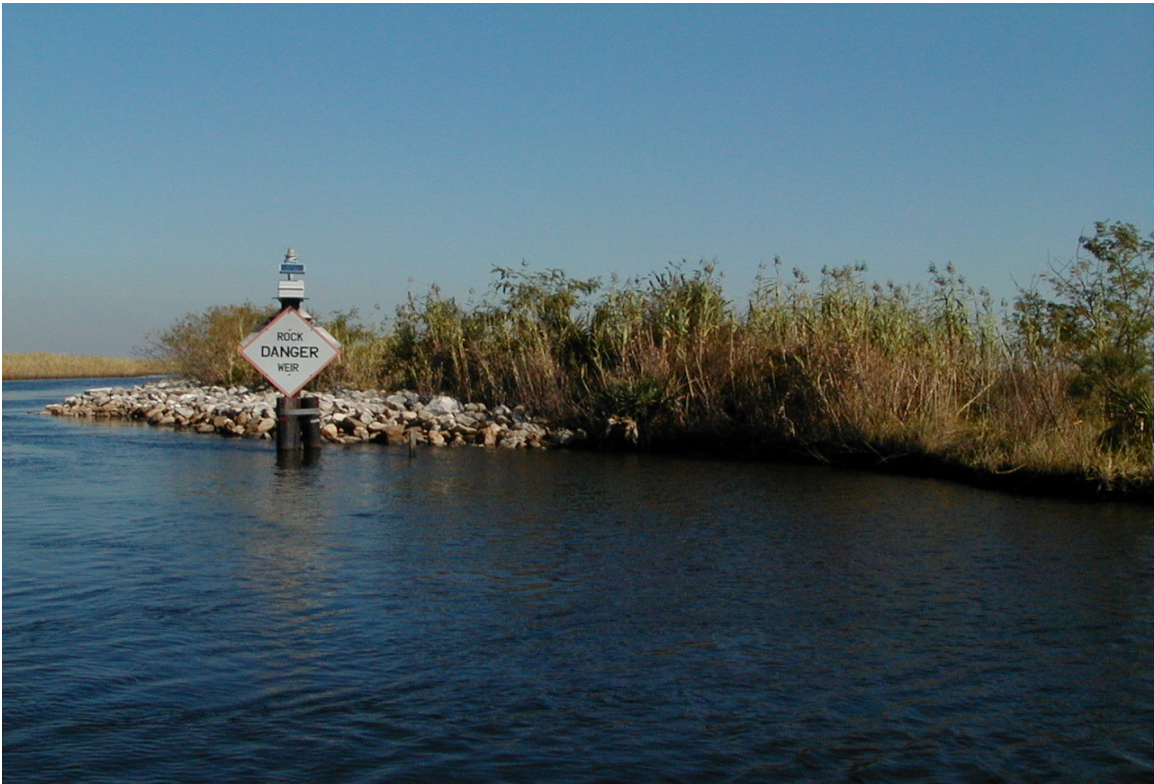
Photo 3—erosion on SE end of Block's Creek Structure

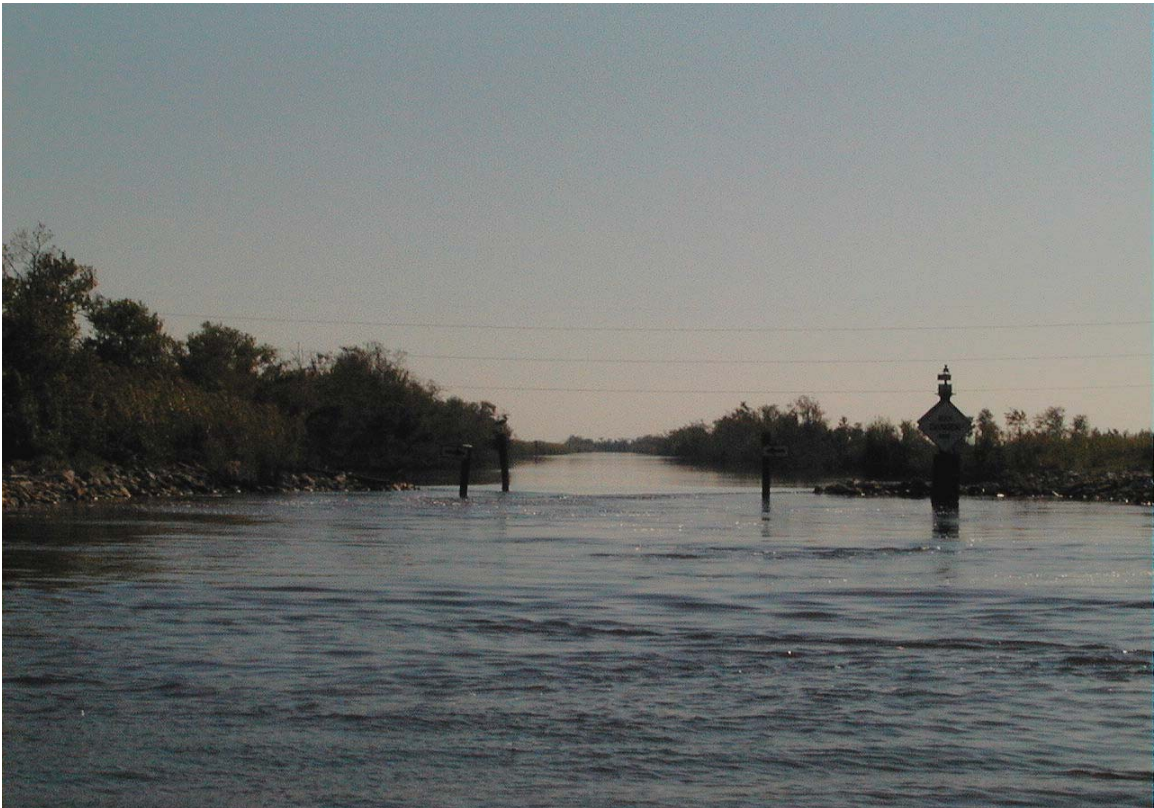
The weir is in good condition. There is some minor scouring along the canal banks inside of the weir at the end of the dike that will be monitored. Severe current through the weir has caused problems for boaters in the area. Although the pilings with the arrow signs have been repositioned, they are still fairly close together and pose a collision hazard. As a result of this, and previous inspections, it is recommended that these pilings be removed and warning signs similar to the ones on the Black Bayou Cut-Off canal be used. The Navigational Aid Lights were inspected and repaired in March, '06. (Photos: Appendix B, Photos 4-5)

Photo 4—Burton Canal Structure

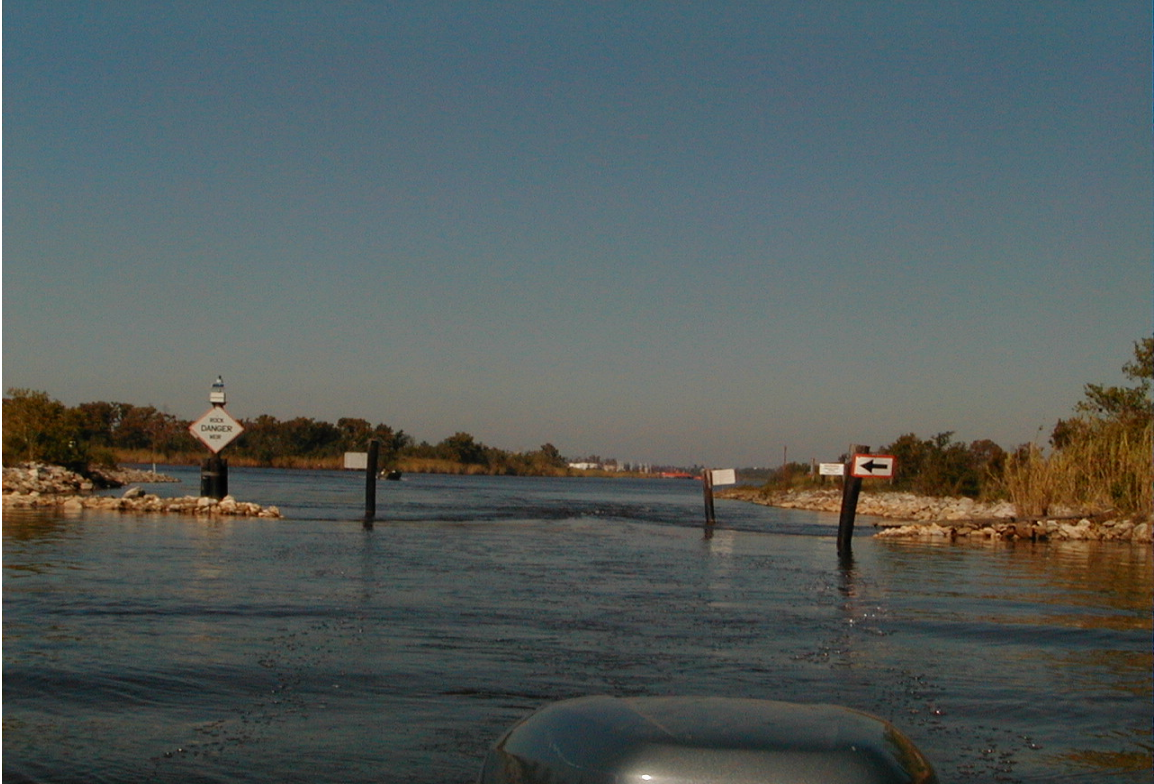
Photo 5—Burton Canal Structure

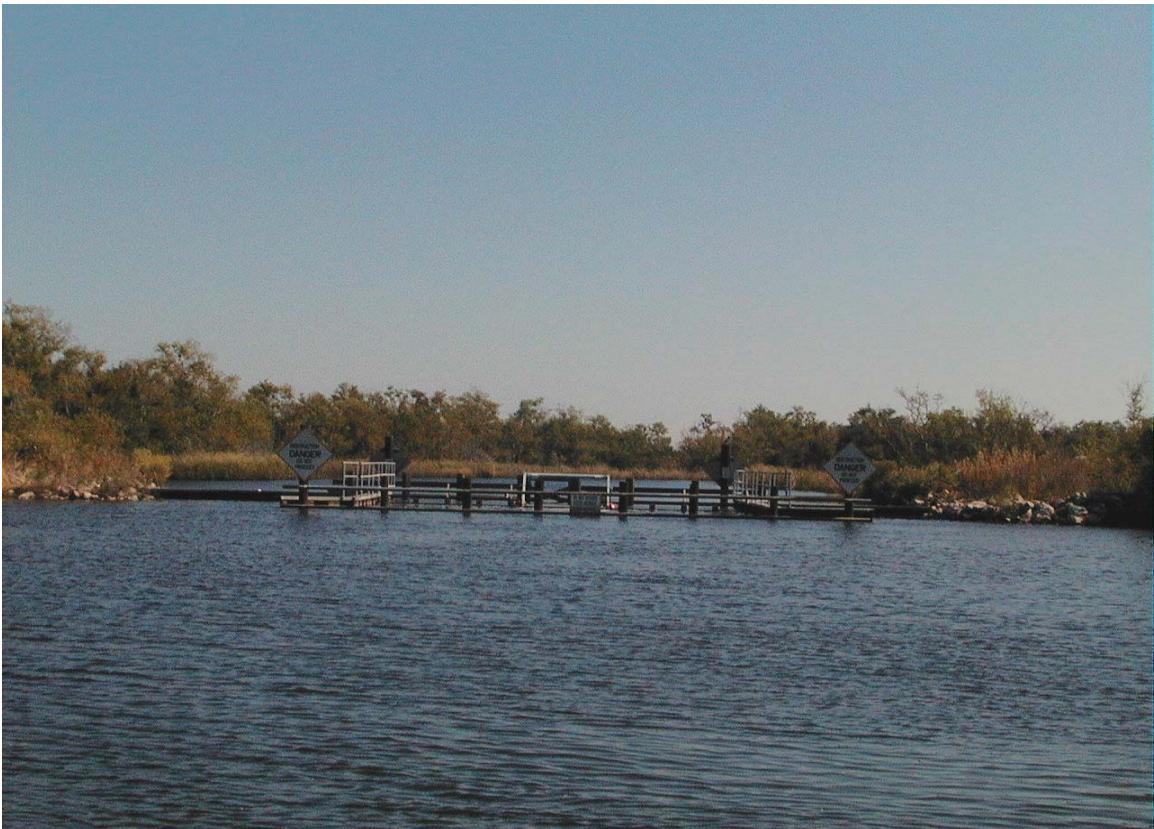
The structure is in very good condition. Signage, railings, wingwalls, etc. in as-built condition. Pillow blocks on new flap have begun to show signs of rust and will need to be monitored. Timber piles need to be re-coated. No need for maintenance other than that which is underway at this time. (Photos: Appendix B, Photos 6-10)

Photo 6—SRT Gate

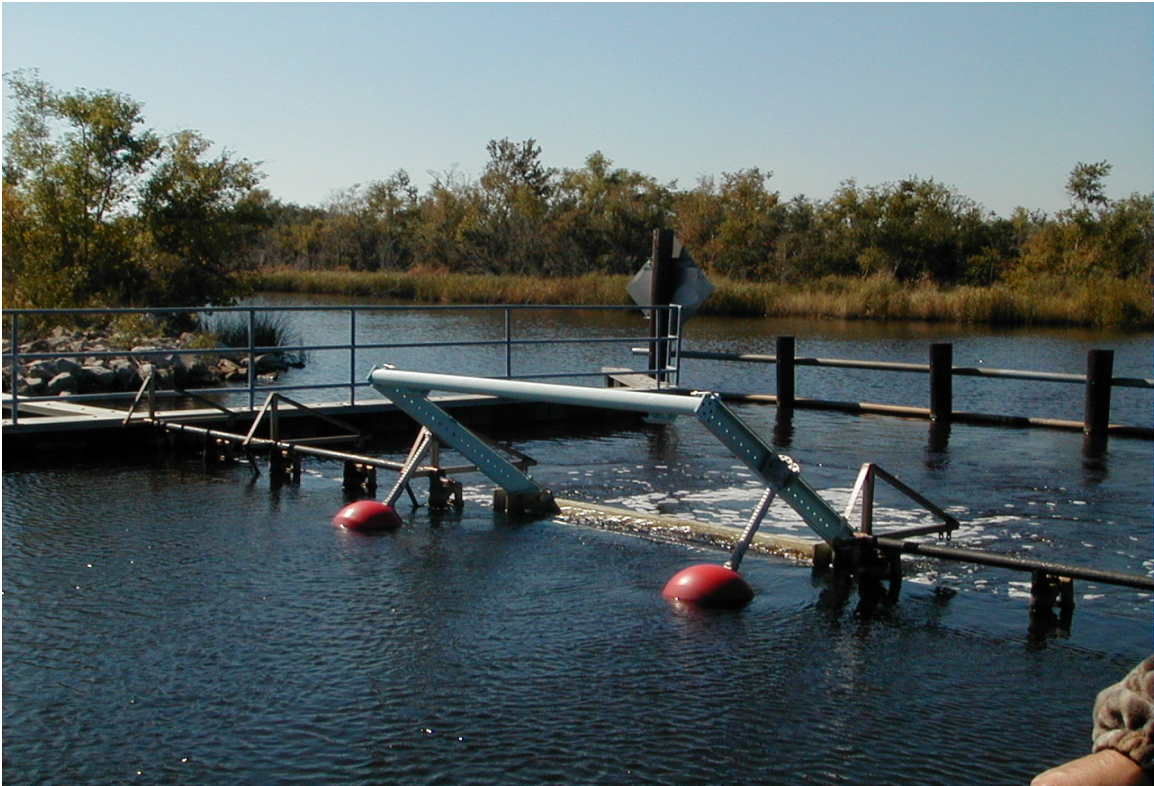
Photo 7—SRT Gate railings, etc.

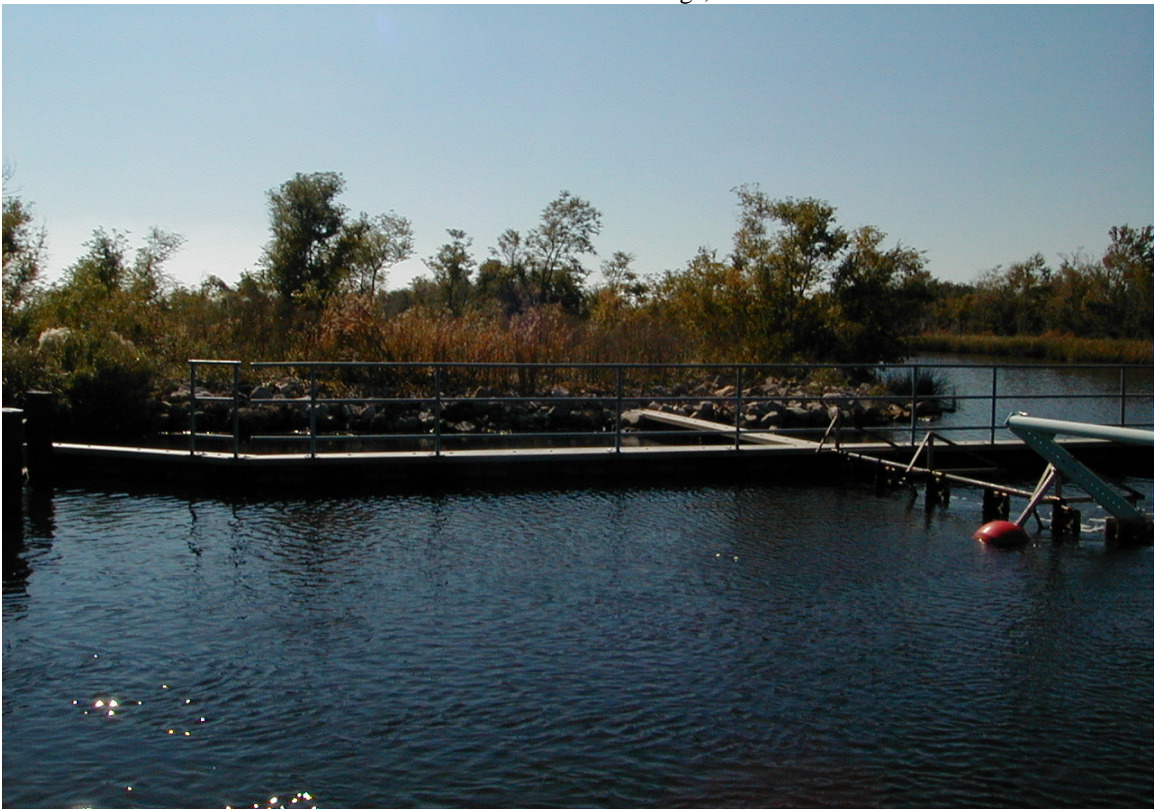
Photo 8—SRT Gate S end

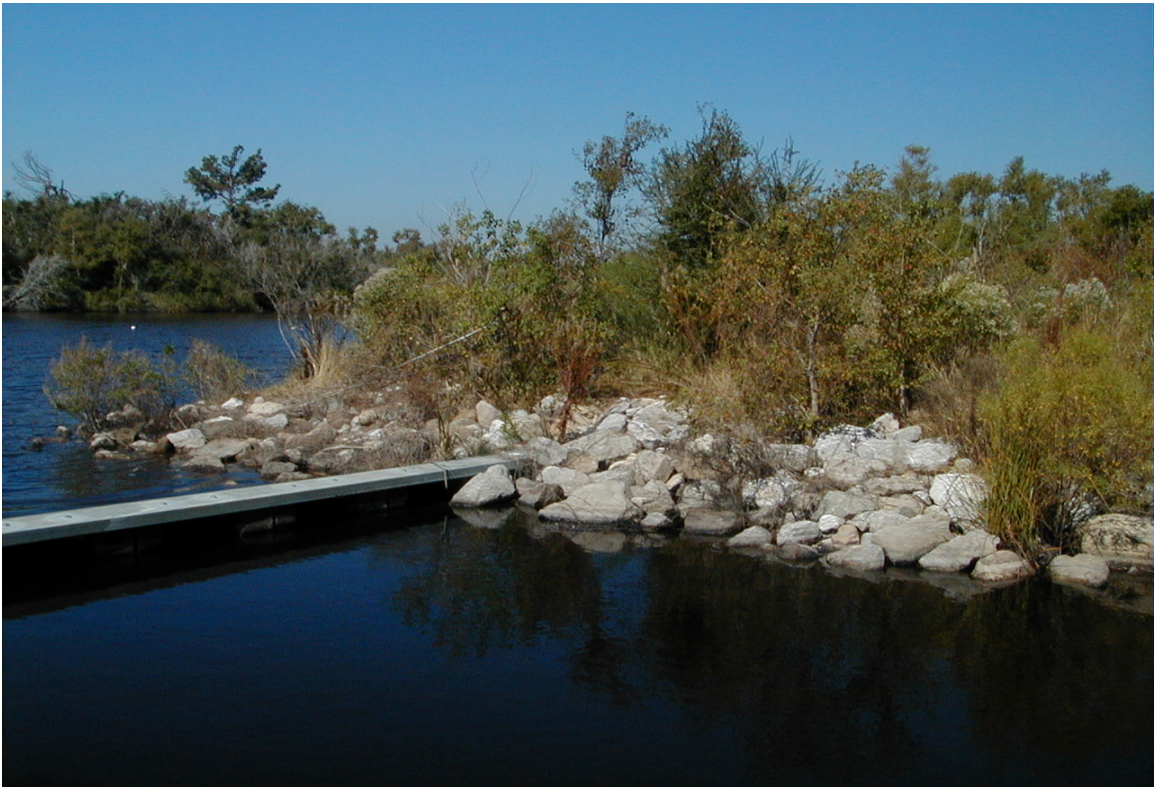
Photo 9—SRT Gate N end

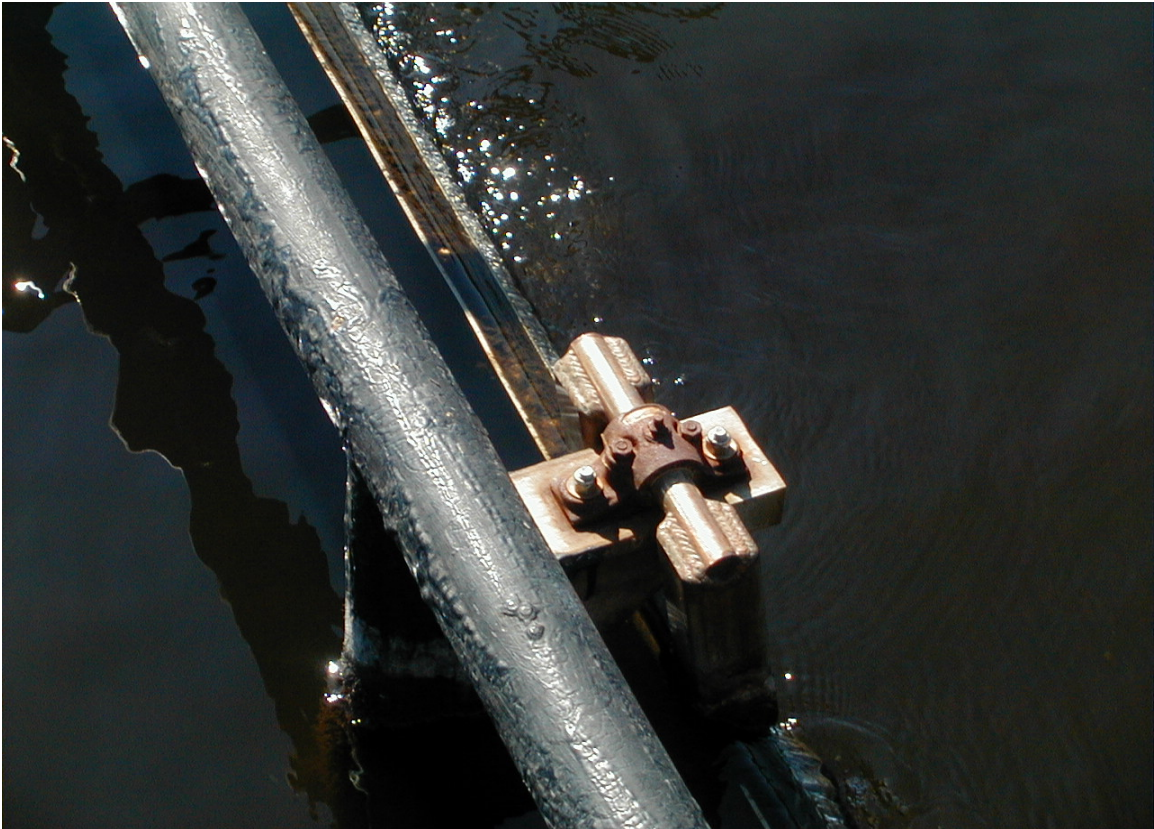
Photo 10—SRT Gate pillow block on new flap

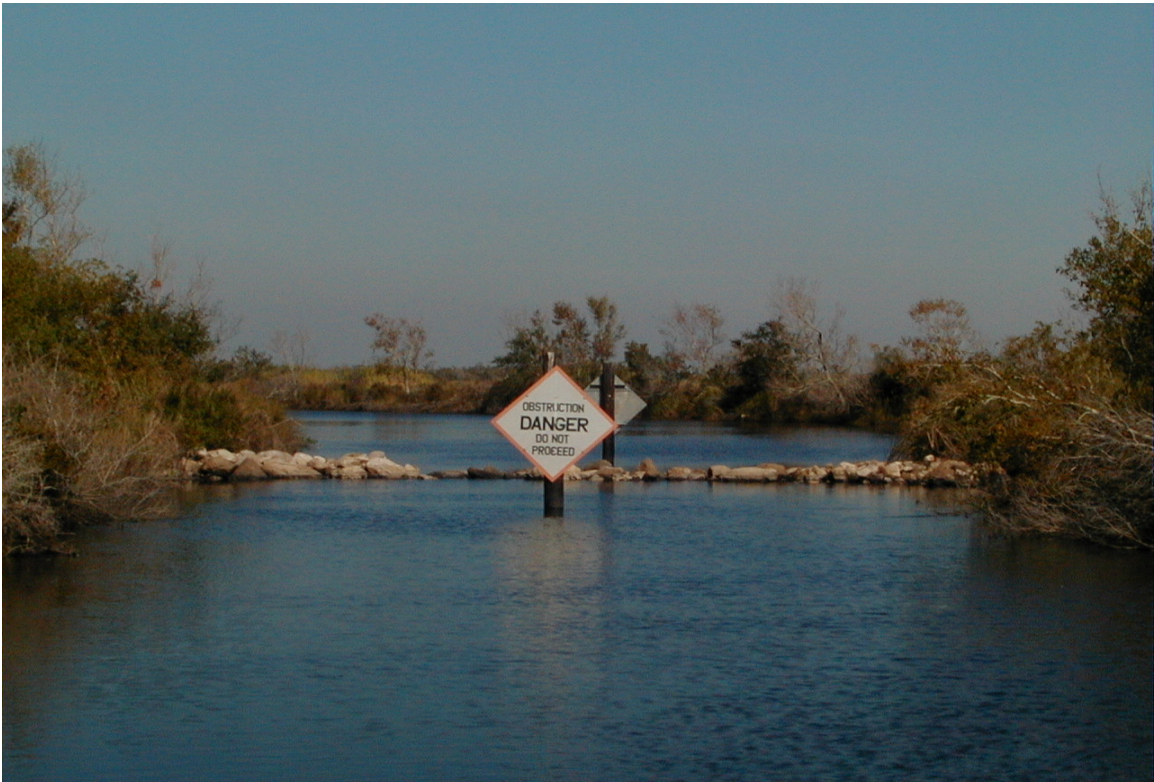
Rock has either been moved or has settled slightly to an approximate elevation of +2.5 feet NAVD '88 in spots. This will need to be addressed, possibly with sacks of QuickCrete placed on the crown of the plug. (Photos: Appendix B, Photo 11)

Photo 11—Rock plug near SRT Gate

- Add bags of concrete to raise the elevation of the rock plug
- Install a new warning sign at Burton Canal
- Address low elevations and gaps in GIWW rock dike and canal closures
- Install staff gauges

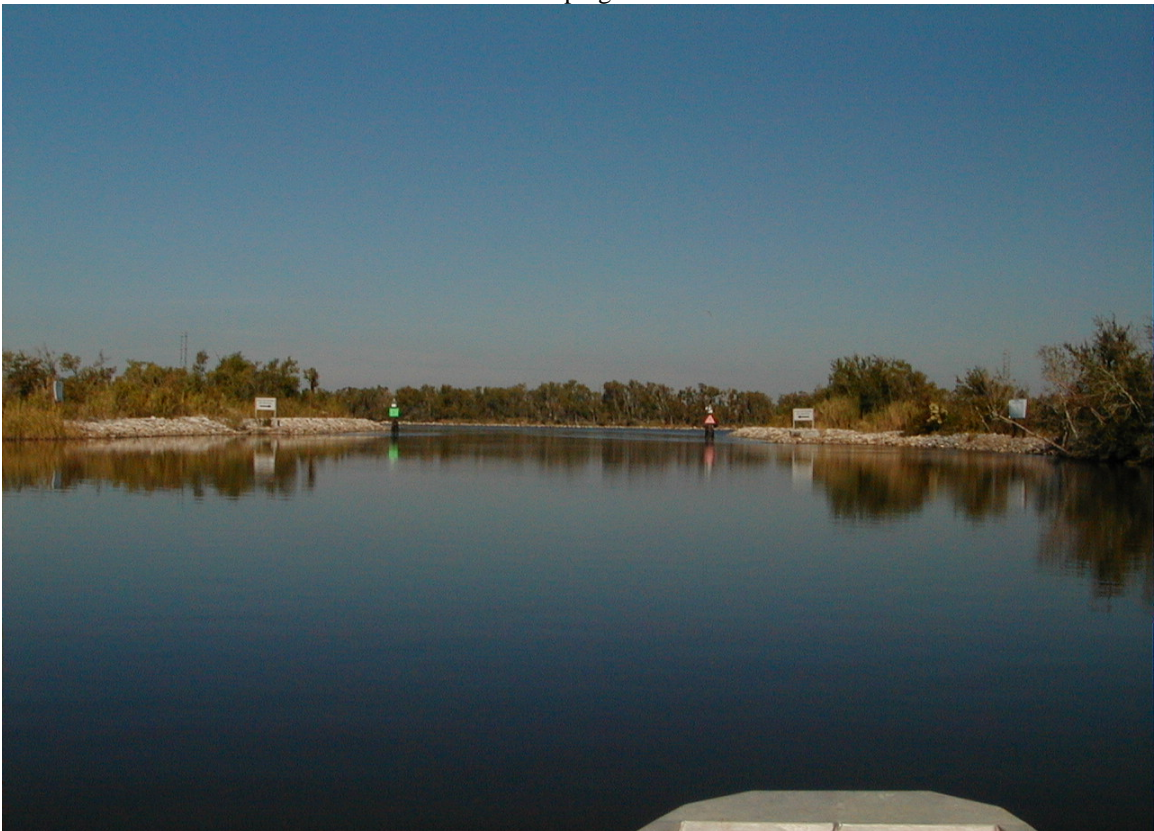
This component is in immediate post construction condition. No need for maintenance at this time. Conditions of the Navigational Aid Lights were inspected in March, '06. (Photos: Appendix B, Photo 12)

Photo 12—Black Bayou Cut-Off Canal Structure; Navigational aids, signs, etc.

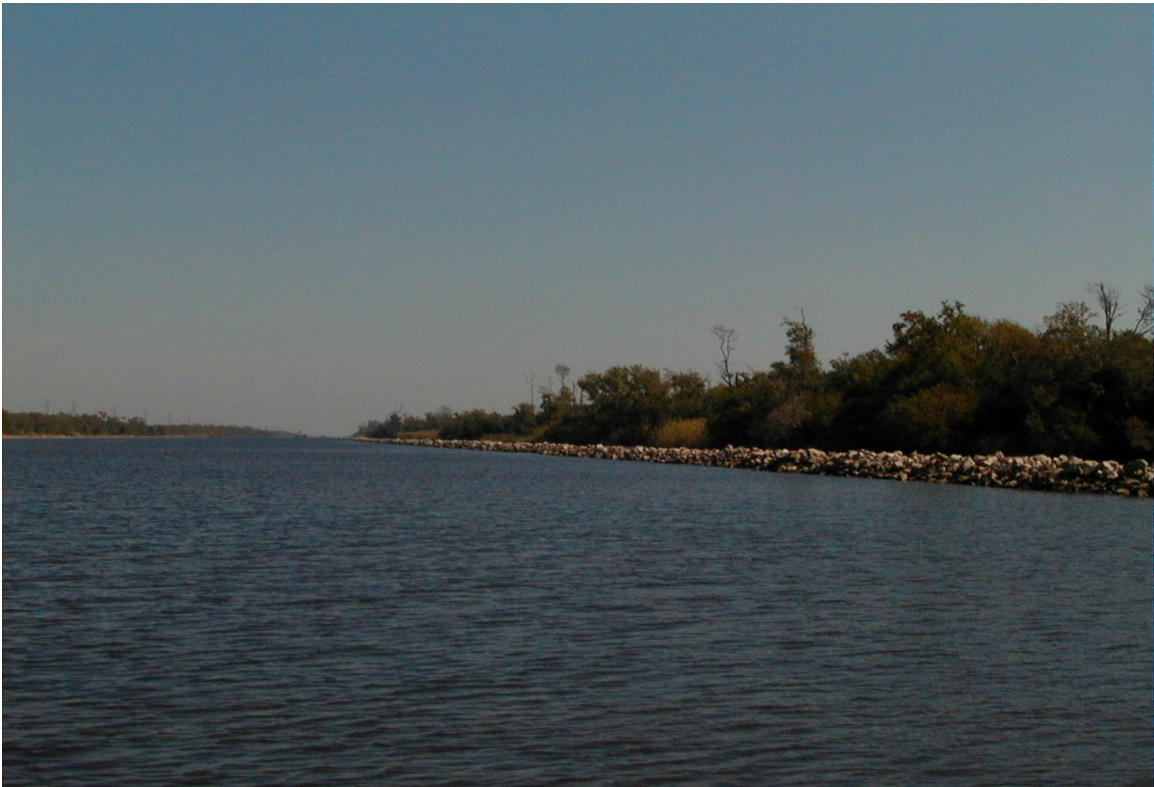
Tie-ins on both the east and west end of the dike are stable. Several random spots along the dike were checked and no apparent toe scour is occurring. As mentioned in previous inspections, the warning signs at both the Vinton and Black Bayou closures have been stolen. The spoil placed behind the rock dike at the Black Bayou Canal has washed away on the western end. Spoil is also gone on the eastern end of the closure at Vinton Canal. There is also a gap in the rock at this location. The second gap from the east has a large gap on the eastern end of the C-stone closure. Rapid water exchange is occurring here, therefore, this area will need to be addressed. The alligator crossing, mentioned in previous inspections, on the 3rd closure from the east has not gotten any worse. (Photos: Appendix B, Photos 13-17)

Photo 13—Typical section of rock dike

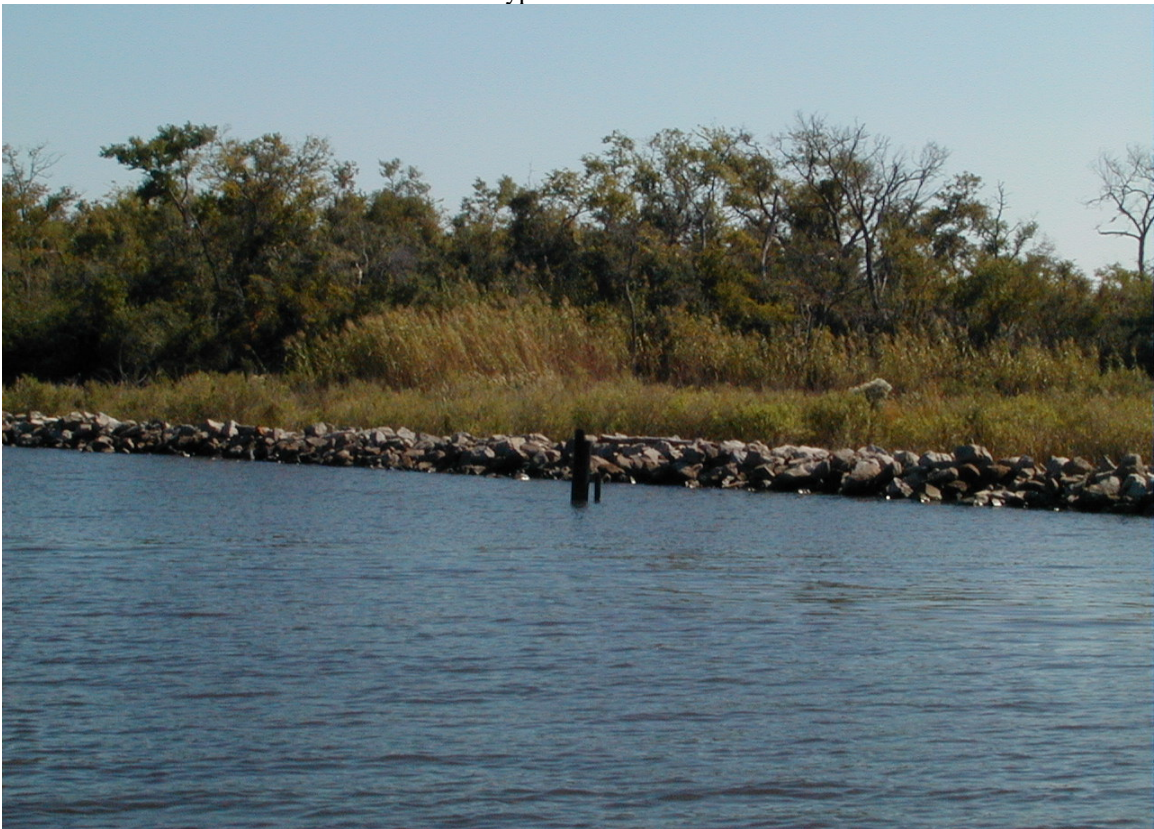
Photo 14—Missing sign at Black Bayou

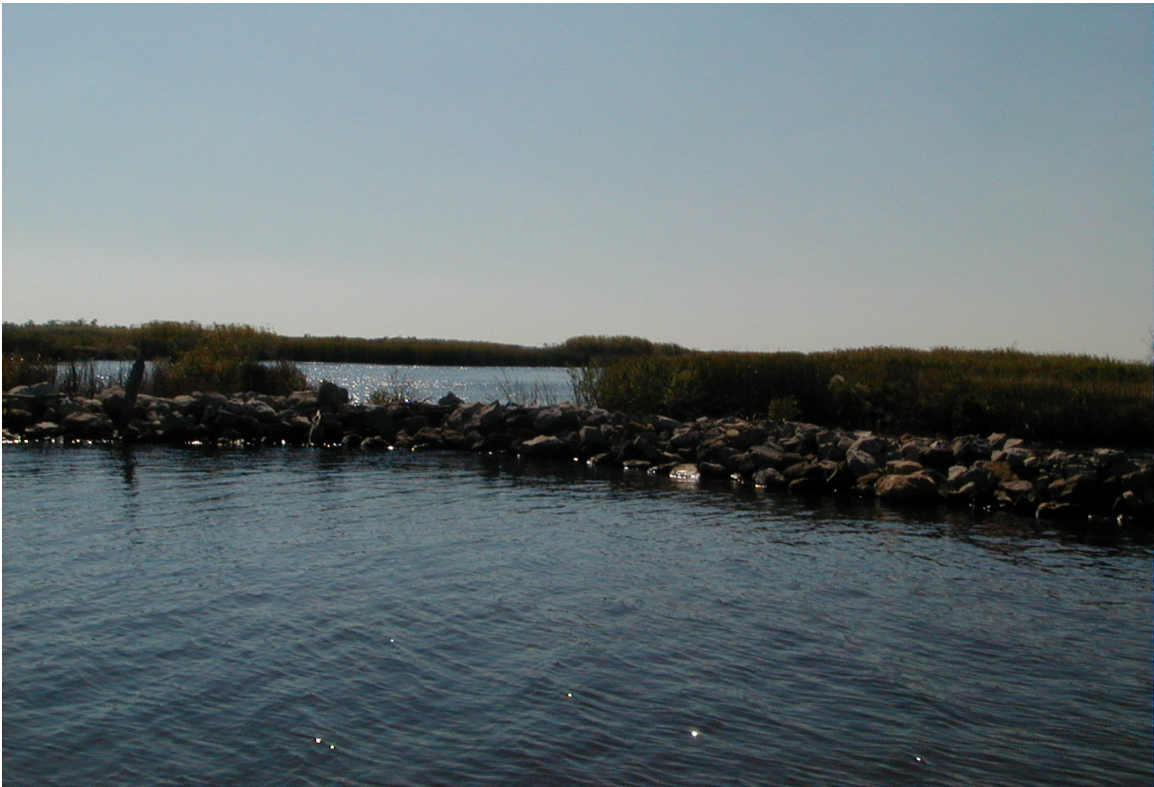
Photo 15—Missing spoil on W. end of Black Bayou Closure

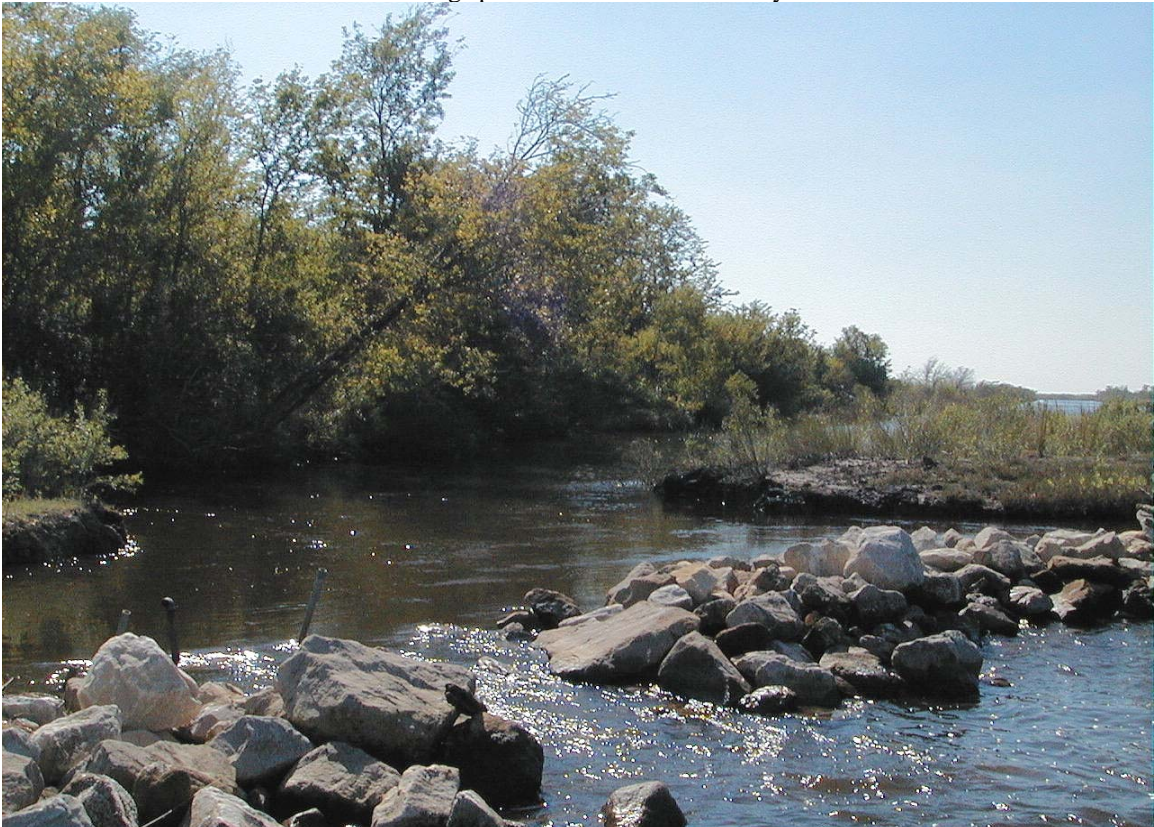
Photo 16—Missing spoil and gap in rock dike at E. end of Vinton Canal Closure

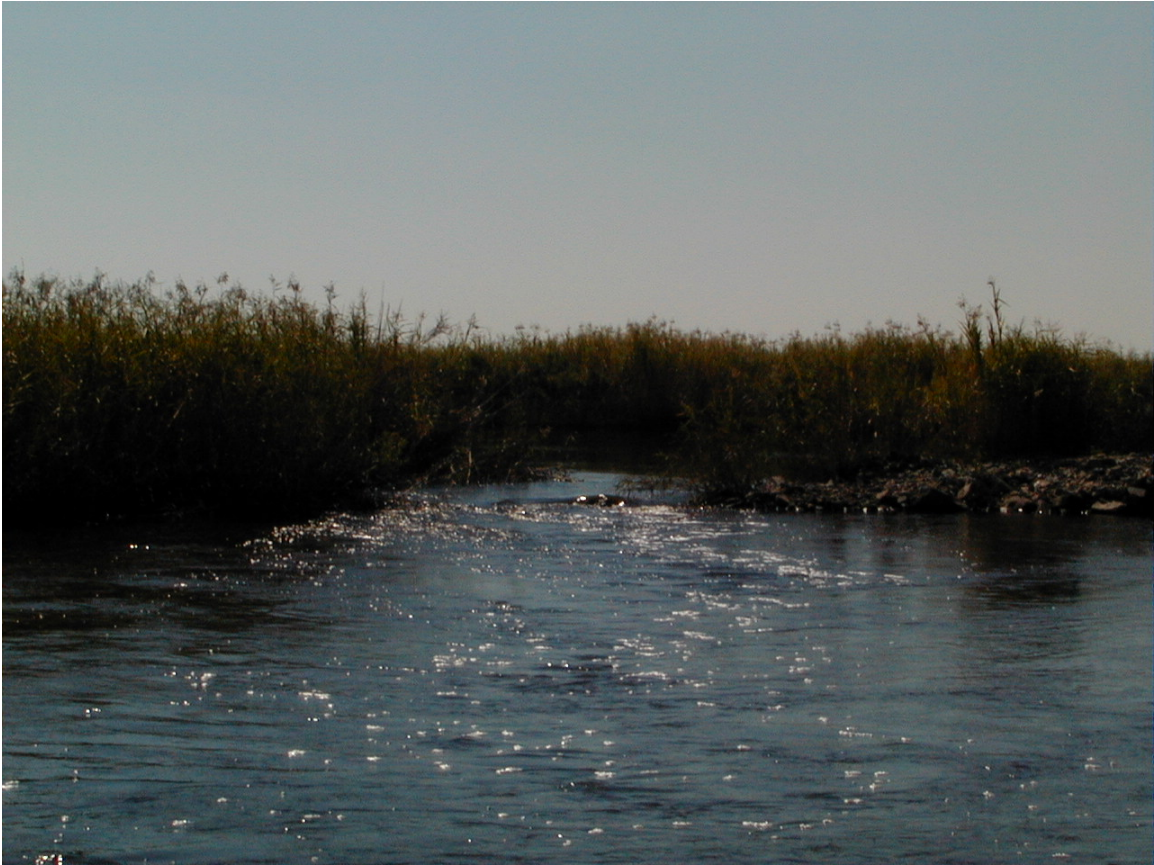
Photo 17—Gap in E. end of C-stone closure at second gap from the east
