**State of Louisiana
Department of Natural Resources
Coastal Engineering Division**

**2006/2007 Annual Inspection
Report**

**PECAN ISLAND TERRACING
PROJECT
(ME-14)**

June 19, 2007
Vermilion Parish

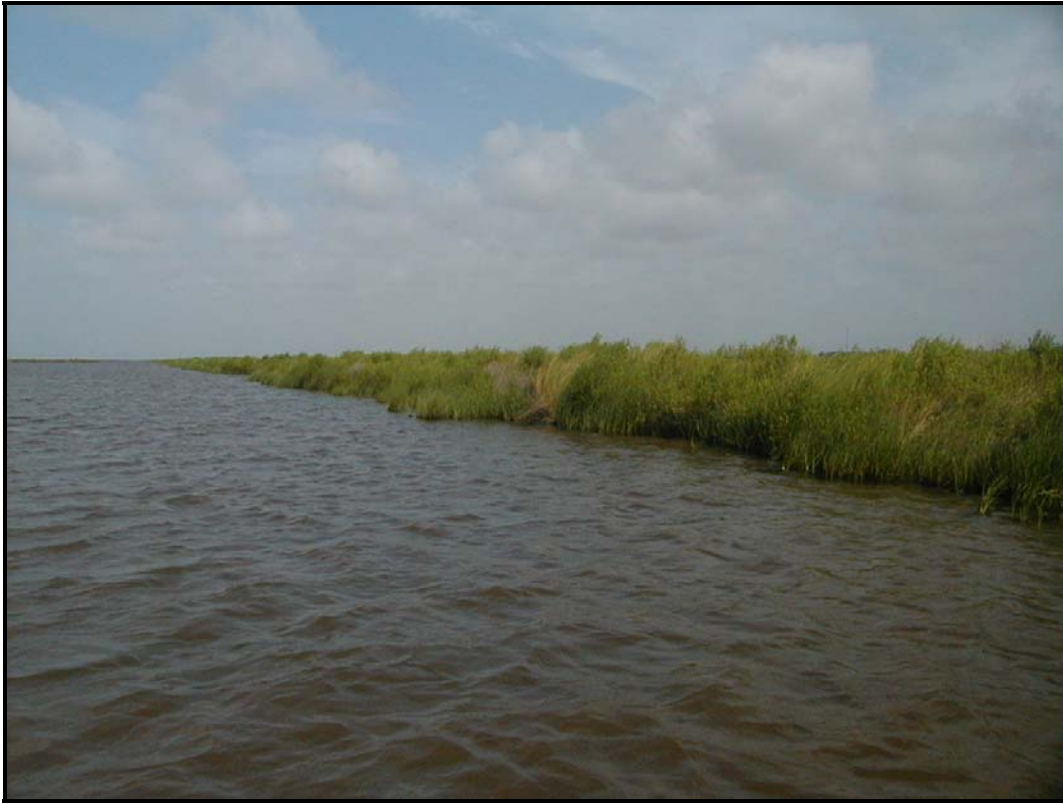
The earthen terraces are in good condition. Previously noted erosion in past O&M Inspections of the southern sacrificial terraces has worsened. The southern sacrificial terraces are providing less protection for the interior earthen terraces than in previous years. (Photos: Appendix B, Photo 1)

Photo 1, Typical earthen terrace.

Overall, the Pecan Island Terracing Project (ME-14) is functioning as designed and in good condition. The erosion of the southern sacrificial terraces will continued to be monitored.

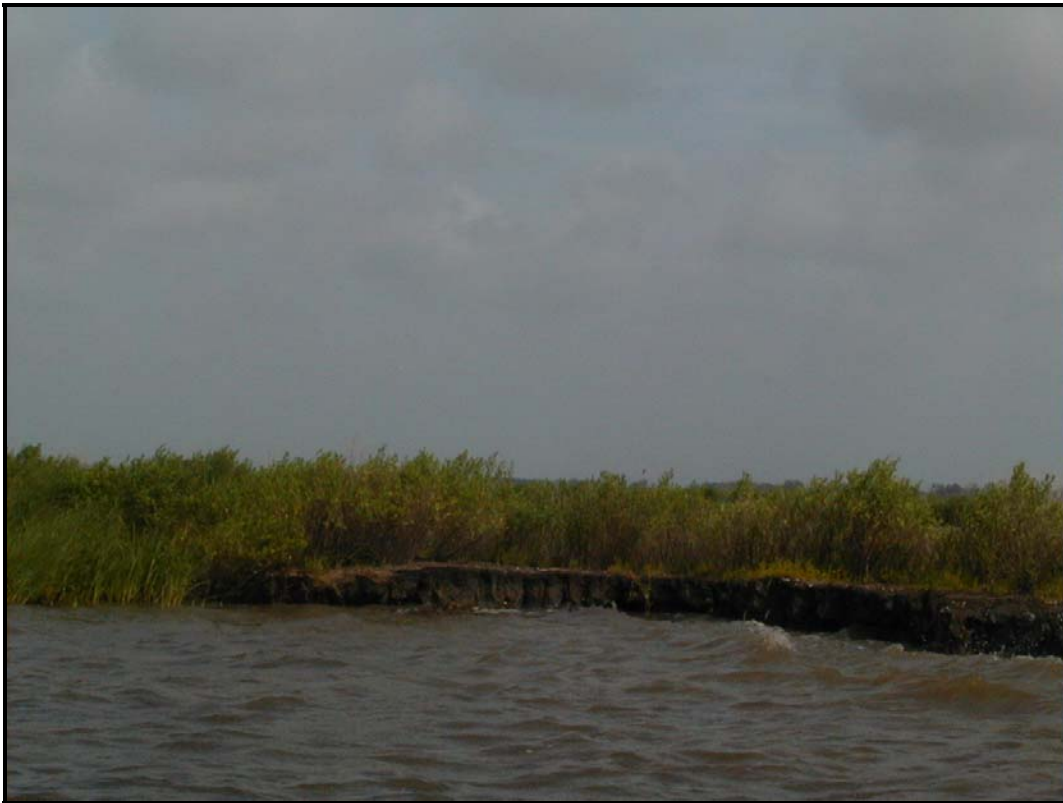
The *Spartina alterniflora* vegetative plantings on the slopes of the earthen terraces were evident, but not as vigorous as prior to Hurricane Rita. The dominant vegetation species observed on the earthen terraces was *Iva frutescens* (Photos: Appendix B, Photo 2)

Photo 2, Typical eroded terrace.
