**State of Louisiana
Department of Natural Resources
Coastal Engineering Division**

**2006/2007 Annual Inspection
Report**

**POINT AU FER ISLAND
HYDROLOGIC RESTORATION
(TE-22)**

State Project Number TE-22
Priority Project List 2

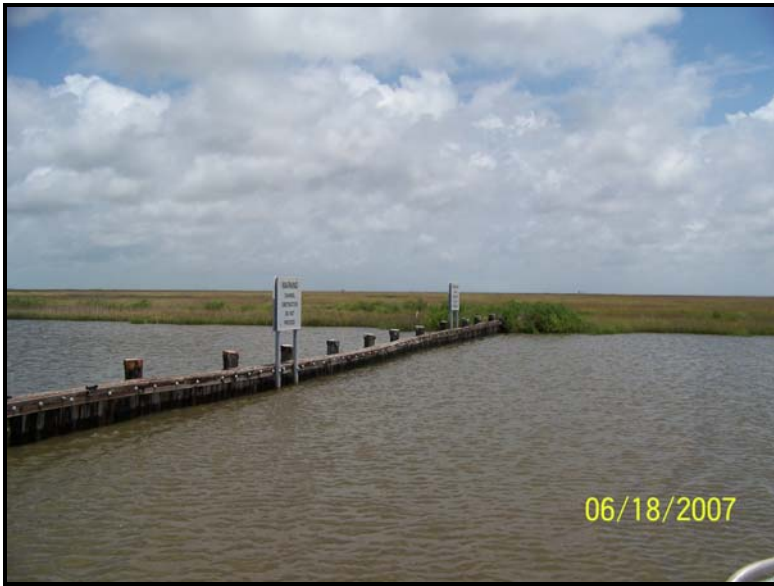
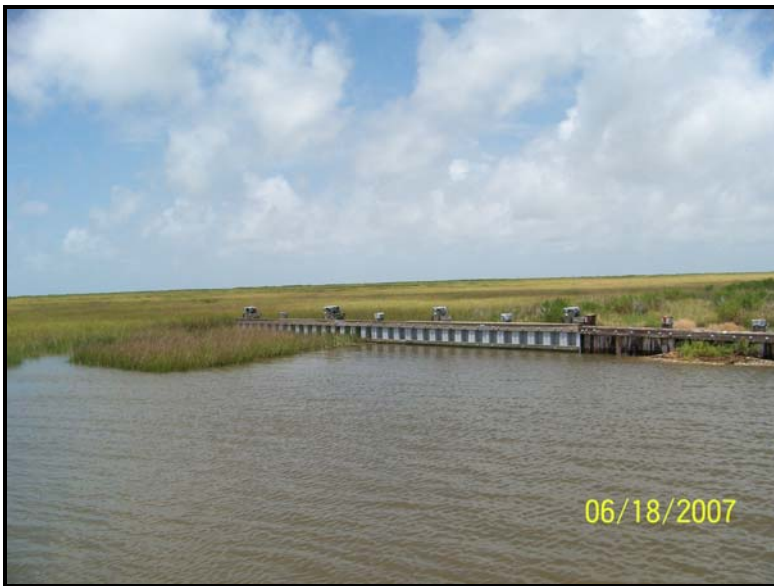
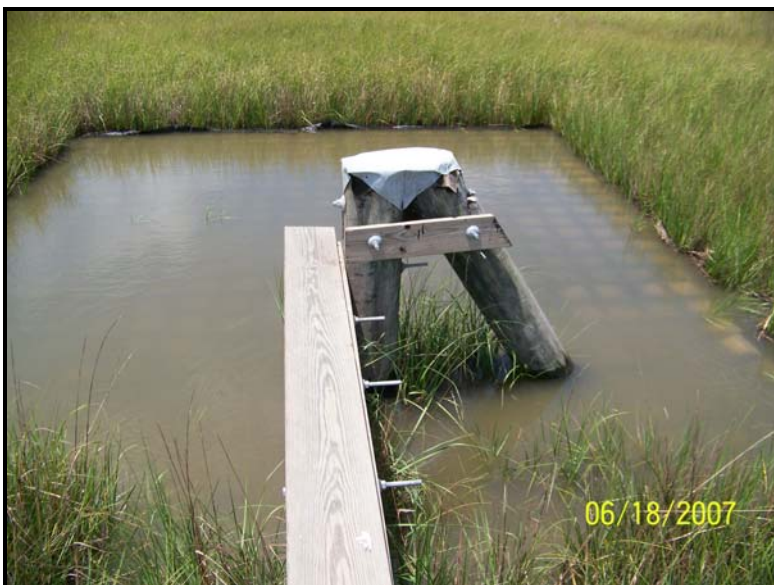
Plug No. 8 – Timber Bulkhead Plug (Photos 1 - 3, Appendix B)

The timber bulkhead is in good condition. The breach around the south end noted in previous inspections was closed in 2005 by construction of a vinyl sheet pile bulkhead extension approximately 60' in length. The north tie-in at the canal bank had no apparent signs of erosion. The warning signs and supports were in good condition. No maintenance will be required at Plug No. 8.

Photo 1. *Plug No. 8 – View of plug from outside looking northwest in Hester Canal.*

Photo 2. *Plug No. 8 – View of south bank tie-in and 2005 maintenance extension of sheet pile wall.*

Photo 3. *Plug No. 8 – View of south tie-in at end of 2005 maintenance extension of sheet pile wall. Submar mats can be seen submerged. No new scour or erosion of marsh was noted.*

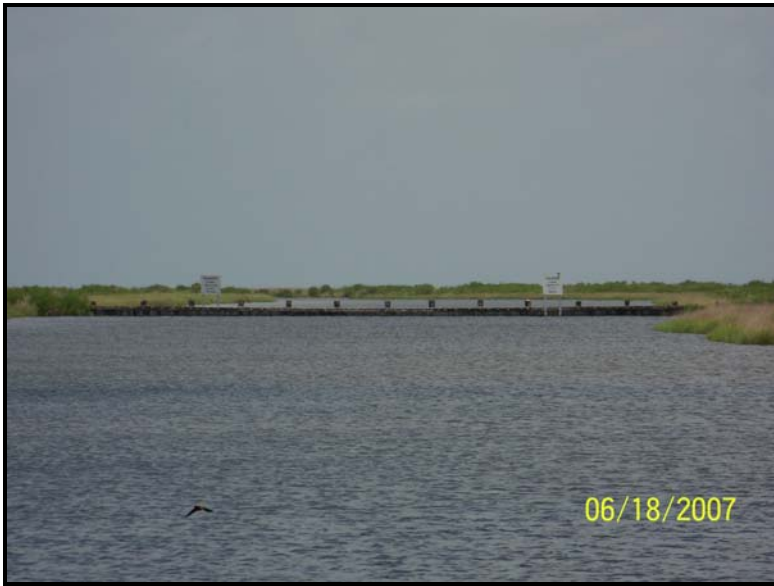
Plug No. 7 – Timber Bulkhead Plug (Photo 4, Appendix B)

Site was not visited due to time constraints and access limitations; however, the plug was observed from outside of Plug No. 8 and appeared to be in good condition. No significant changes from previous years are expected. No maintenance will be required at Plug No. 7.

Photo 4. *Plug No. 7 – View of plug from outside looking west in Hester Canal*

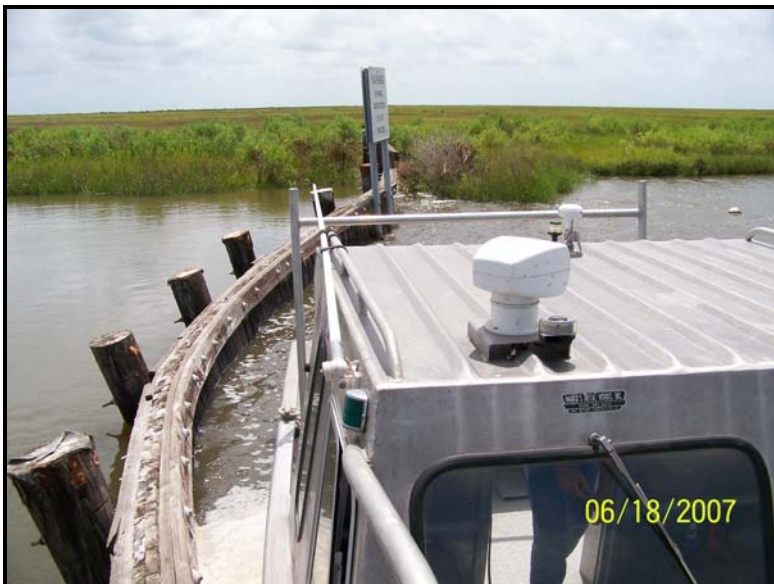
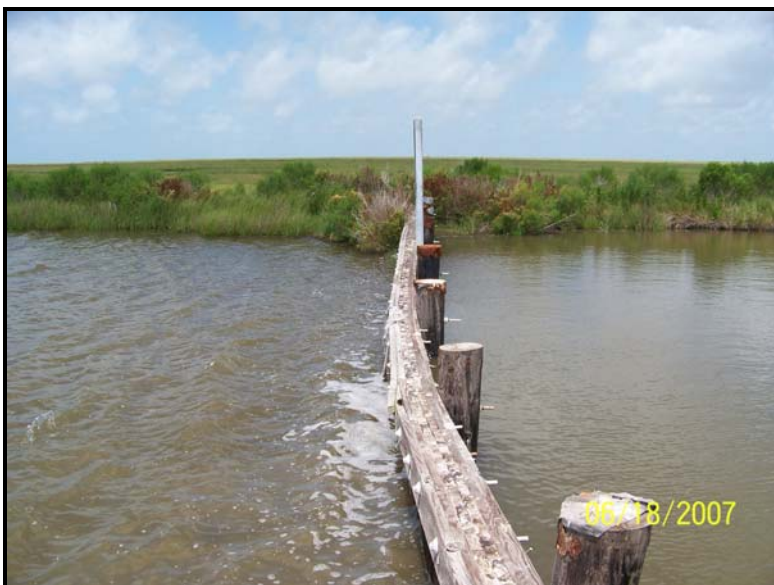
Plug No. 6 – Timber Bulkhead Plug (Photos 5 - 6, Appendix B)

The timber bulkhead appears to be in good condition despite the existing deflection of the middle of the structure which occurred during construction. Both tie-ins appear intact with no apparent signs of erosion. The warning signs and supports were also in good condition. At this time no maintenance is recommended at Plug No. 6; however, the condition of the timber bulkhead should continue to be monitored on future site visits.

Photo 5. *Plug No. 6 – View of plug deflection from approximate centerline of plug looking east in Transco Canal.*

Photo 6. *Plug No. 6 – View along approximate centerline of plug looking west in Transco Canal.*

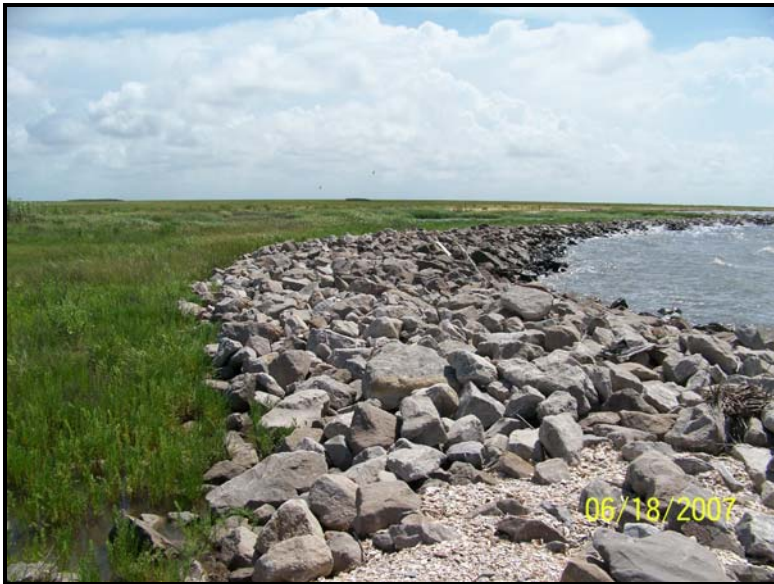
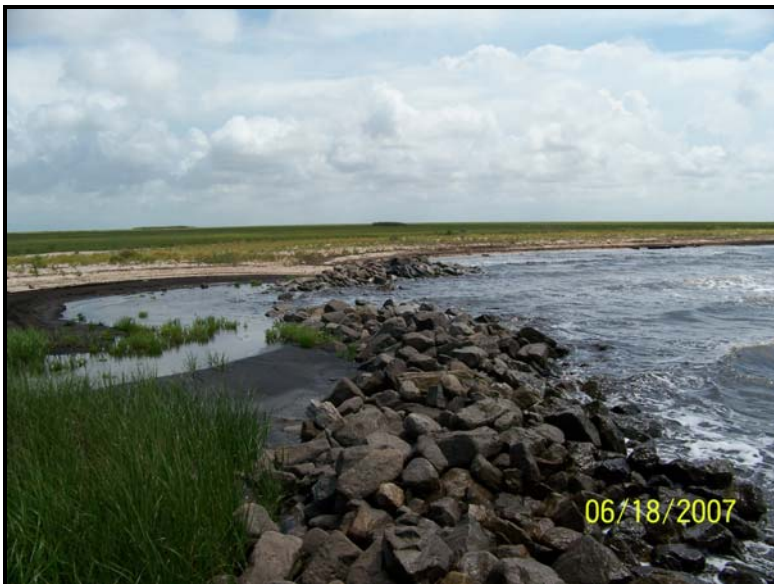
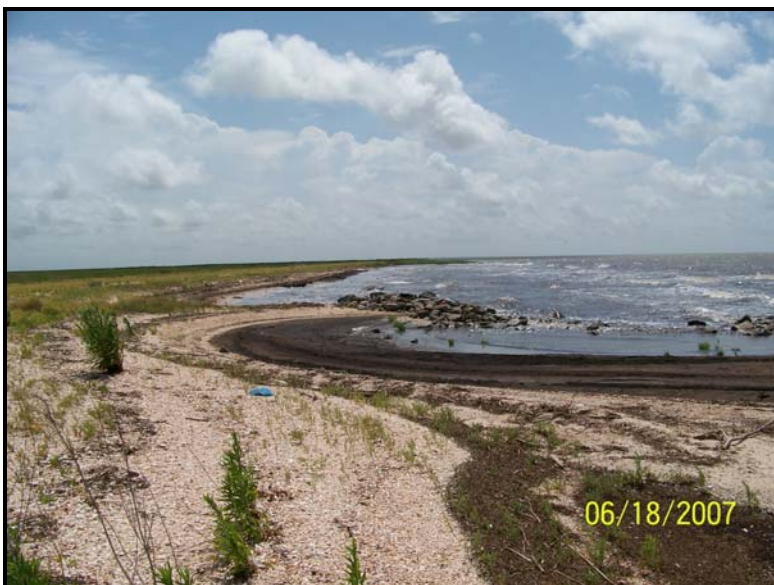
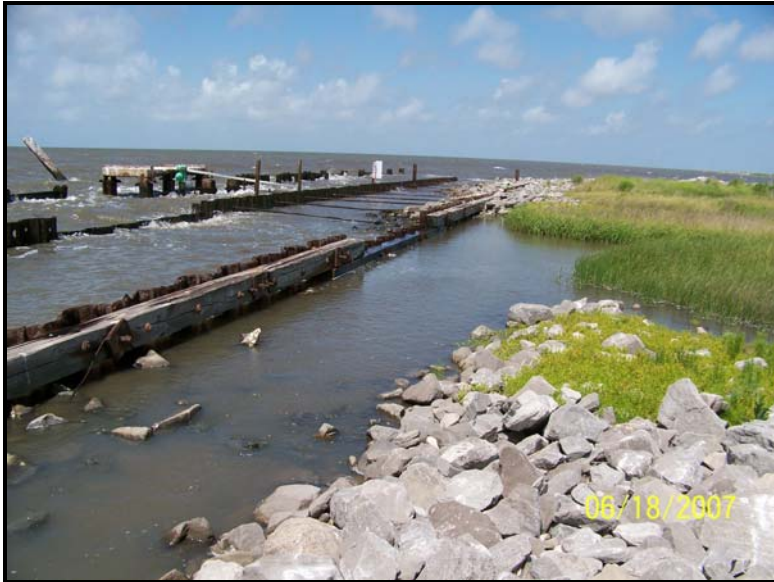
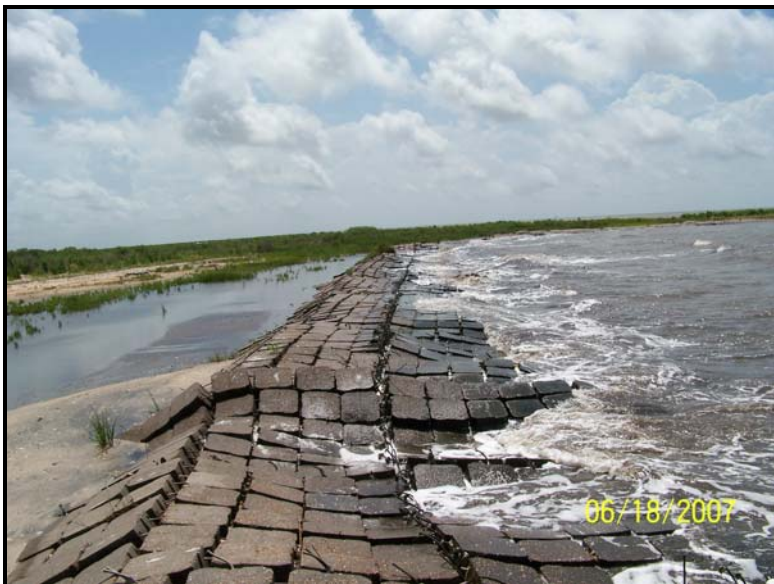
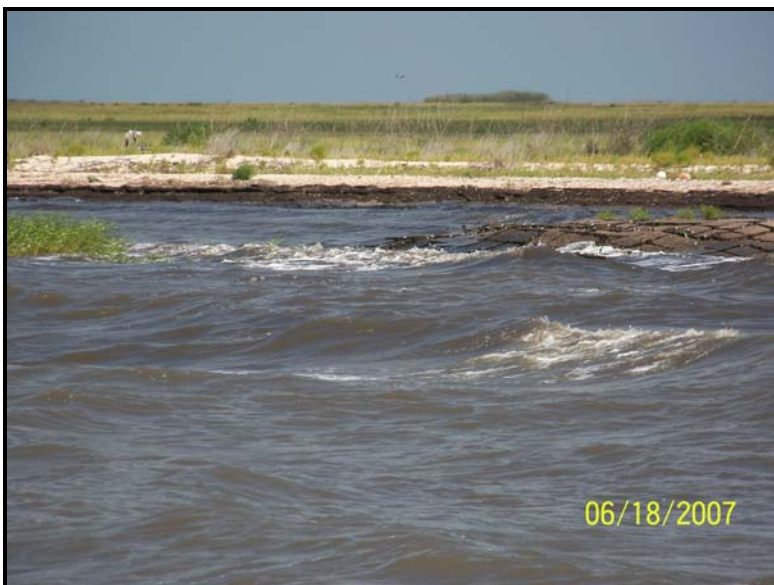
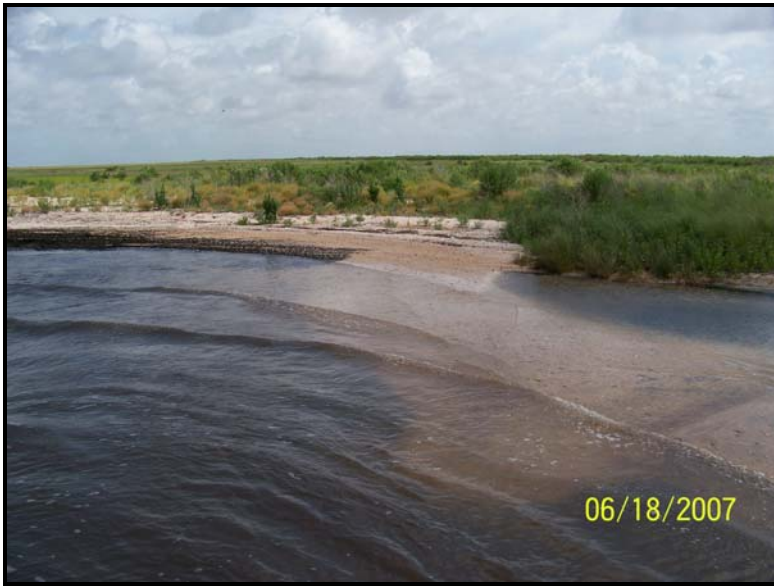
Plug No. 4A – Transco Canal Gulf bulkhead (Photos 7 - 13, Appendix B)

The erosion directly behind the east mats noted in previous inspections appears to have been slowed or halted as a result of the rock lift placed in 2005 (Photos 7 - 13, Appendix A). However, continued shoreline erosion was noted at the east end of the 2005 maintenance rock. Also, the rock dike appears to have settled. There is a small breach in the dike near the east tie-in that was a result of the 2005 hurricanes. The shoreline erosion here should continue to be monitored on future inspections. The western mats are in good condition, although shoreline erosion continues to increase near the end of the mats. There continues to be a small breach behind the existing bulkhead where water is passing behind the bulkhead and over the rocks and into Transco Canal. The steel sheetpile and tie-rods are heavily corroded and should continue to be monitored. No maintenance activities are recommended at this time other than continuing the annual inspections of the site.

Photo 7. *Plug No. 4A – View of east side of plug looking east. This is the additional lift of rock placed over the Petraflex mats as part of the 2005 maintenance project.*

Photo 8. *Plug No. 4A – View of east shoreline tie-in of 2005 maintenance rock. The small breach resulted from the 2005 hurricanes. Continued erosion can be seen at the tie-in.*

Photo 9. *Plug No. 4A – View of east shoreline tie-in of 2005 maintenance rock looking east along shoreline. The small breach resulted from the 2005 hurricanes. Continued shoreline erosion can be seen at the tie-in and beyond.*

Photo 10. *Plug No. 4A – View of steel sheet pile bulkhead at the south end of Transco Canal looking southwest.*

Photo 11. *Plug No. 4A – View of Petraflex mats on west side of plug looking east back toward Transco Canal.*

Photo 12. *Plug No. 4A – View of west end of Petraflex mats and the continued shoreline erosion at the west tie-in looking northwest.*

Photo 13. *Plug No. 4A – View of continued shoreline erosion behind and beyond west end of the Petraflex mats looking northwest.*

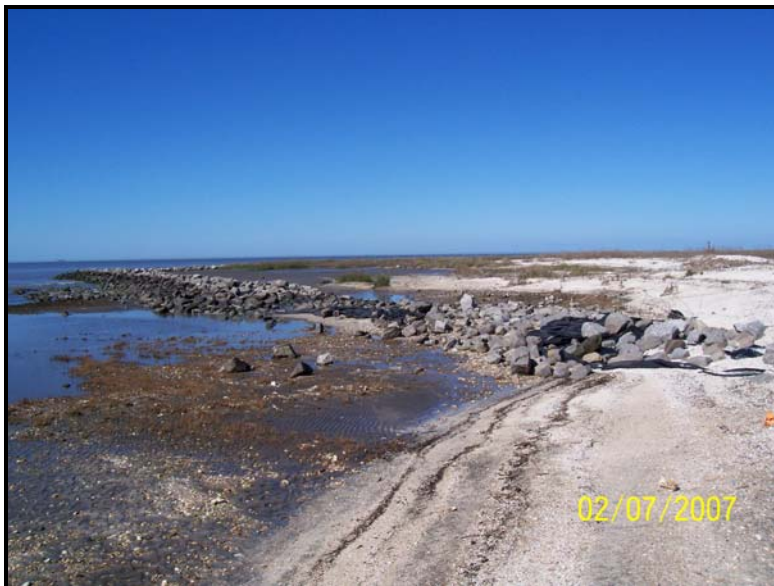
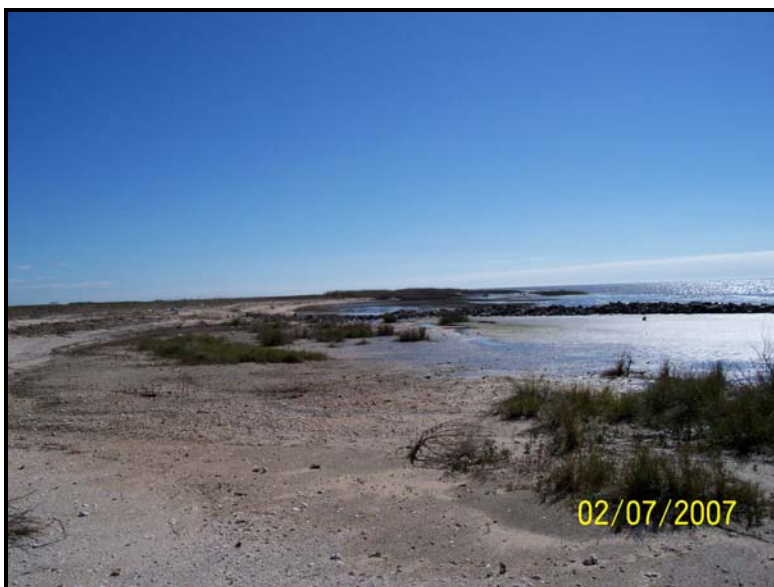
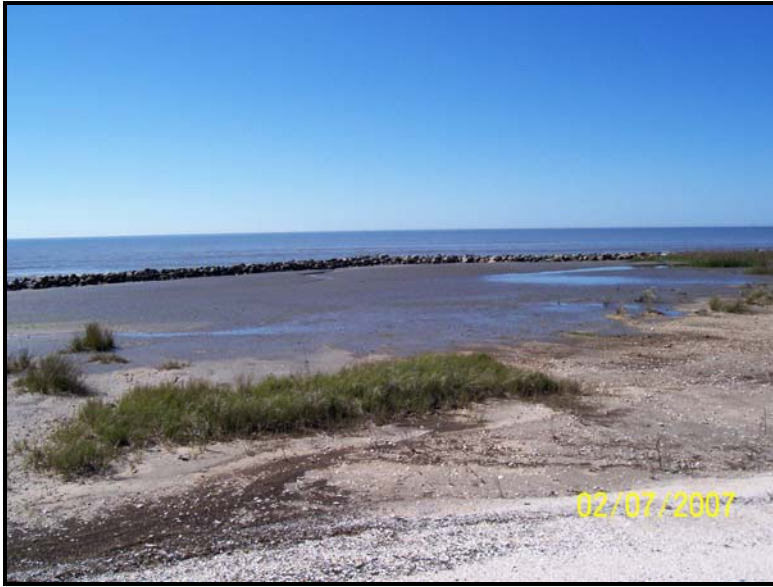
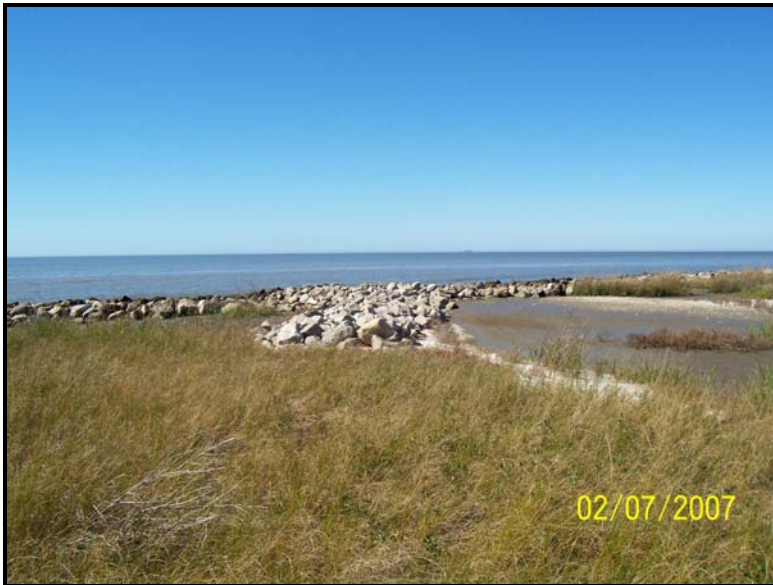
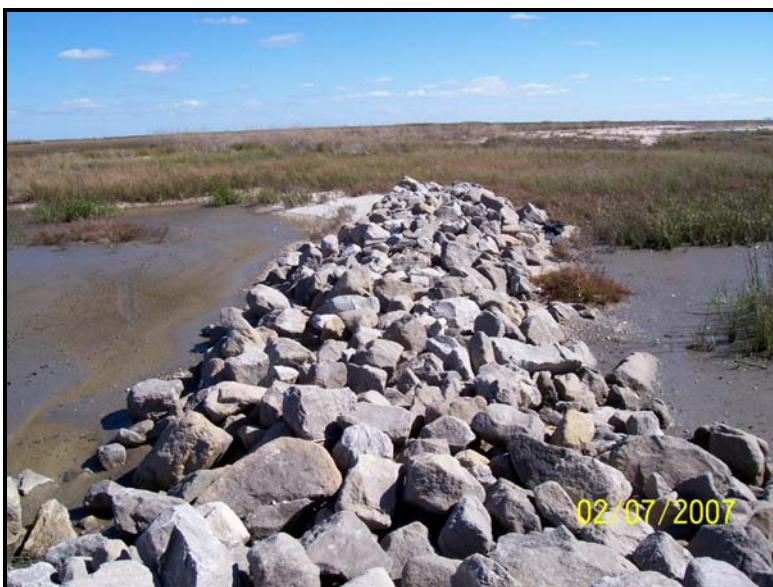
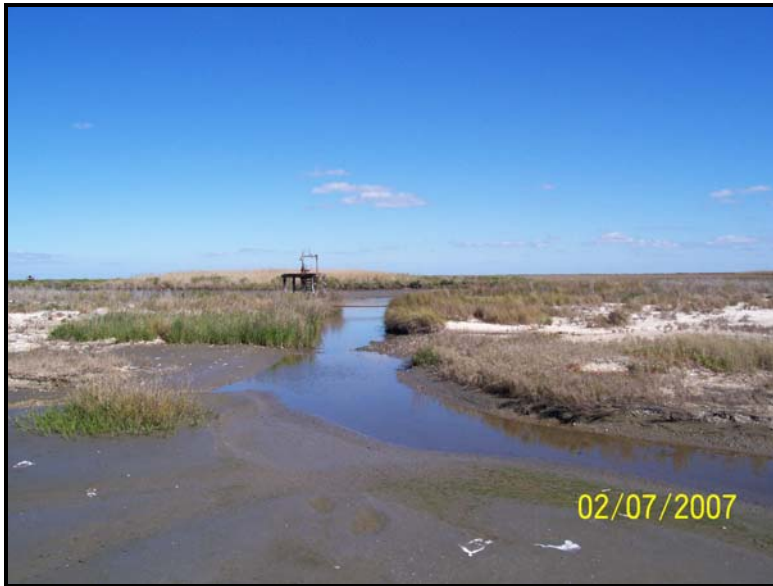
Phase III – Area 4, Rock Dike (Photos 14 - 19, Appendix B)

The breach around the east end of Area 4 rock dike noted in previous inspections was closed by the 2005 maintenance project with construction of approximately 300' of rock dike to the shoreline. The new rock lift and extension dike appeared to be in good condition; however, continued shoreline erosion was noted at the east end shoreline tie-in and should continue to be monitored on future inspections. Also, the small area of displaced rocks near the east end was due to the 2005 hurricanes as noted in the 2006 inspection report. It appears that some settlement has occurred along sections of the dike and should continue to be monitored on future inspections. No maintenance will be required in Area 4.

Photo 14. *Area 4 Rock Dike – View of east end of 2005 maintenance rock looking southwest from shoreline.*

Photo 15. *Area 4 Rock Dike – View of east end of 2005 maintenance rock looking southeast from shoreline. Continued shoreline erosion can be seen at tie-in and beyond.*

Photo 16. *Area 4 Rock Dike – View of 2005 maintenance rock at east end of Area 4 rock dike looking south from shoreline.*

Photo 17. *Area 4 Rock Dike – View of 2005 maintenance rock at east end of Area 4 rock dike looking south from shoreline. The rock spur plug extending from the dike can be seen in the foreground.*

Photo 18. *Area 4 Rock Dike – View of rock spur plug extending from dike into marsh. The plug was constructed as part of the 2005 maintenance project.*

Photo 19. *Area 4 Rock Dike – View of breach in Mobil Canal bank behind rock dike. Currently, the spur plug constructed as part of the 2005 maintenance project prevents a direct connection to the Gulf.*

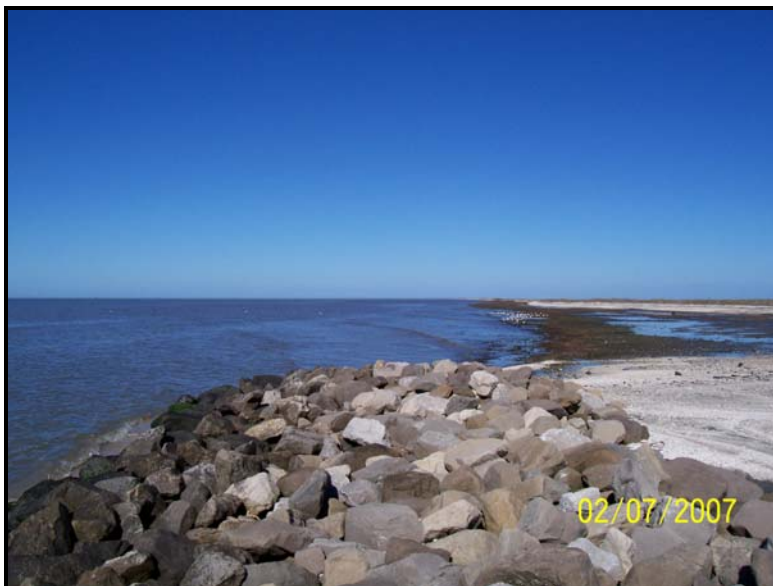
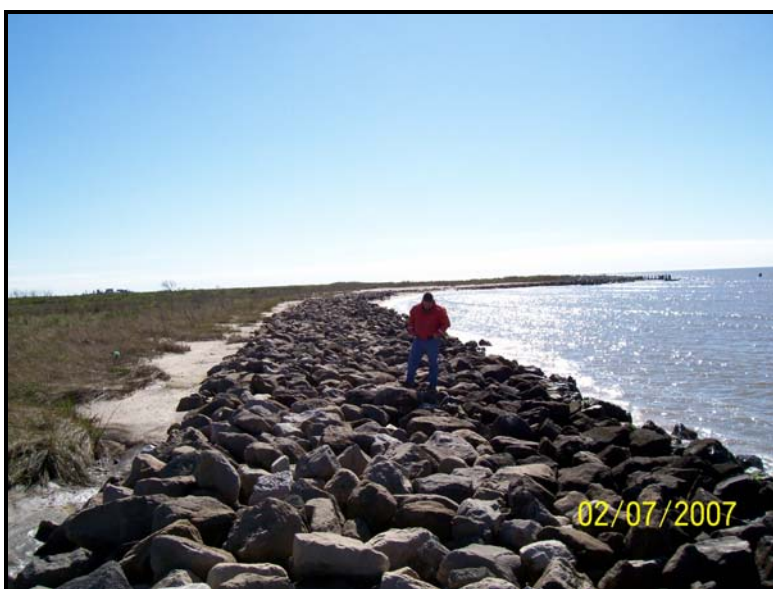
Phase III – Area 5, Rock Dike (Photos 20 - 21, Appendix B)

The rock dike along Area 5 of Phase III appeared to be in good condition with no noticeable settlement of the structure. Beyond the west end of the dike, erosion of the beach face was observed and should continue to be monitored on future site visits. No maintenance will be required in Area 5.

Photo 20. *Area 5 Rock Dike – View of west end of rock dike looking northwest. Continued shoreline erosion can be seen just beyond the tie-in.*

Photo 21. *Area 5 Rock Dike – View of rock dike, standing at the west end of dike looking southeast.*
