**State of Louisiana
Department of Natural Resources
Coastal Engineering Division**

**2006/2007 Annual Inspection
Report**

**LITTLE VERMILION BAY
SEDIMENT TRAPPING
PROJECT (TV-12)**

March 6, 2007
Vermilion Parish

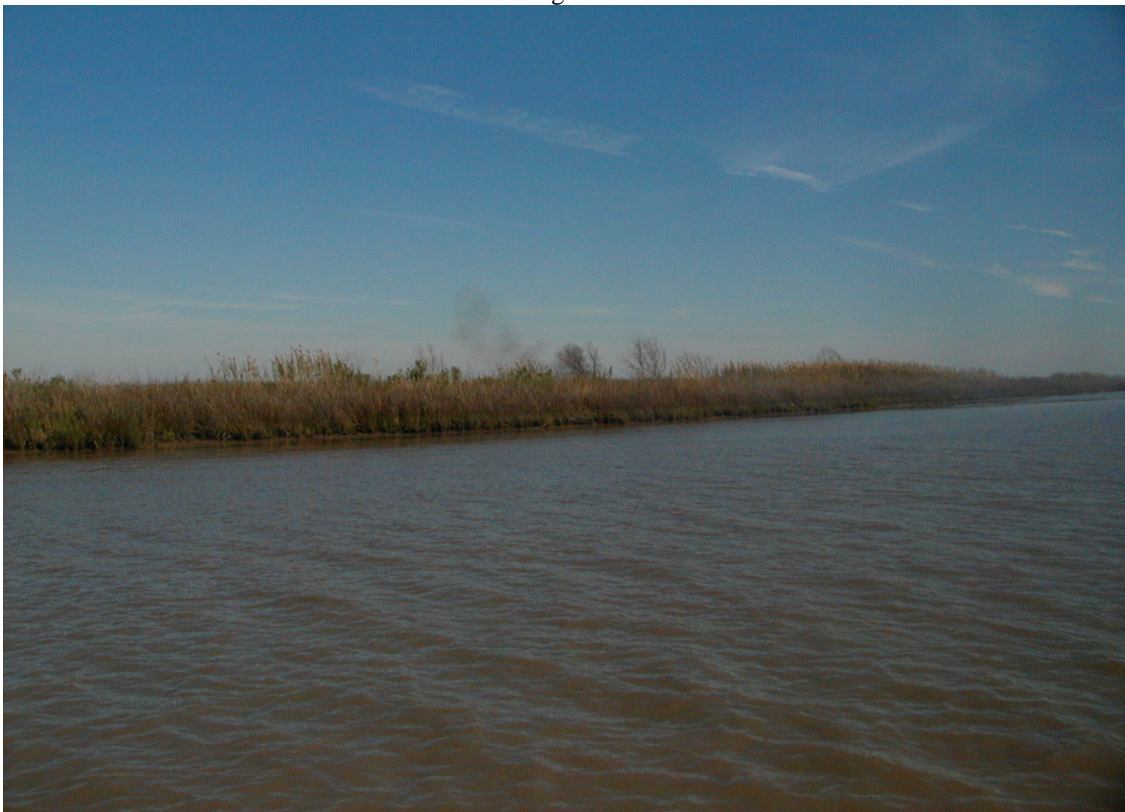
Vegetation planted on the terraces has recovered from the stress caused by the hurricanes. No maintenance needed at this time.

Photo 2—typical vegetated terrace
