**State of Louisiana
Department of Natural Resources
Coastal Restoration Division**

**2006/2007 Annual Inspection
Report**

**Barataria Bay Waterway East
Bank Protection
(BA-26)**

State Project Number BA-26
Priority Project List 6

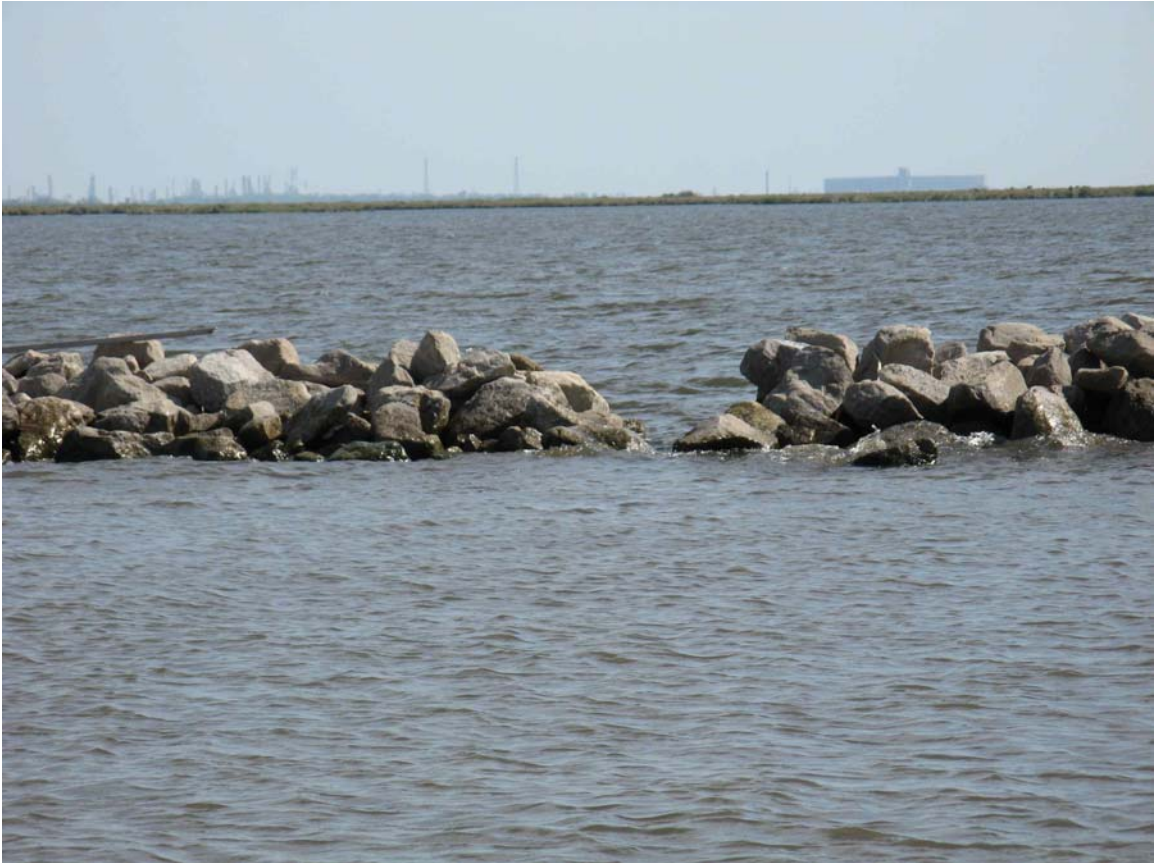
Photo No. 3 – Small gap in Shoreline Protection.
