# 2008/2009 Annual Inspection Report

## PERRY RIDGE SHORELINE PROTECTION PROJECT (CS-24)

State Project Number CS-24  
Priority Project List 4

October 2, 2008  
Calcasieu Parish

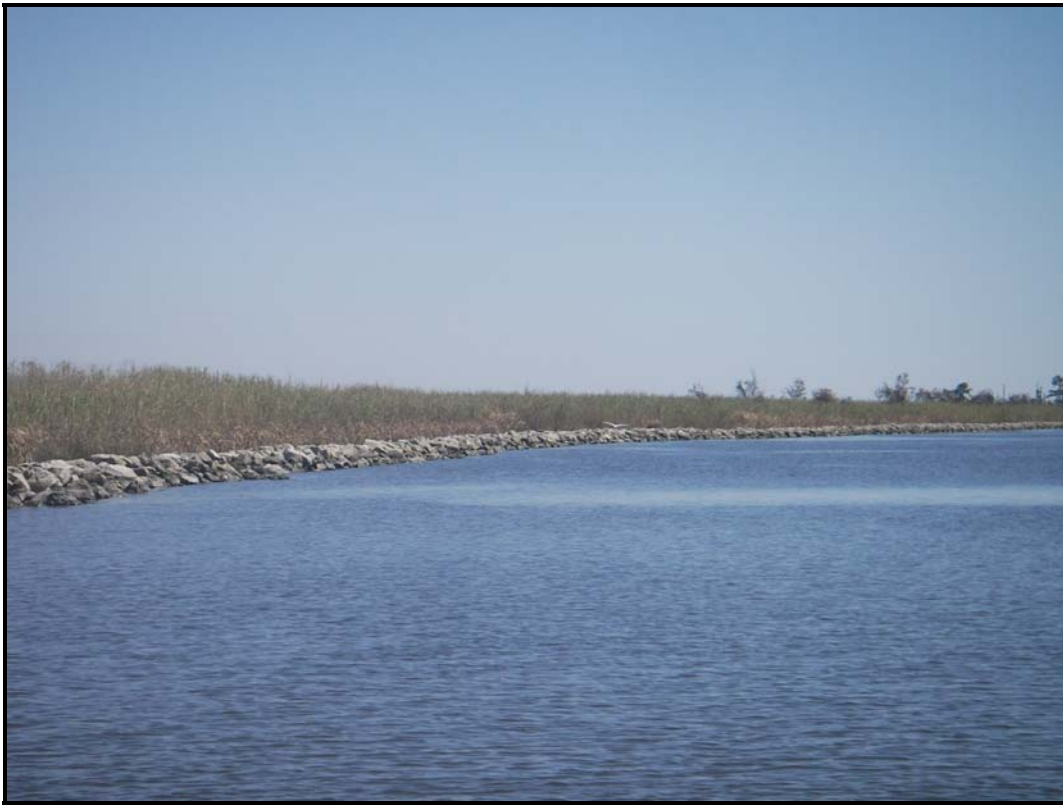
The dike is in excellent condition with some very small areas being below constructed elevation. Visible signs of accretion are occurring behind the rock dike in some areas. No maintenance is recommended at this time. Water salinity was 11 ppt in the GIWW near the western end of the rock dike. (Photos: Appendix B, Photo 1)

**Photo No.1**, Typical rock dike

| Item | Condition | Physical Damage | Corrosion | Photo # | Observations and Remarks |
|---|---|---|---|---|---|
| Rip Rap (fill) (foreshore dike) | Good | | | 1 | Accretion occurring behind rock dike. |
