**2008/2009 Annual Inspection  
Report**

**BLACK BAYOU HYDROLOGIC  
RESTORATION PROJECT  
(CS-27)**

State Project Number CS-27  
Priority Project List 6

October 2, 2008  
Calcasieu and Cameron Parishes

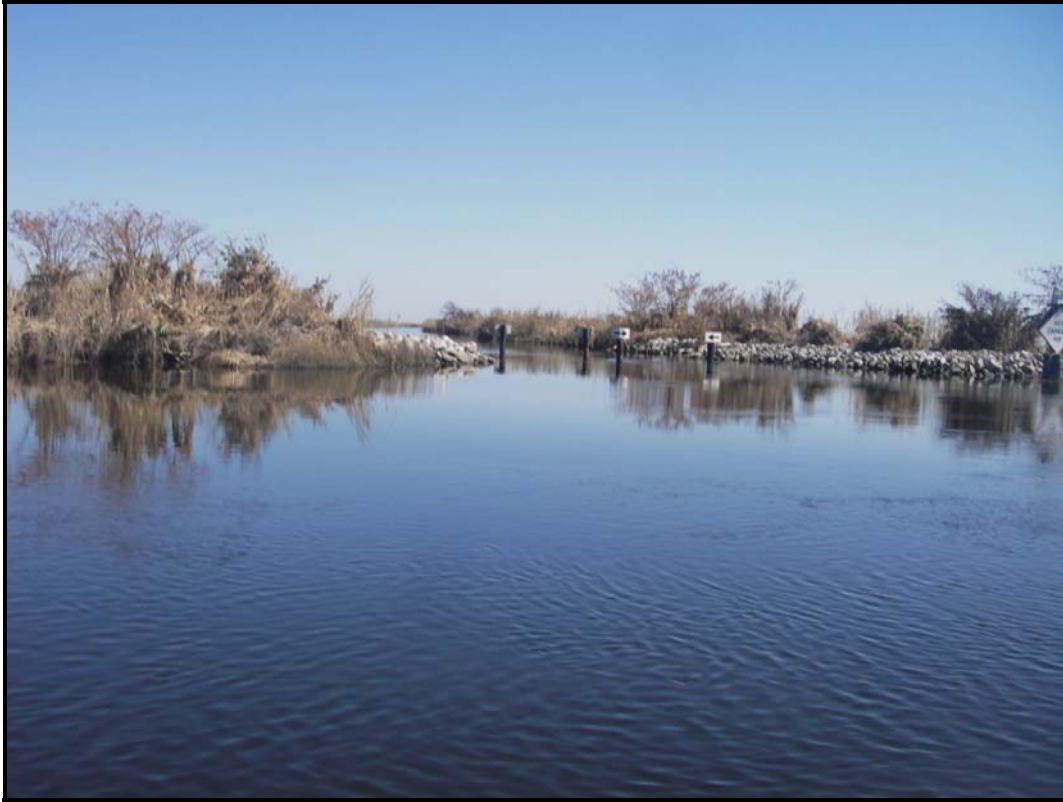
The rock weir is in excellent condition. Signage is stable. The erosion on the SE bank, while has not gotten any worse, will continue to be monitored. No immediate need for maintenance at this structure. Conditions of the Navigational Aid Lights were last inspected in December '08. (Photos: Appendix B, Photos 1-3)

**Photo 1**—Navigational Aids and signage at Block's Creek

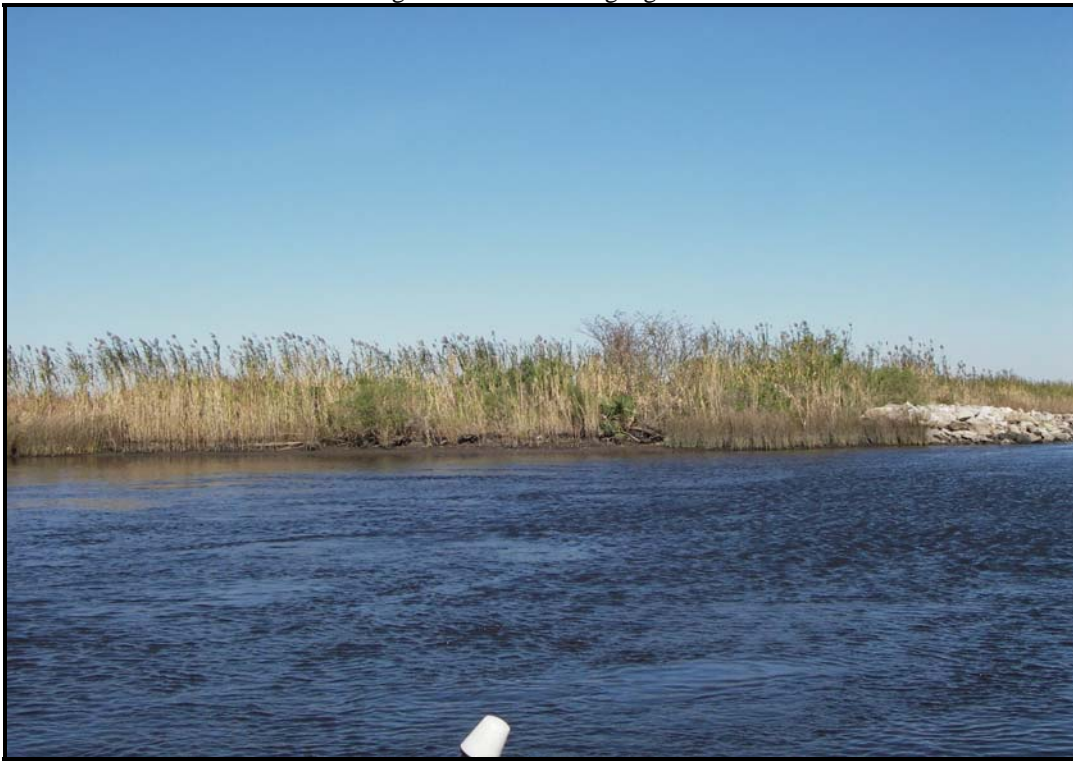
**Photo 2**—western side of Block's Creek Structure & signage

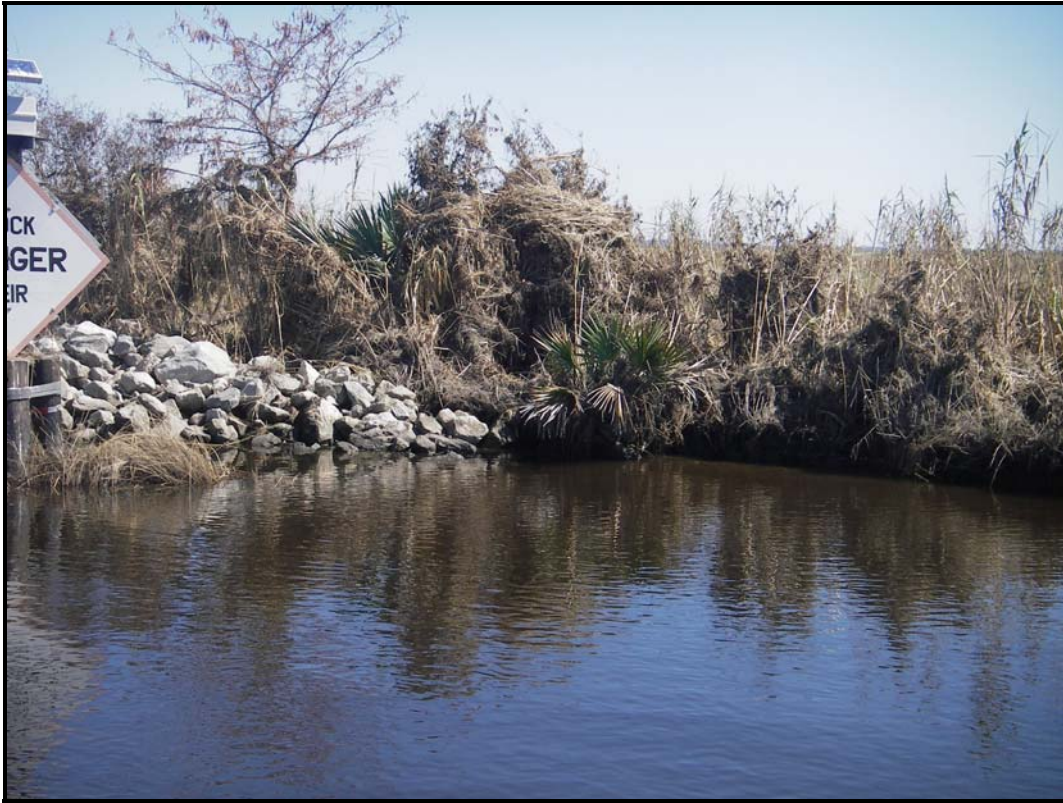
**Photo 3**—erosion on SE end of Block's Creek Structure

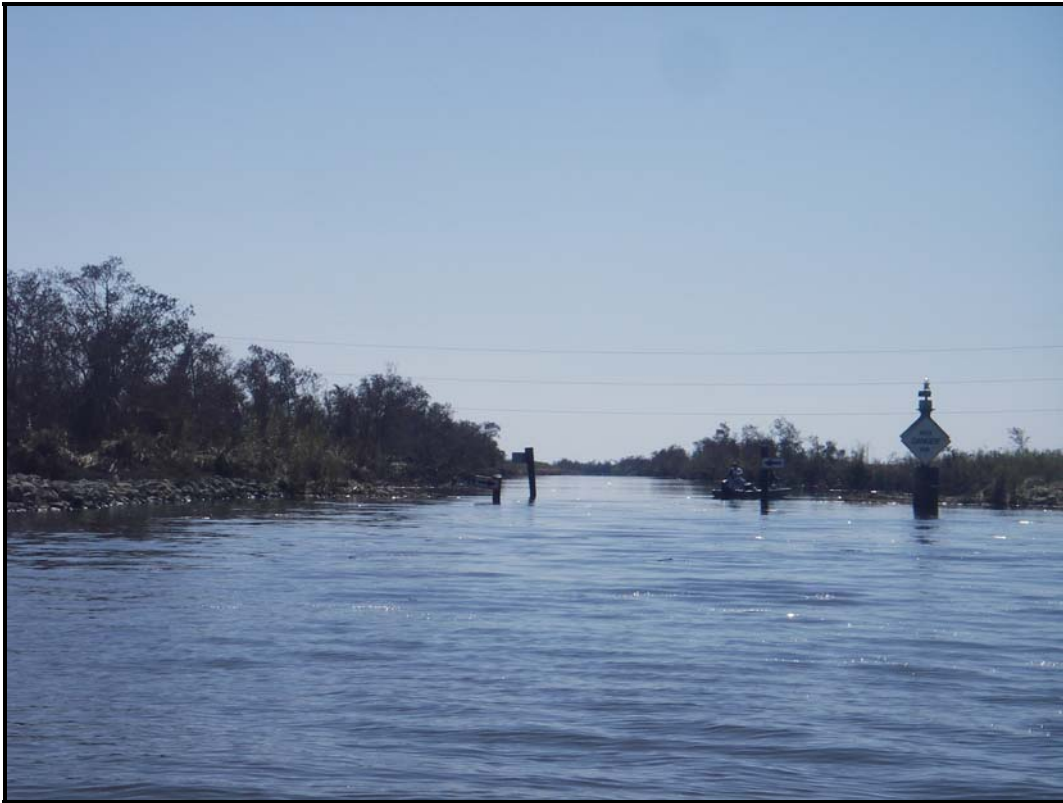
The weir is in good condition. There is some minor scouring along the canal banks inside of the weir at the end of the dike that will continue to be monitored. Severe current through the weir has caused problems for boaters in the area. The SE arrow sign is missing. As part of the maintenance project scheduled for the spring of 2009, the remaining piling will be removed and warning signs similar to the ones on the Black Bayou Cut-Off canal will be used. The Navigational Aid Lights were last inspected in December '08. (Photos: Appendix B, Photo 4)

**Photo 4**—Burton Canal Structure

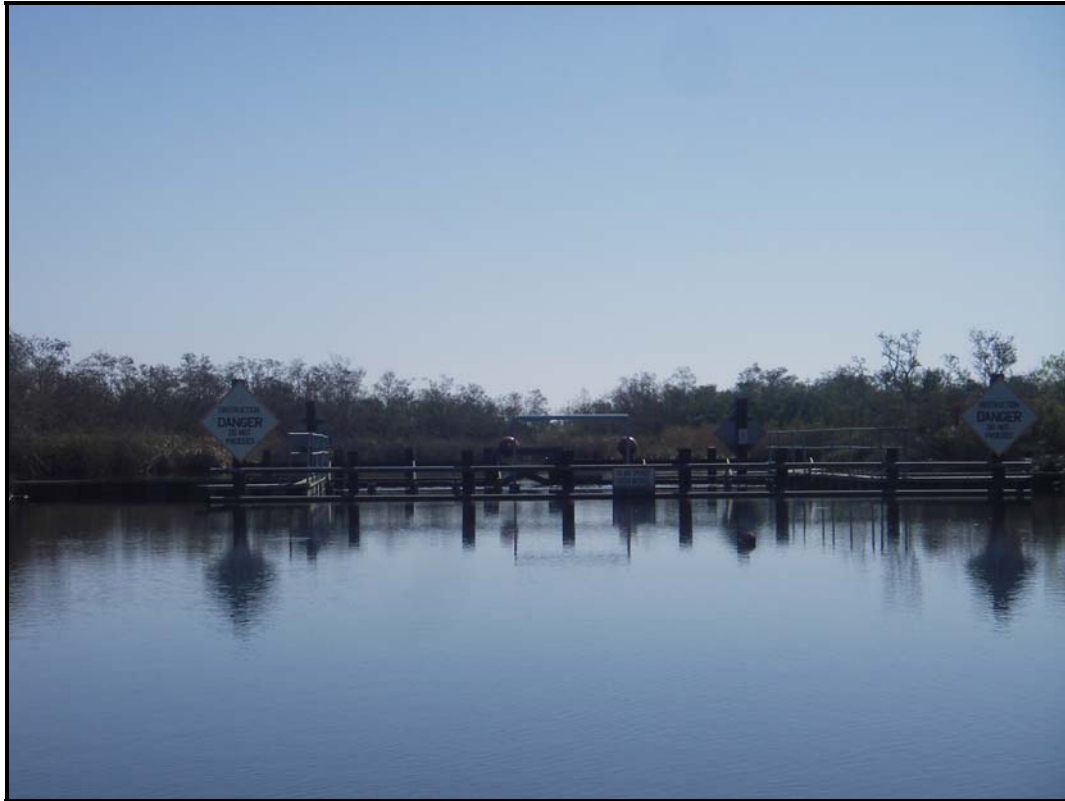
The structure itself is in very good condition. Signage, railings, wingwalls, etc. in as-built condition. Pillow blocks on new flap have rusted to the point that the flapgate has frozen and cannot move. The entire hinge mechanism will be replaced in the maintenance event which is scheduled for the spring of 2009. (Photos: Appendix B, Photos 5-7)

**Photo 5**—SRT Gate railings, etc.

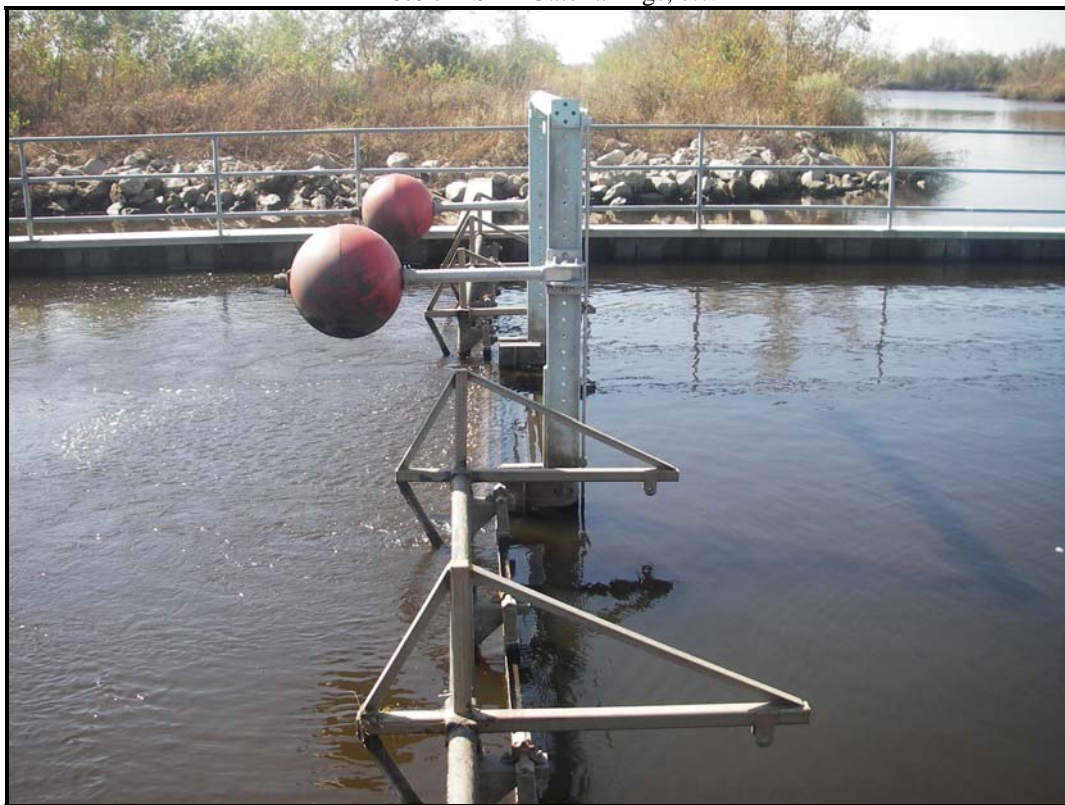
**Photo 6**—SRT Gate

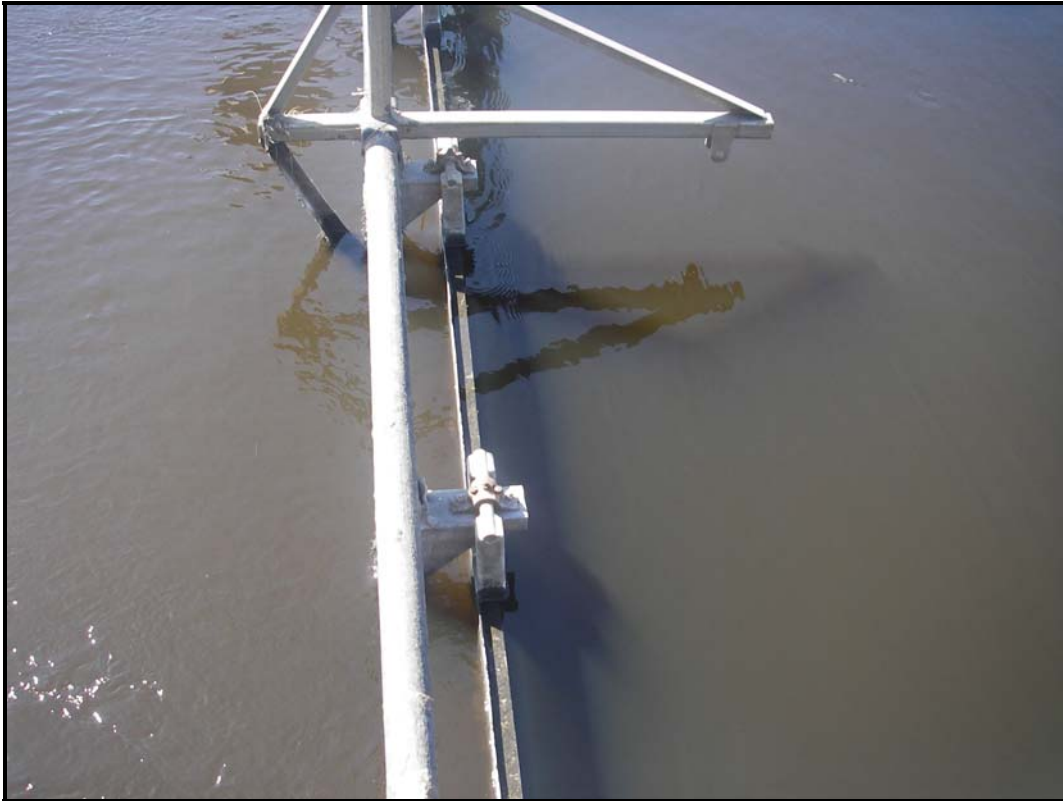
**Photo 7**—SRT Gate pillow block on new flap

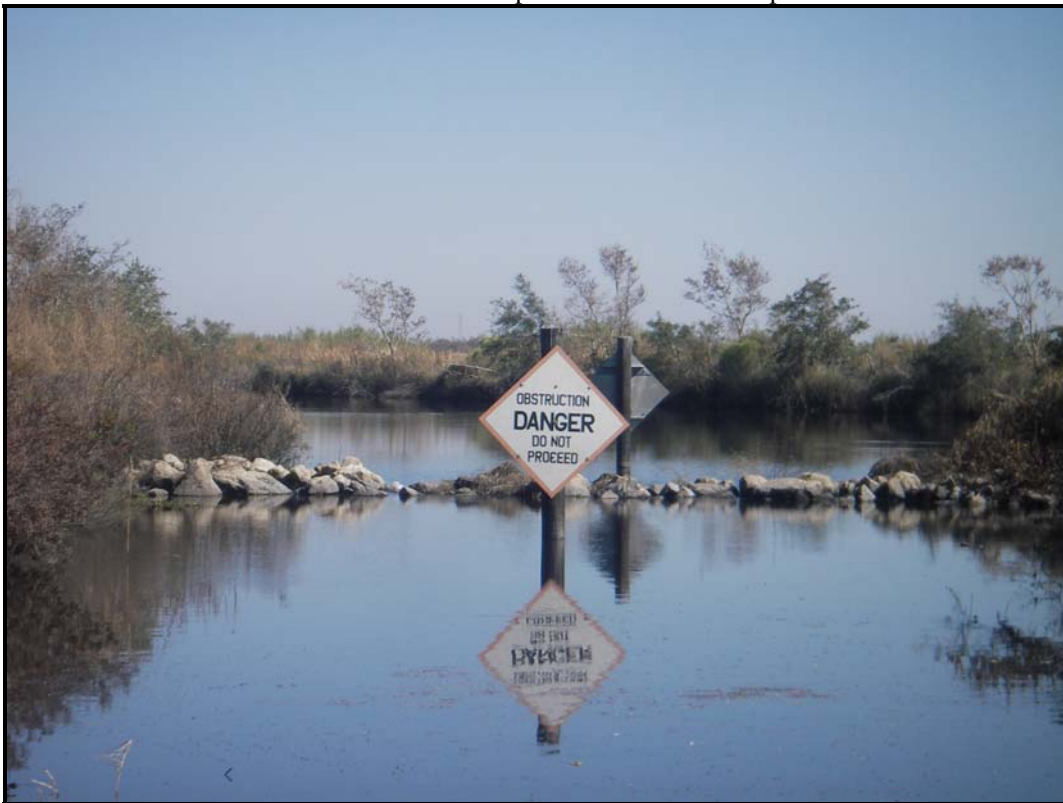
Rock has either been moved or has settled slightly to an approximate elevation of +2.5 feet NAVD '88 in spots. Also, eastern end of the dike is well below elevation where it ties into the bank. This will be addressed, with sacks of QuickCrete placed on the crown of the plug and on the tie-in to the bank, in the maintenance event scheduled for the spring of 2009. (Photos: Appendix B, Photo 8)

**Photo 8**—Rock plug near SRT Gate

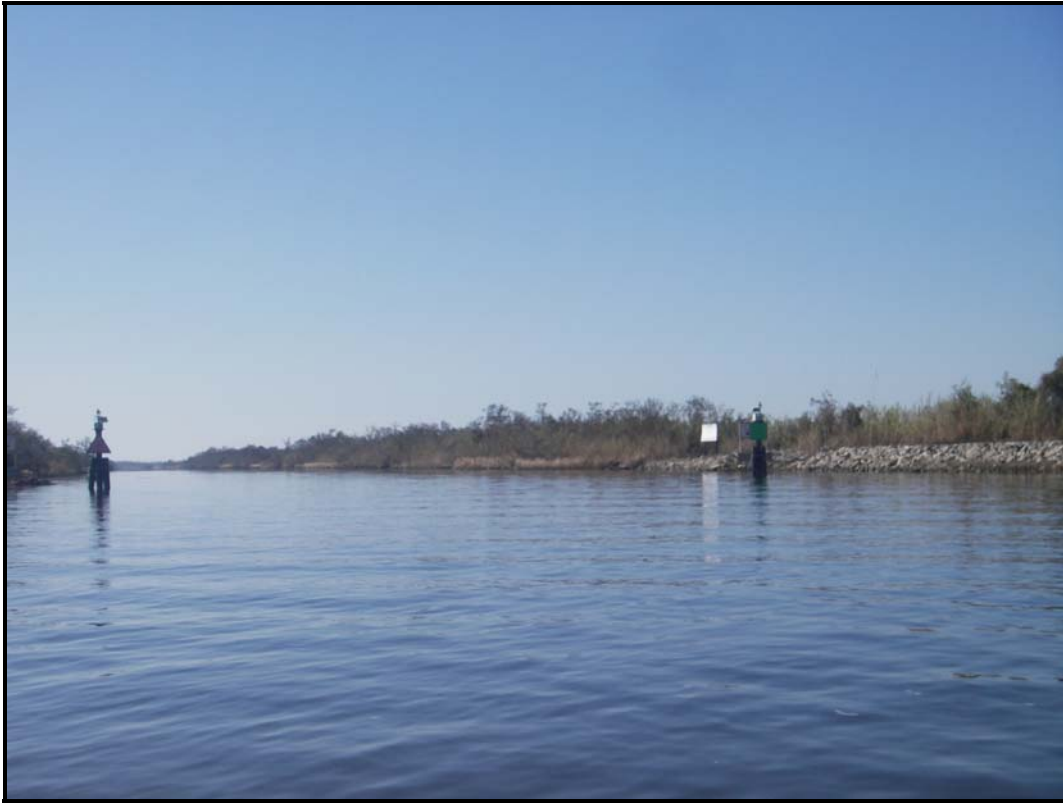
This component is in immediate post construction condition. No need for maintenance at this time. Conditions of the Navigational Aid Lights are inspected quarterly. (Photos March, '06: Appendix B, Photo 9)

**Photo 9**—Black Bayou Cut-Off Canal Structure; Navigational aids, signs, etc.

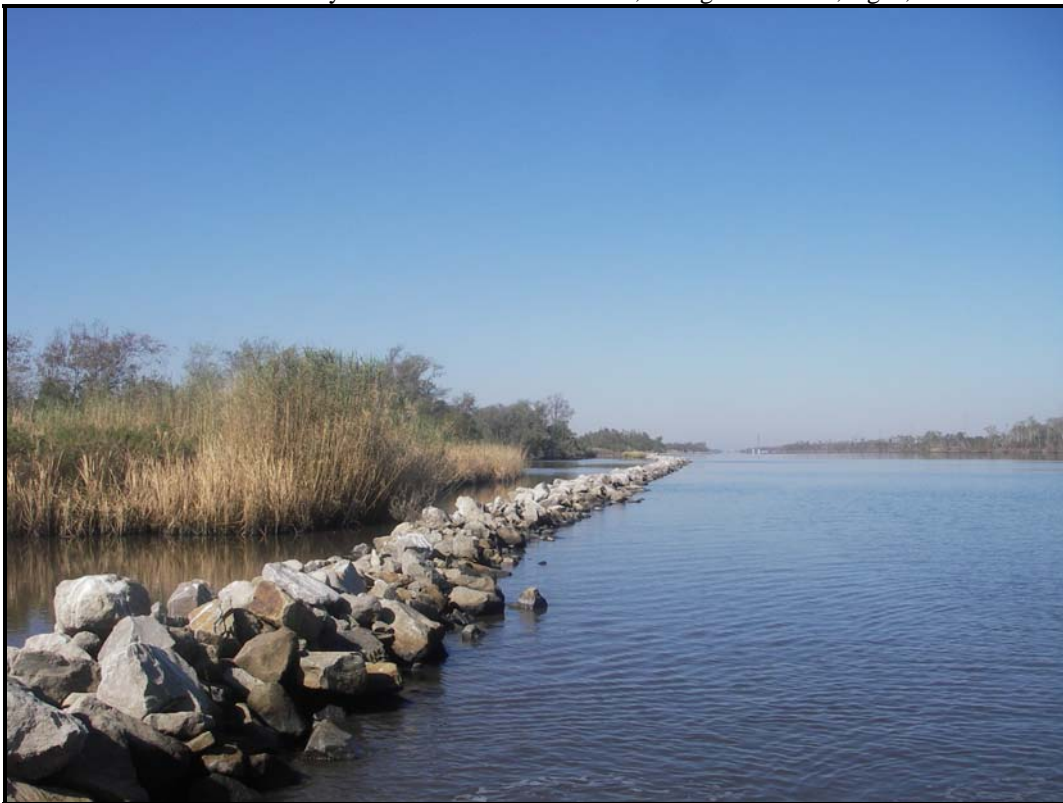
Tie-ins on both the east and west end of the dike are stable. Several random spots along the dike were checked and no apparent toe scour is occurring. As mentioned in previous inspections, the warning signs at both the Vinton and Black Bayou closures have been stolen. The spoil placed behind the rock dike at the Black Bayou Canal has washed away on the western end. Spoil is also gone on the eastern end of the closure at Vinton Canal. There is also a gap in the rock at this location. The second gap from the east has a large gap on the eastern end of the C-stone closure. Rapid water exchange is occurring here and the breach is getting wider and deeper than in previous inspections. The alligator crossing, mentioned in previous inspections, on the 3<sup>rd</sup> closure from the east has not gotten any worse. These three areas will be addressed with QuickCrete sacks in the maintenance event in the spring of 2009. (Photos: Appendix B, Photos 10-12)

**Photo 10**—Typical section of rock dike

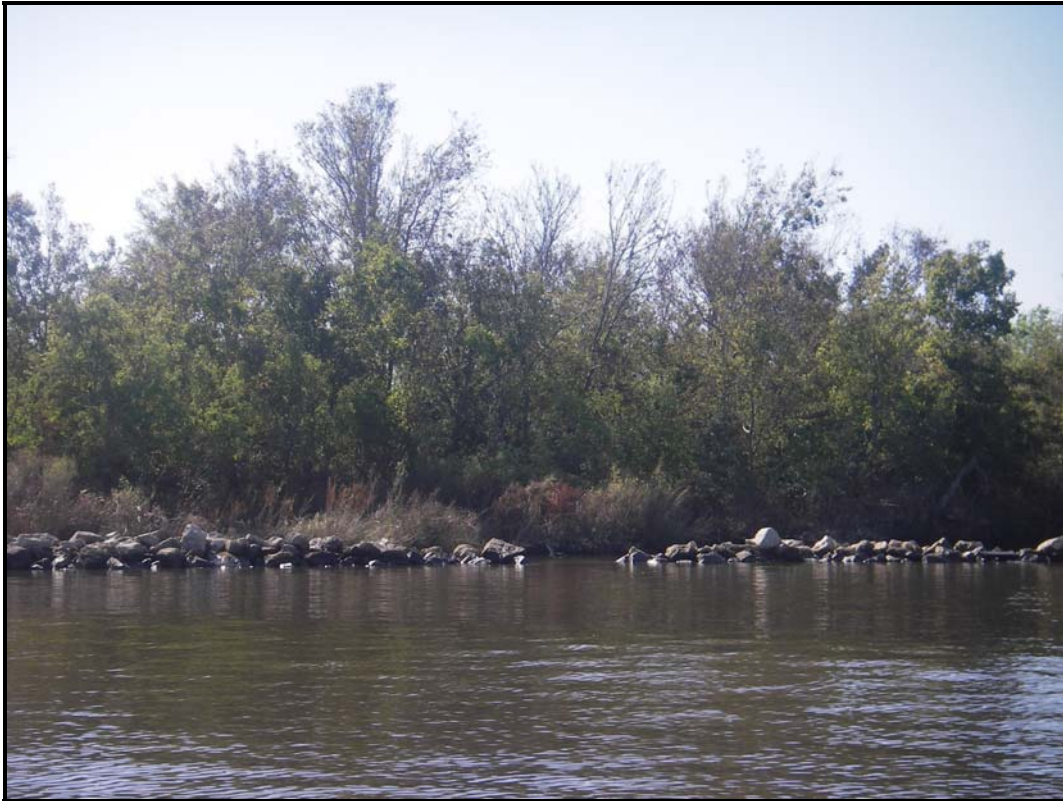
**Photo 11**—Missing spoil and gap in rock dike at E. end of Vinton Canal Closure

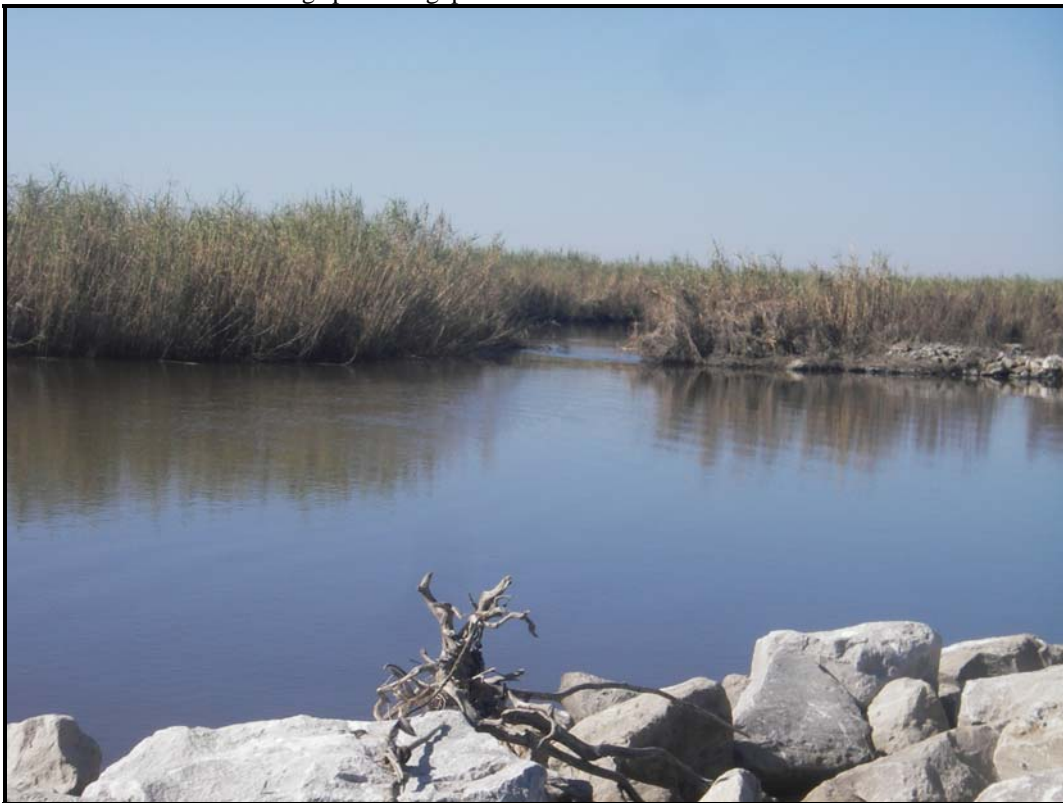
**Photo 12**—Gap in E. end of C-stone closure at second gap from the east
