**2010 Annual Inspection Report**

**LAKE CHAPEAU SEDIMENT INPUT  
AND HYDROLOGIC RESTORATION  
PROJECT**

State Project Number TE-26  
Priority Project List 3

June 1, 2010  
Terrebonne Parish

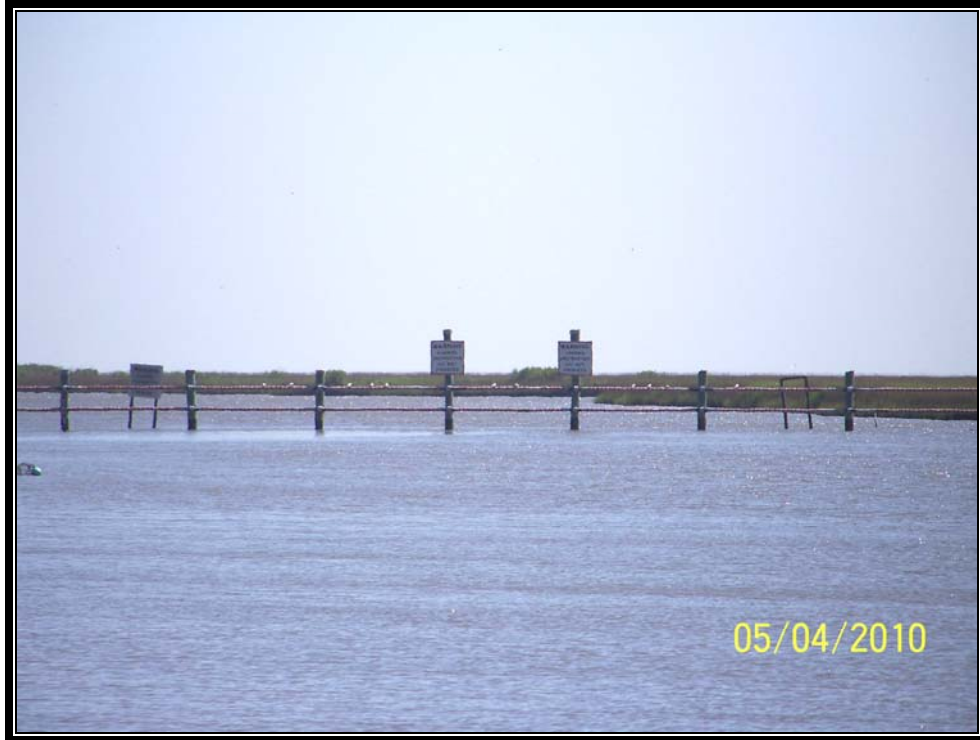
Due to a floating gate across the canal approximately 500' before Site No. 1 (Appendix B, Photo 4), a close inspection of the Rock Weir and Timber Barricade was not possible. Overall, the rock weir appeared to be in good condition with no apparent erosion or breaching around the ends of the weir. The timber barricade system and warning signs also appeared to be in good condition with no visible damage or corrosion. Because we could not get close to the structure, we were unable to determine if the two (2) timber piles that were missing their galvanized metal caps last year were being degraded by the weather.

The latest elevation data available from the 2004 survey profile of the structure indicates that the crest of the rock weir has settled approximately 1.39' since 1999. The newly set TE26-07 data recorder station, located approximately 600' from the structure, was reading a tide level of 0.5' NAVD88 at the time of the inspection of Site No. 1. (Appendix B, Photos 1 - 4)

Photo No.1 –View of barrage system and rock weir at the center of Structure No.1

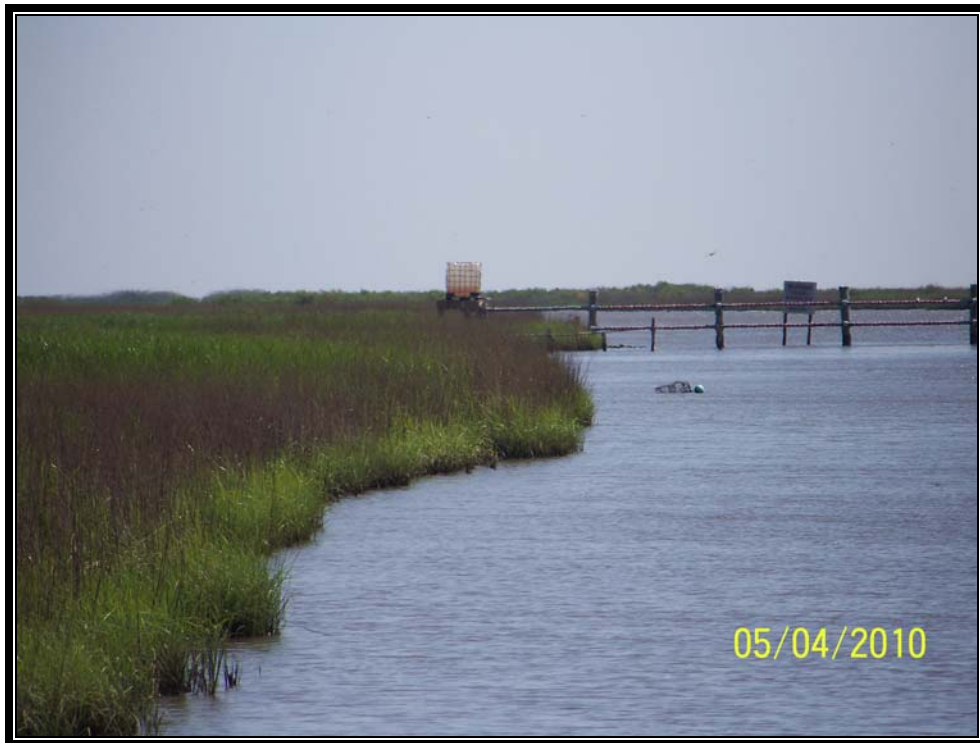
Photo No.2 – View of the barrage system and rock weir tie-in on the west end of Structure No.1

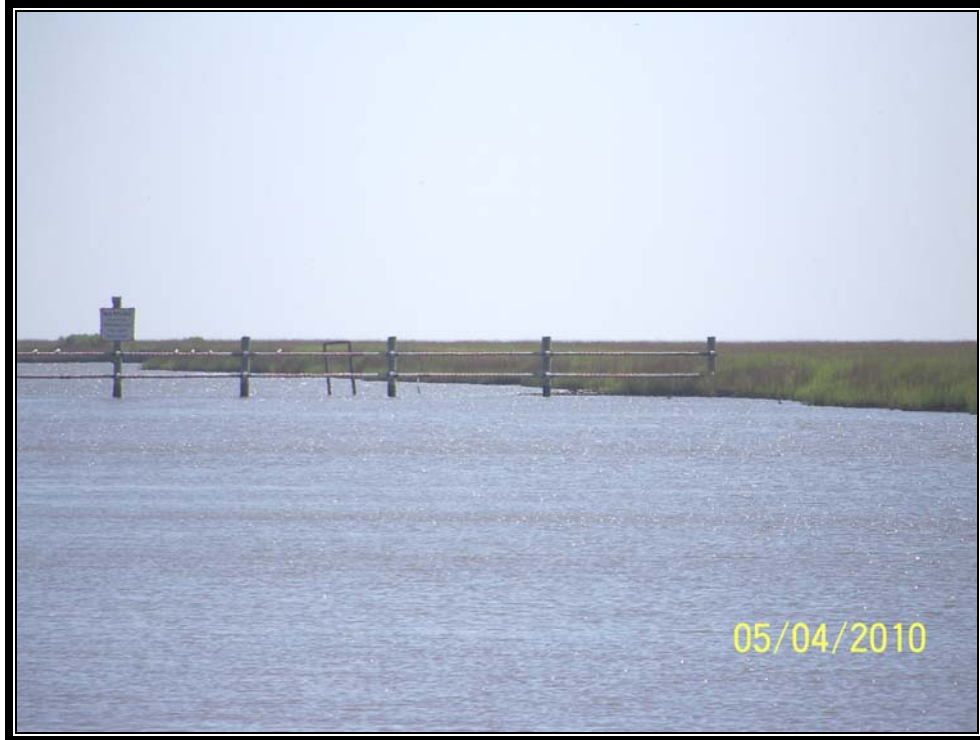
Photo No.3 – View of the barrage system and rock weir tie-in on the east side of Structure No.1

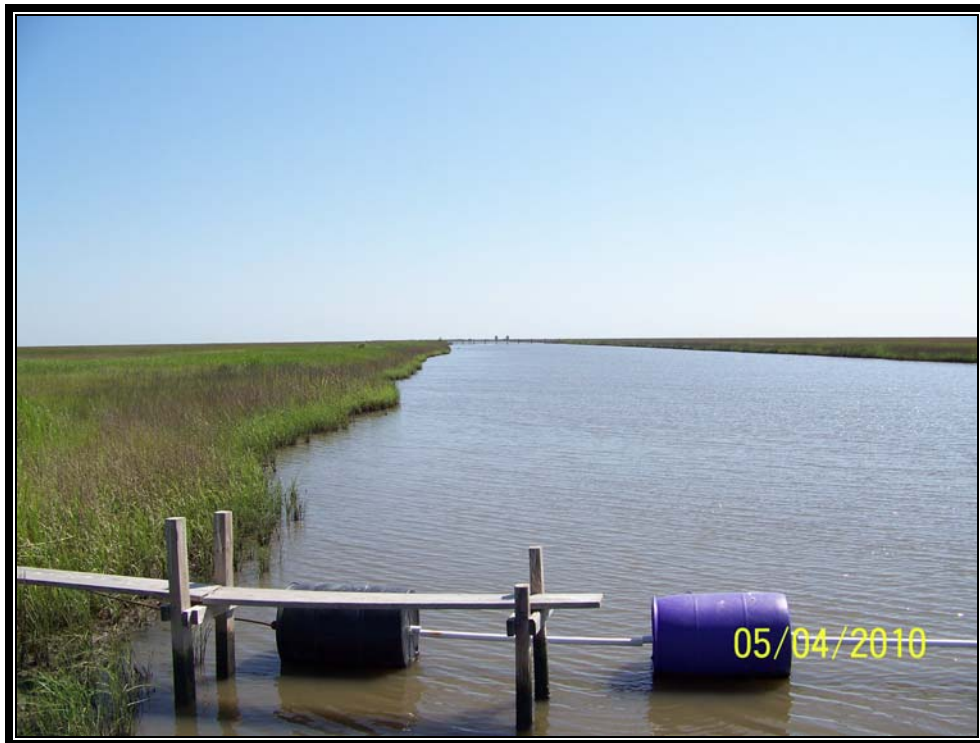
Photo No.4 – View of the gate blocking access to Structure No. 1

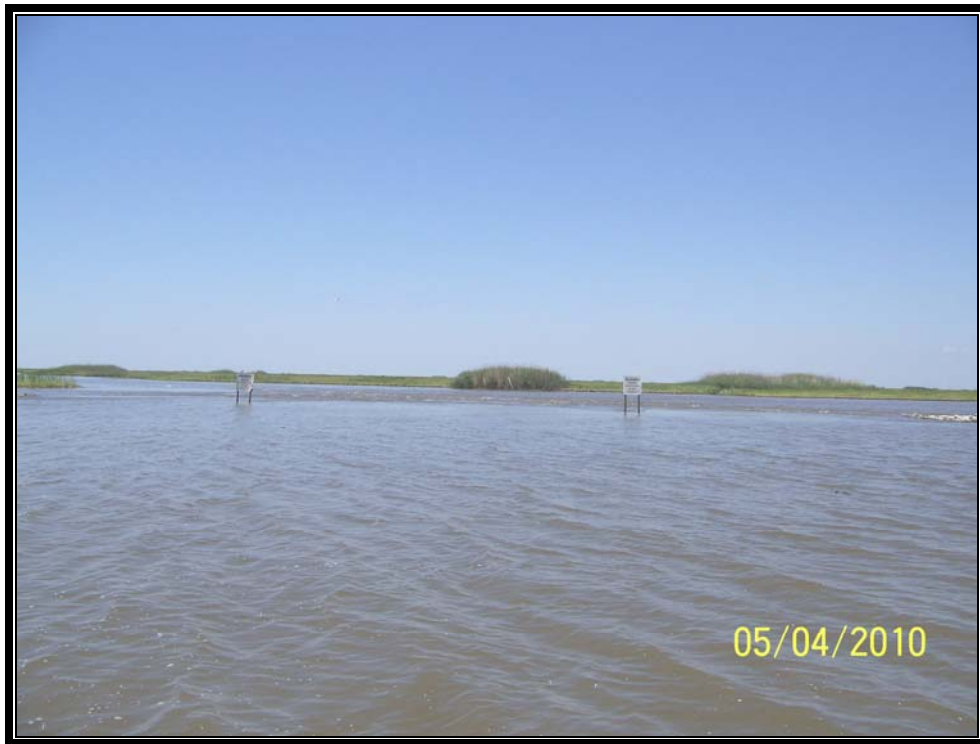
The rock weir appeared to be in good condition however, there was a significant breach at the north tie-in and a small breach developing at the southern tie-in. It was previously determined that repairing the structure was no longer an option due to the amount of land loss occurring along the shoreline north of the structure. With erosion rates in this area exceeding 60 ft/year, it is no longer feasible to maintain Structure No.3. Currently, the OCPR is in the process of designing plans and specifications to degrade the structure to an -8' NAVD 88 elevation. The permitting and plans and specifications are expected to be completed by late fall and construction of the project should be completed by January 2011.

Photo No. 5 – View of center of Structure No.3.

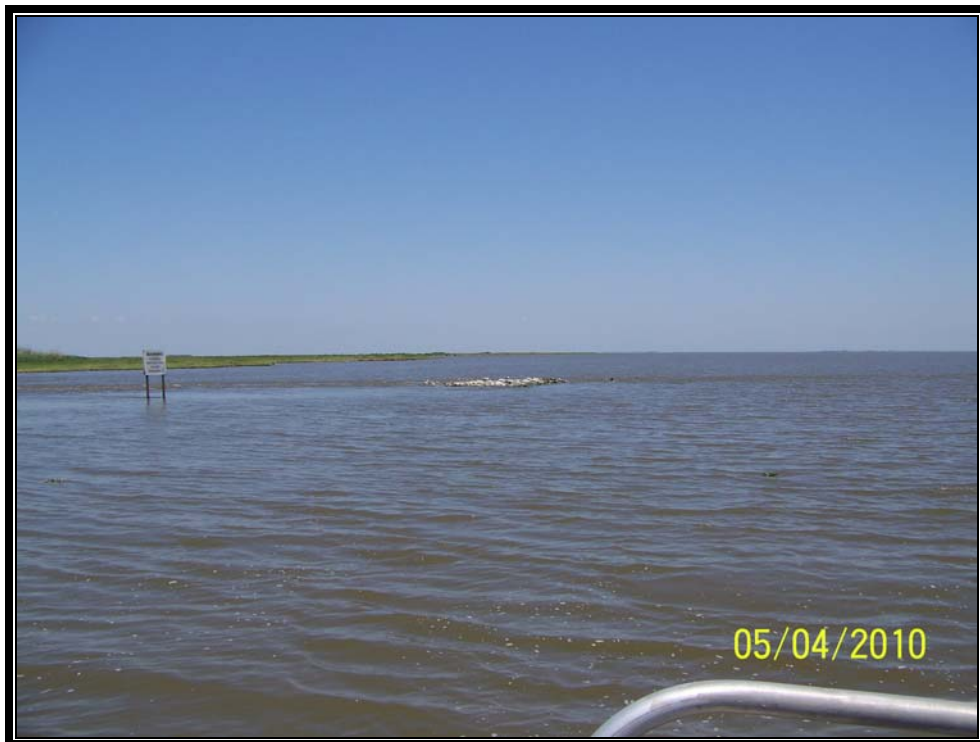
Photo No. 6 – View of north tie-in of Structure No.3.

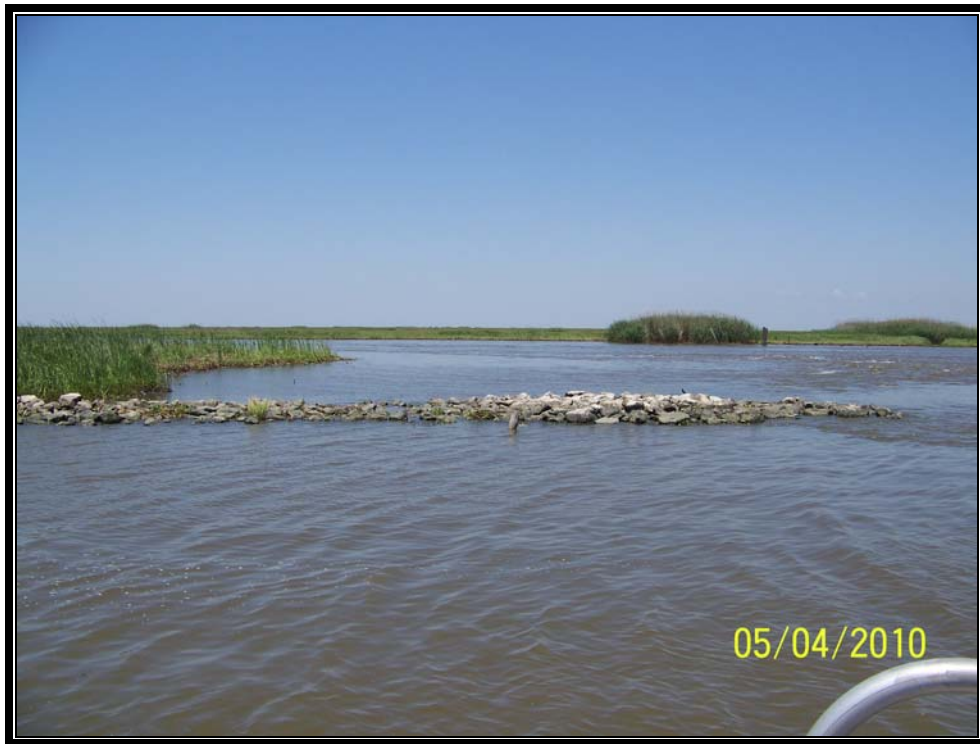
In the case of Structure No.3, there did not seem to be any widening of the breach on the northern side of the structure. The breach remains to be approximately 350' wide. Also the southern side of the structure has eroded and is very near breaching. The OCPR is in the process of designing a project to degrade the structure. This project is anticipated to be completed by January 2011.

Photo No. 7 – View of the southern tie-in of Structure No.3.

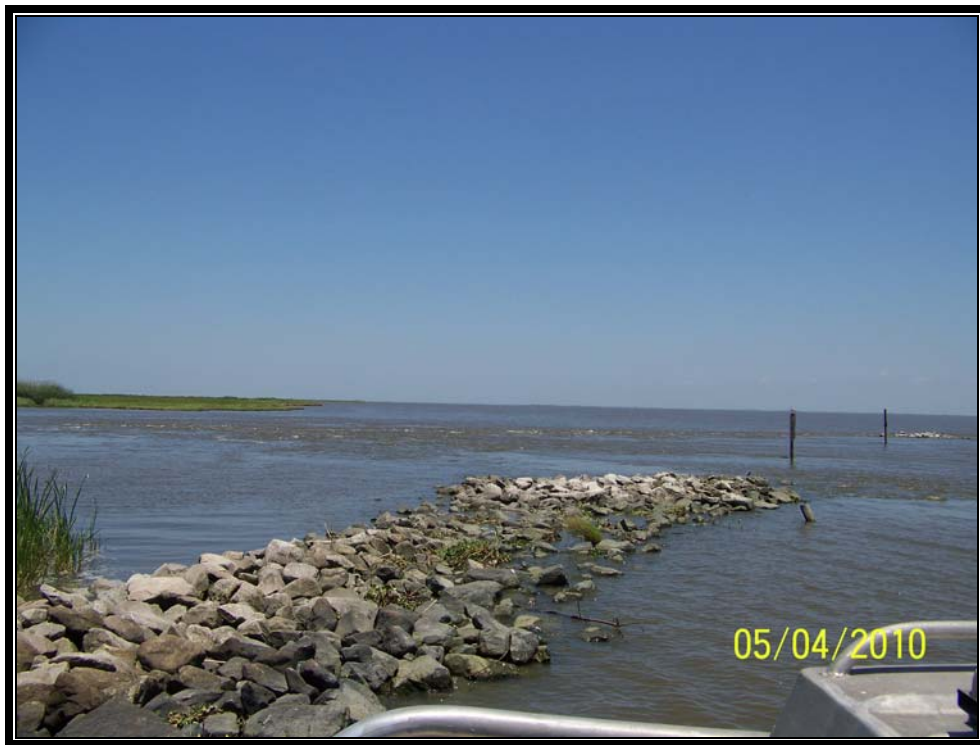
Photo No. 8 - View of breach at northern tie-in of Structure No.3. Photo taken from southern tie-in.

**Operation and Maintenance Assumptions:** Includes an unplanned maintenance event to remove Structure No.3 entirely. Method of construction includes removing all signage and supports and degrading the rock weir by spreading rip rap material along the bottom of the channel and bay to an elevation that would not interfere with navigation.

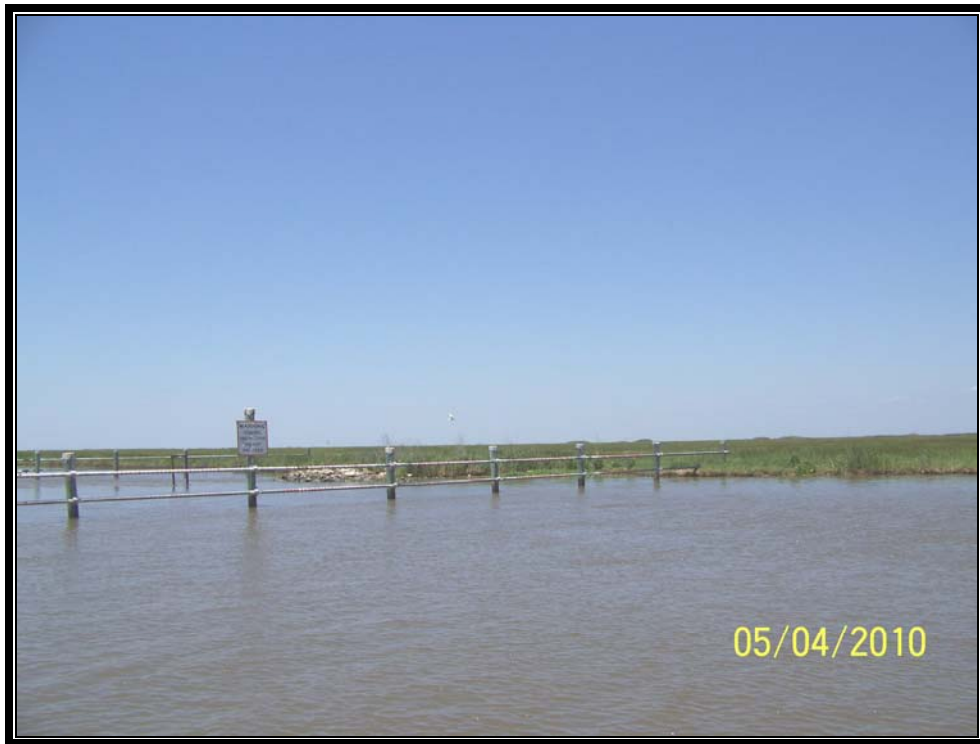
The rock weir appeared to be in good condition with no breaching around the ends. As in previous inspections, we found that the existing marsh connecting the structure to land on the south side of the weir was thin. However it didn't seem that there was any significant erosion since the last inspection.

Photo No.9 – View of the northern tie-in of Structure No.4.

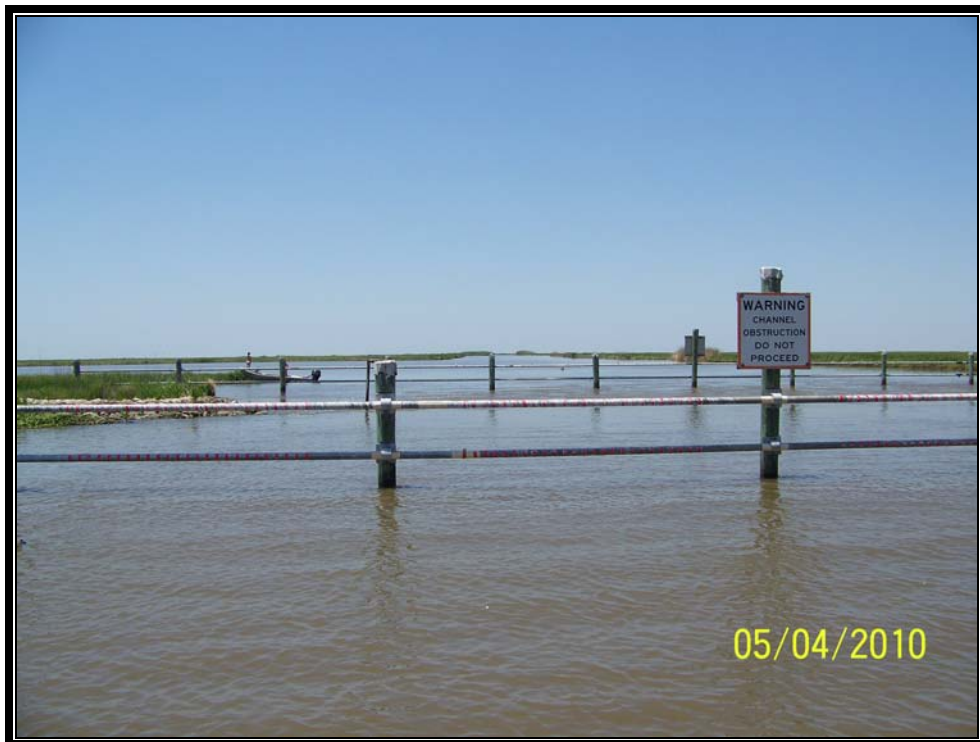
The timber barricade system and signage appeared to be in good condition. As reported in previous inspections, the two (2) center pilings were found to be slightly unstable. A combination of the inadequate embedment depths and poor soil conditions could have caused the instability in these piles. With the lateral support provided by the two (2) horizontal steel pipe members, we do not believe that minor instability in the center piles is a cause for concern at this time. Also a 10' section of the lower pipe on the northern side of the western barricade was cut out by vandals. (Appendix B, Photo 12). We do not believe that this missing section of pipe will have any detrimental effect on the barricade system and we are not recommending any repairs at this time. The inspection team will continue to monitor the stability of the timber pile supports and the cut section of pipe on future field trips. (Appendix B, Photos 9 - 12).

Photo No. 10 – View of the barricade system and rock weir at Structure No.4 looking southwest.

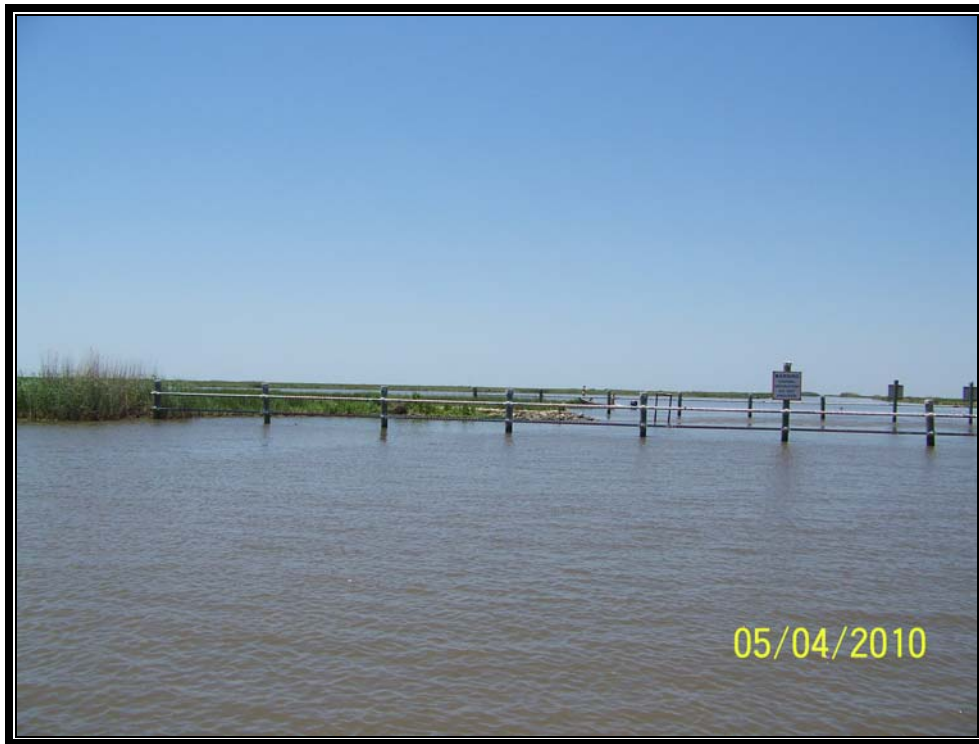
Photo No. 11 – View of the southern tie-in of Structure No.4

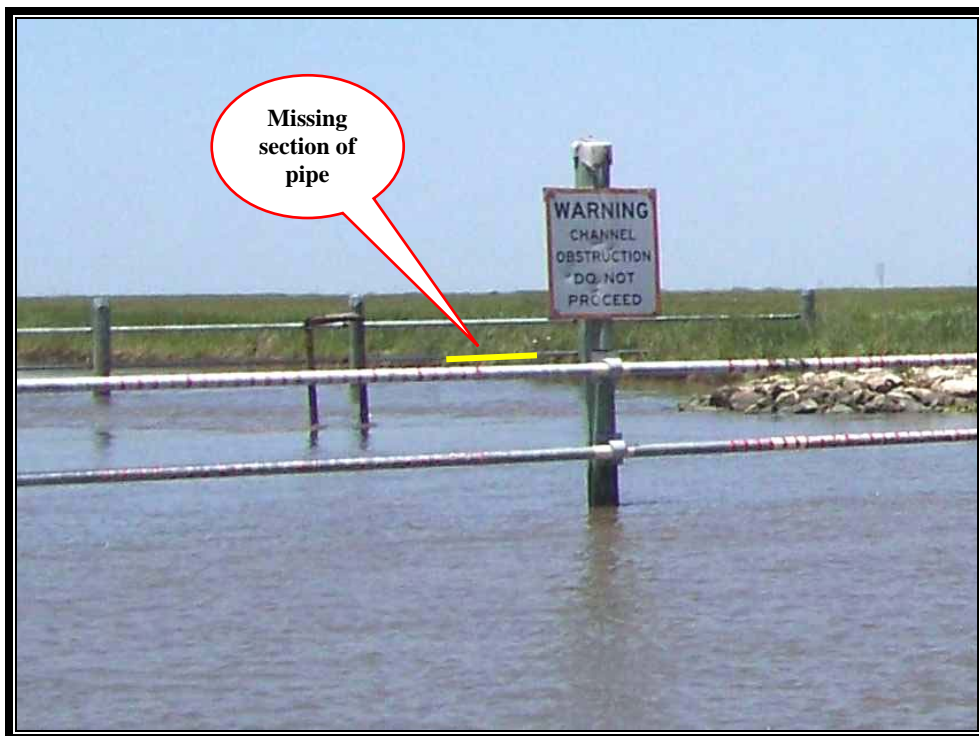
Photo No. 12 – View of the cut pipe in the barricade system at the north tie-in of Structure No. 4.

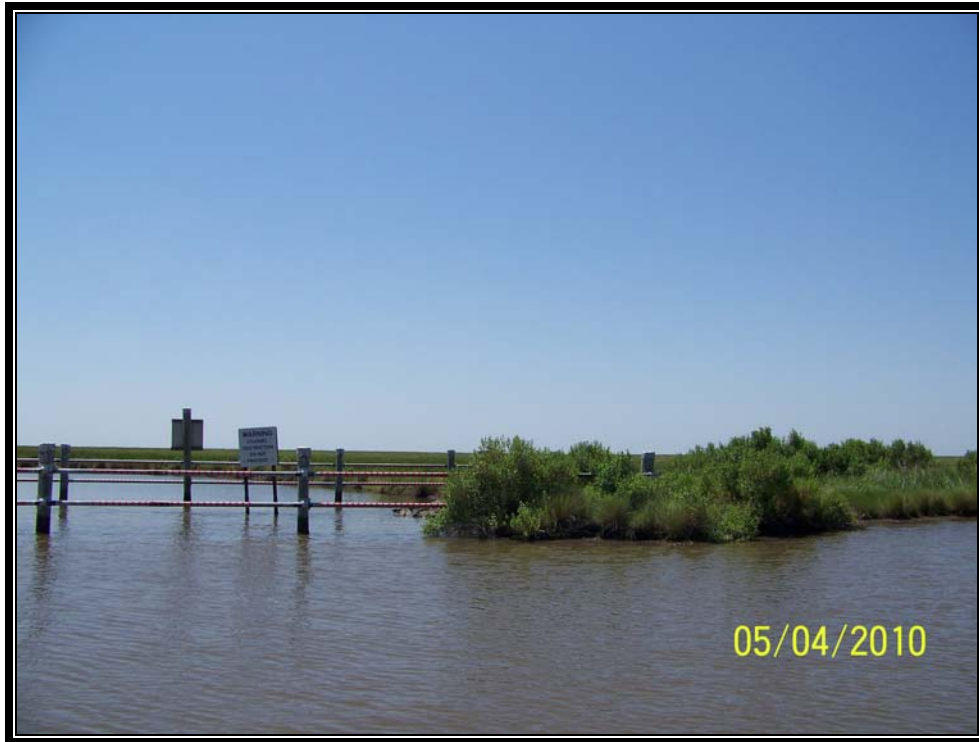
The rock plug, tie-ins, earthen embankments, barricade system, warning signs and supports appeared to be in good condition with no visible signs of marsh erosion adjacent to the structure or damage to the barricade system. The latest elevation data from the 2004 survey profile of Structure No.5 indicates that the structure has settled on average of 0.14' from the designed elevation. (Appendix B, Photos 13 - 15)

Photo No. 13 – View of the western tie-in of Structure No.5.

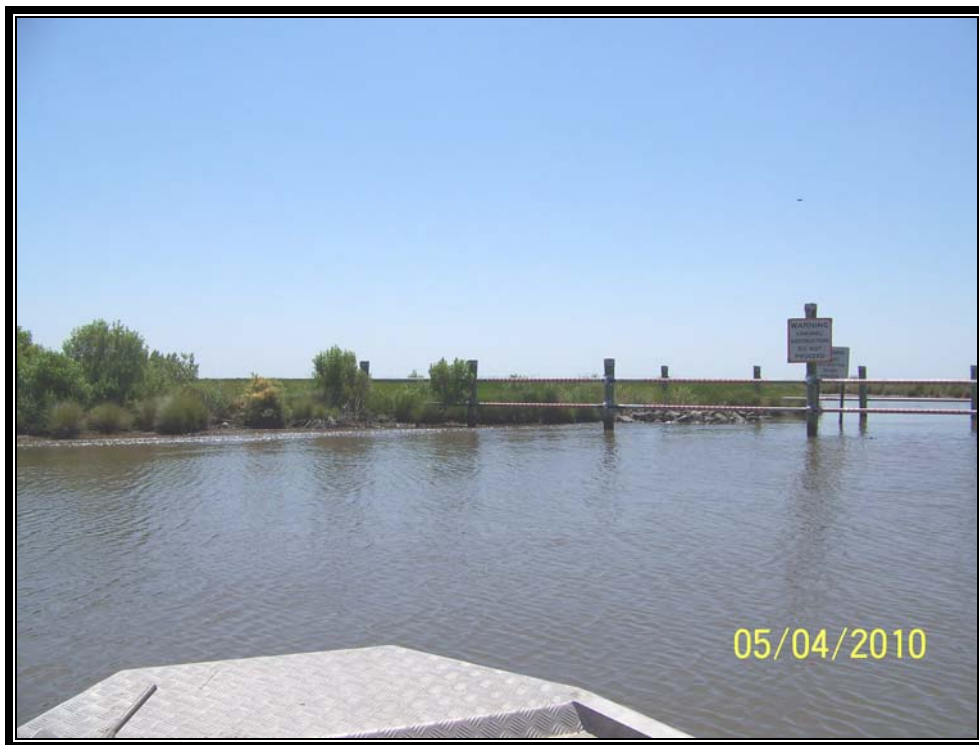
Photo No.14 – View of the eastern tie-in of Structure No.5.

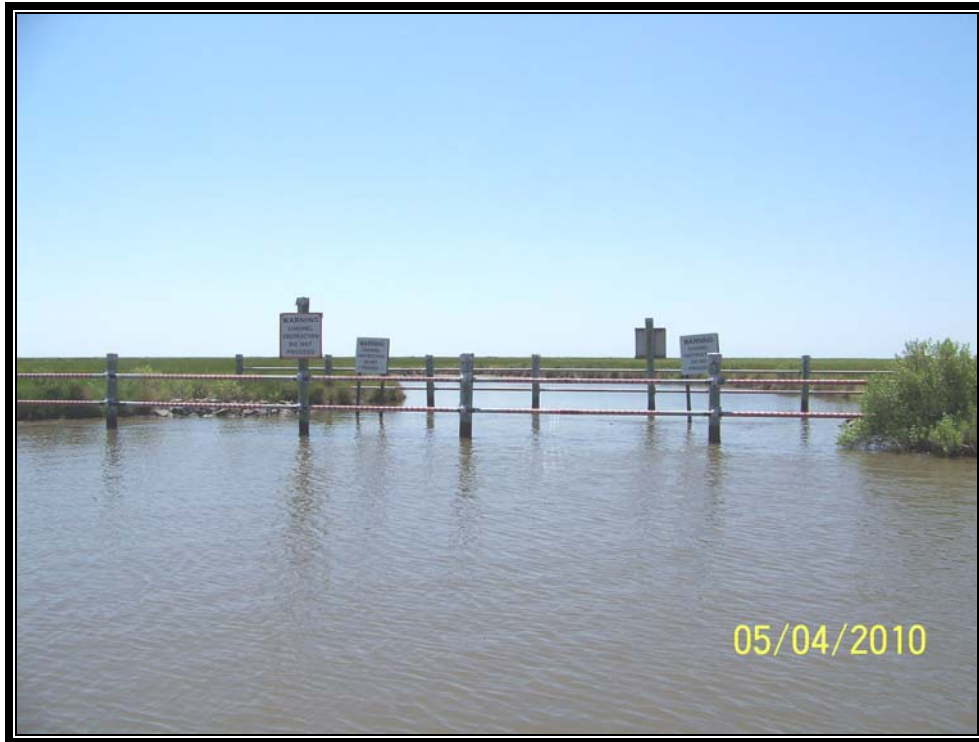
Photo No. 15 – Overall view of the Structure No.5 weir and barrage system looking east.

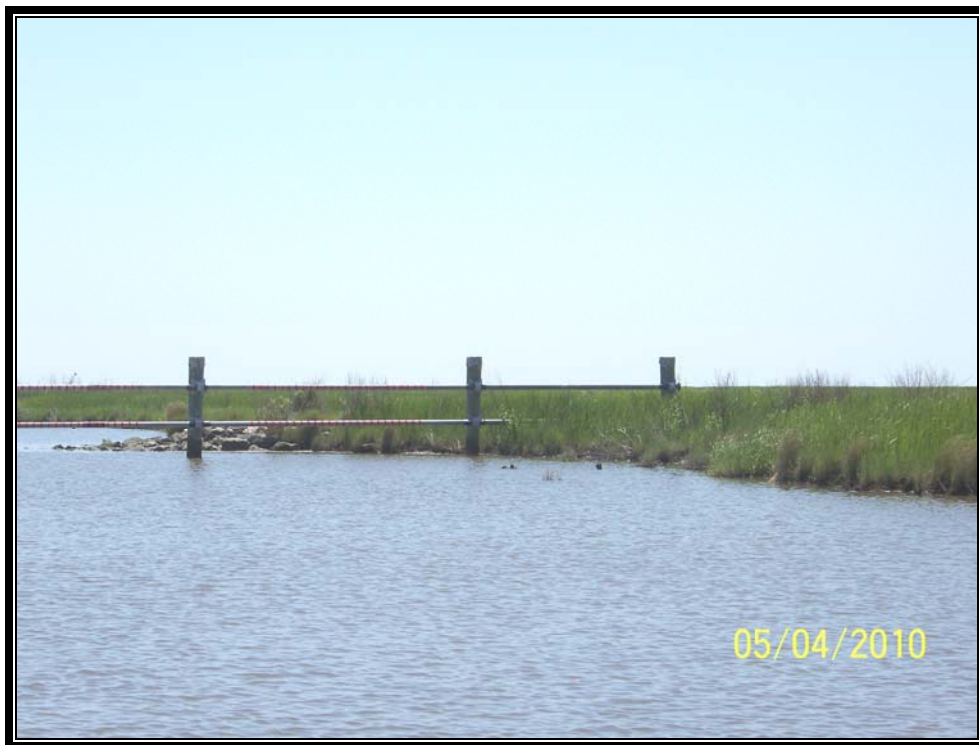
It was discovered during the 2008 Annual Inspection that the timber barricade system in from of the structure had been vandalized. A ten (10) foot section of the two (2) steel pipe cross members between the center piles had been cut with a torch and were missing. It remains our opinion that any attempt to repair the damage to the barricade system, preventing access across the weir, would be unsuccessful; therefore, we are not recommending repairs to the steel pipe cross members. Other than the damage to the barricade system, the rock weir, earthen embankments, warning signs and supports were in very good condition. From the 2004 profile survey of the structure, it was determined that the rock weir had settled an average of approximately 1.1 ft. (Appendix B, Photos 16 - 18)

Photo No. 16 – View of the southern tie-in of Structure No.6.

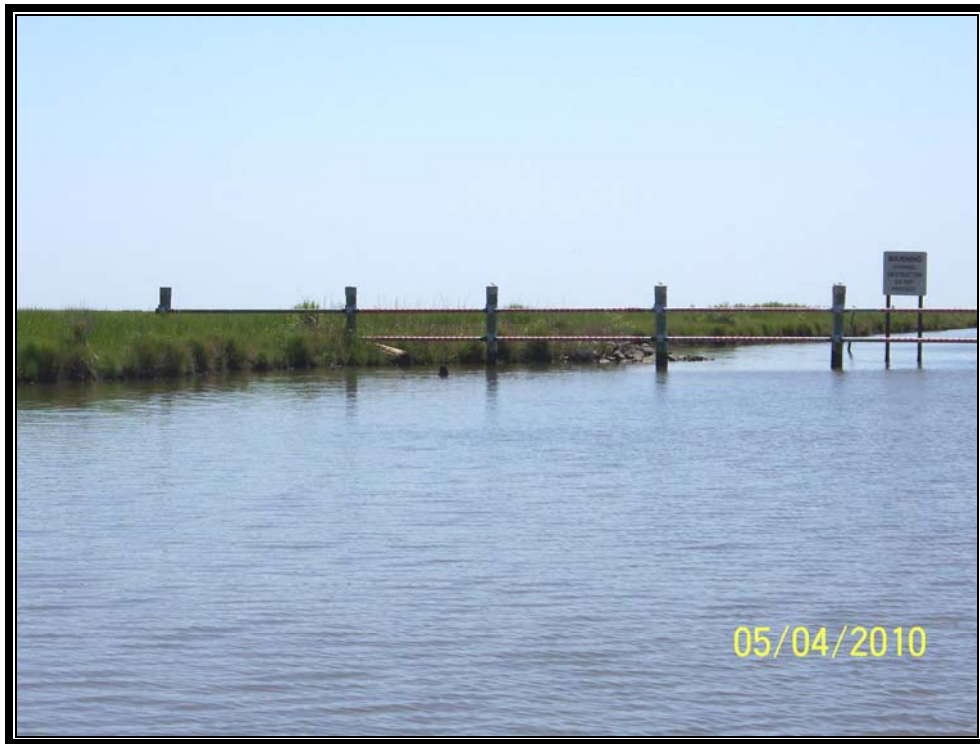
Photo No. 17 – View of the northern tie-in of Structure No.6.

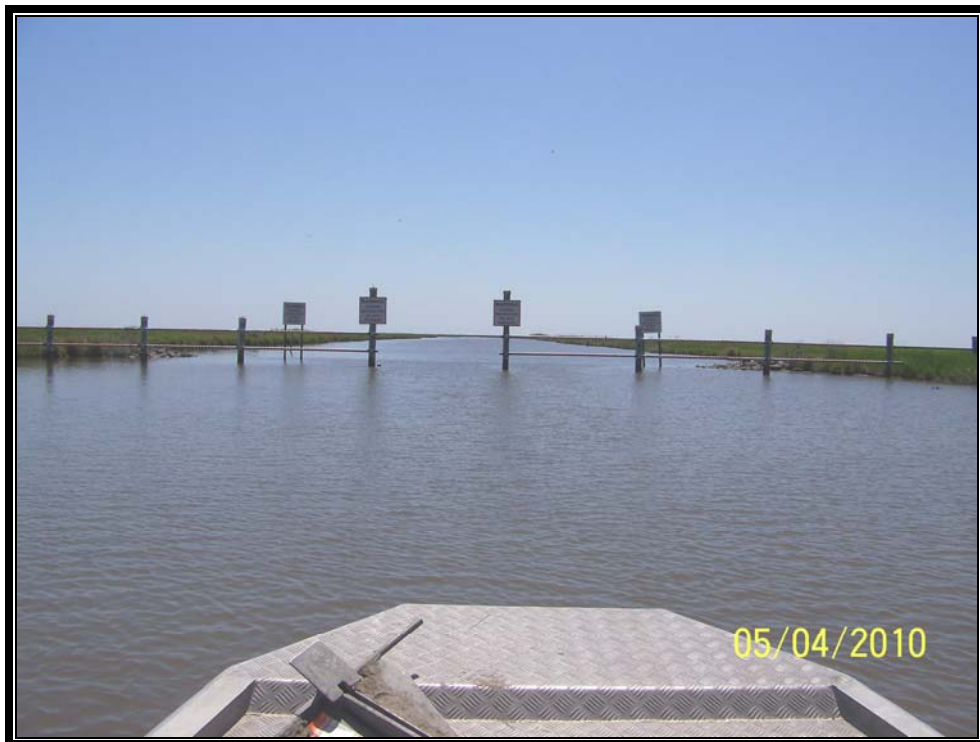
Photo No.18 – Overall view of Structure No.6 weir and barrage system looking east.

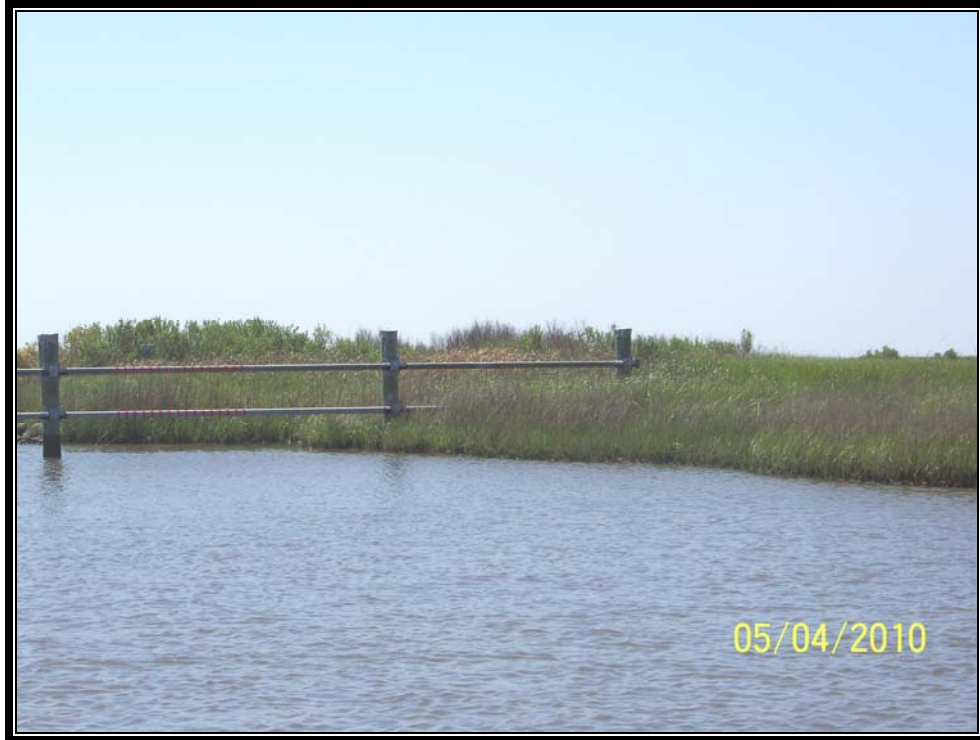
The rock weir, earthen embankments, timber barricade system and signs and supports were all in very good condition with no apparent structure damage or erosion problems. Based on a survey profile of the rock weir in 2004, the structure has settled approximately 1.7' from its designed elevation. (Appendix B, Photos 19 - 21).

Photo No. 19 – View of southern tie-in of Structure No.7.

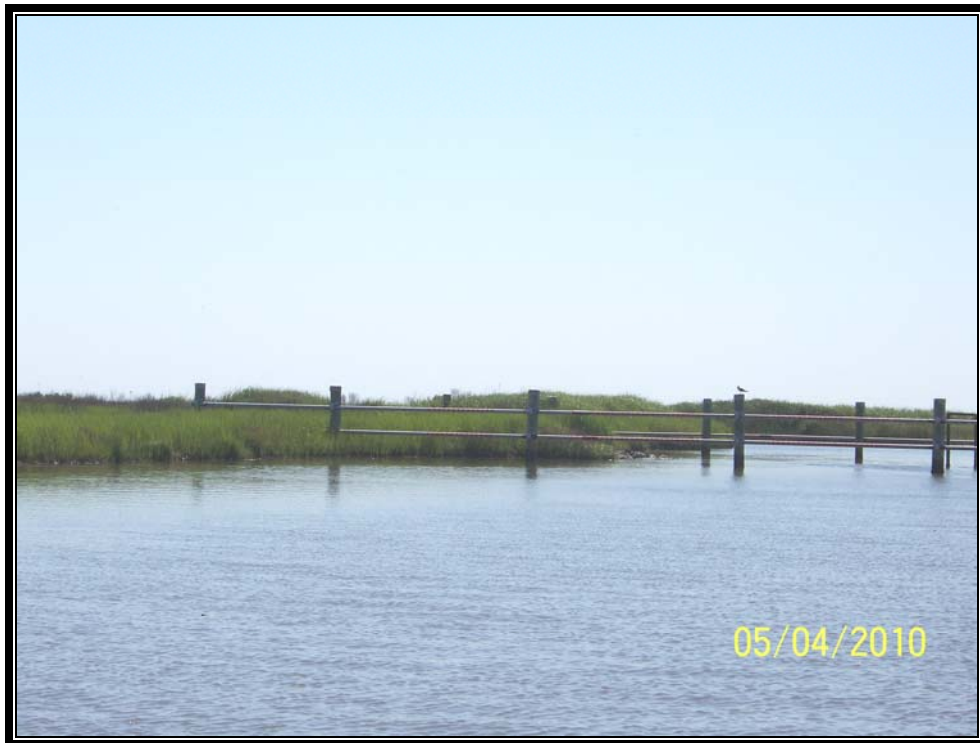
Photo No. 20 – View of northern tie-in of Structure No.7.

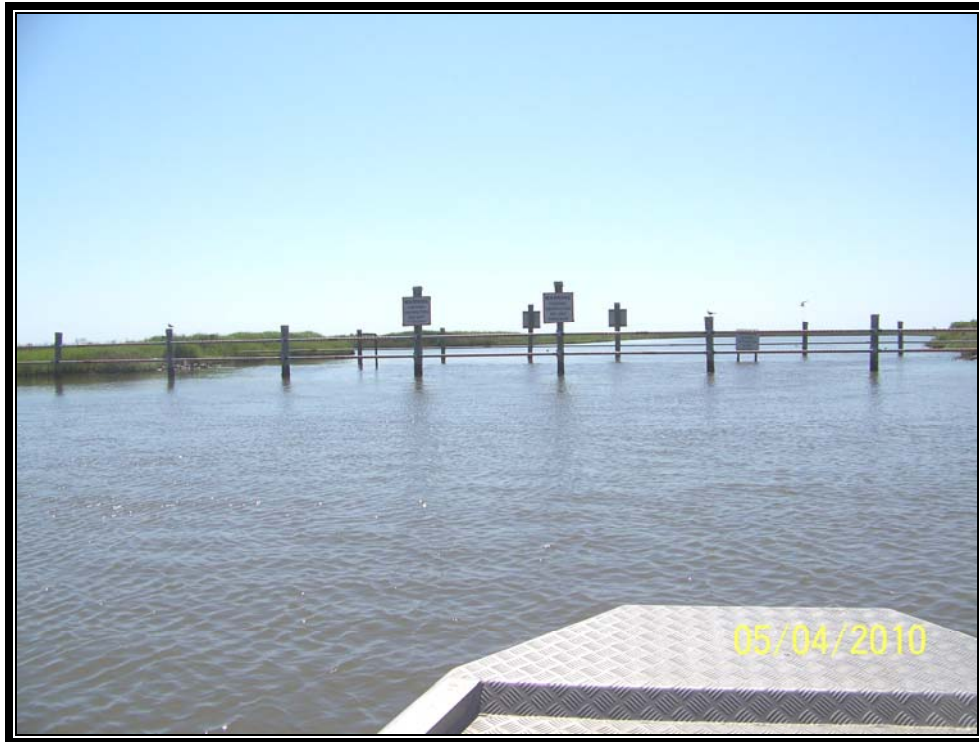
Photo No. 21 – Overall view of Structure No.7 weir and barrage system looking east.

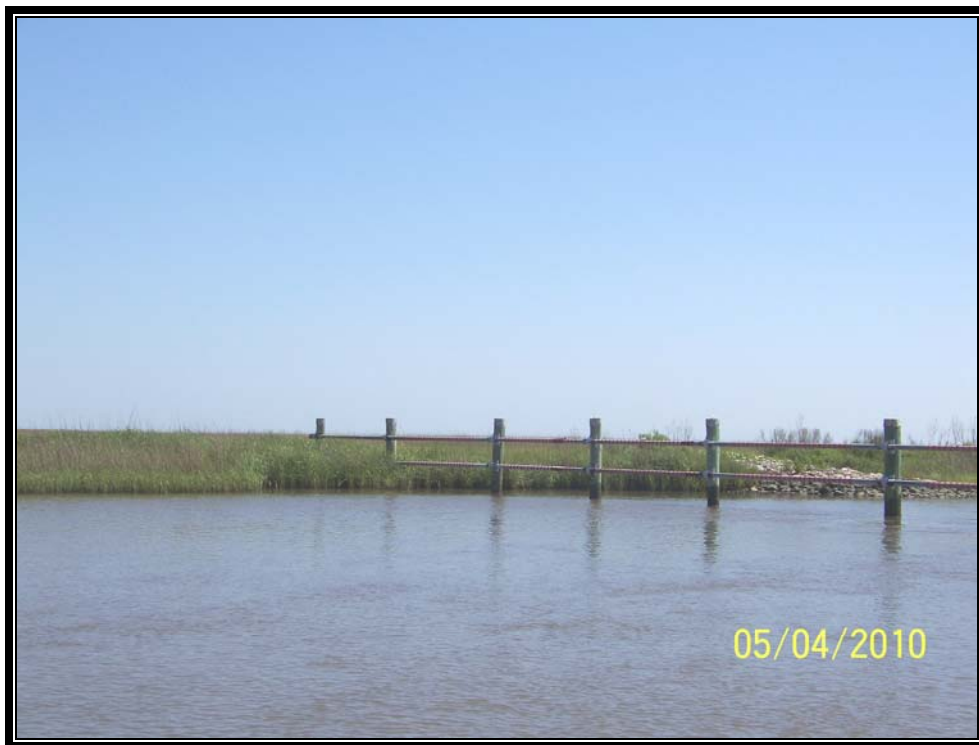
The rock weir at this location was in good condition with no noticeable damage to the timber barricade system or erosion around the ends of the weir. Based on the 2004 survey profile of the structure, it was determined that the rock weir had settled an average of 1.7' from the

designed elevation. (Appendix B, Photos 22 - 24).

Photo No.22 – View of the northern tie-in of Structure No.9

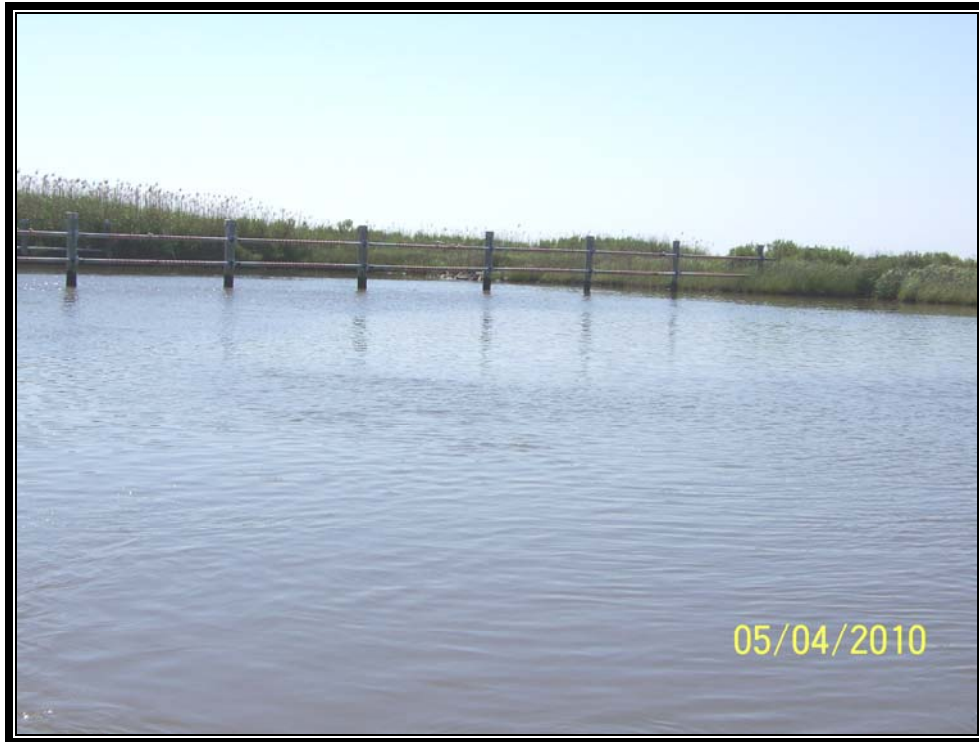
Photo No.23 – View of the southern tie-in of Structure No.9.

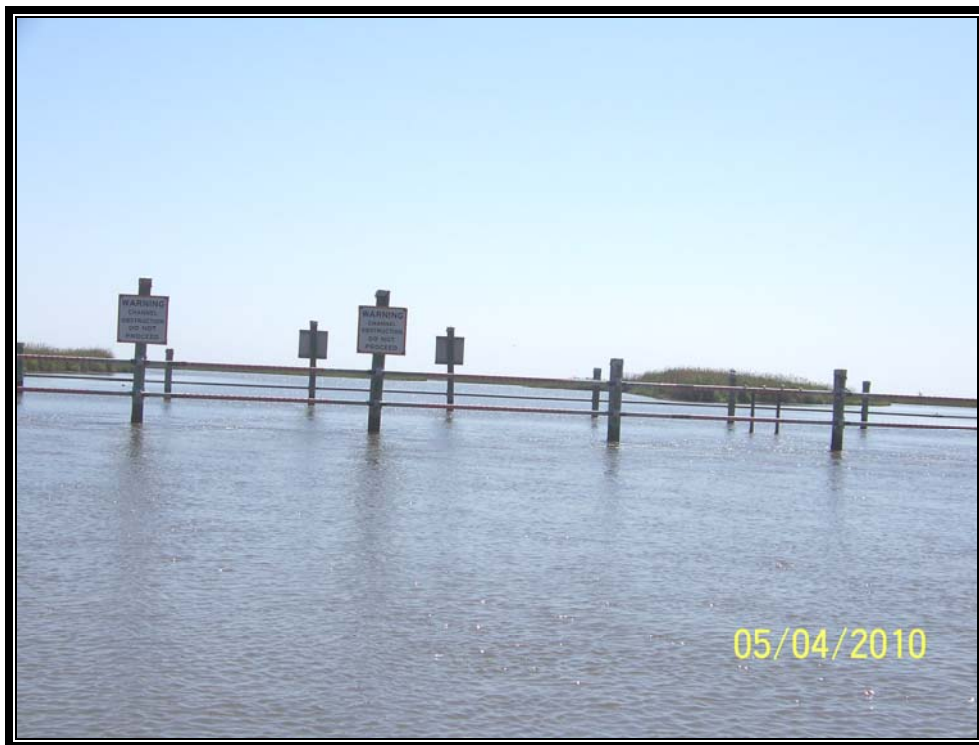
Photo No.24 – View of the center of Structure No.9 weir and barricade system looking east.
