2010 Annual Inspection Report

**POINT AU FER ISLAND
HYDROLOGIC RESTORATION**

State Project Number TE-22
Priority Project List 1

October 27, 2010
Terrebonne Parish

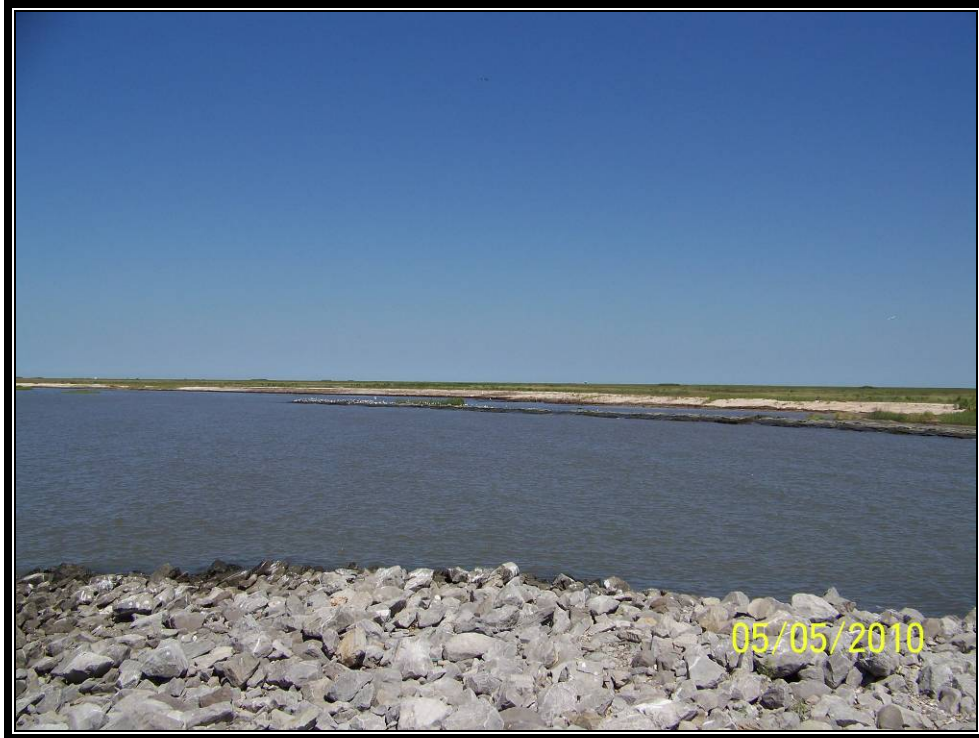
To the east of the bulkhead, the erosion directly behind the east mats noted on inspections prior to 2006 has been slowed or halted since the rock lift placed in 2005. Material has accreted behind the rock lift, and that deposited material is now vegetated. However, continued shoreline erosion was noted at the shoreline tie-in of the 2005 maintenance rock (east end of extension dike). On the west side, the west mats appear to have settled and are beginning to be over washed during normal tidal events. The west end of the mats is no longer connected to the shoreline due to erosion of the shoreline around the tie-in. Consequently tidal exchange is now occurring behind the mats, and erosion of the shoreline behind the mats was noted similar to that observed behind the east mats prior to the 2005 maintenance event. At the existing bulkhead, the exchange between the Gulf and Transco Canal where water is passing behind the bulkhead and over the rocks into Transco Canal seems to be getting slightly larger every. The steel sheetpile and tie-rods are heavily corroded and should continue to be monitored.

Photo No. 1 (3420) – view of Petraflex mats on the west side of Plug No.4A looking west.

Immediate maintenance recommendations include surveying of the shoreline and shoreline protection along both the west and east mats and tie-ins in order to determine the best course of action to prevent breaching of the Gulf into the Canal. Preliminary recommendations would include constructing a rock lift on the west mats, closing off the connection behind those mats with a rock dike extension back to the shoreline, and for the east extending and constructing a rock lift on the 2005 extension dike.

At Plug No. 4A (Transco at Gulf) in order to address the continued erosion at the west shoreline tie-in, behind the west mats, and at the east shoreline tie-in, recommendations include surveying of the west mats and tie-in area and the east rock dike extension and shoreline tie-in. Depending on the results of the survey, maintenance activity recommendations may include constructing a rock lift on the west mats, closing off the connection behind those mats with a rock dike extension back to the shoreline, and for the east extending and constructing a rock lift on the 2005 extension dike (See Appendix D).

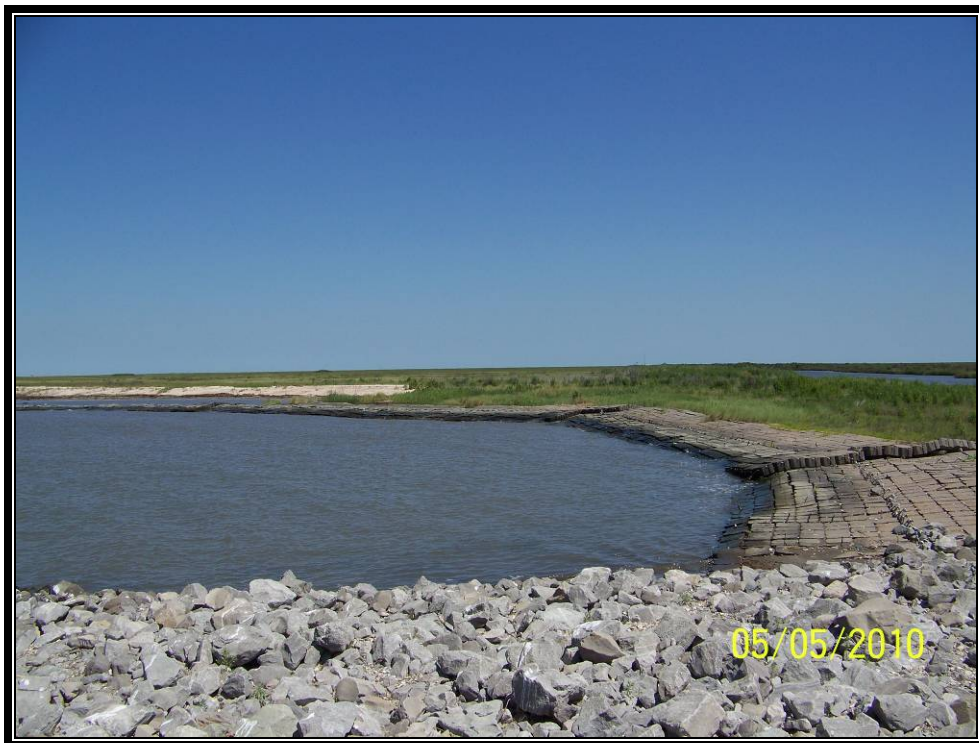
Photo No.2 (3419) – view of marsh behind Petraflex mats on the west side of Plug No. 4A looking east. Erosion can be seen behind the mats.

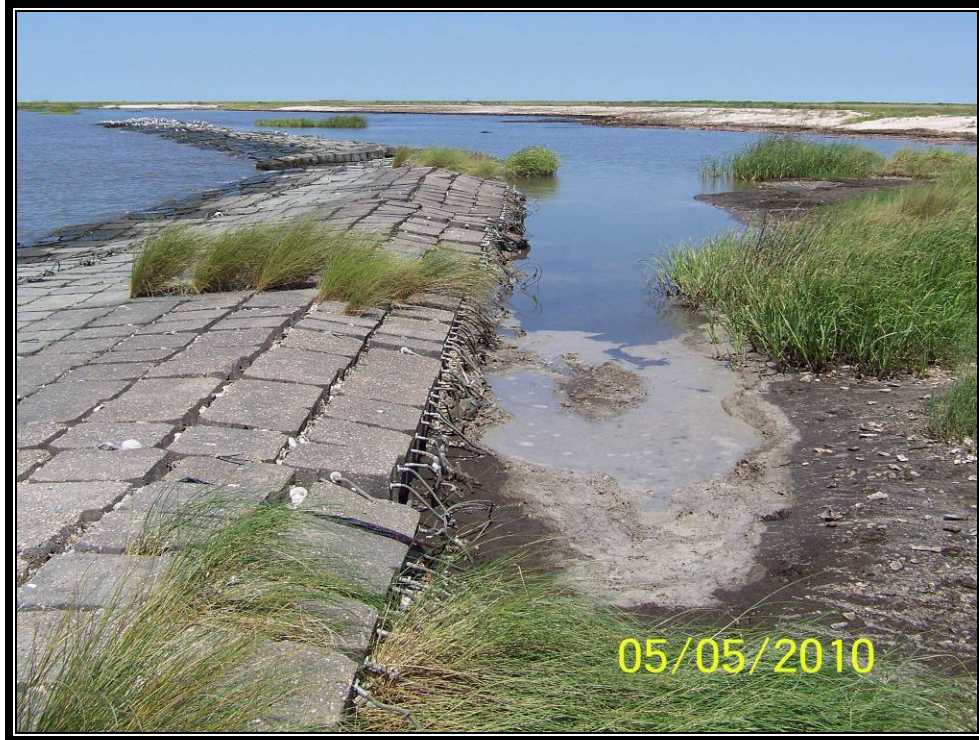
Photo No.3 (3422) – view of Petraflex mats on the west side of Plug No. 4A looking west along the shoreline. The shoreline has retreated as a result of erosion around the mats.

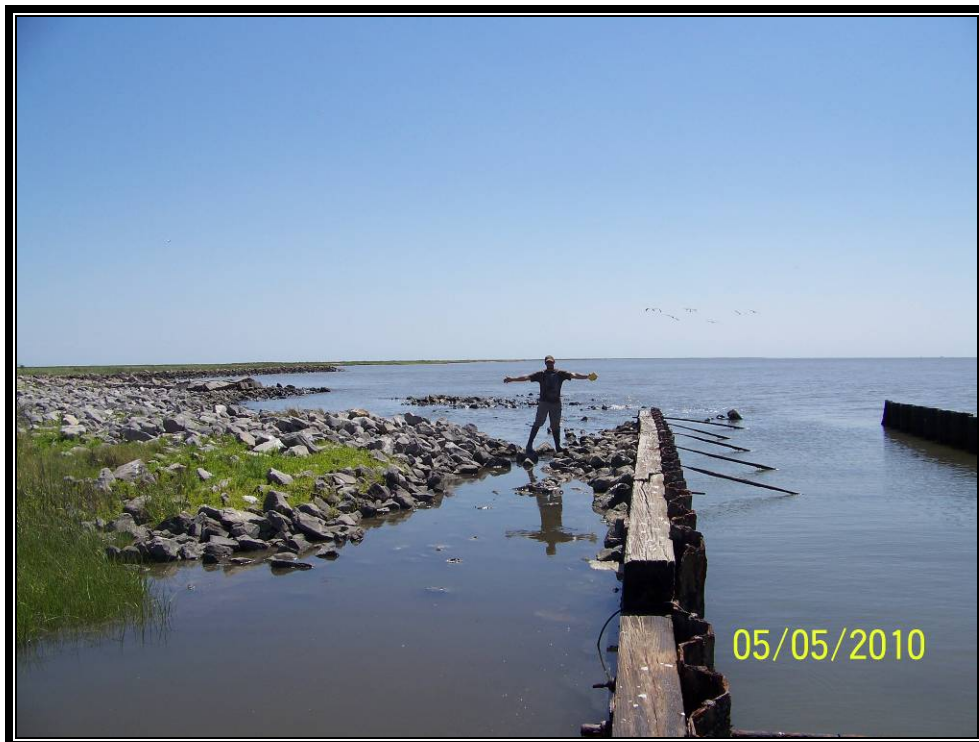
Photo No.4 (3416) – view of Plug No. 4A looking east. The rock material behind the sheet pile placed by the pipeline company has been displaced by recent tropical events.

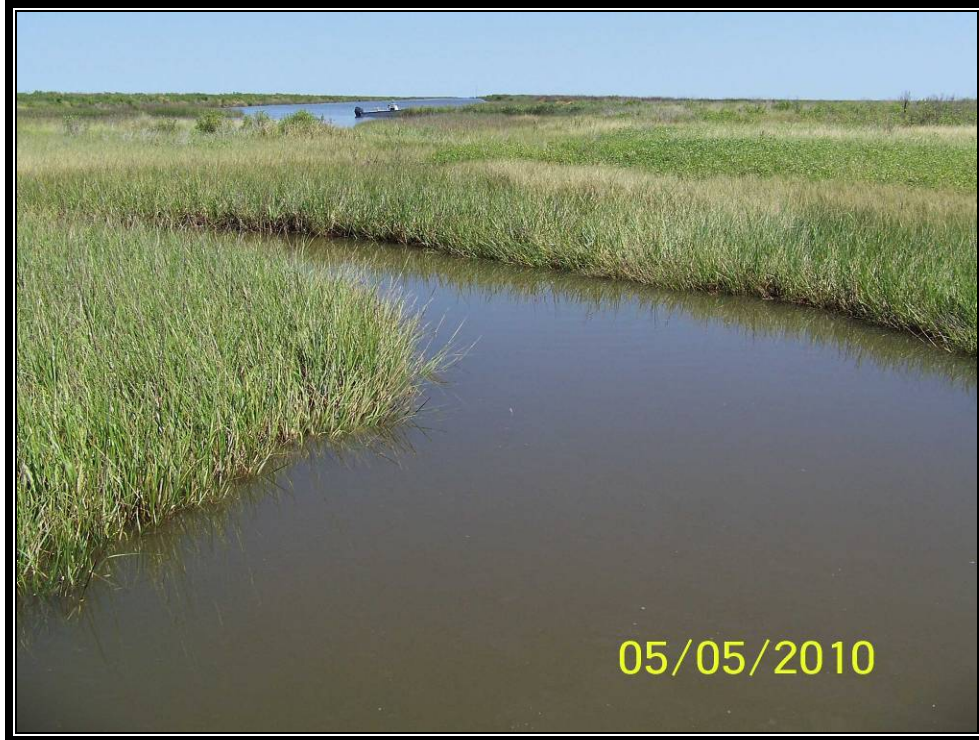
Photo No.5 (3417) – view of tidal channel connecting Transco Canal to the Gulf behind Plug No. 4A looking north.

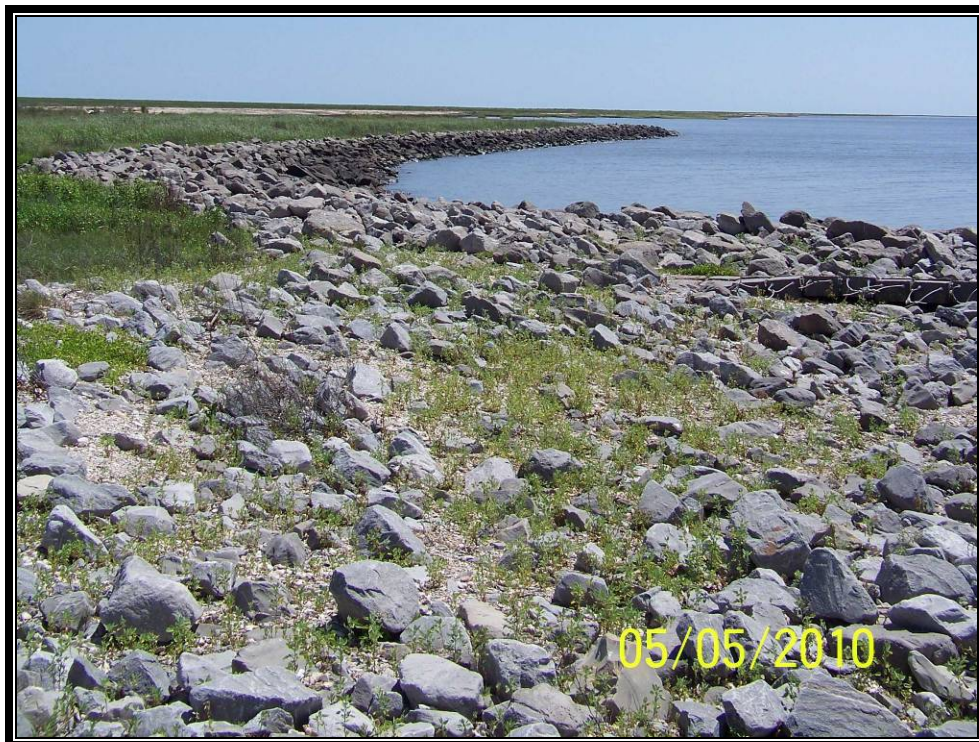
Photo No.6 (3424) – rock covering the existing Petraflex mats on the east side of Plug No. 4A. The rock installed by the pipeline company has been displaced along the shoreline.

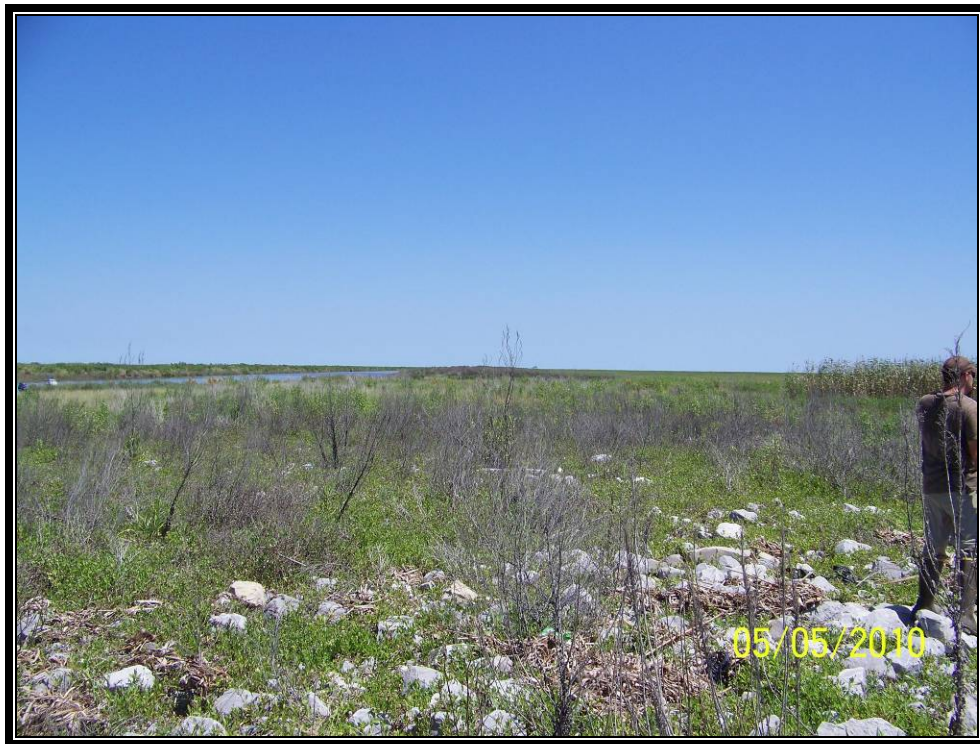
Photo No.7 (3426) – dispersed rock installed by the pipeline company on the east side of Plug No. 4A looking north.

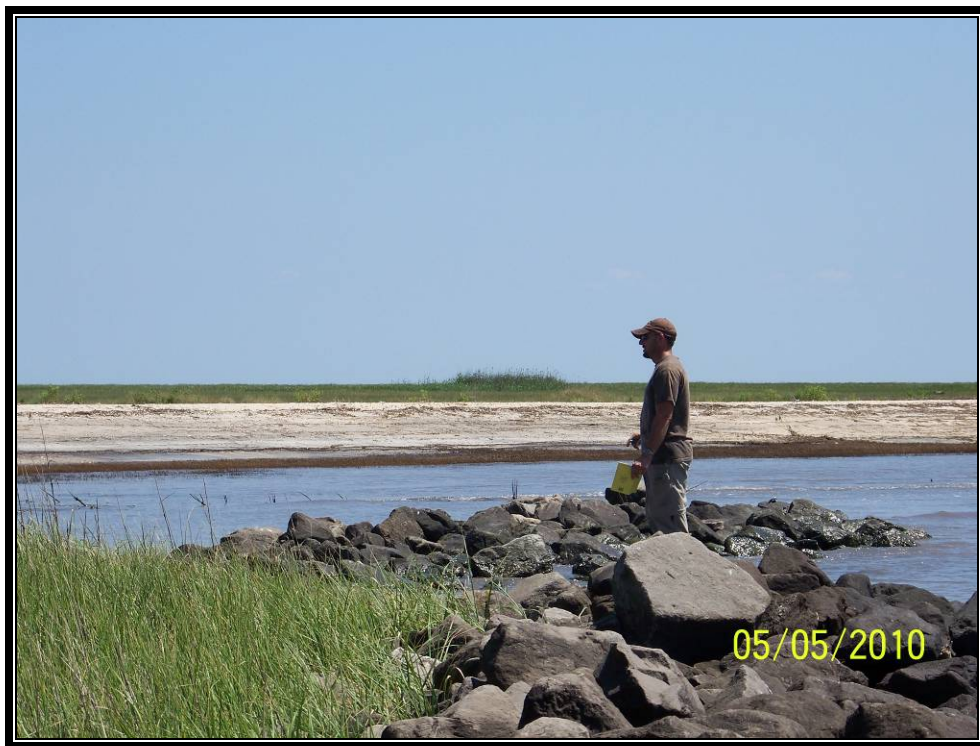
Photo No.8 (3427) – Rock dike extension at shoreline on the east side of Plug No. 4A.

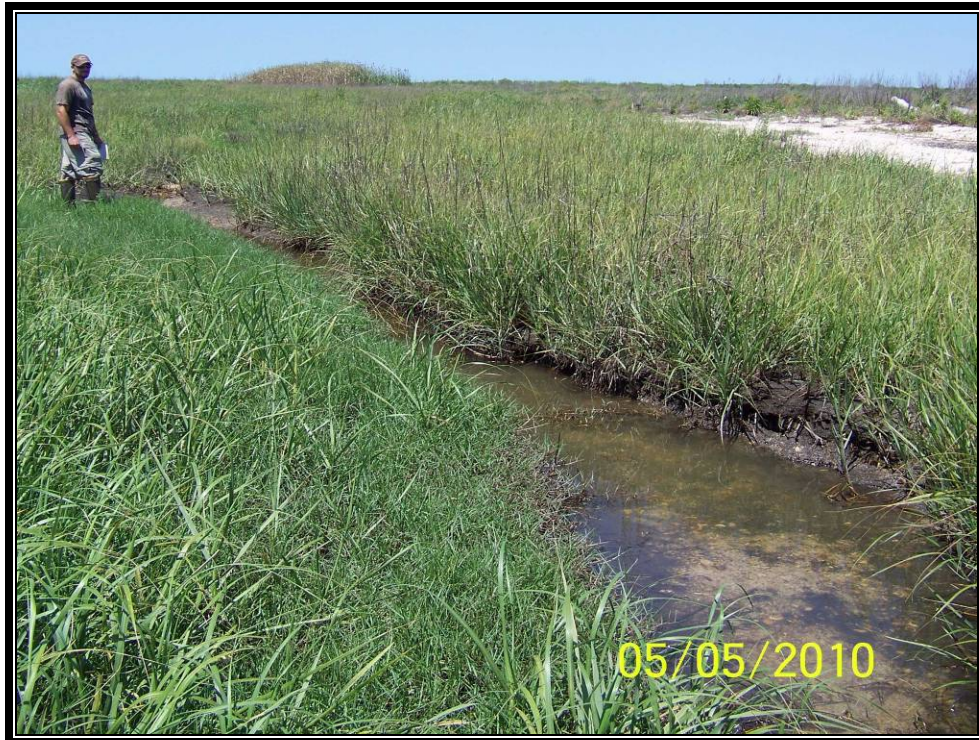
Photo No.9 (3430) – vegetation on accreted material behind the rock dike on the east side of Plug No. 4A.

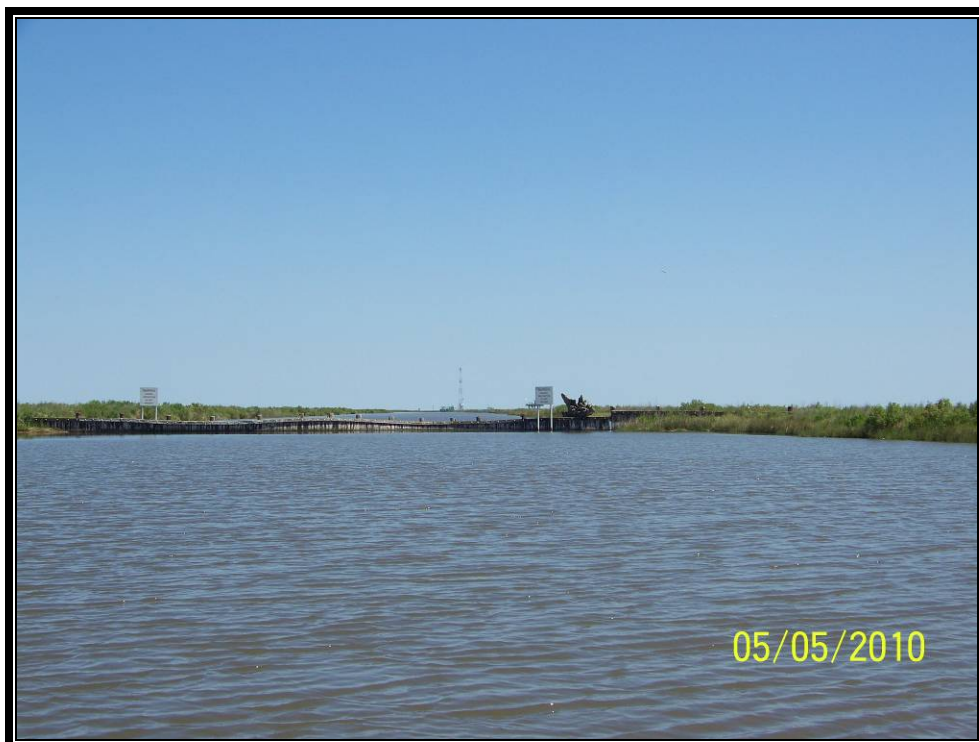
The deflection of the timber bulkhead appears to be more apparent than what occurred during construction. Both tie-ins appear intact with no apparent signs of erosion. However there is a separation of the bulkhead (or missing board) near the eastern tie in. This separation was noticed when looking at the photographs after the inspection was complete. We were not able to get close to the structure because the canal had silted in. The warning signs and supports were in good condition. At this time no maintenance is recommended at Plug No. 6; however, the condition of the timber bulkhead should continue to be monitored on future site visits.

Photo No.10 (3413) – Plug No.6 – view of timber bulkhead plug looking north in Transco Canal.

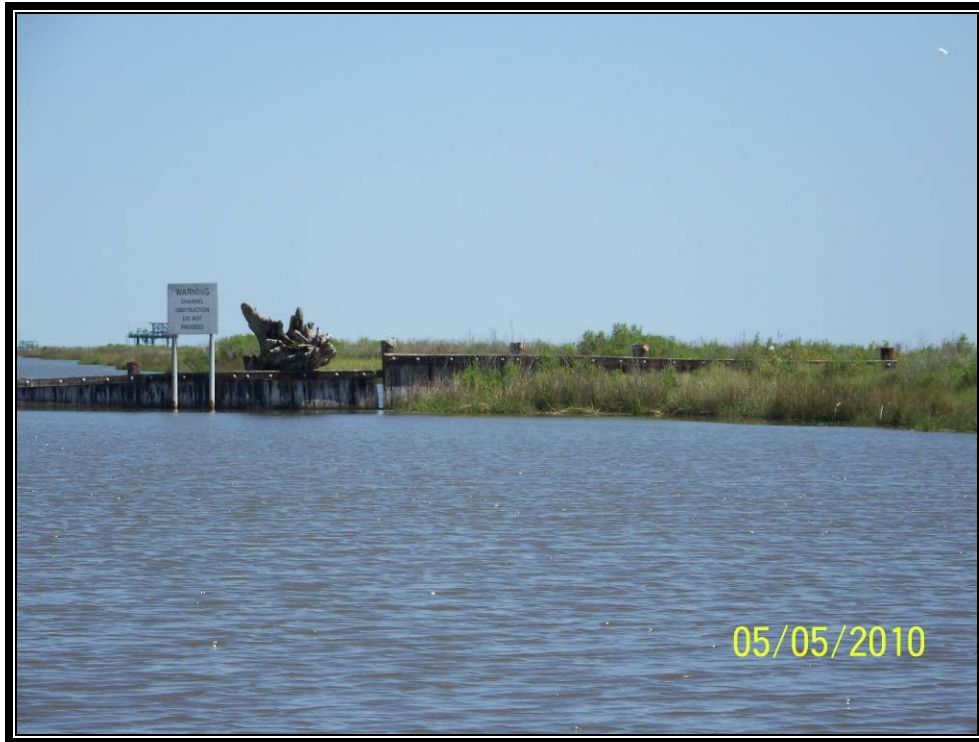
Photo No.11 (3412) – Plug No.6 – view of east tie-in of plug looking north in Transco Canal. A separation in the bulkhead can be noticed to the right of the warning sign.

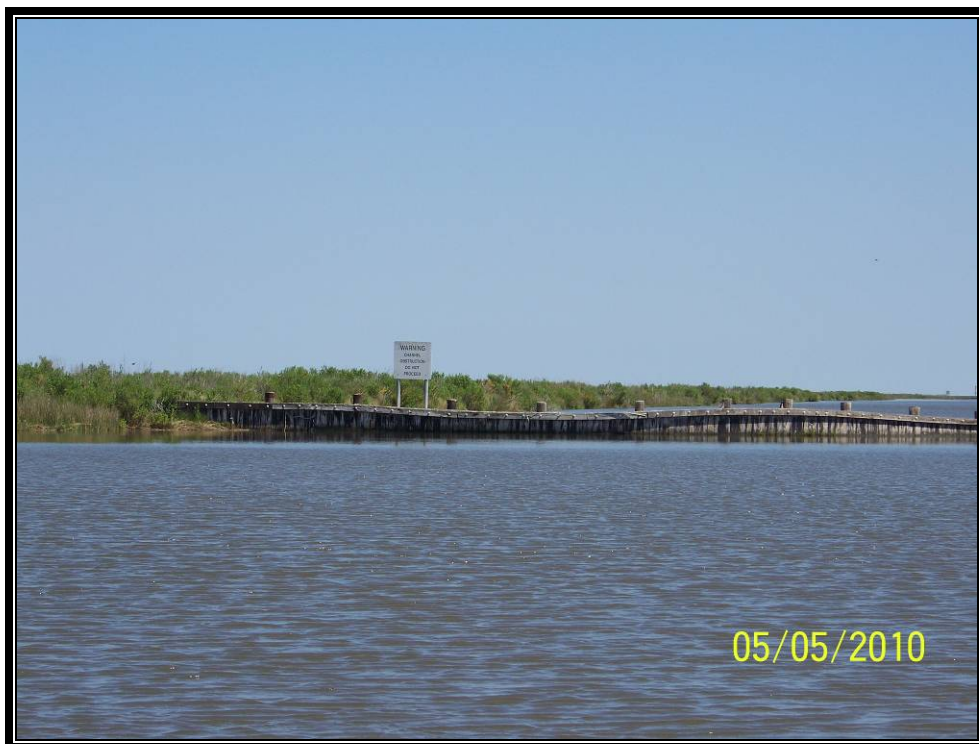
Photo No. 12 (3411) – Plug No.6 – view of west tie-in of plug looking north in Transco Canal.

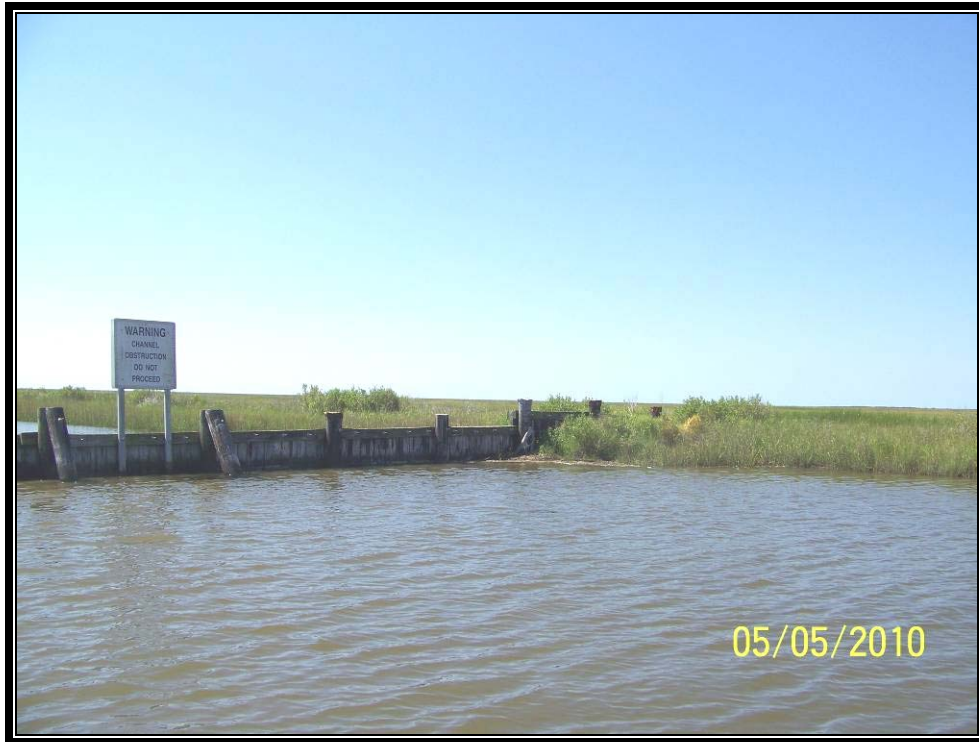
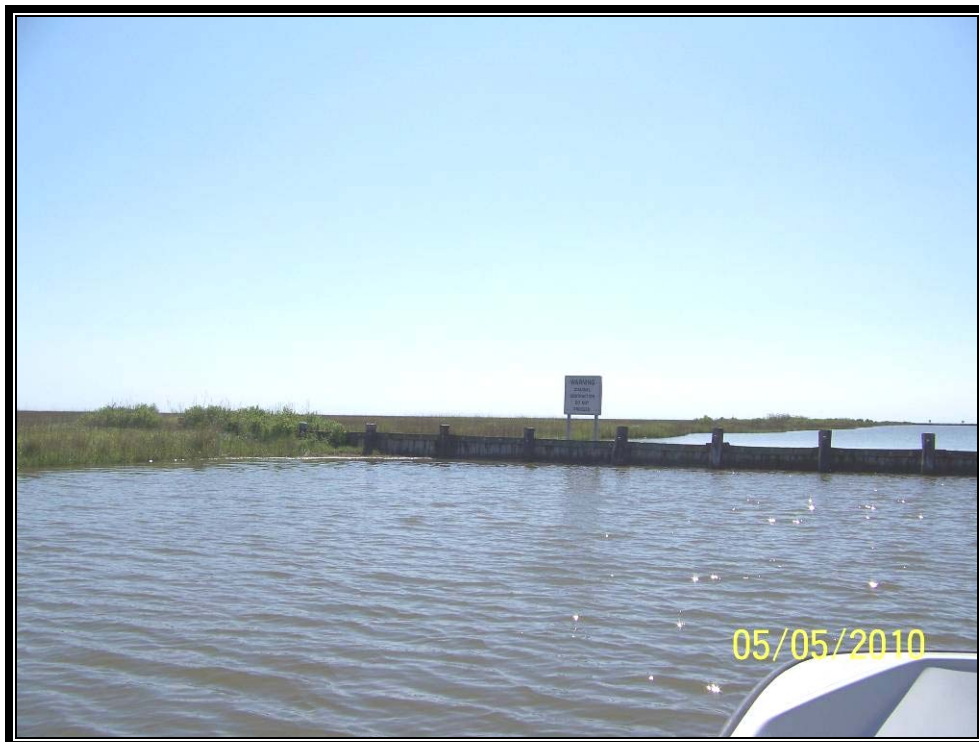
The timber bulkhead plug located across Hester Canal east of Transco Canal appeared to be in good condition with no noticeable structural defects. The tie-ins at the banks had no apparent signs of erosion. The warning signs and supports were also in good condition. No maintenance will be required at Plug No. 7.

Photo No. 13 (3401) - Plug No.7 – view of plug and tie-in at south bank from inside looking southeast in Hester Canal.

Photo No. 14 (3400) – Plug No.7 – view of plug and tie-in at north bank from inside looking southeast in Hester Canal.

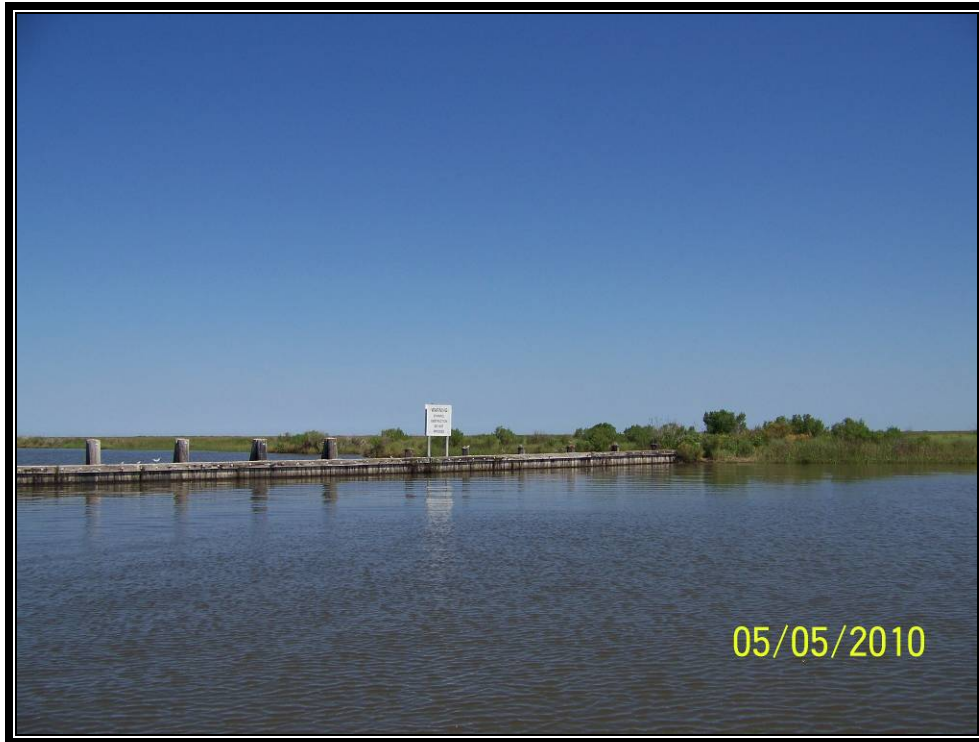
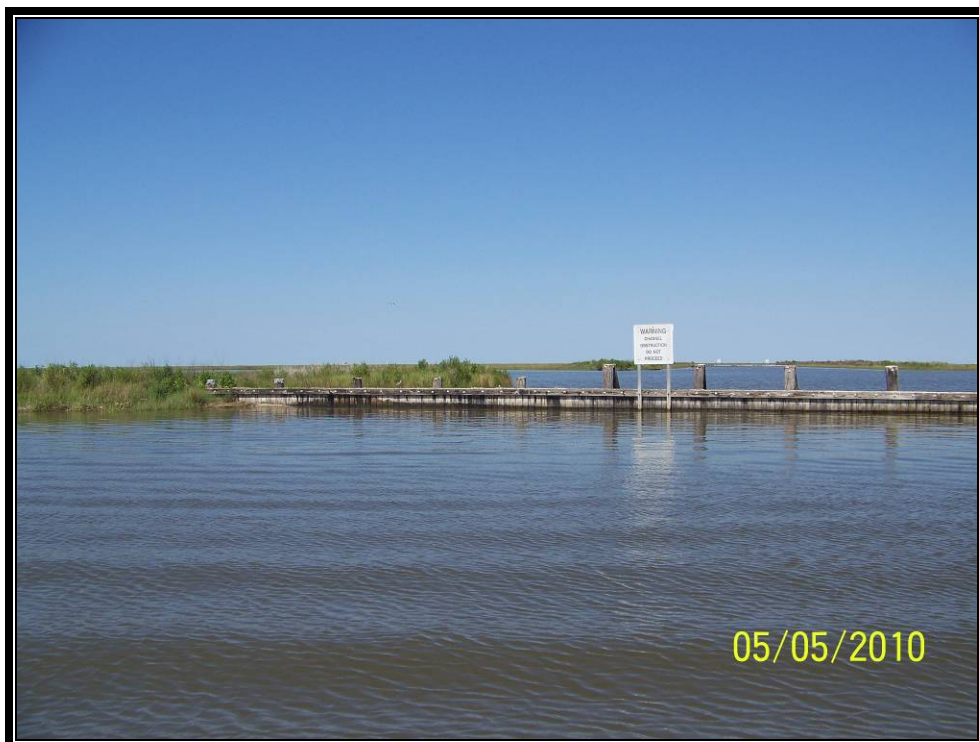
The timber bulkhead plug located across Hester Canal just west of Transco Canal appeared to be in good condition with no noticeable structural defects. The tie-ins at the banks had no apparent signs of erosion. The warning signs and supports were also in good condition. No maintenance will be required at Plug No. 2.

Photo No.15 (3398) – Plug No.2 – view of the north tie-in of timber bulkhead plug in Hester Canal from inside (east side).

Photo No.16 (3397) – Plug No.2 – view of the south tie-in of timber bulkhead plug in Hester Canal from inside (east side).

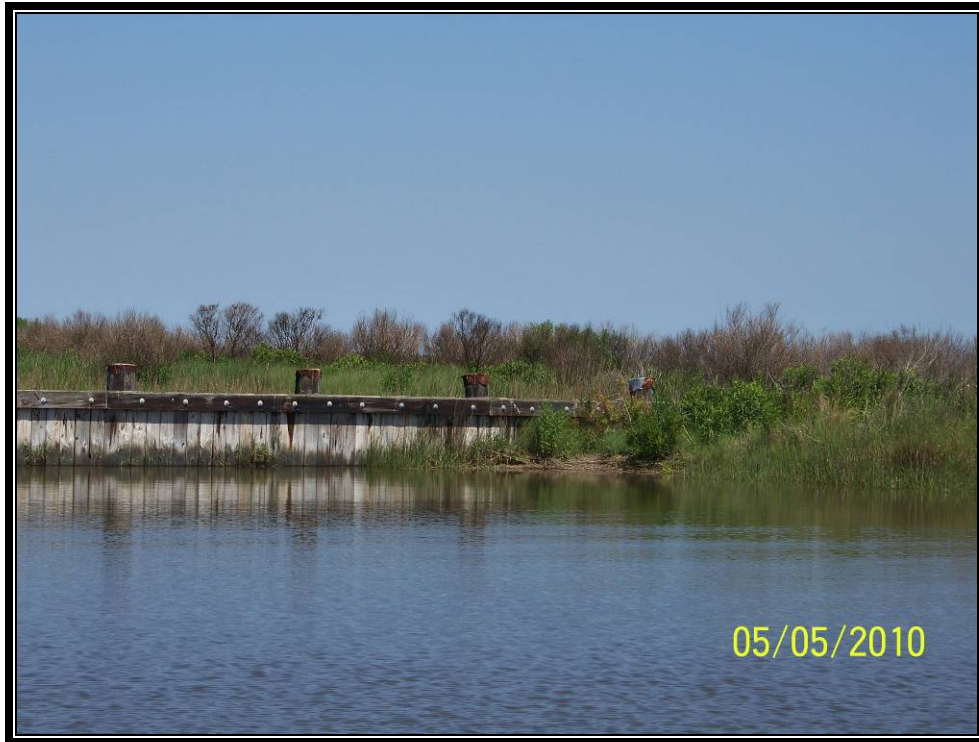
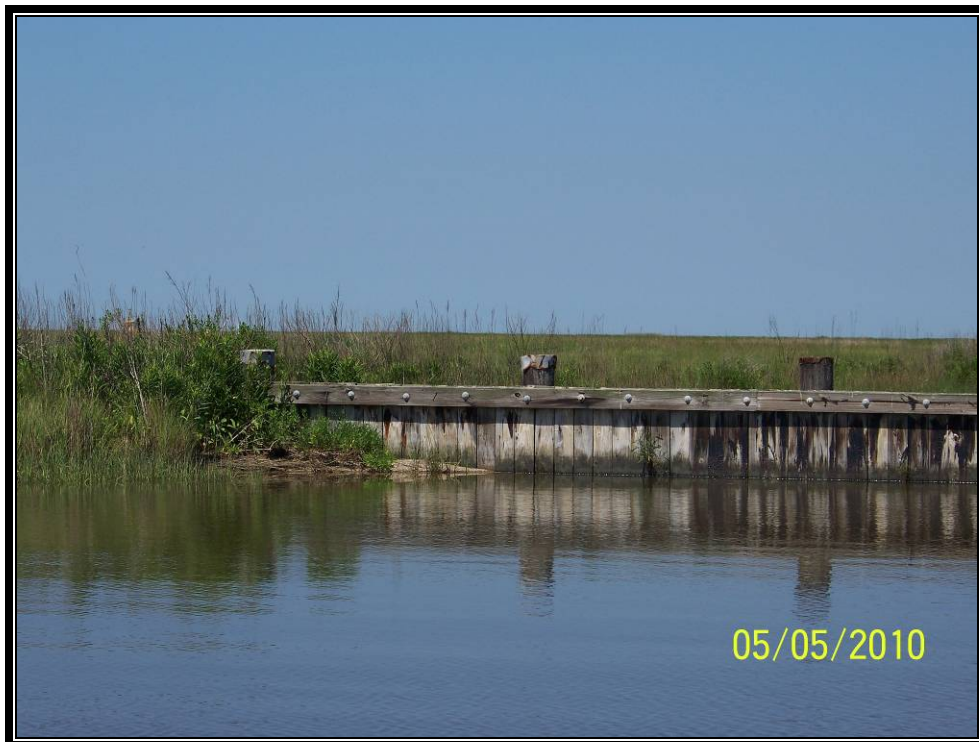
The timber bulkhead plug located on the west end of Hester Canal near Mosquito Bay appeared to be in good condition with no noticeable structural defects. The tie-ins at the banks had no apparent signs of erosion. The warning signs and supports were also in good condition. No maintenance will be required at Plug No. 1.

Photo No. 17 (3409) – Plug No.1 – view of timber bulkhead plug and north bank tie-in from inside (east side) in Hester Canal looking west.

Photo No.18 (3408) – Plug No.1 – view of timber bulkhead and south bank tie-in from inside (east side) in Hester Canal looking west.

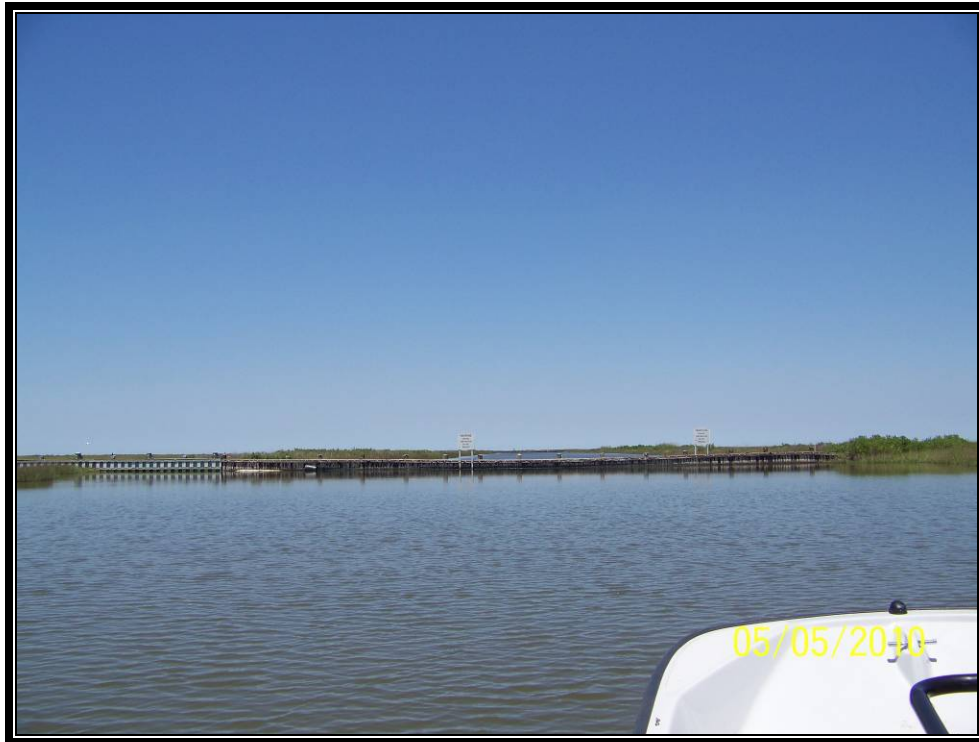
Photo No.19 (3432) – Plug No.8 - view of plug looking west in Hester Canal.

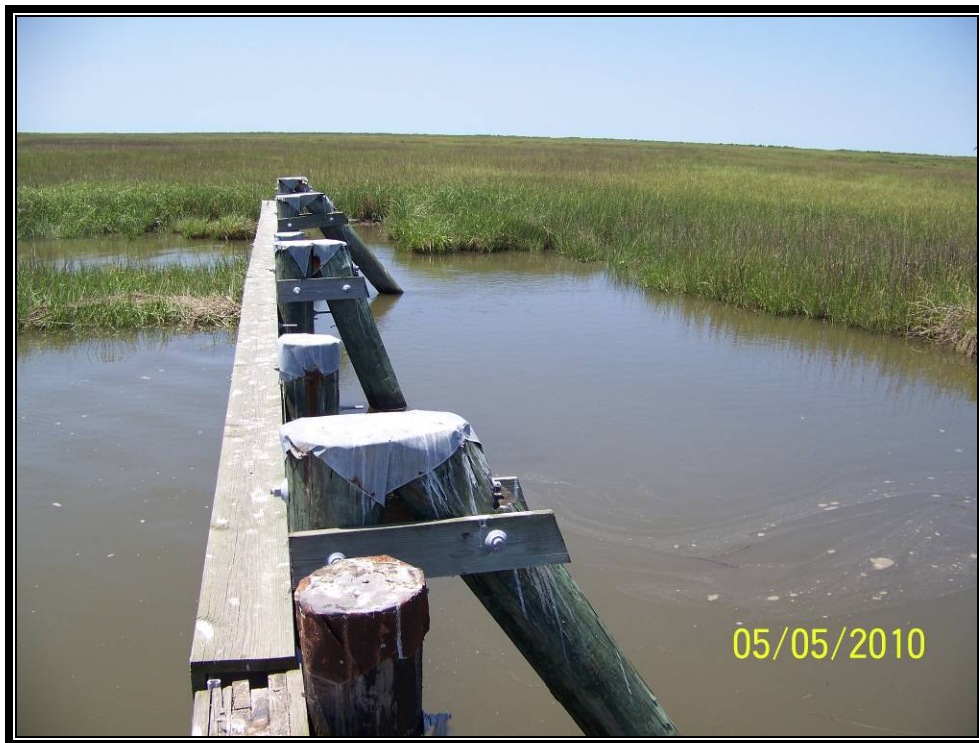
The timber bulkhead and vinyl sheet pile extension are in good condition. However there is a breach around the southern tie-in of the vinyl sheet pile. The breach measured 2' in width and 11' in depth and occurs adjacent to the sheetpile. Also there were a couple of sections of concrete mats that were no longer visible adjacent to the structure. It is assumed that these sections were undermined from the water rushing through the breach and may lie somewhere on the bottom of the breach. The remaining concrete mats (scour pad) seem to have limited the erosion at the south tie-in. The north tie-in at the canal bank had no apparent signs of erosion. The warning signs and supports were in good condition. No maintenance will be required at Plug No. 8 at this time, however the breach should be monitored on future inspections to ensure that it is not getting any wider or deeper.

along its southern tie-in. The breach is fairly small in nature (2' wide x 11' deep) and should be monitored for any widening or deepening.

Photo No.20 (3433) – Plug No.8 – View of south tie-in of 2005 maintenance extension of sheet pile wall. Scour has occurred on the southern end of the structure.

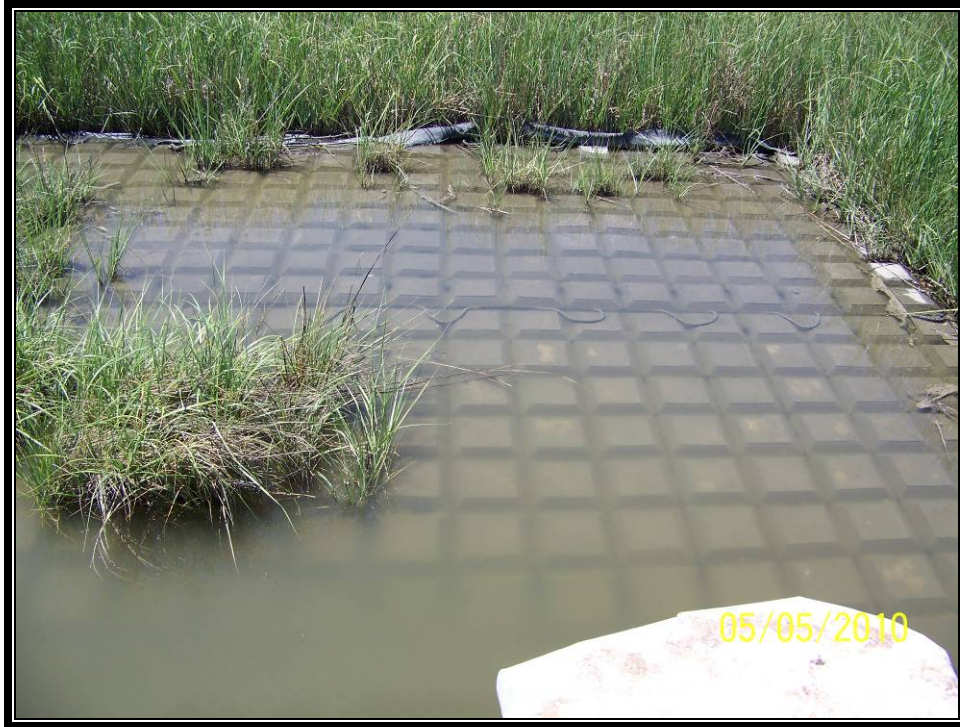
Photo No.21 (3434) - Plug No.8 – view of the Submar scour mats on the southern end of the vinyl bulkhead extension constructed under the 2005 maintenance project. Erosion adjacent to the vinyl bulkhead had taken place. Some of the Submar scour mats were missing.

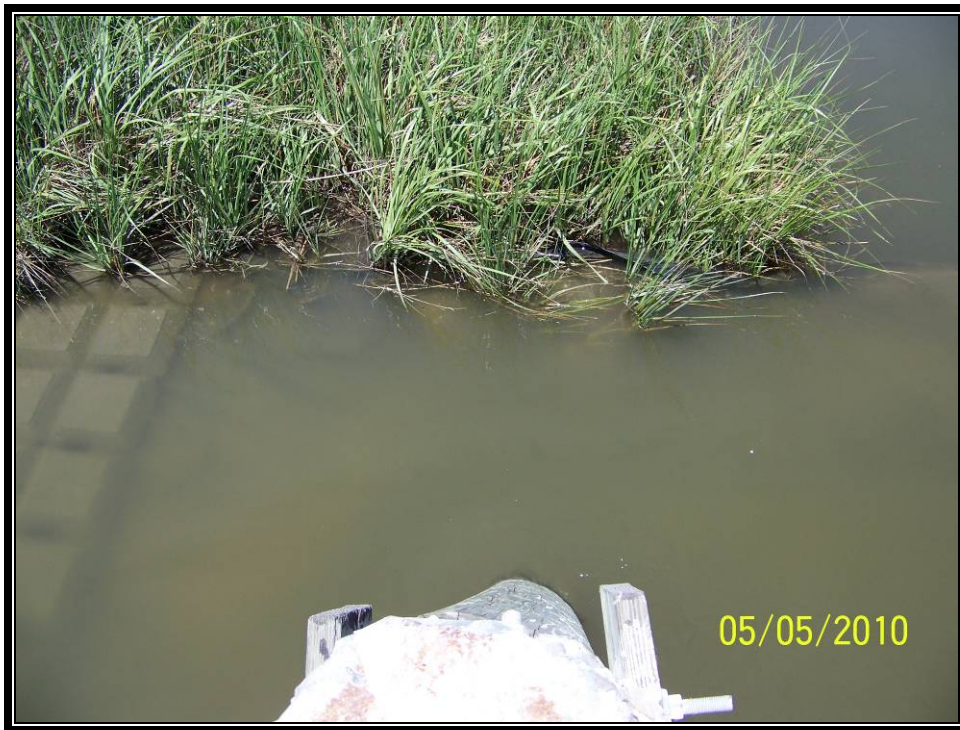
Photo No.22 (3440) - Plug No.8 – view of the Submar scour mats on the west side of the southern end of the vinyl bulkhead extension. Some of the Submar scour mats were missing.

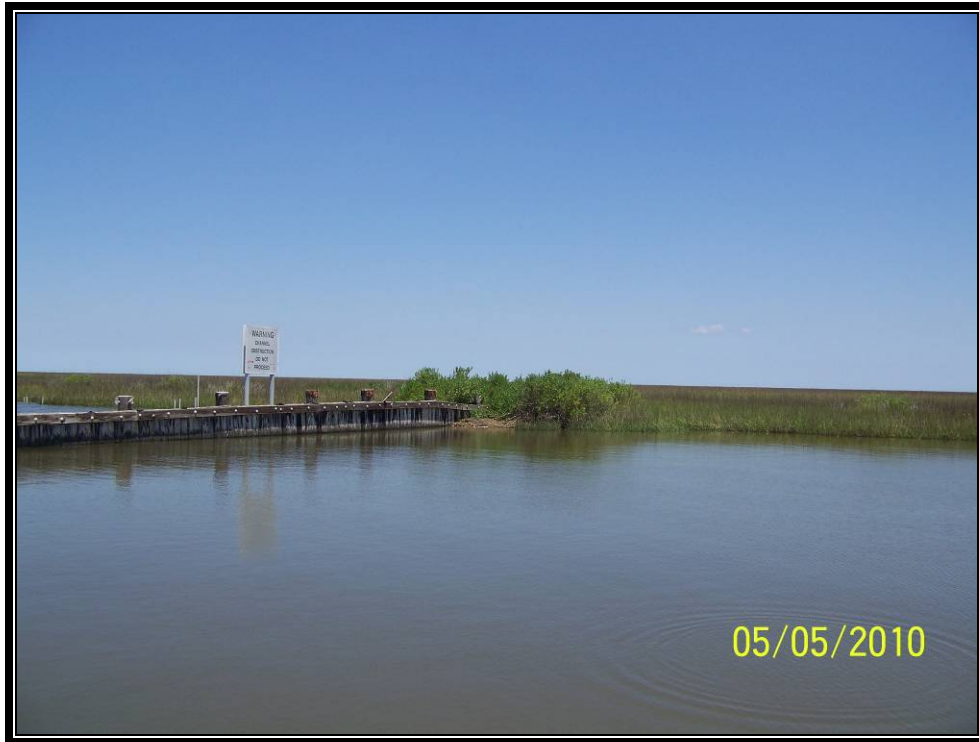
Photo No.23 (3440) – Plug No.8 – View of timber bulkhead at north bank tie-in looking northwest from Hester Canal.

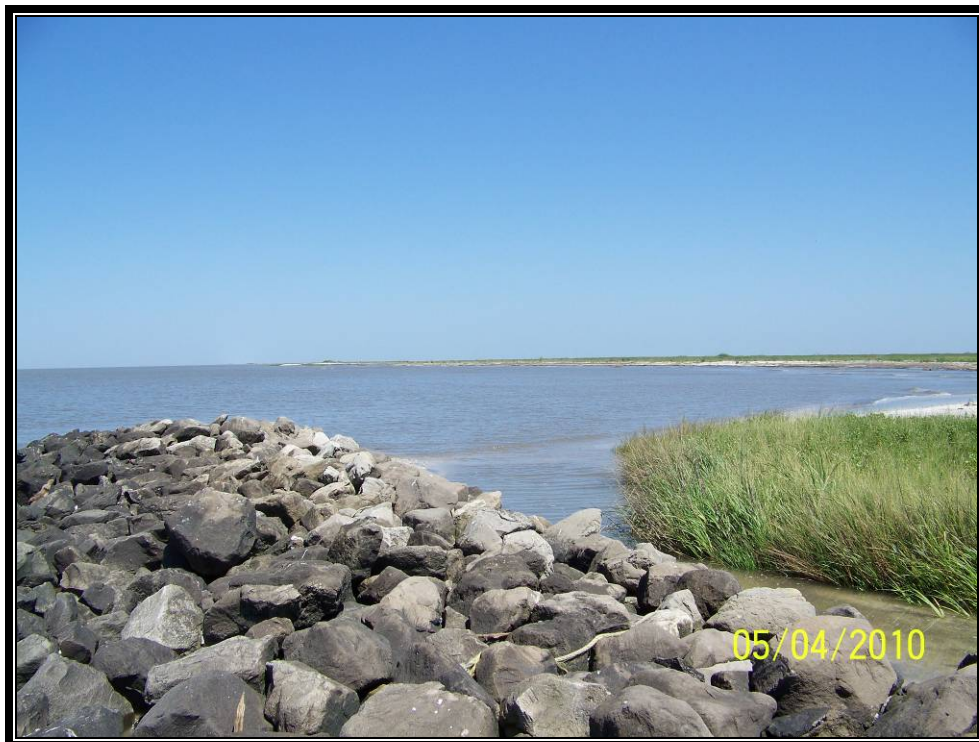
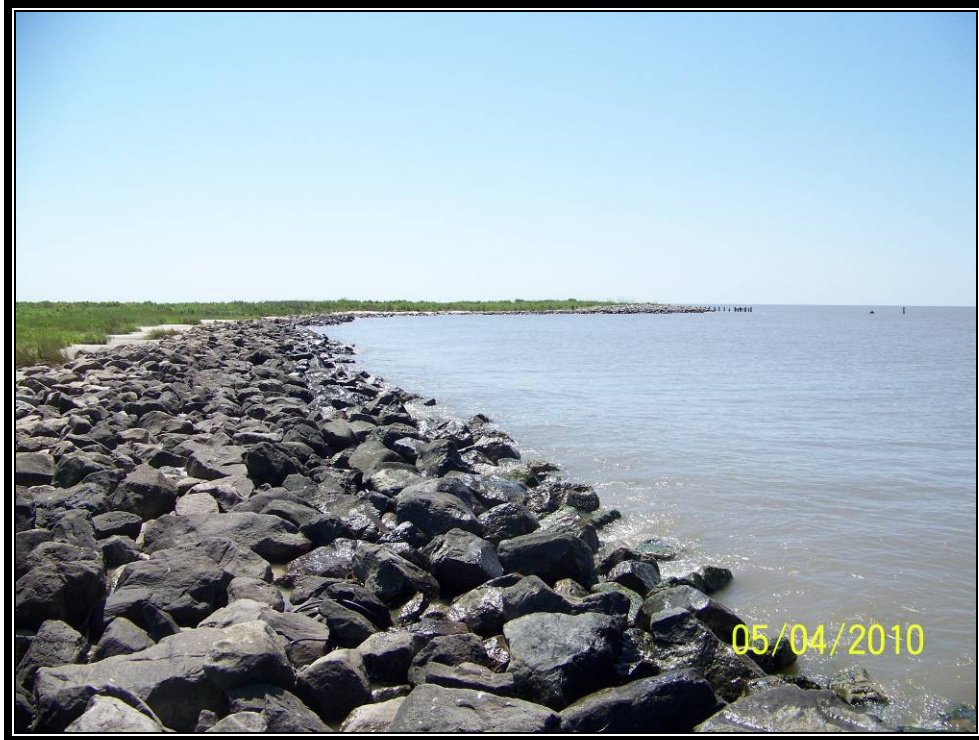
The rock dike along Area 5 of Phase III appeared to be in good condition with no noticeable settlement of the structure. Beyond the west end of the dike, erosion of the beach face has increased and the shoreline has moved inland. Consequently tidal exchange is now occurring behind the mats, and erosion of the shoreline behind the mats was observed. Immediate maintenance recommendations include surveying the rock dike and shoreline at tie-in.

Photo No.24 (3375) – Shoreline Protection, Phase III, Area 5 end of rock dike along the Gulf of Mexico looking west.

Photo No.25 (3377) – Shoreline Protection - Phase III, Area 5 rock dike along the Gulf of Mexico looking east from end of dike.

For the Phase II and III rock dikes, several areas appear to be low. Also, the Gulf shoreline continues to erode where the project rock terminates. This is true of the Phase III Area 4 and Area 5 rock dike. Immediate maintenance recommendations include surveying the entire rock dike and tie-in areas. Depending on the results of the survey, maintenance activity recommendations may include a rock lift along low areas of the dike and extension of the ends back to the shoreline (See Appendix D).

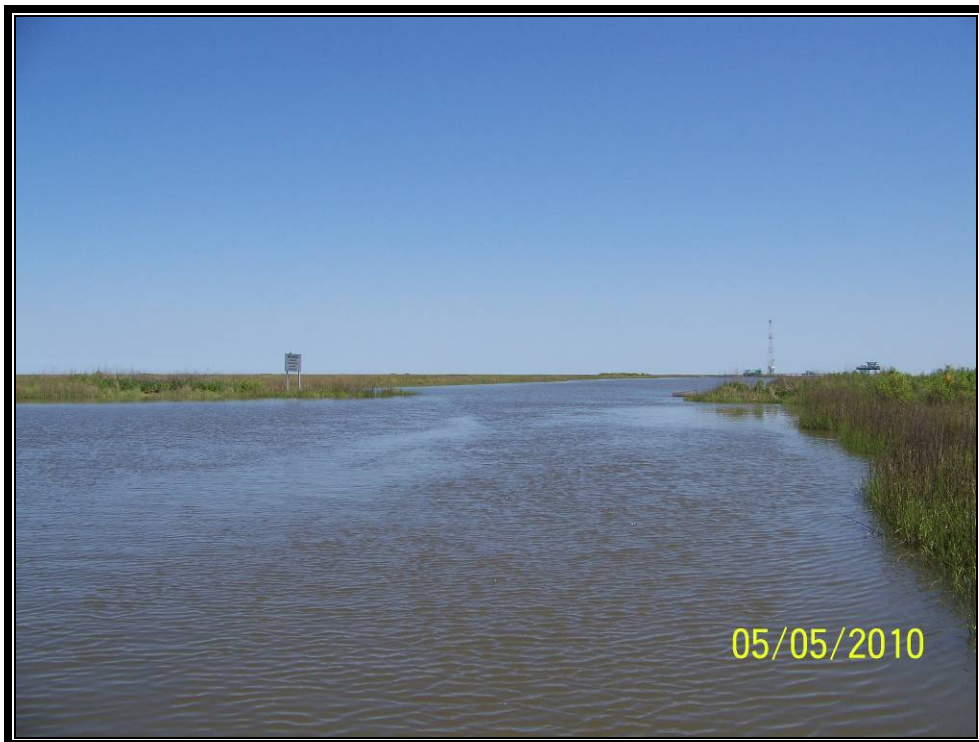
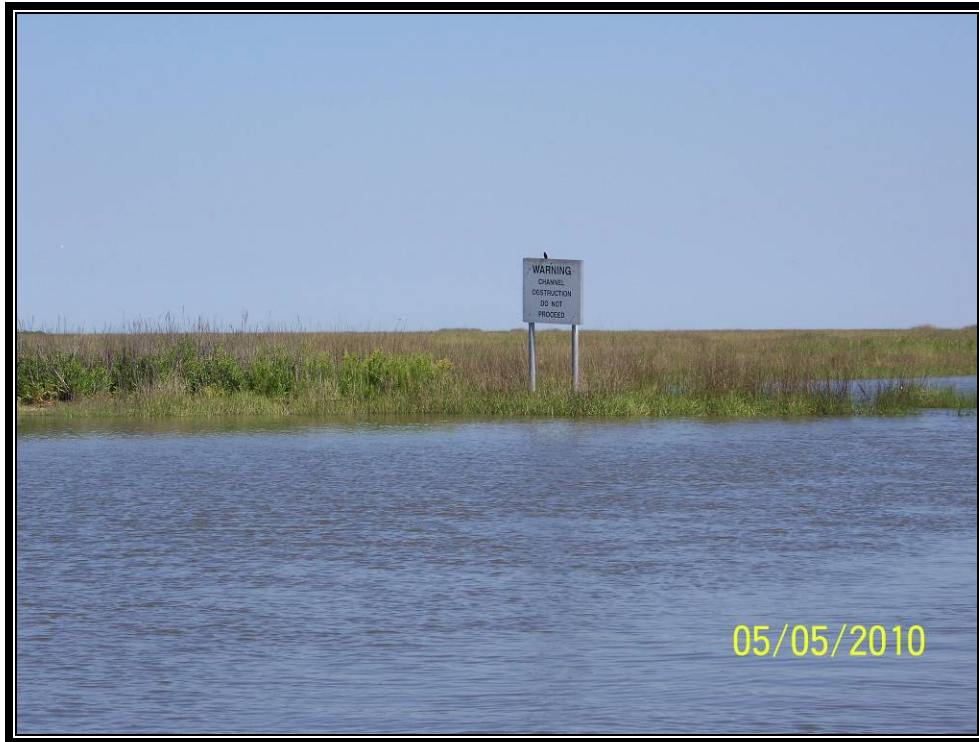
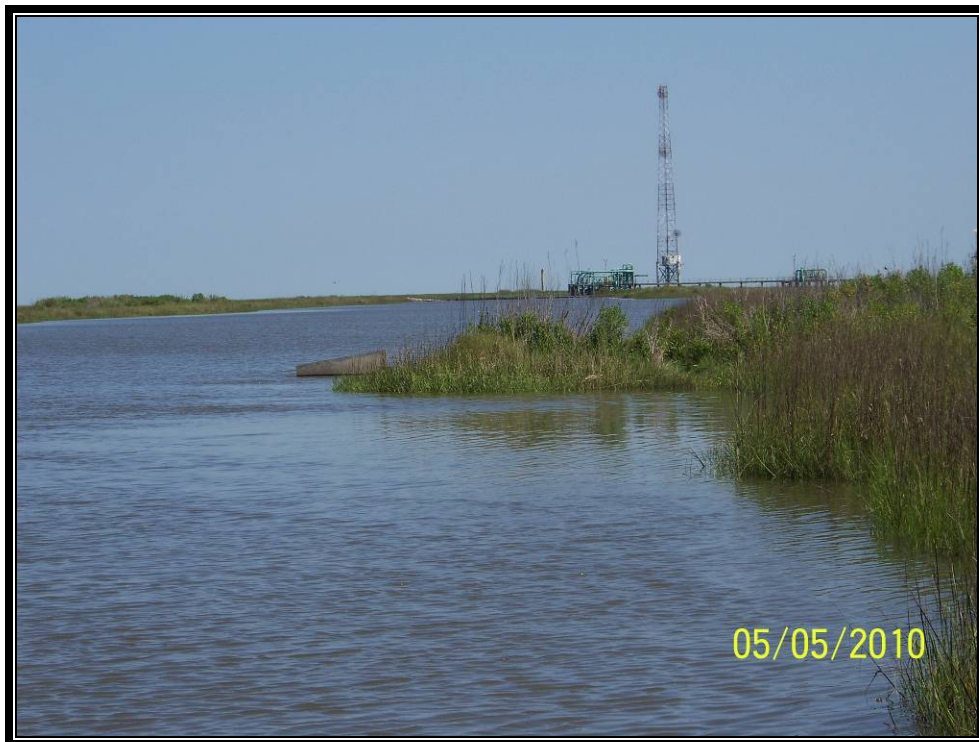
The shell plug located across Transco Canal north of Hester Canal is in poor condition. As noted in previous years' inspection reports, the shell plug has eroded in the center of the structure. According to the as-built and construction plans, the shell plug was constructed to elevation +4.0 NGVD. The shell tie-ins at the banks had no apparent signs of erosion. The west warning sign and supports were in good condition, but the east warning sign was missing. At this time repairing the shell plug is not recommended due to construction access constraints; however, this plug should continue to be monitored on future site visits.

Photo No.26 (3506) – Plug No.3 – View of shell plug from Transco Canal looking north.

Photo No.27 (3505) – Plug No.3 – View of west bank tie-in from Transco Canal looking northwest.

Photo No.28 (3507) – Plug No.3 – View of east bank tie-in from Transco Canal looking north.
