2010 Annual Inspection Report

**BRADY CANAL HYDROLOGIC
RESTORATION PROJECT (TE-28)**

State Project Number TE-28
Priority Project List 3

December 28, 2010
Terrebonne Parish

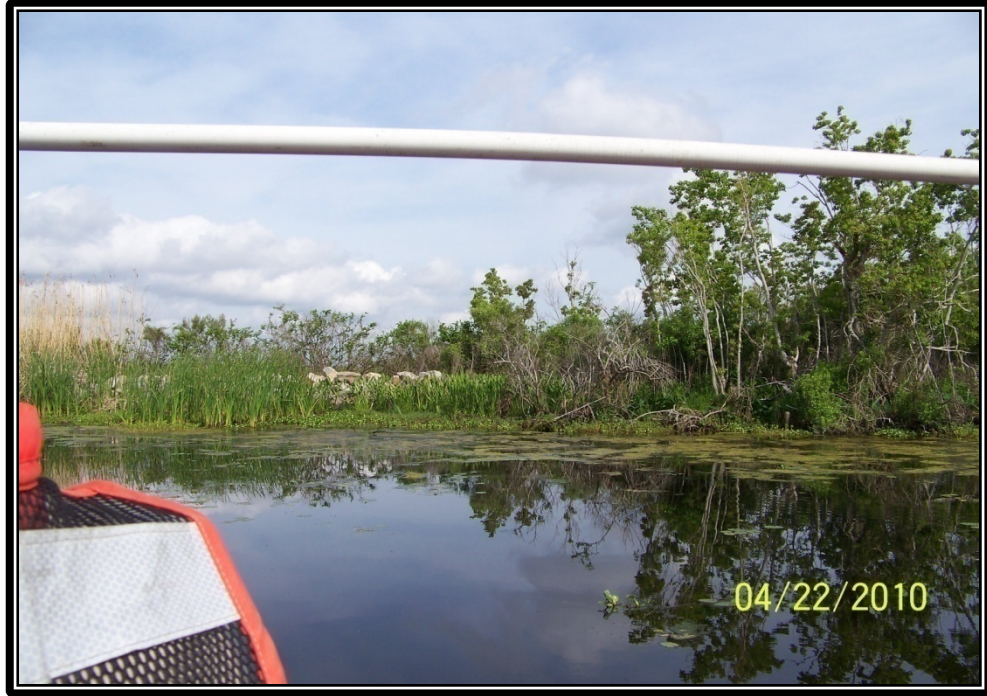
Photo No.1 – rock breach closure “Breach 7” installed in 2003 along an existing location Canal off of Superior Canal looking northeast.

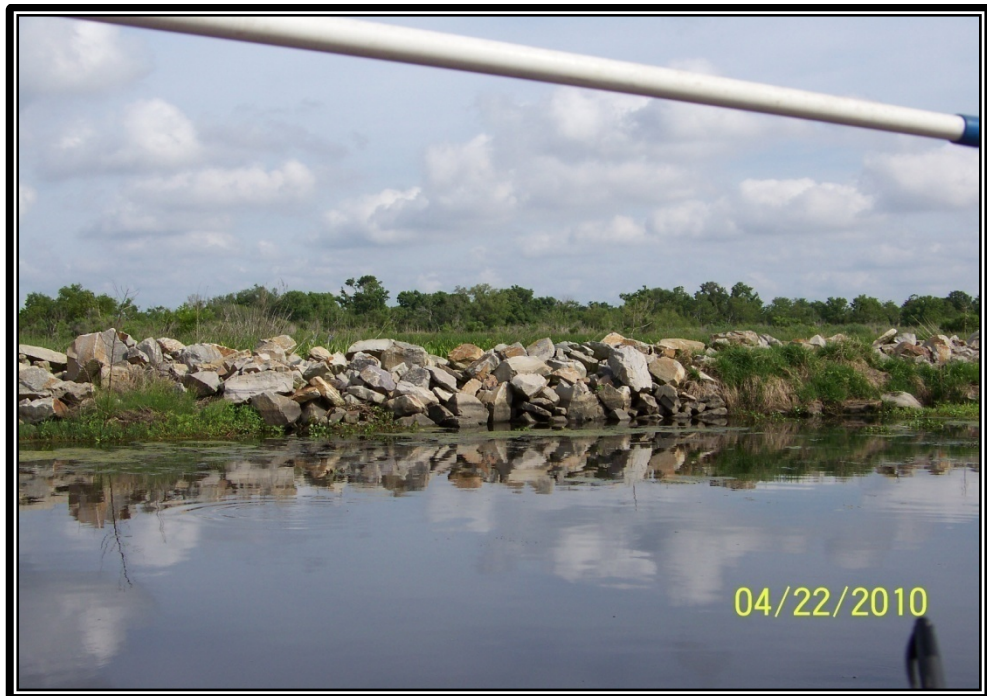
Photo No.2 – rock breach closure “Breach 7” installed in 2003 along an existing location Canal off of Superior Canal looking northeast.

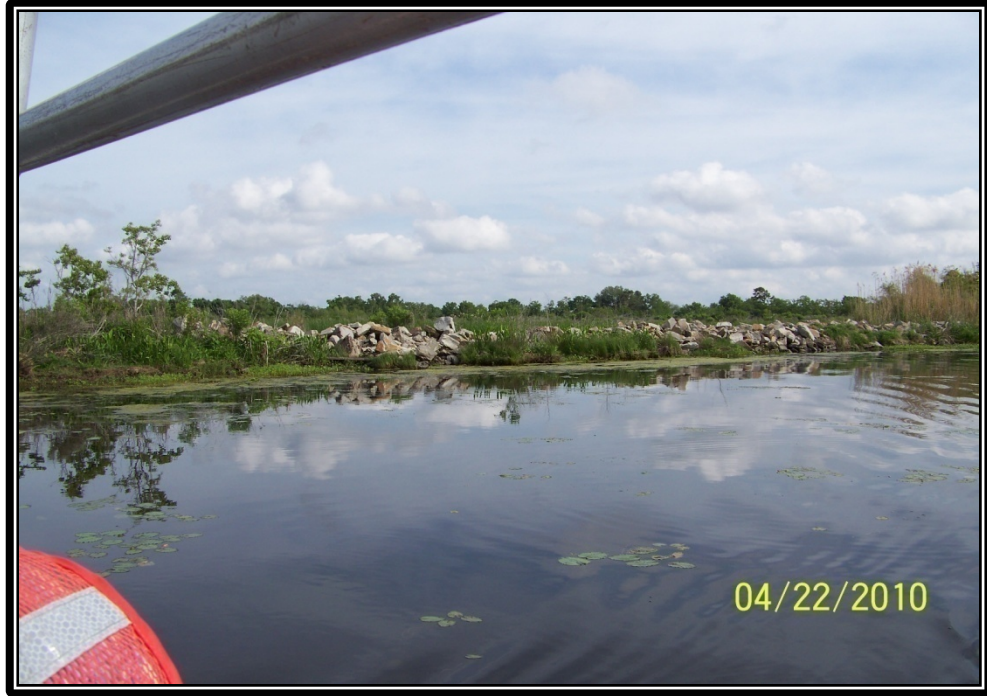
Photo No.3 – rock breach closure “Breach 7” installed in 2003 along an existing location Canal off of Superior Canal looking northeast.

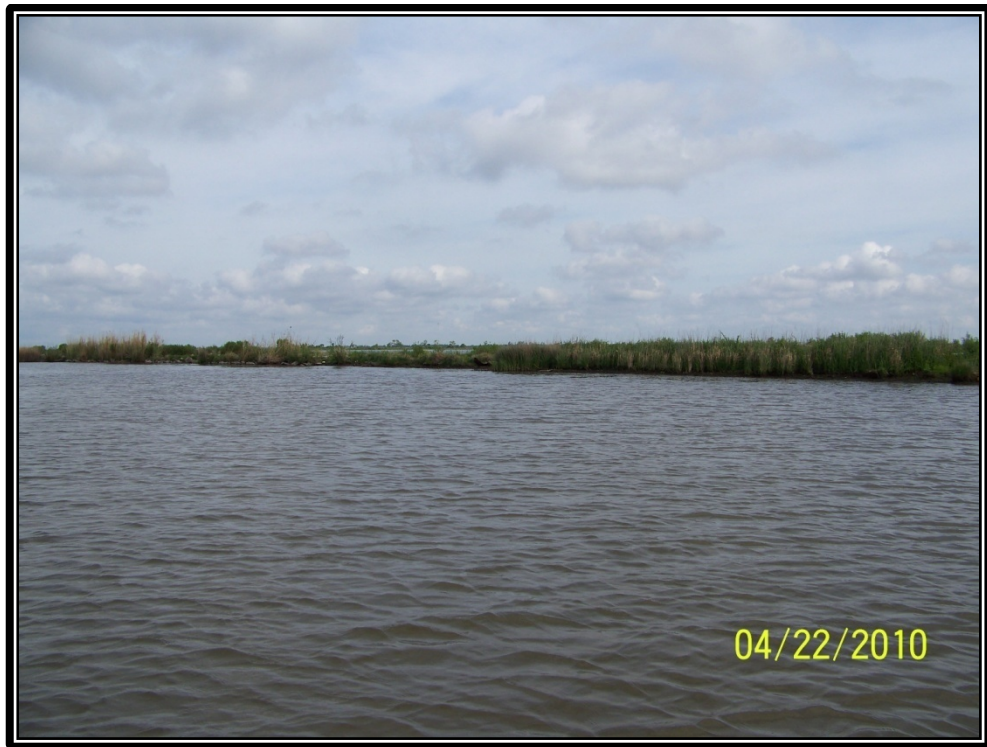
Photo No.4 – view of north bank of Bayou Decade near the intersection of Turtle Bayou and Bayou Decade.

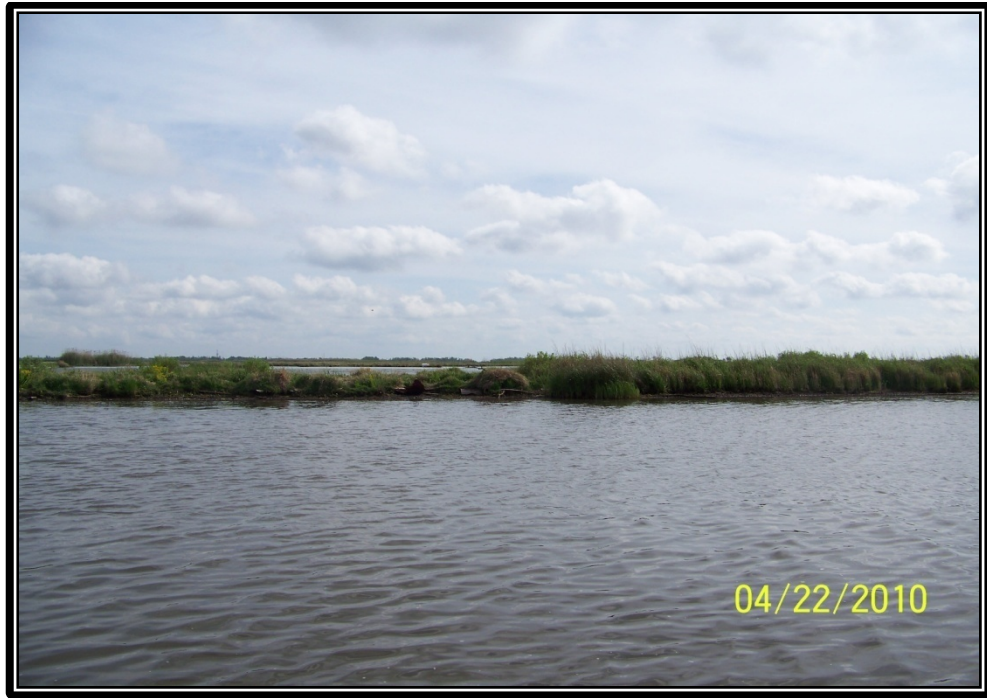
Photo No.5 - view of rock dike and breach closure (Breach 1 thru 4) constructed along the north bank of Bayou Decade in 2003 looking north.

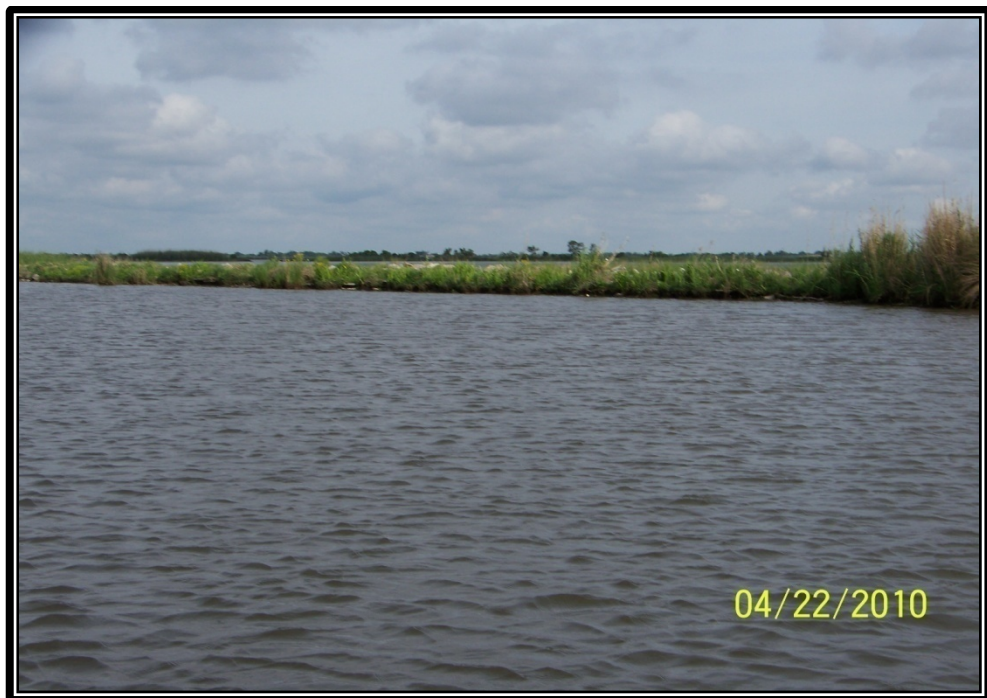
Photo No.6 - view of rock dike and breach closure (Breach 1 thru 4) constructed along the north bank of Bayou Decade in 2003 looking north.

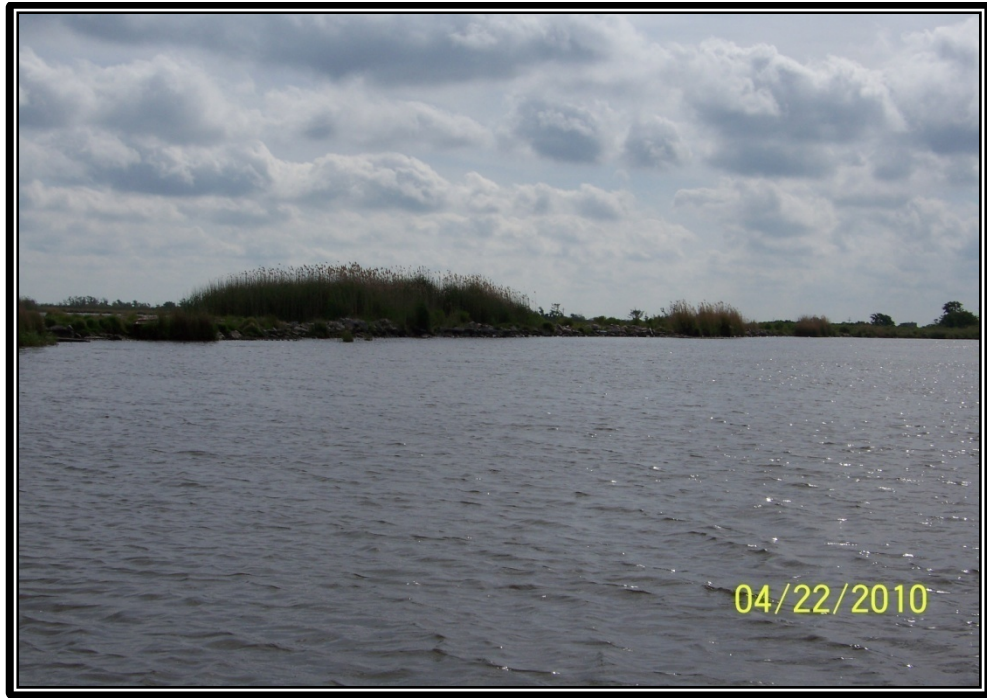
Photo No.7 - view of rock dike and breach closure (Breach 1 thru 4) constructed along the north bank of Bayou Decade in 2003 looking north.

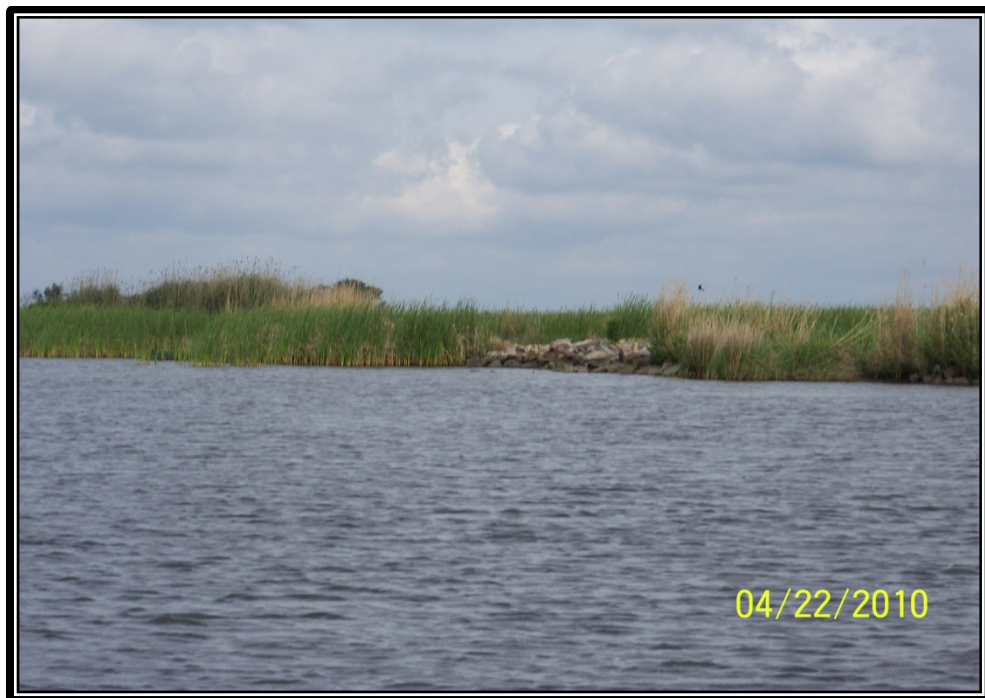
Photo No.8 - view of rock dike and breach closure (Breach 1 thru 4) constructed along the north bank of Bayou Decade in 2003 looking north.

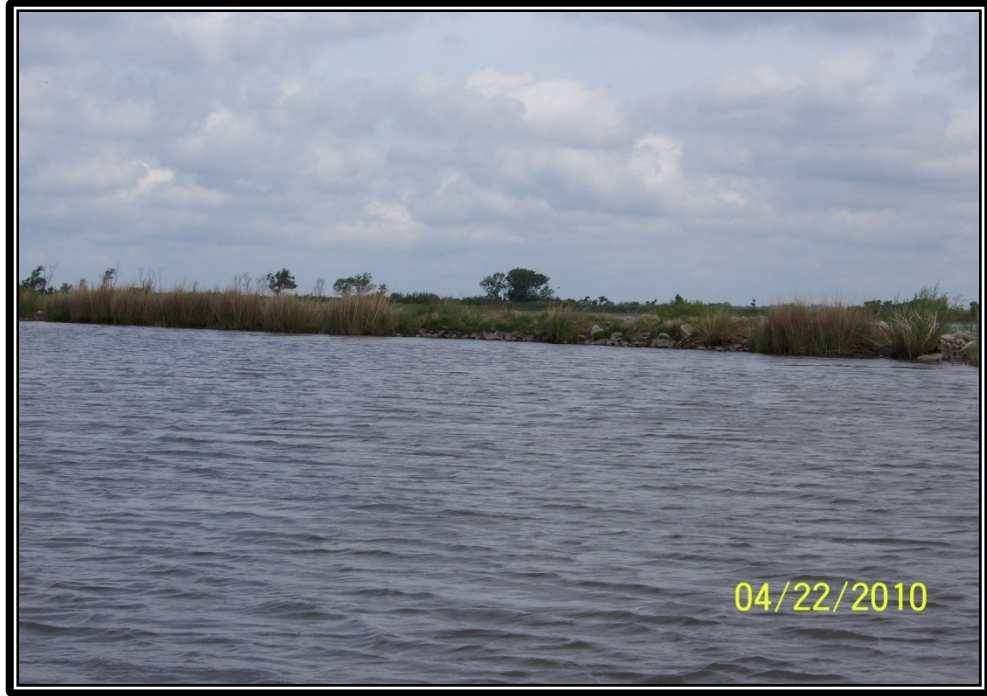
Photo No.9 - view of rock dike and breach closure (Breach 1 thru 4) constructed along the north bank of Bayou Decade in 2003 looking north.

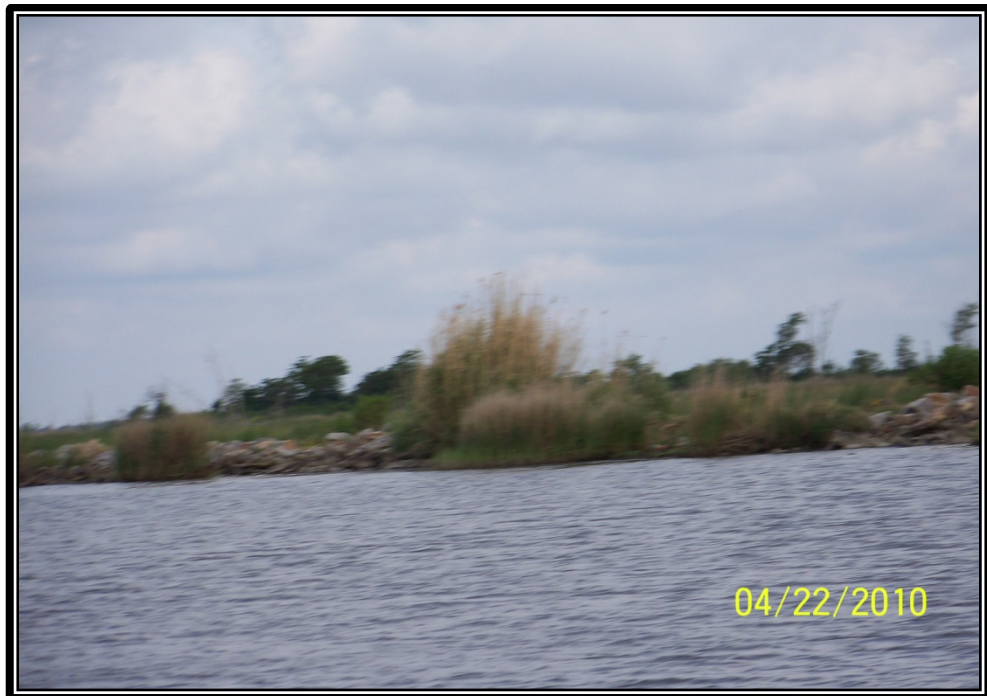
Photo No.10 - view of rock dike and breach closure (Breach 1 thru 4) constructed along the north bank of Bayou Decade in 2003 looking north.

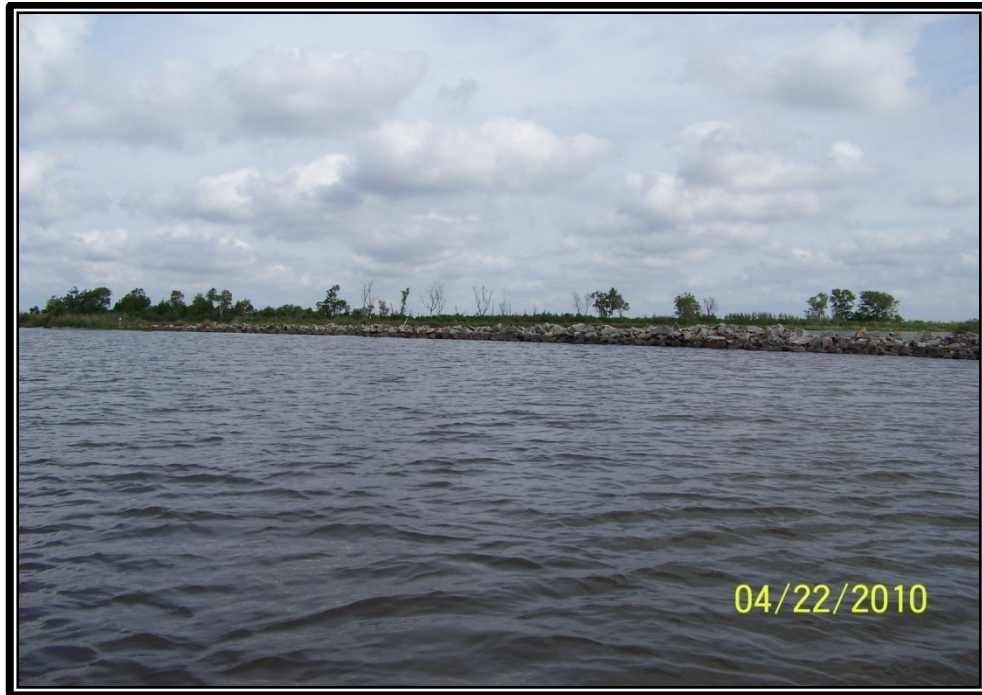
Photo No.11 - view of rock dike and breach closure (Breach 1 thru 4) constructed along the north bank of Bayou Decade in 2003 looking north.

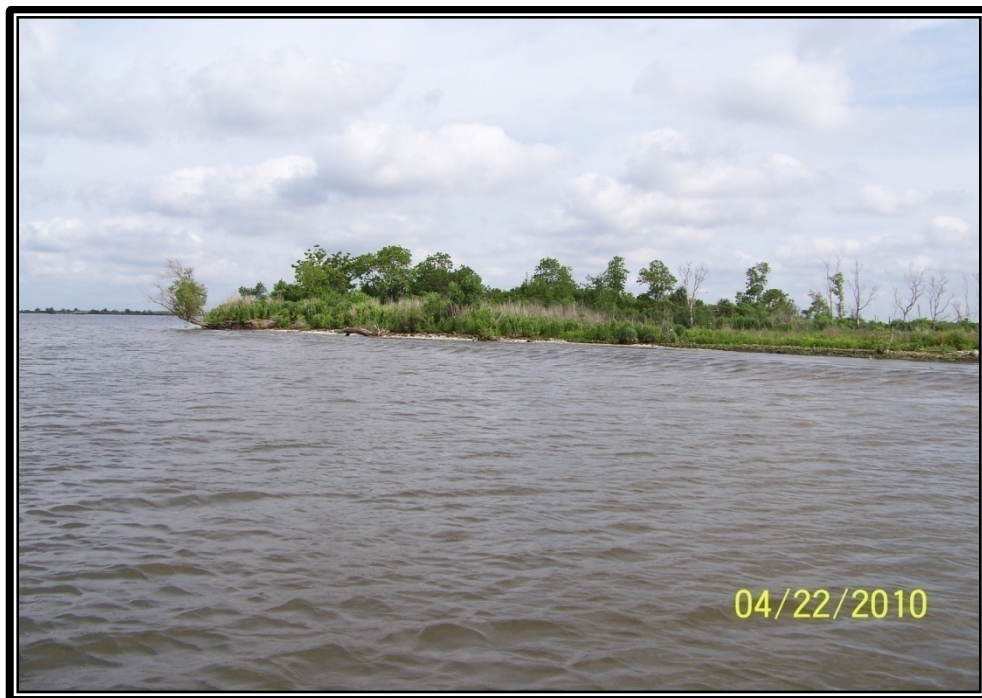
Photo No.12 – view of existing shoreline along the north bank of Bayou Decade at the entrance to Jug Lake looking northwest.

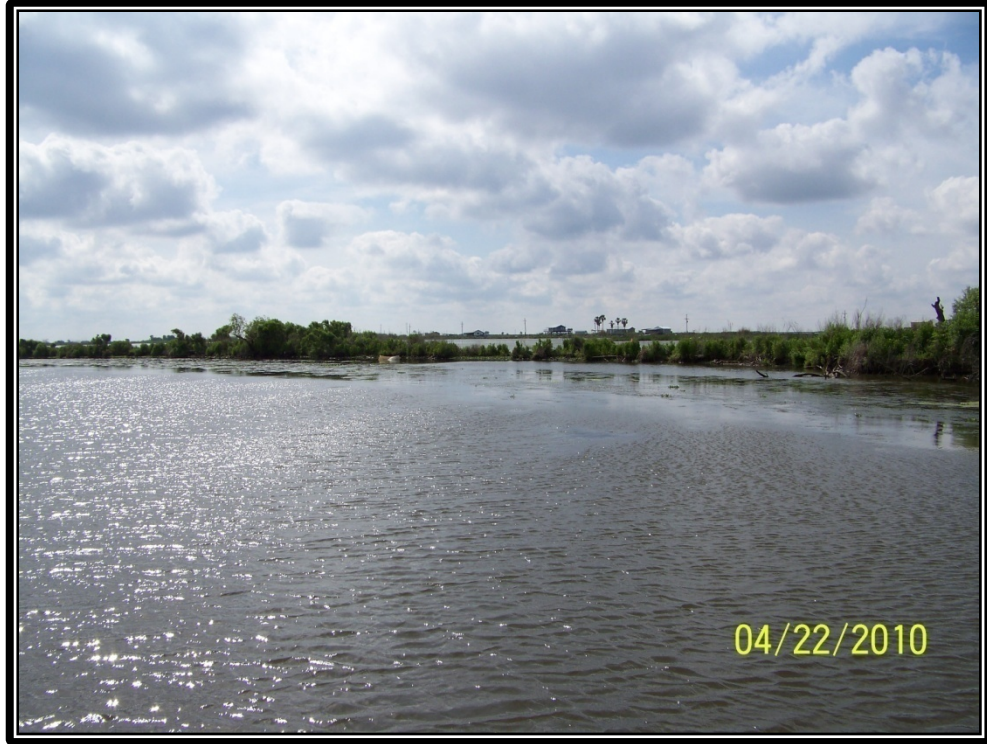
Photo No.13 – view of thin bank line along the southern bank of Jug Lake west of Structure No.24. The refurbishment of this bank line is included in the 2010 Maintenance Project.

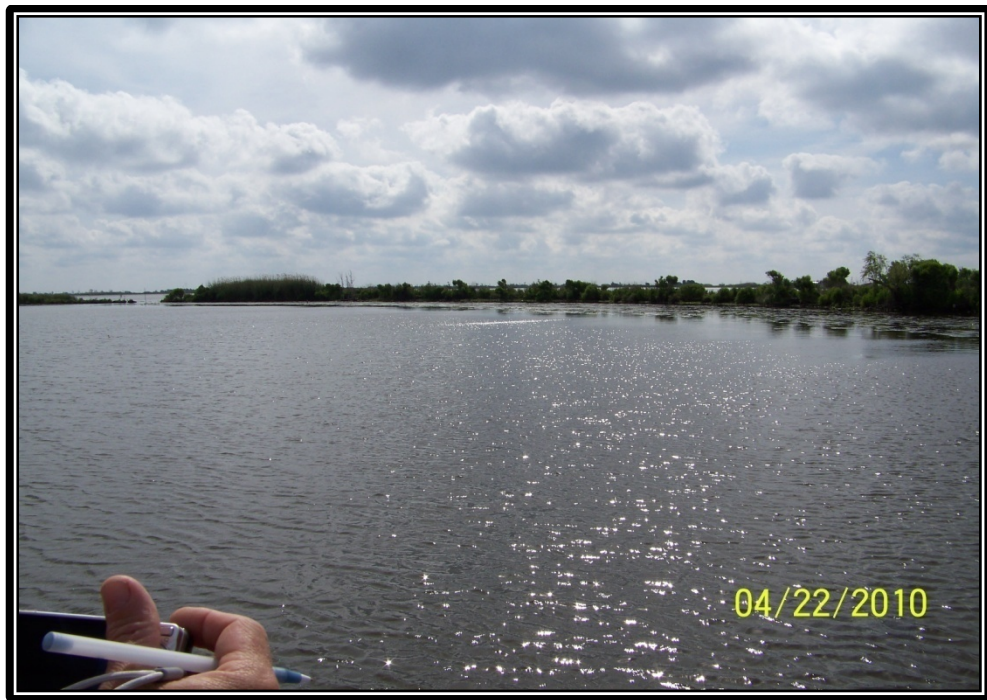
Photo No.14 – view of thin and low bank line along the southern bank of Jug Lake west of Structure No.24. The refurbishment of this bank line is included in the 2010 Maintenance Project. Note the large breach on the left side of the photo that has opened up since Hurricanes Gustave and Ike.

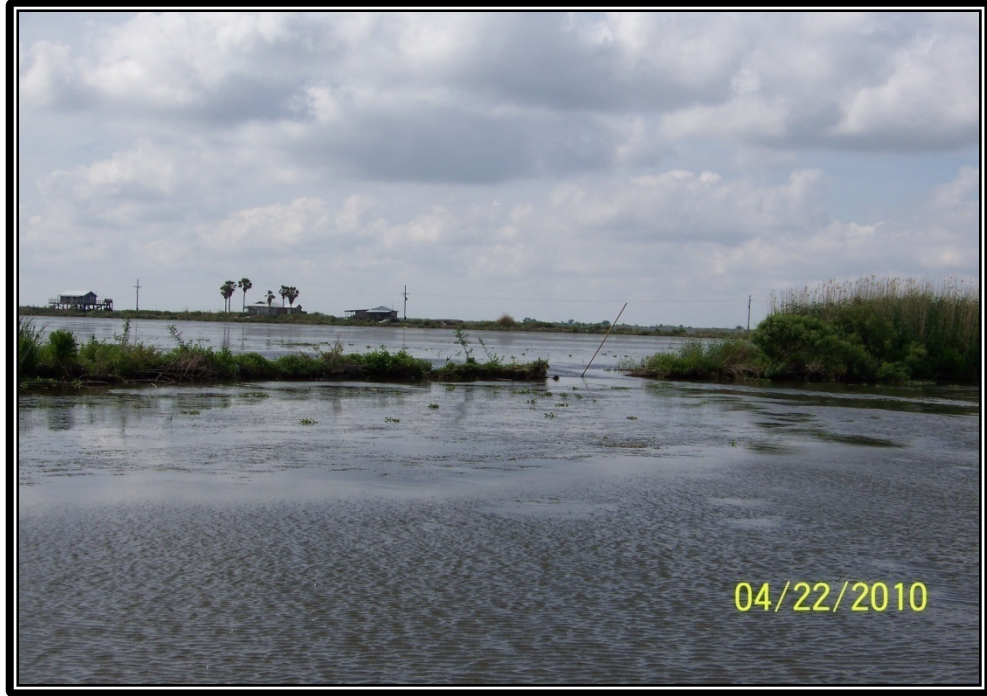
Photo No.15 – view of large breach in the south bank of Jug Lake west of Structure No.24. The breach opened up after Hurricanes Gustave and Ike. The refurbishment of this bank line is included in the 2010 Maintenance Work Plan.

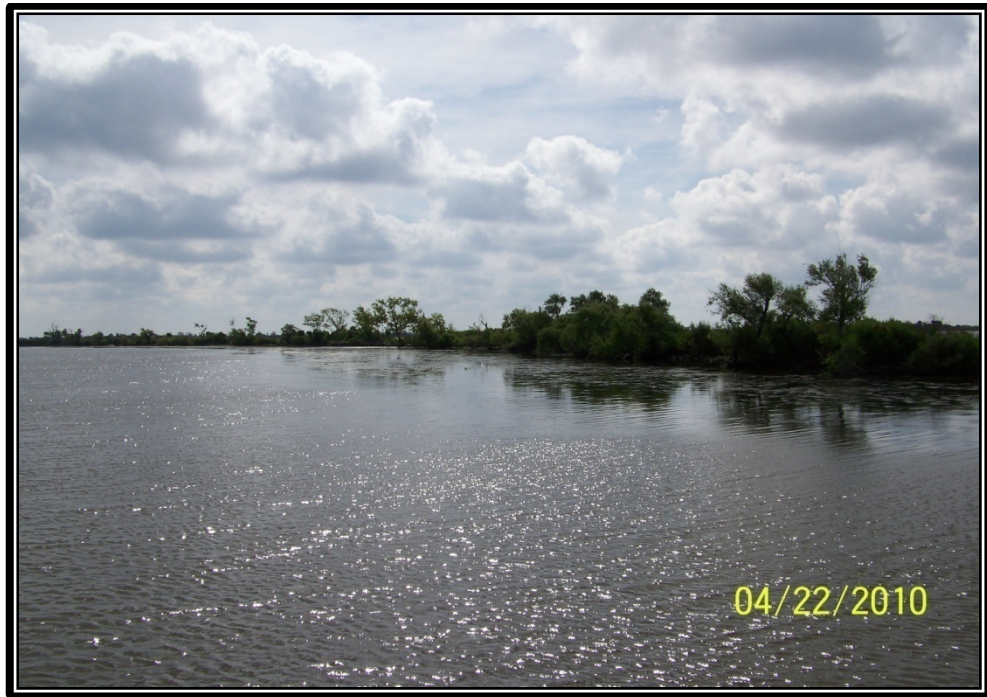
Photo No.16 – view of thin and low bank line along the southern bank of Jug Lake west of Structure No.24. The refurbishment of this bank line is included in the 2010 Maintenance Project.

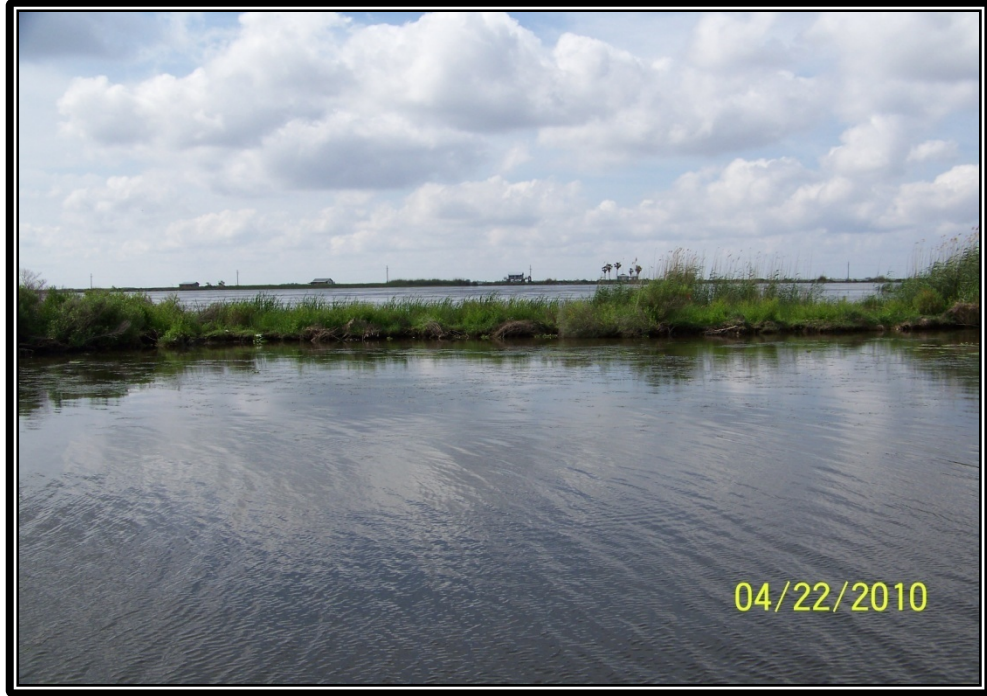
Photo No.17 – view of thin and low bank line along the southern bank of Jug Lake west of Structure No.24. The refurbishment of this bank line is included in the 2010 Maintenance Project.

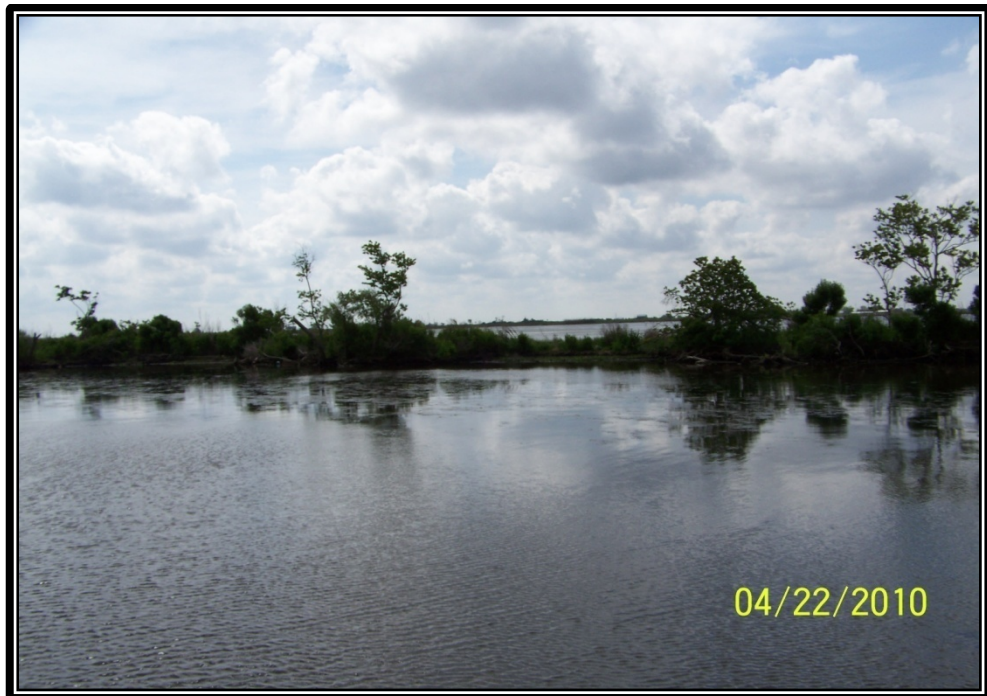
Photo No.18 – view of thin and low bank line along the southern bank of Jug Lake west of Structure No.24. The refurbishment of this bank line is included in the 2010 Maintenance Project.

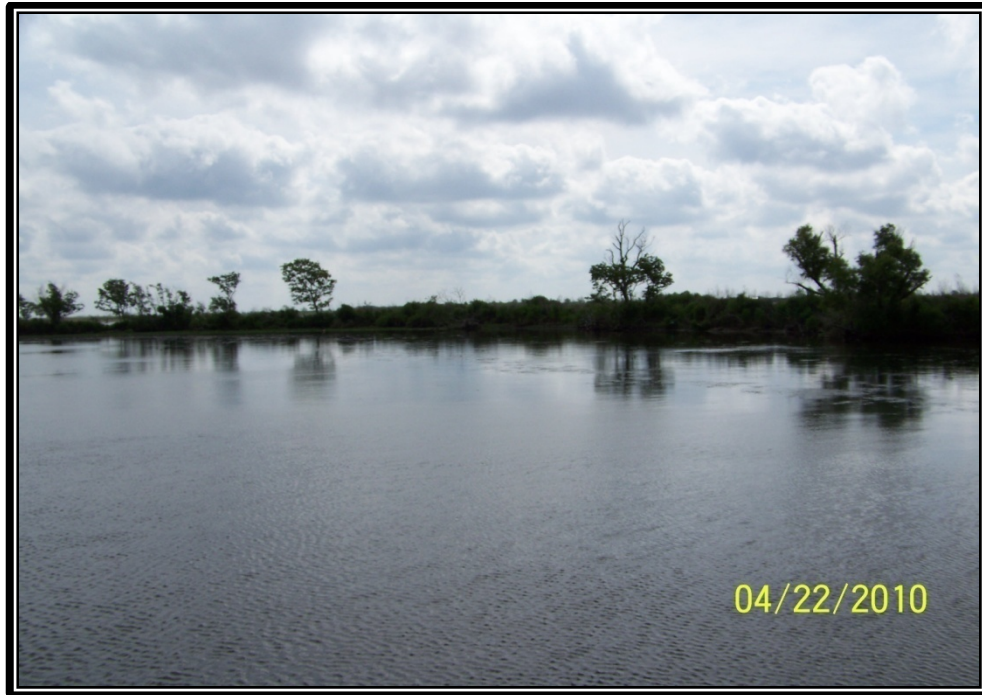
Photo No.19 – view of thin and low bank line along the southern bank of Jug Lake west of Structure No.24. The refurbishment of this bank line is included in the 2010 Maintenance Project.

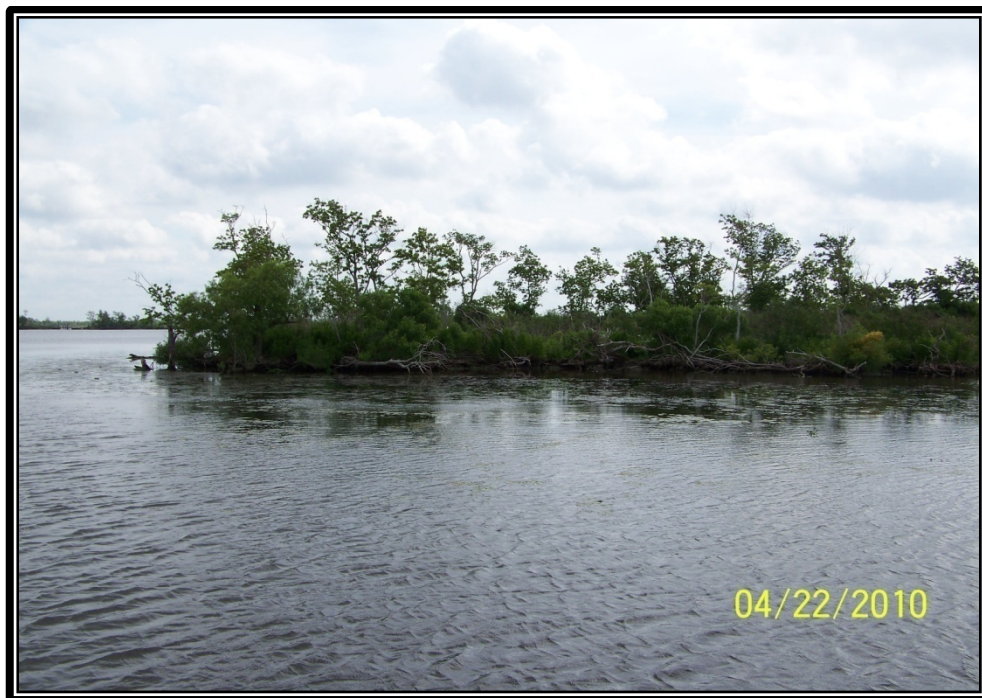
Photo No.20 – view of bank line along the southern bank of Jug Lake just west of Structure No.24. This section of bank line is heavily vegetated and appears to be stable. The refurbishment of this bank line is included in the 2010 Maintenance Project.

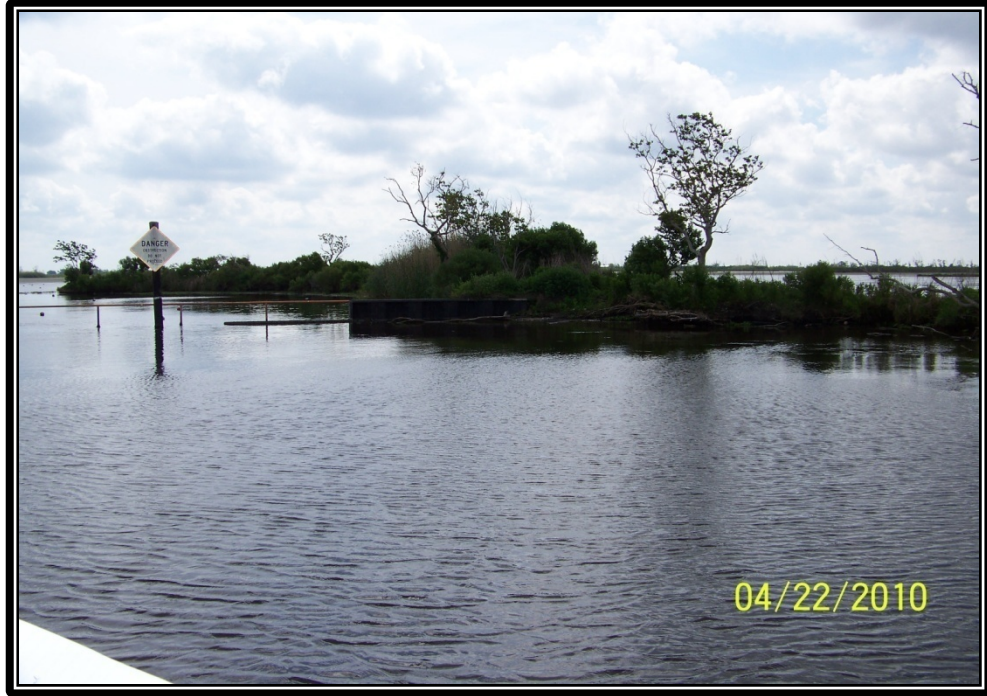
Photo No.21 – view of earthen bank tie-in on the west side of Structure No.24 in Jug Lake. The refurbishment of this earthen embankment tie-in is included in the 2010 Maintenance Project and will be armored with rock riprap approximately 100' west of the structure.

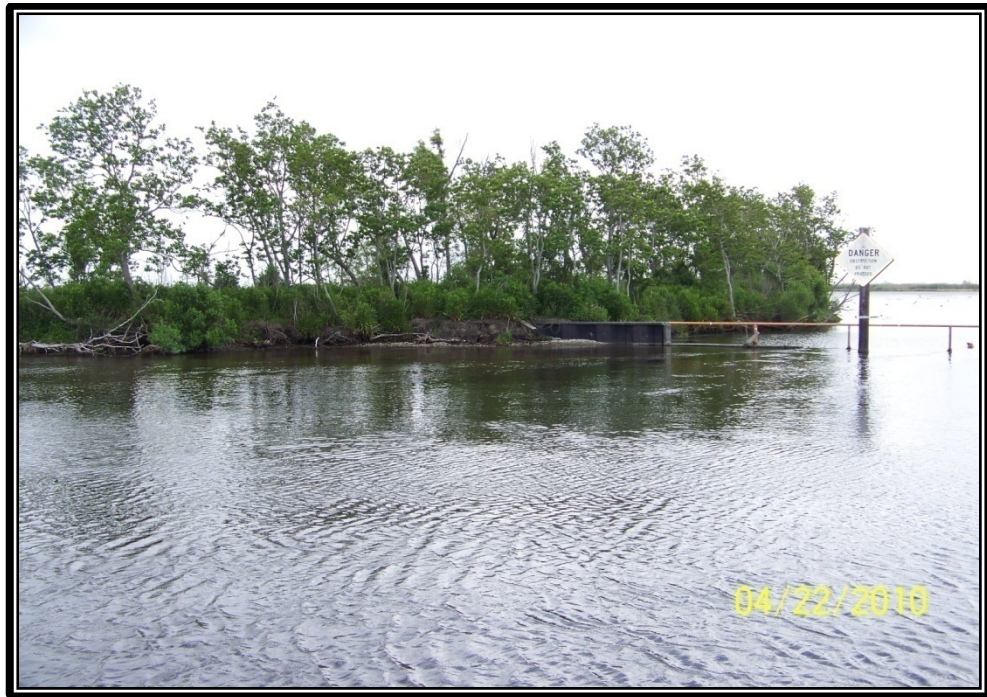
Photo No.22 – view of earthen bank tie-in on the east side of Structure No.24 in Jug Lake. The refurbishment of this earthen embankment tie-in is included in the 2010 Maintenance Project and will be armored with rock riprap approximately 100' east of the structure.

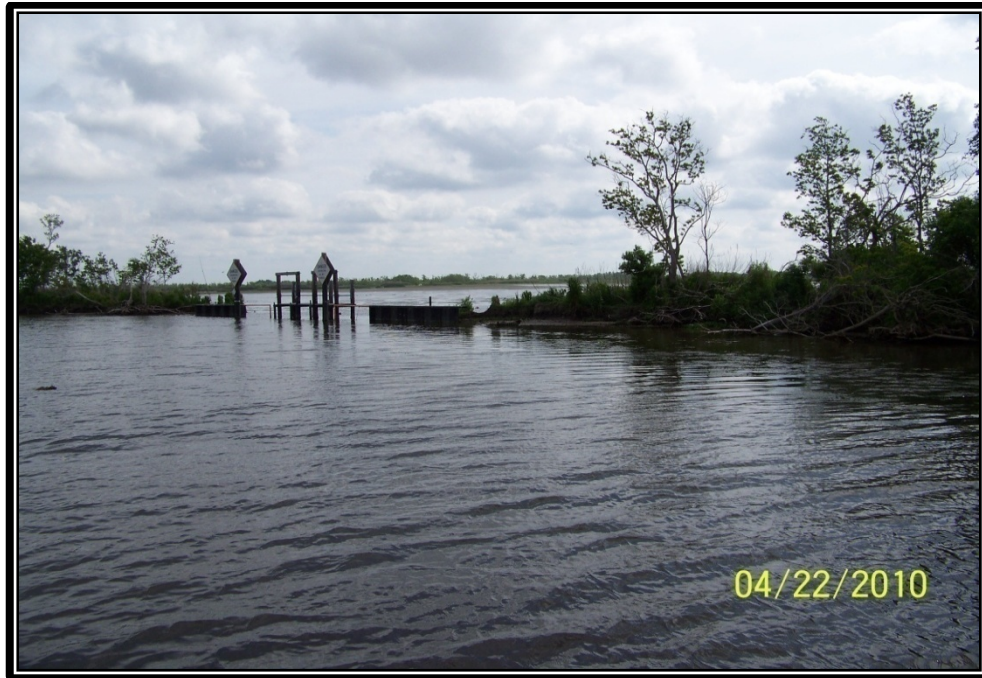
Photo No.23 – view of earthen bank tie-in on the south side of Structure No.23 in Jug Lake. The earthen embankment tie-in is nearly breach on this side with a small amount of material connecting the structure to the embankment. This section of tie-in will be armored with rock riprap approximately 100' south of the structure.

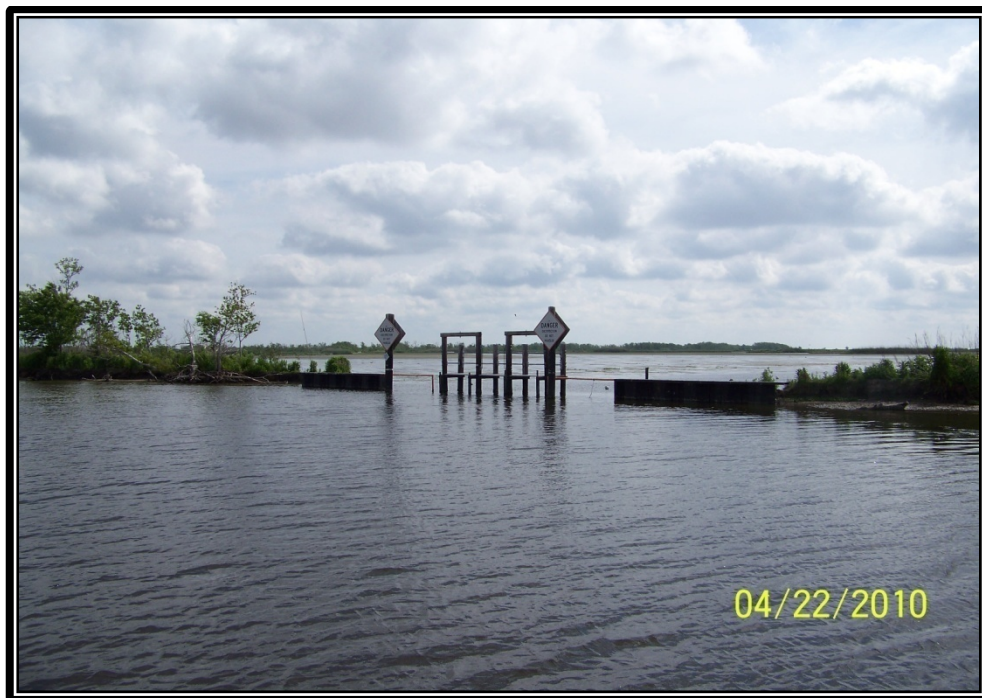
Photo No.24 – view of the two (2) bay variable crest structure (Structure No.23) located in Jug Lake on the northeast side of Jug Lake.

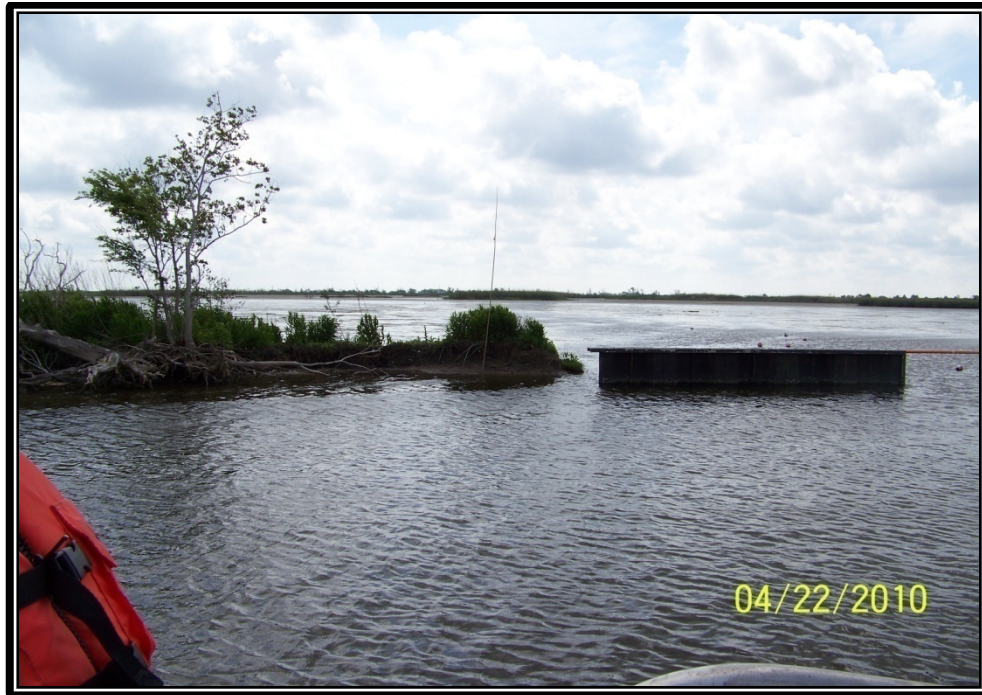
Photo No.25 – view of earthen bank tie-in on the north side of Structure No.23 in Jug Lake. The earthen embankment tie-in is breached on this side. This section of tie-in will be armored with rock riprap approximately 100' north of the structure.

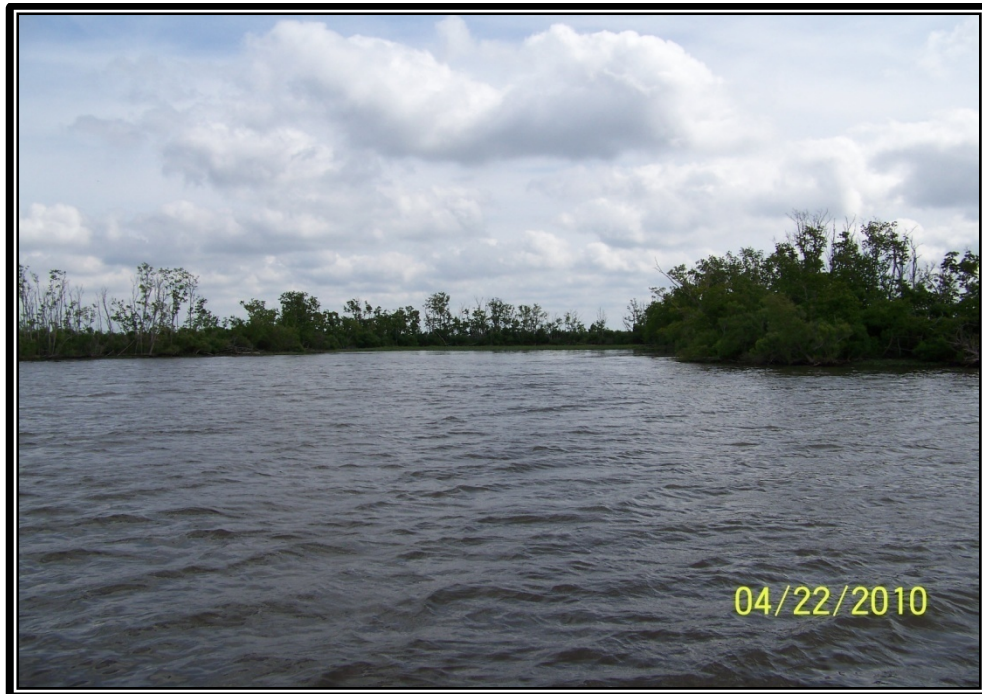
Photo No.26 – view of shoreline of Jug Lake on the north side of the lake near what appears to an old existing slip.

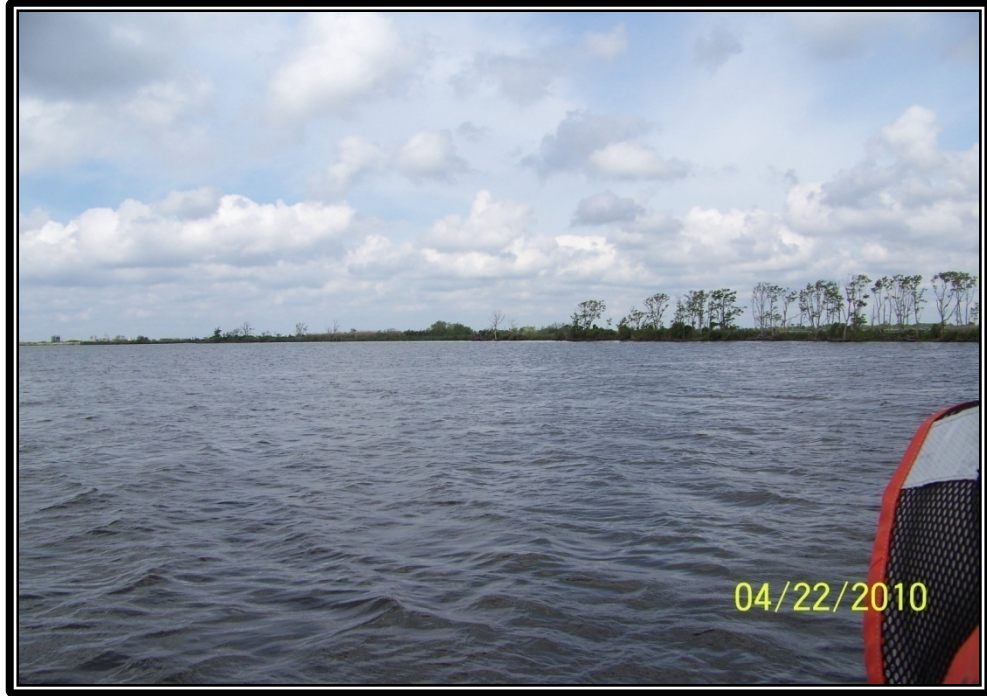
Photo No.27 – view of shoreline of Jug Lake on the north side of the lake northeast of Structure No.21.

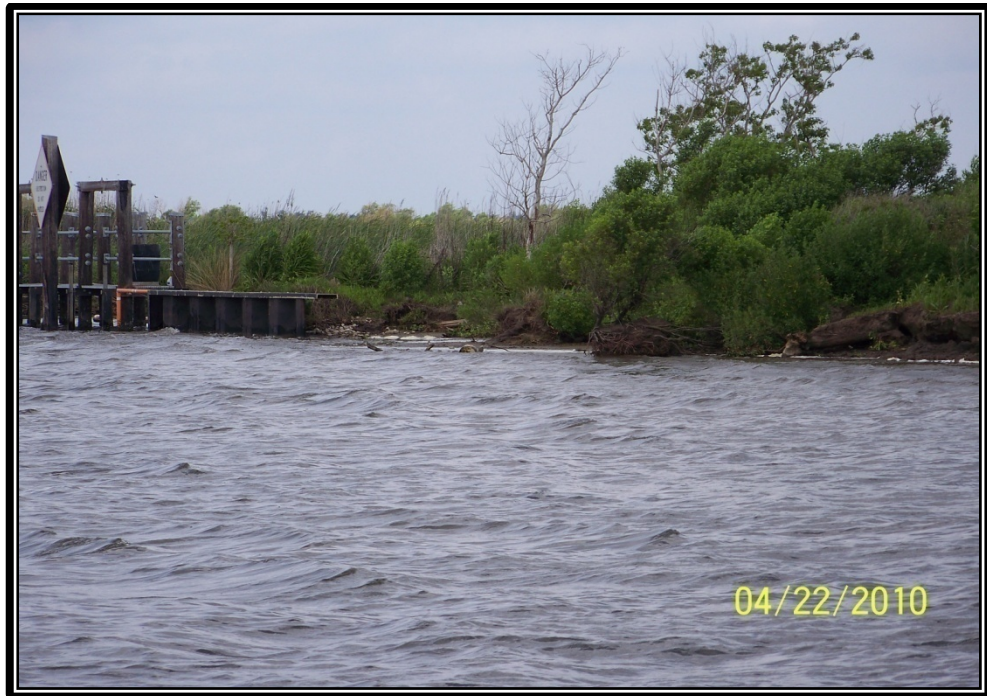
Photo No.28 – view of the exposed steel bulkhead on the northeast side of Structure No. 21 along the north bank of Jug Lake. This embankment will be reconstructed and armored with riprap under the 2010 Maintenance project.

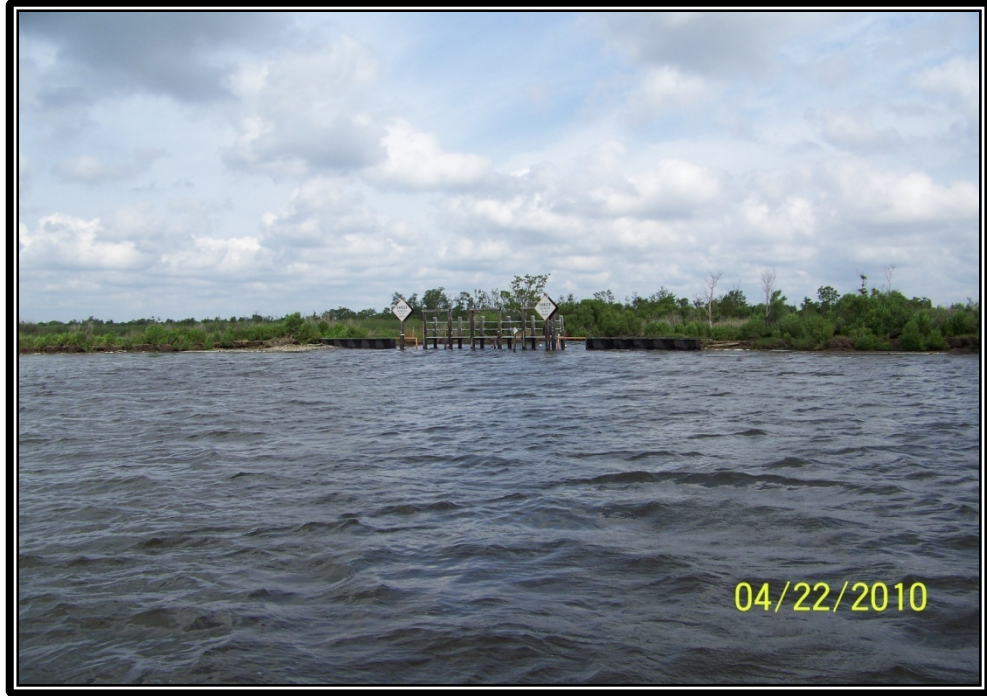
Photo No.29 – view of the three (3) bay variable crested weir structure along the north bank of Jug Lake looking north.

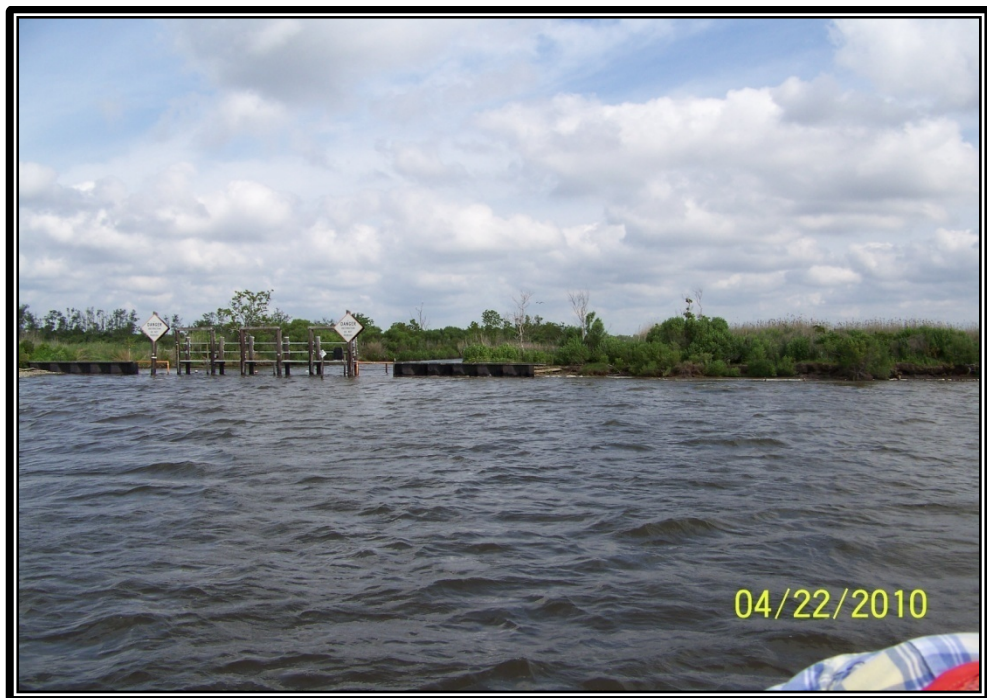
Photo No.30 – view of the three (3) bay variable crested weir structure along the north bank of Jug Lake looking north.

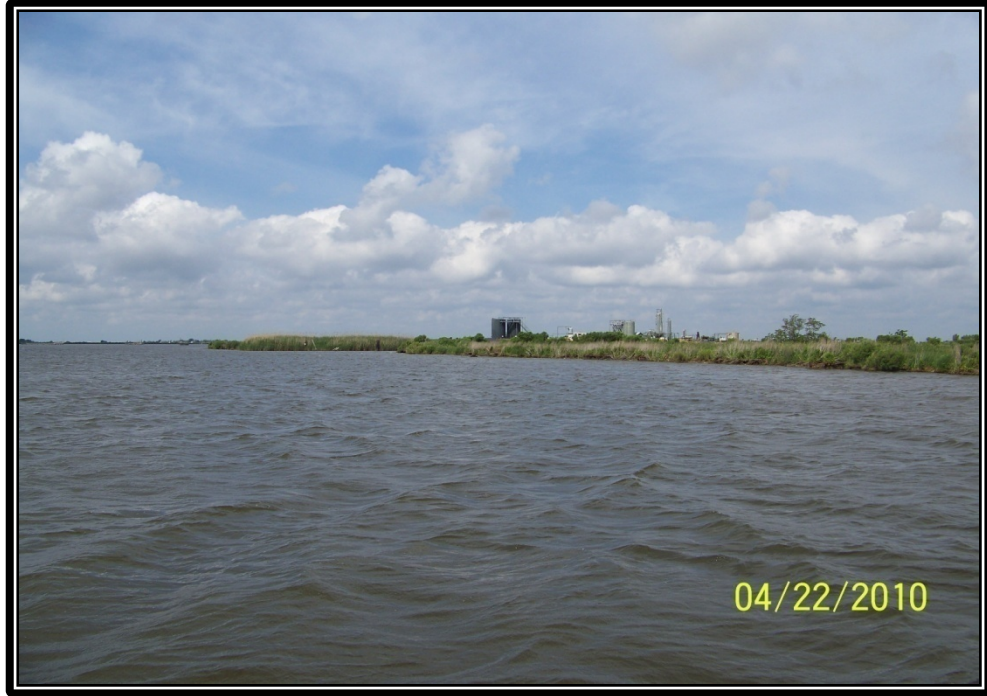
Photo No.31 – view of the bank line and marsh along the north bank of Jug Lake south of Structure No. 21. This section of earthen embankment was reconstructed by the landowner in 2005. This section of earthen embankment will be refurbished under the 2010 Maintenance Project.
