2010 Annual Inspection Report

**BRADY CANAL HYDROLOGIC
RESTORATION PROJECT (TE-28)**

State Project Number TE-28
Priority Project List 3

December 28, 2010
Terrebonne Parish

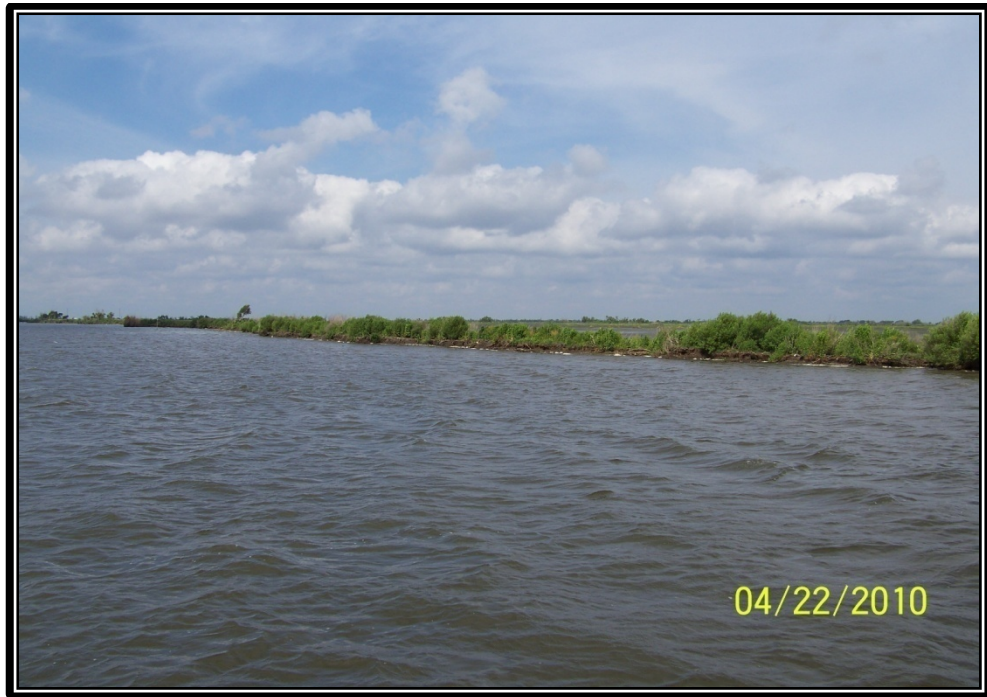
Photo No.32 – view of the bank line and marsh along the north bank of Jug Lake south of Structure No. 21. This section of earthen embankment was reconstructed by the landowner in 2005. This section of bank will be refurbished under the 2010 Maintenance Project.

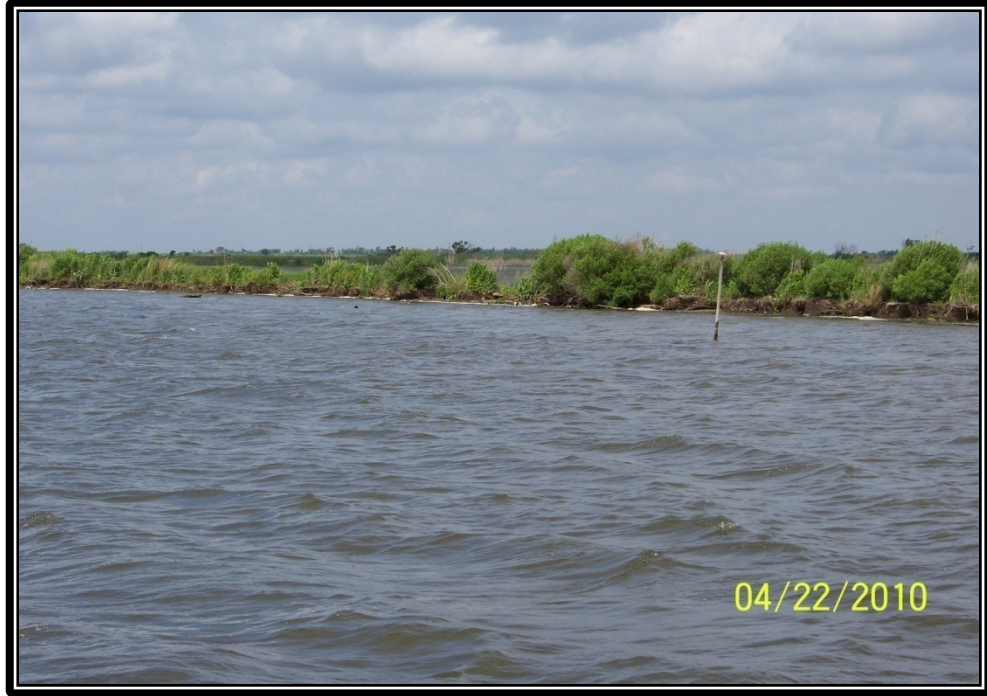
Photo No.33 – view of the bank line and marsh along the north bank of Jug Lake south of Structure No. 21. This section of earthen embankment was reconstructed by the landowner in 2005. This section of bank will be refurbished under the 2010 Maintenance Project.

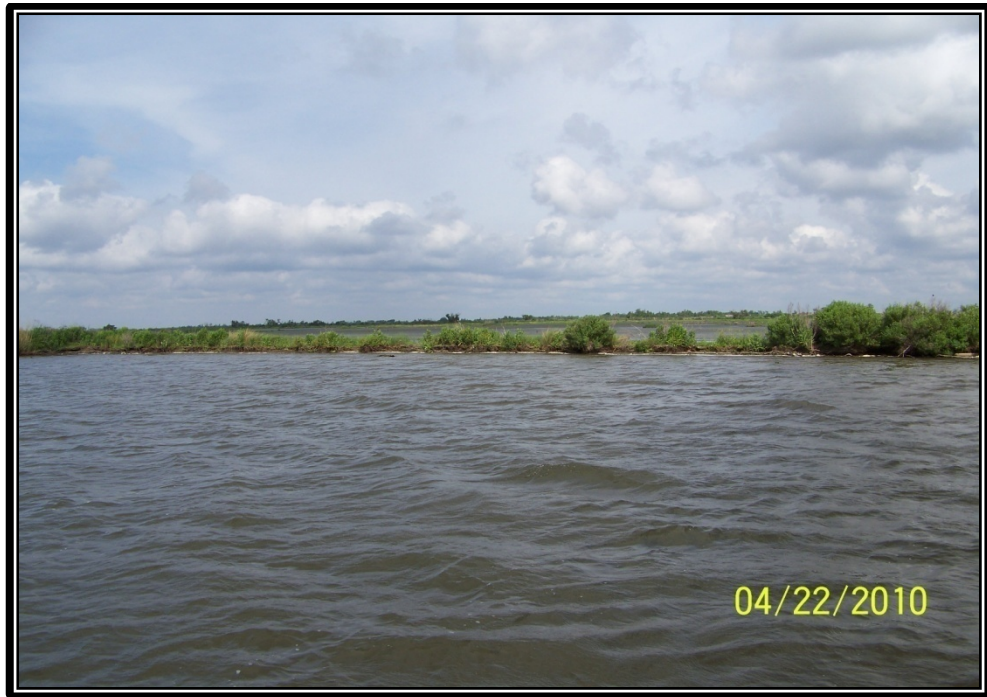
Photo No.34 – view of the bank line and marsh along the north bank of Jug Lake south of Structure No. 21. This section of earthen embankment was reconstructed by the landowner in 2005. This section of bank will be refurbished under the 2010 Maintenance Project.

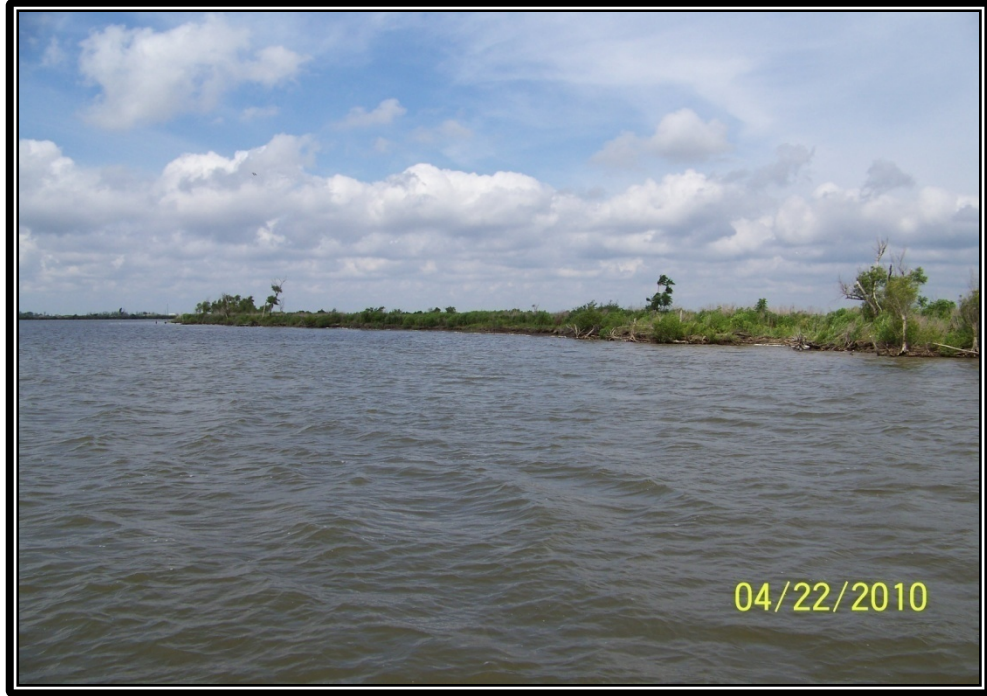
Photo No.35 – view of the bank line and marsh along the north bank of Jug Lake south of Structure No. 21. This section of earthen embankment was reconstructed by the landowner in 2005. This section of bank will be refurbished under the 2010 Maintenance Project.

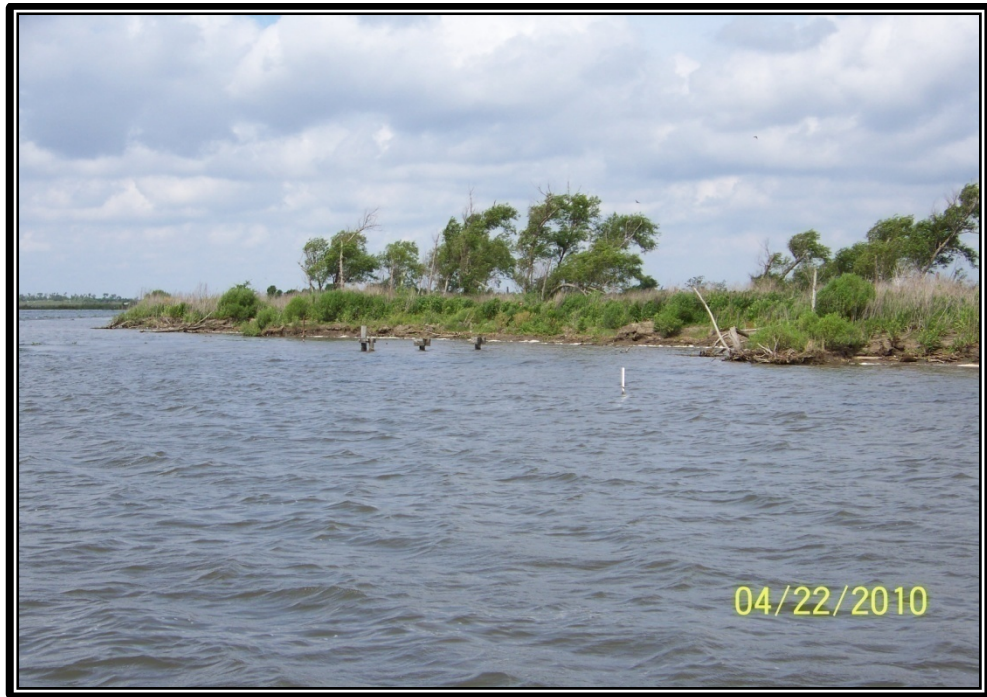
Photo No.36 – view of the bank line and marsh along the north bank of Jug Lake south of Structure No. 21. This section of earthen embankment was reconstructed by the landowner in 2005. This section of bank will be refurbished under the 2010 Maintenance Project.

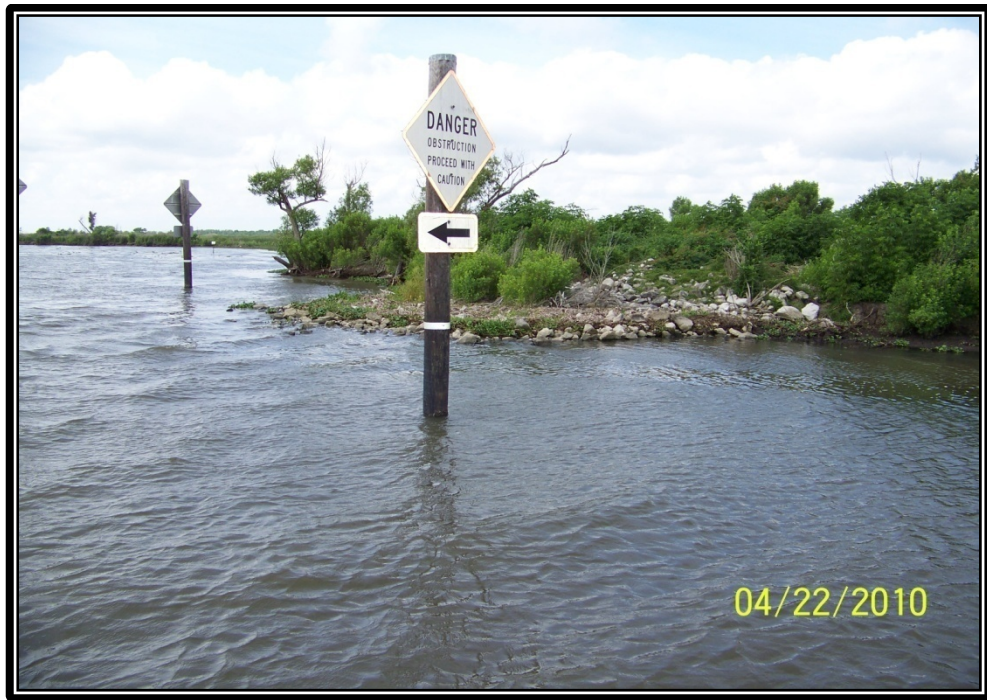
Photo No.37 – view of the rock channel liner along the south bank of Structure 20.

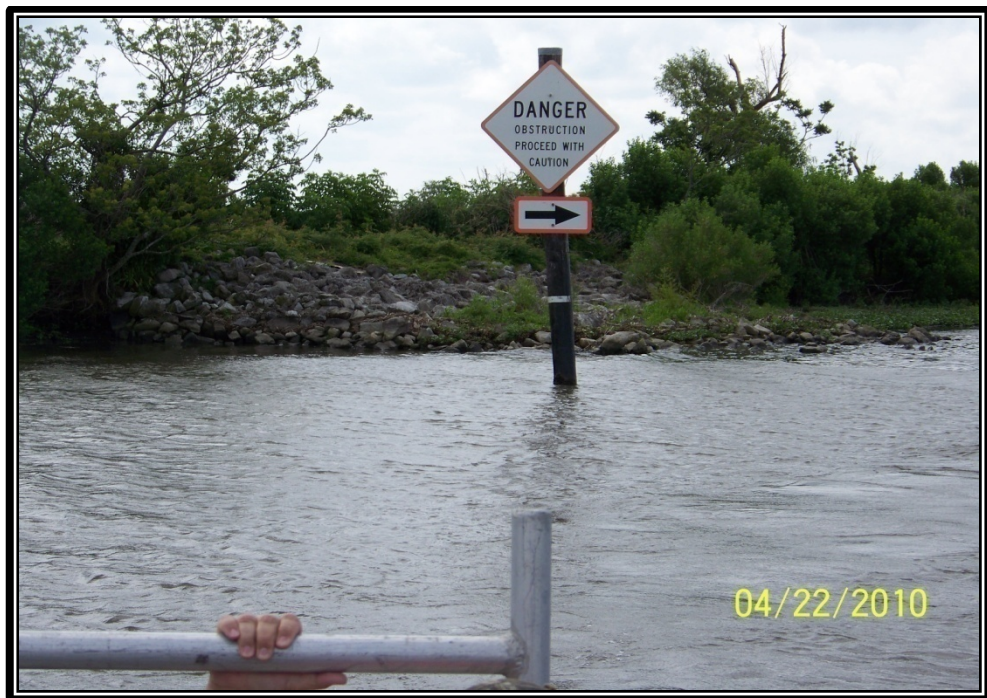
Photo No.38 – view of the rock channel liner along the north bank of Structure 20.

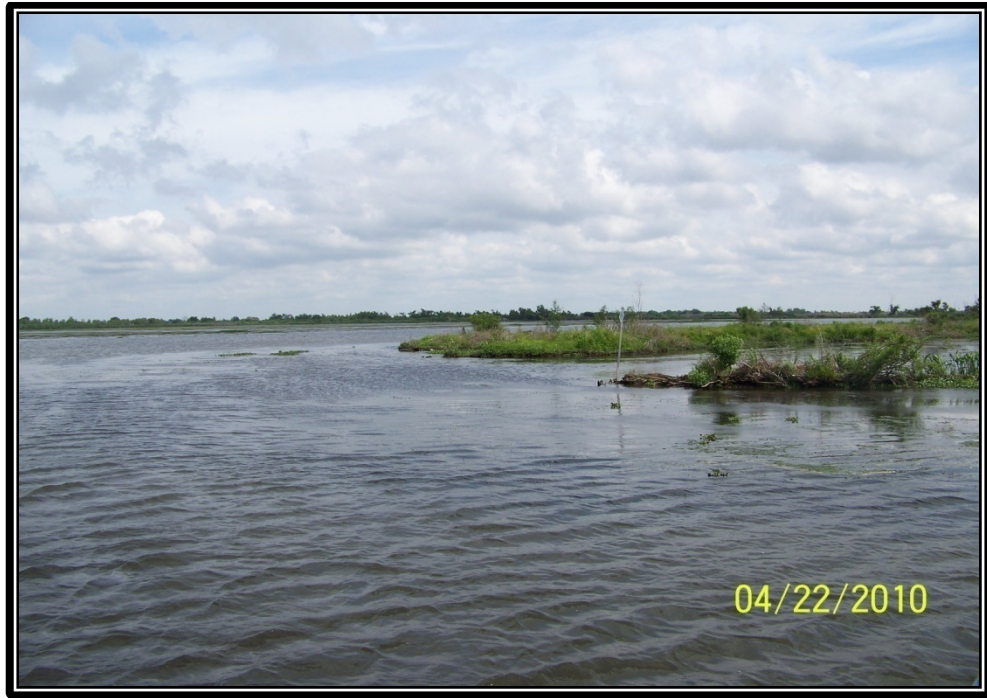
Photo No.39 – view of a breach in the bank of an existing channel on the interior marsh of Structure 20.

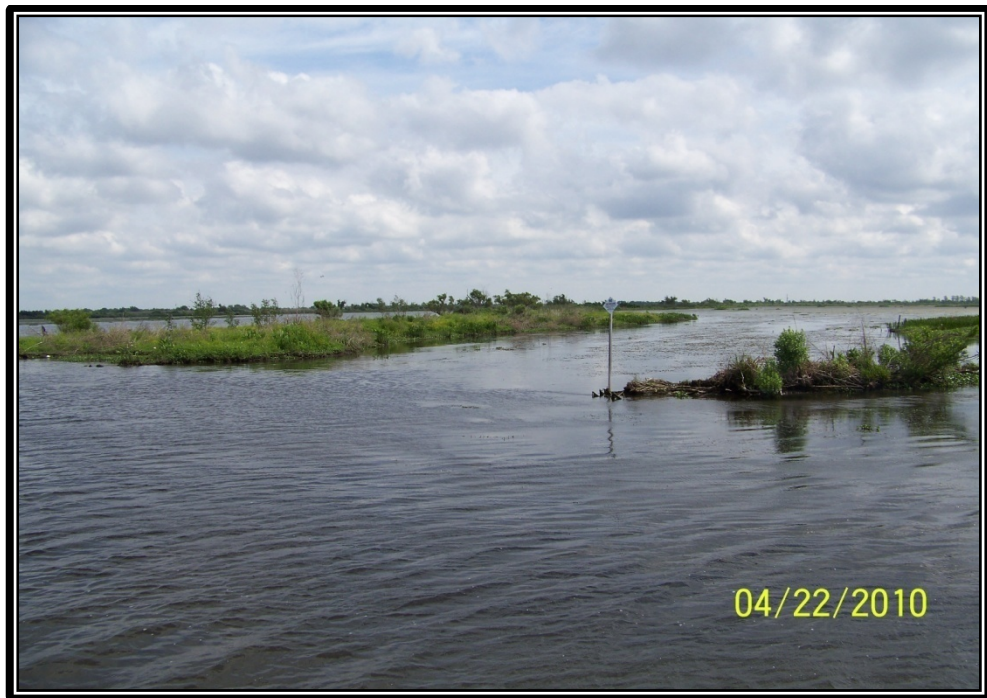
Photo No.40 – view of a breach in the bank of an existing channel on the interior marsh of Structure 20.

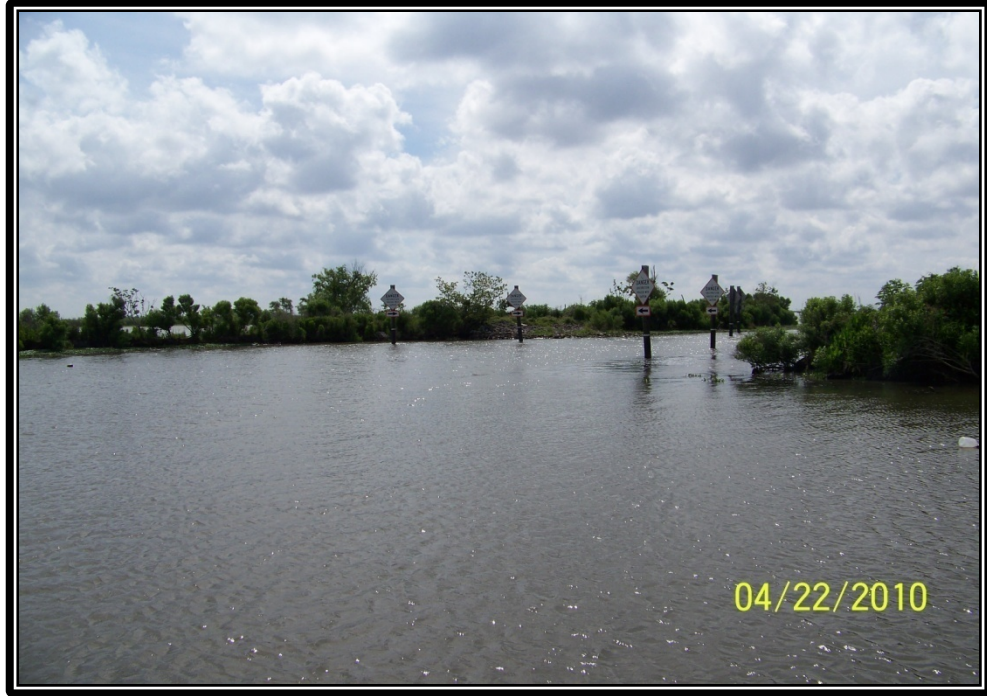
Photo No.41 – view of the rock lined channel of Structure No.20 looking northeast from the interior.

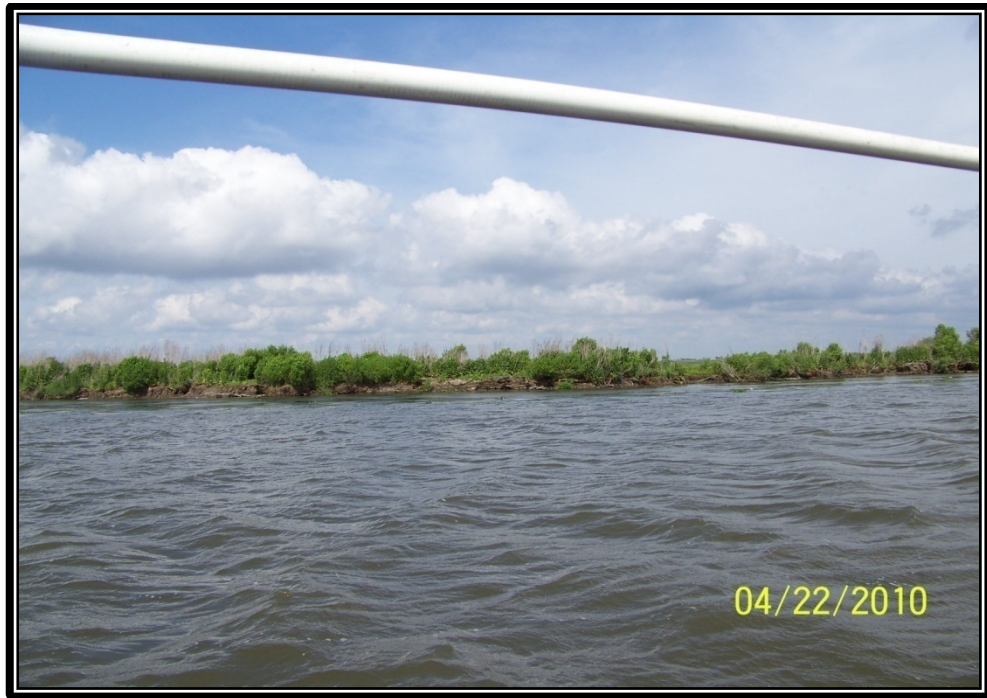
Photo No.42 – view of the existing bank line and marsh along the west bank of Jug Lake south of Structure 20.

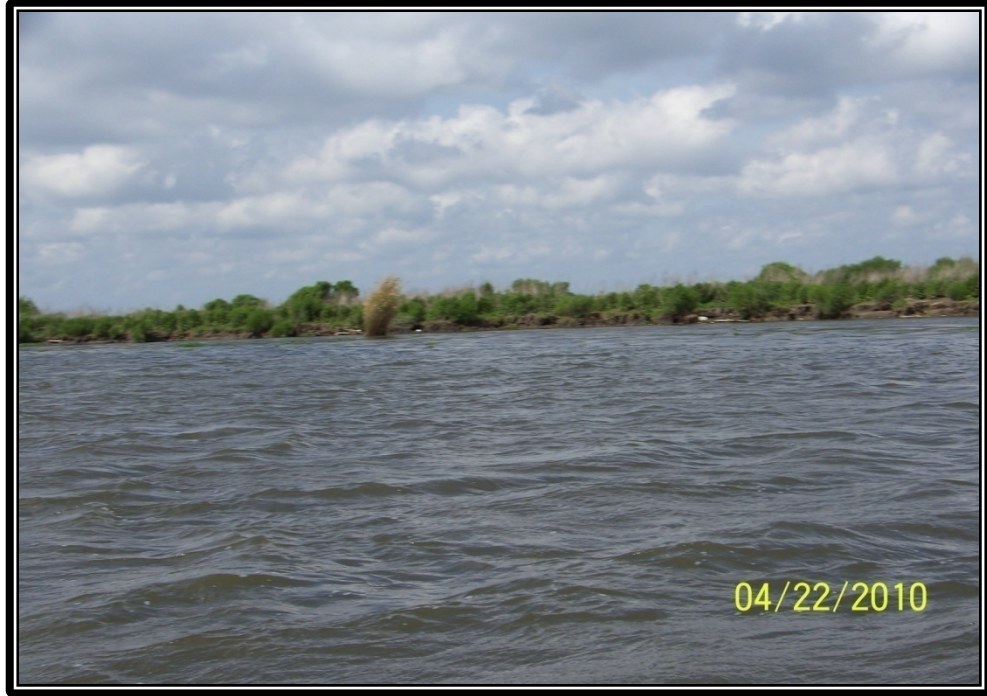
Photo No.43 – view of the existing bank line and marsh along the west bank of Jug Lake south of Structure 20.

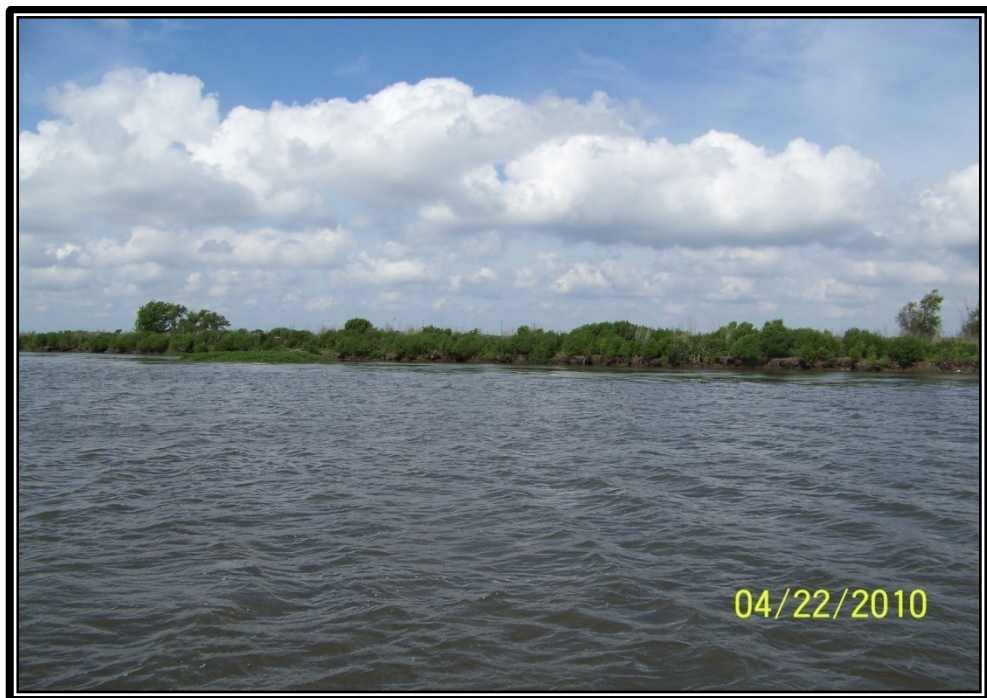
Photo No.44 – view of the existing bank line and marsh along the west bank of Jug Lake south of Structure 20.

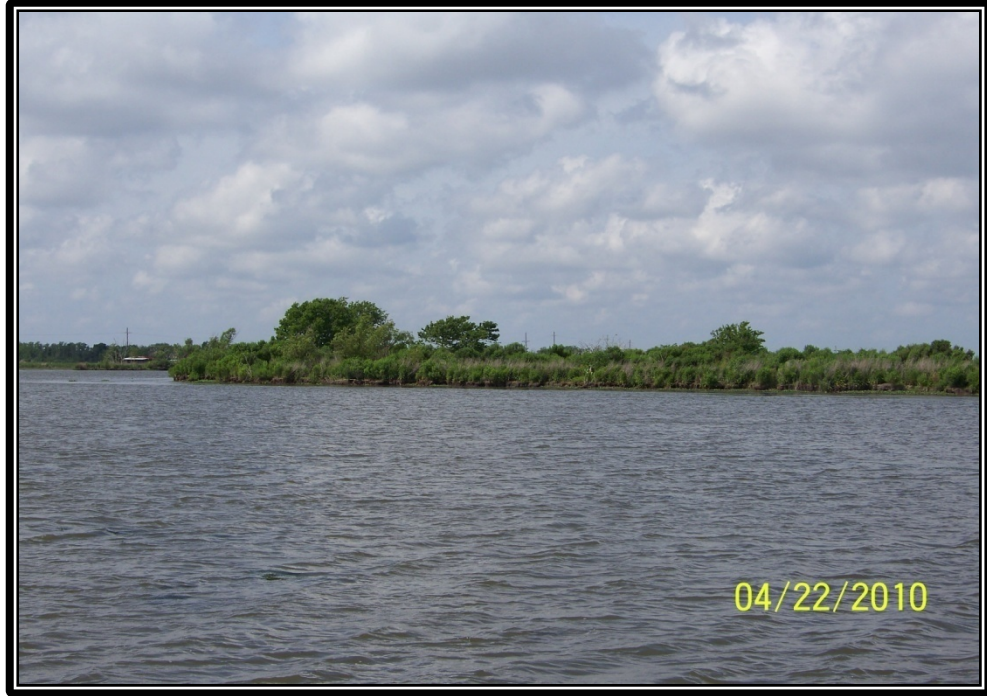
Photo No.45 – view of the existing bank line and marsh along the west bank of Jug Lake south of Structure 20.

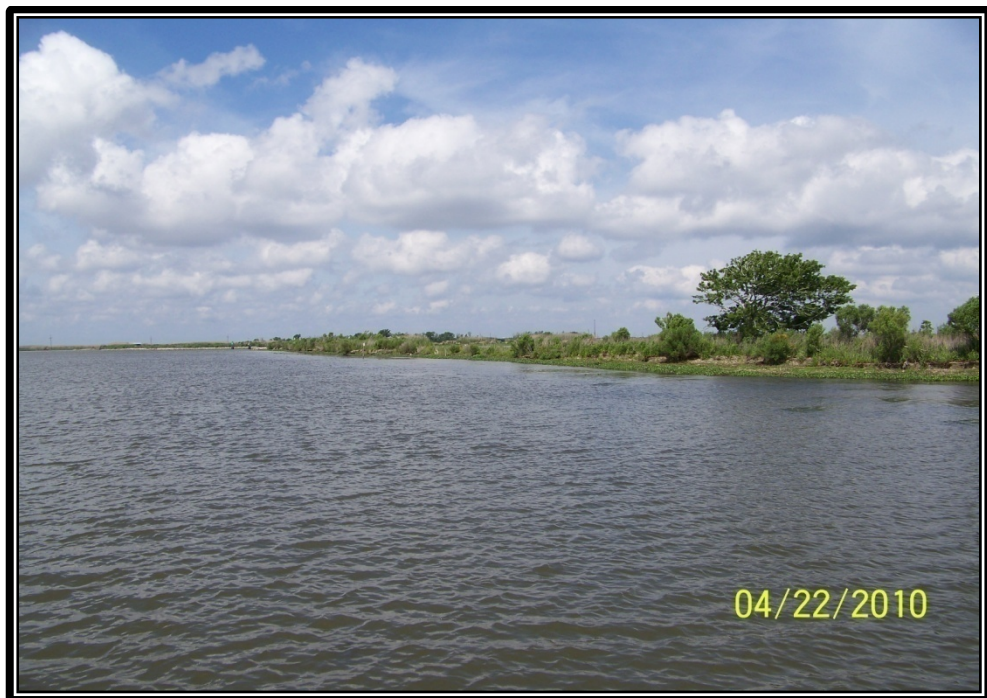
Photo No.46 – view of the existing bank line and marsh along the west bank of Jug Lake south of Structure 20.

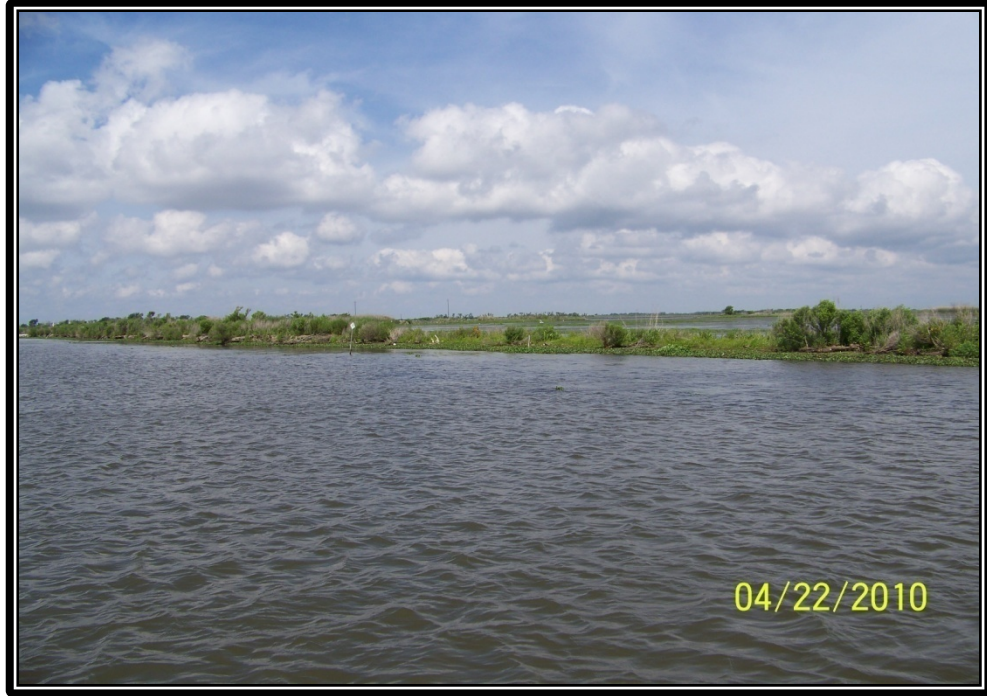
Photo No.47 – view of the existing bank line along the north bank of Jug Lake east of Structure No.6. This bank line appears to be low and will be added to the 2010 Maintenance Project for refurbishment.

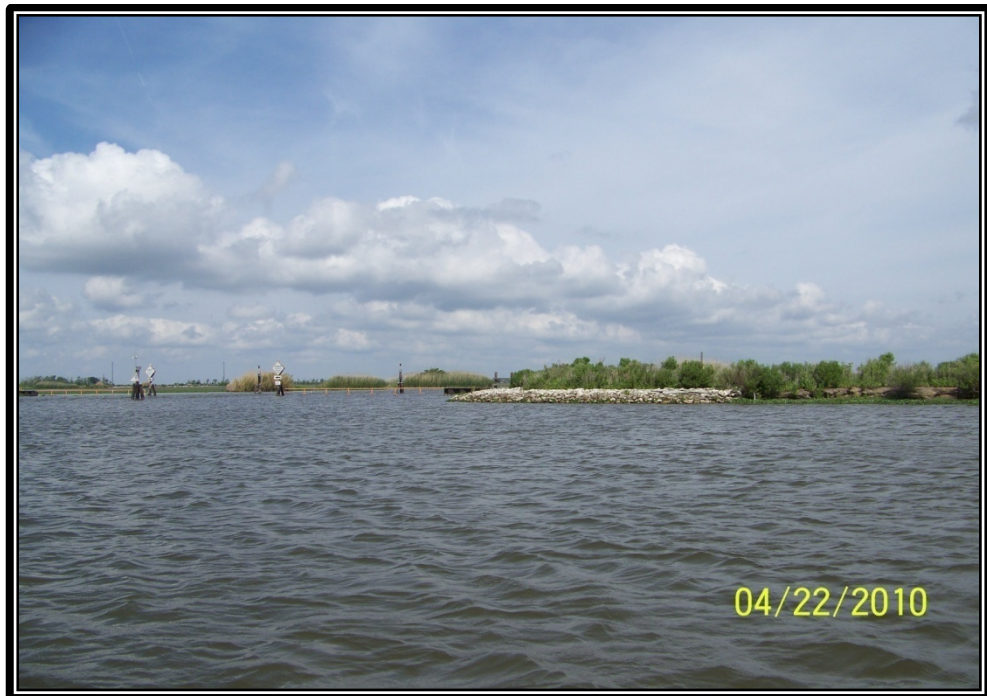
Photo No.48 – view of the fixed crest weir with barge bay and navigational aids at Structure No.6.

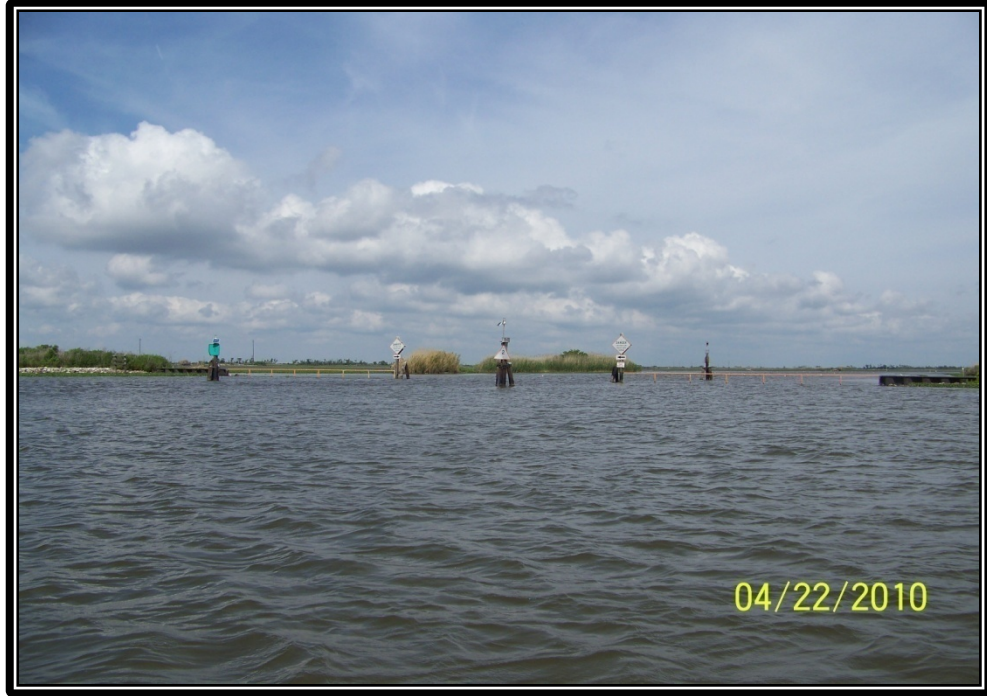
Photo No.49 – view of the fixed crest weir with barge bay and navigational aids at Structure No.6.

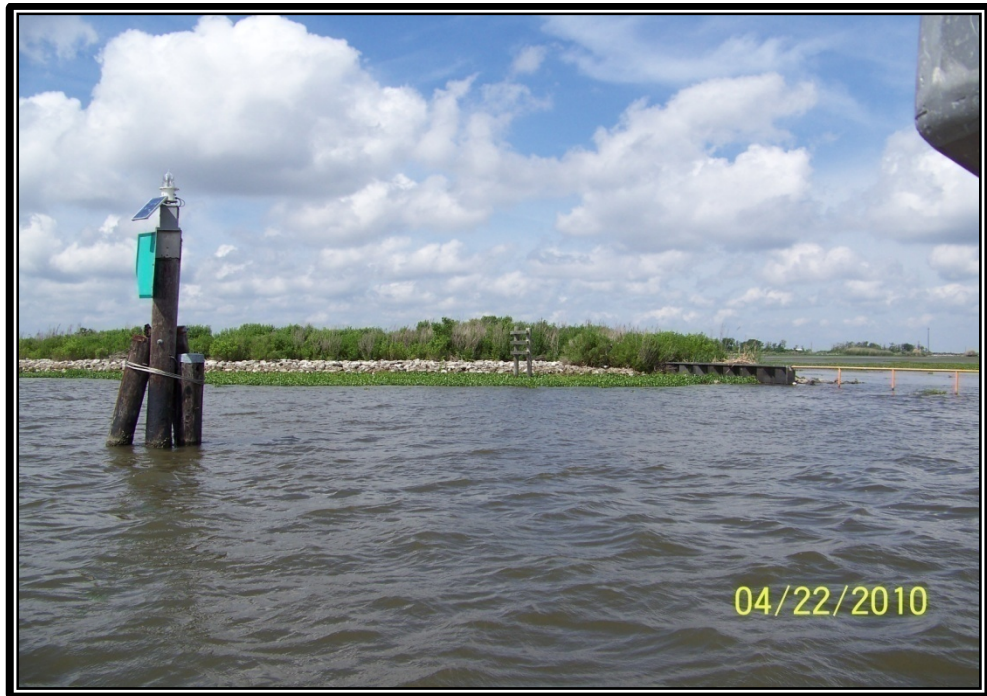
Photo No.50 – view of timber pile dolphin with navigational aid and the bank tie-in on the west side of the Structure No.6.

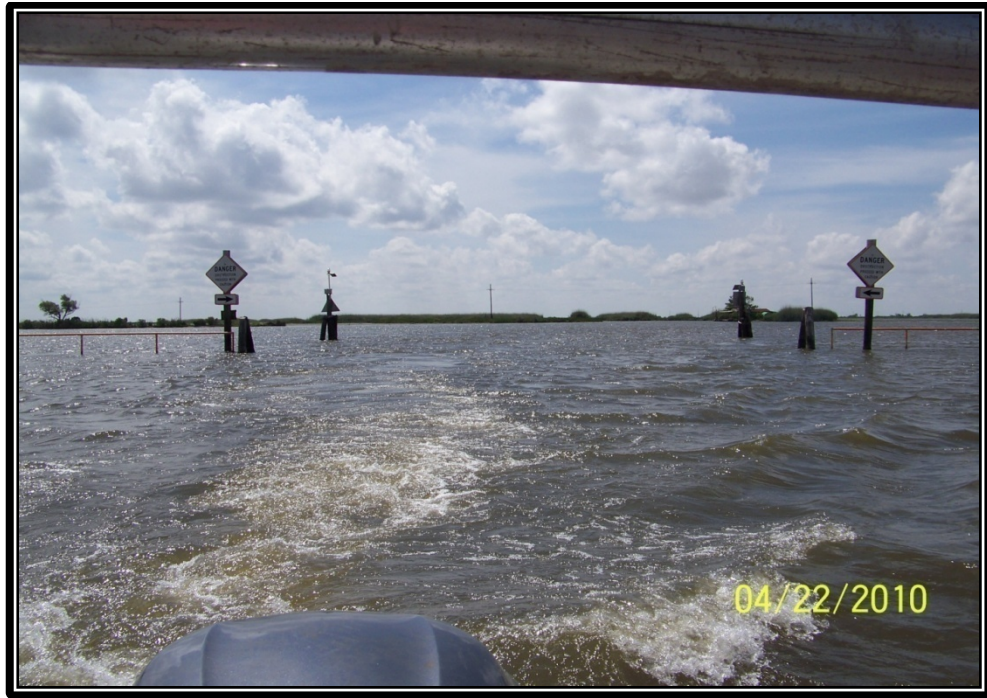
Photo No.51 – view of the fixed crest weir, warning signs and navigation aid structure at the entrance to the barge bay of Structure No.6 looking south.

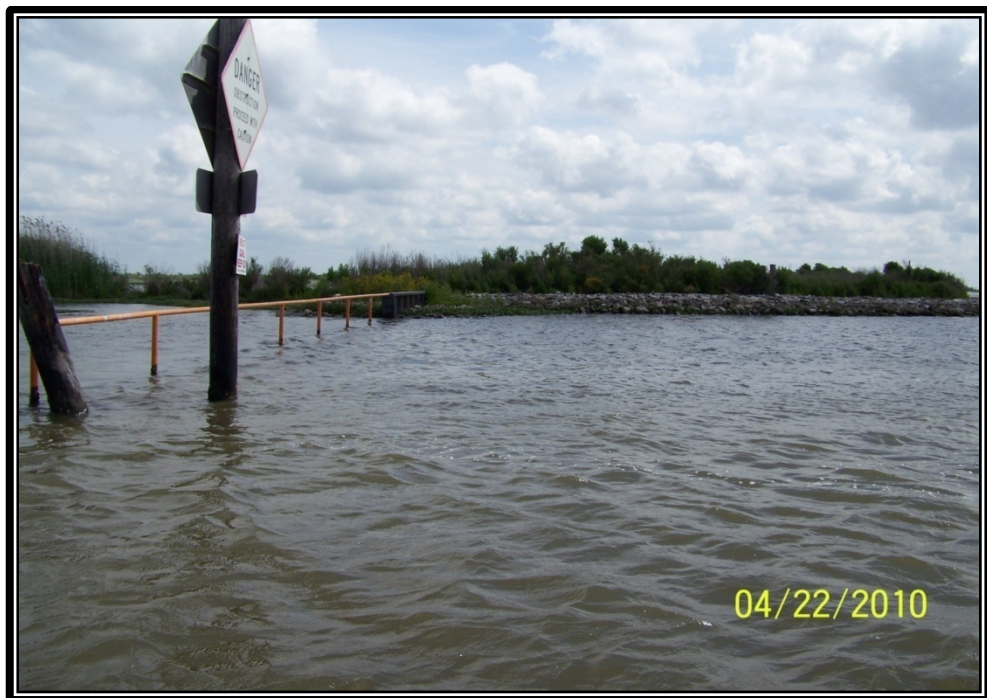
Photo No.52 – view of the fixed crest weir, warning sign and bank tie-in on the east side of Structure No.6

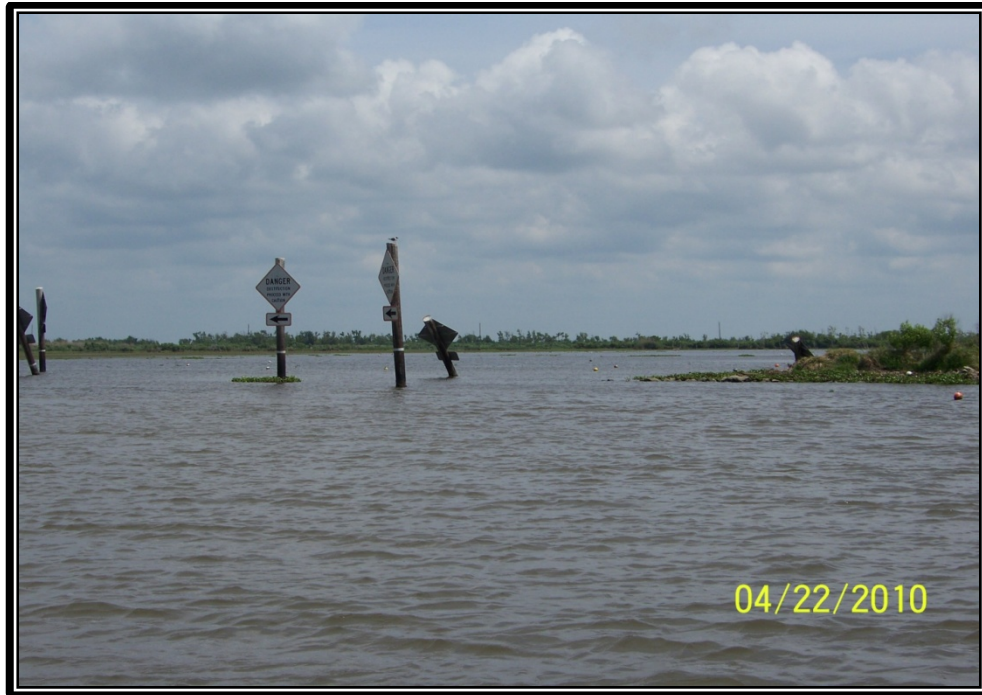
Photo No.53 – view of timber pile warning signs and the southern end of the rock riprap channel liner of Structure No.10. The timber piles that are leaning over were damaged during Hurricane Ike and will be repaired under the 2010 Maintenance Project.

Warning sign replacement shall include the removal of four (4) existing timber piles and signage and replacement with new material including timber piles, hardware and warning signs.

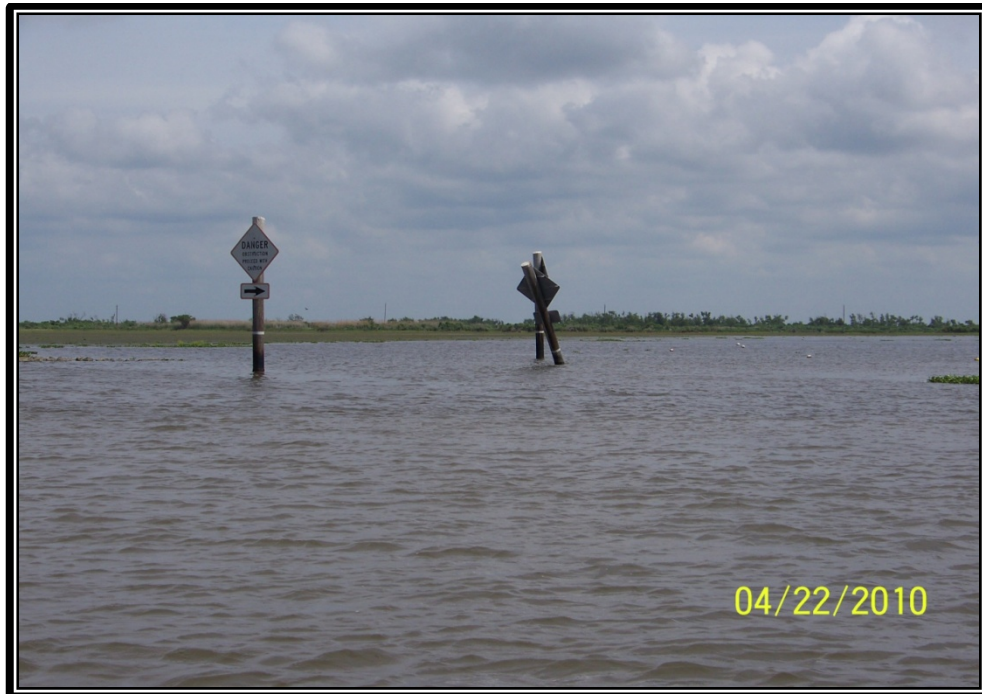
Photo No.54 – view of timber piles, warning signs and the rock riprap channel liner of Structure No.10. The timber piles that are leaning over were damaged during Hurricane Ike and will be repaired under the 2010 Maintenance Project.

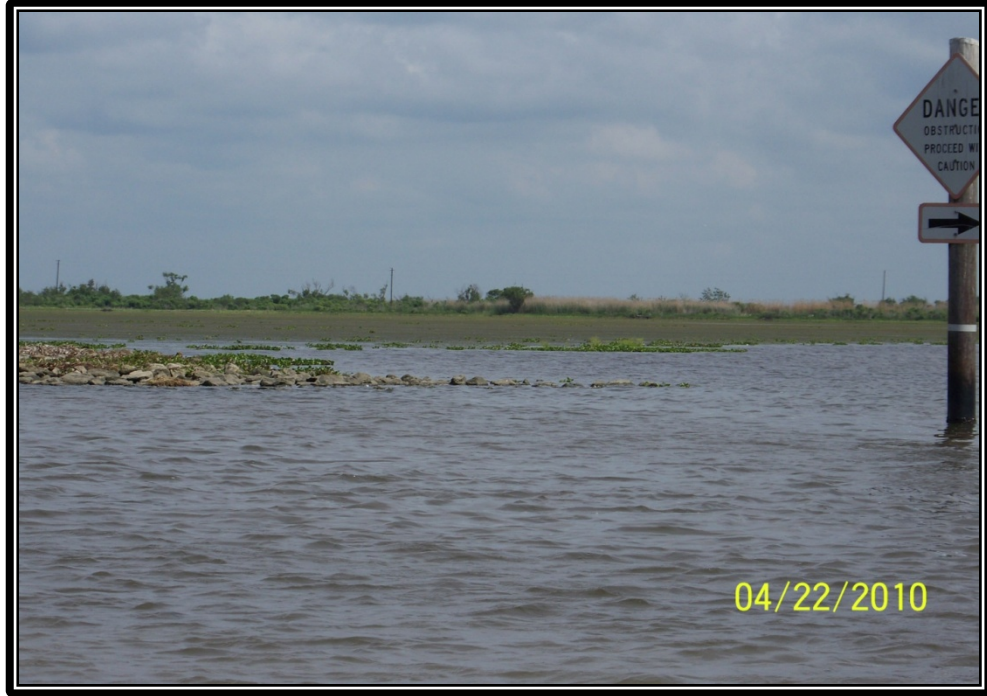
Photo No.55 – view of timber piles, warning sign and the northern end of the rock riprap channel liner of Structure No.10.

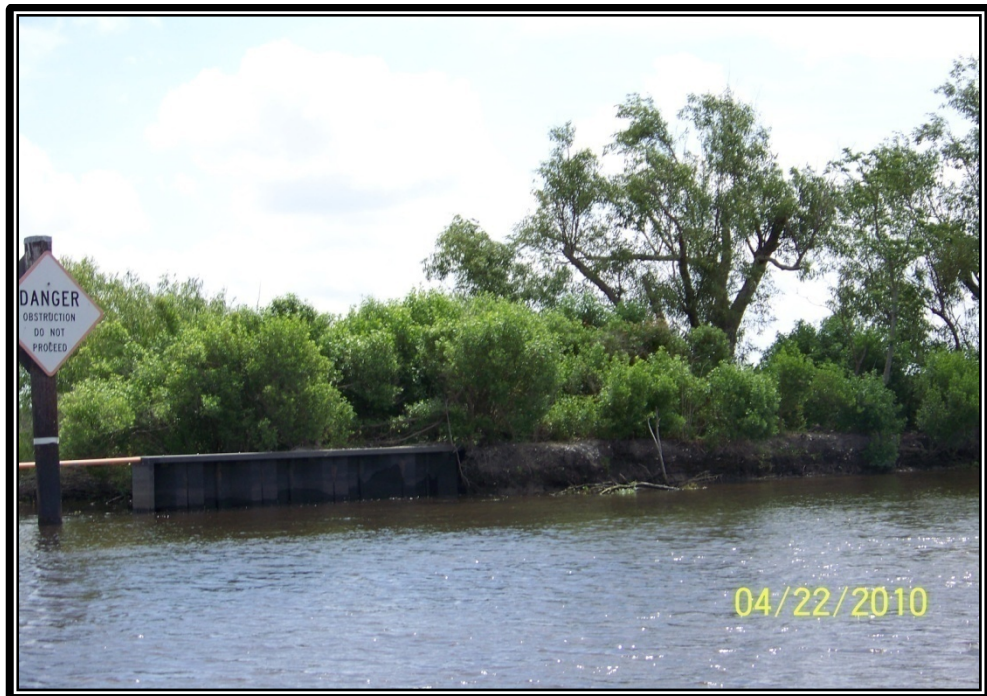
Photo No.56 – view of steel bulkhead and earthen embankment tie-in on the south side of Structure No. 14 along Bayou Carencro.

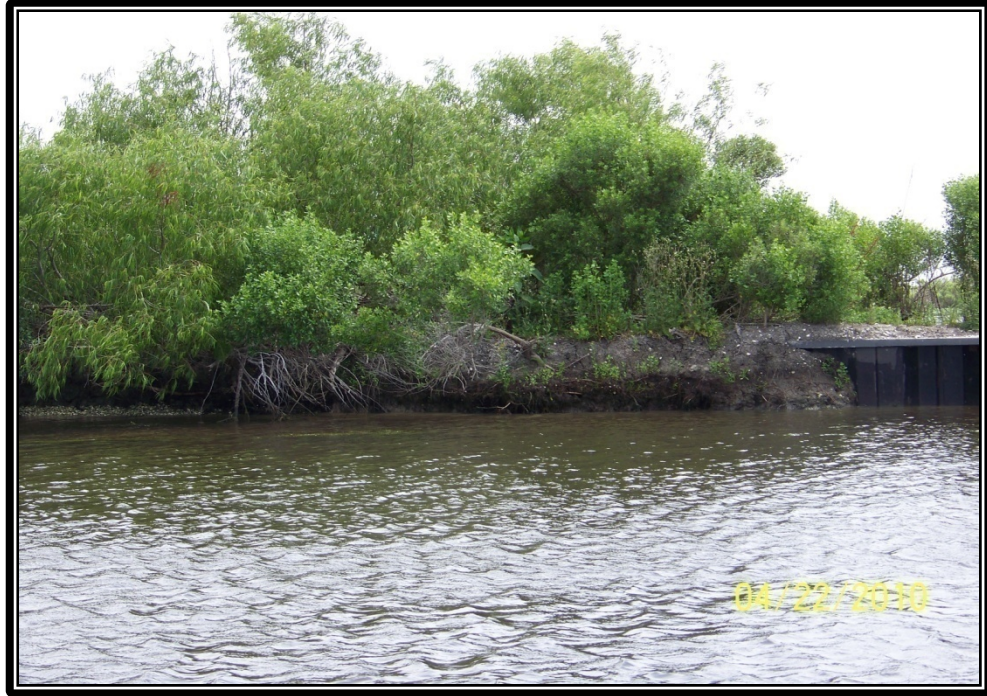
Photo No.57 – view of steel bulkhead and earthen embankment tie-in on the north side of Structure No. 14 along Bayou Carencro.

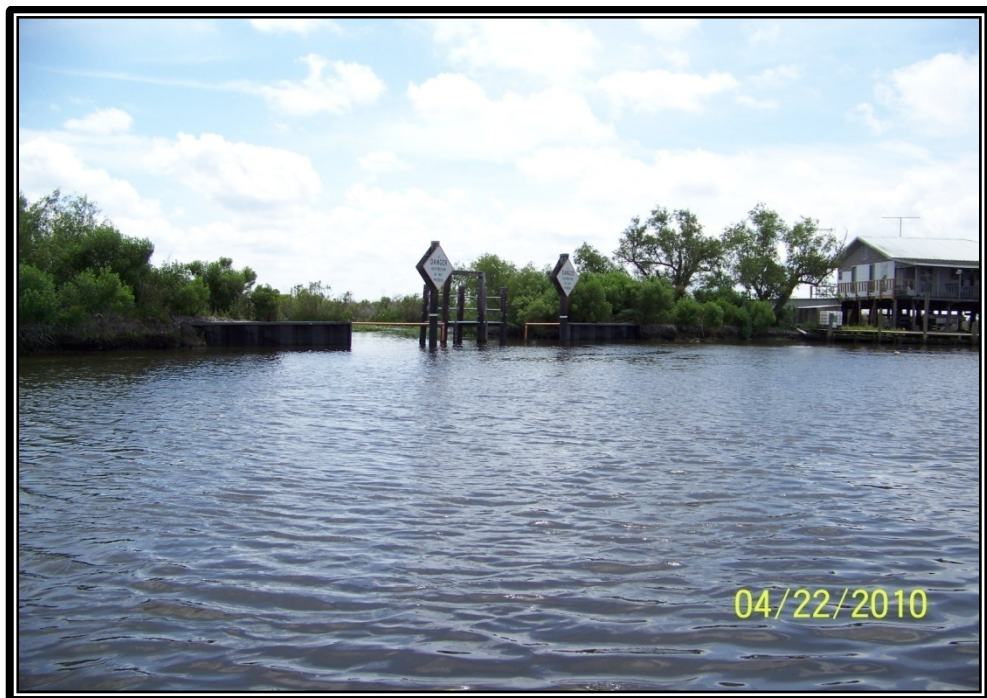
Photo No.58 – view of single bay variable crest weir Structure No.14 along the east bank of Bayou Carencro.

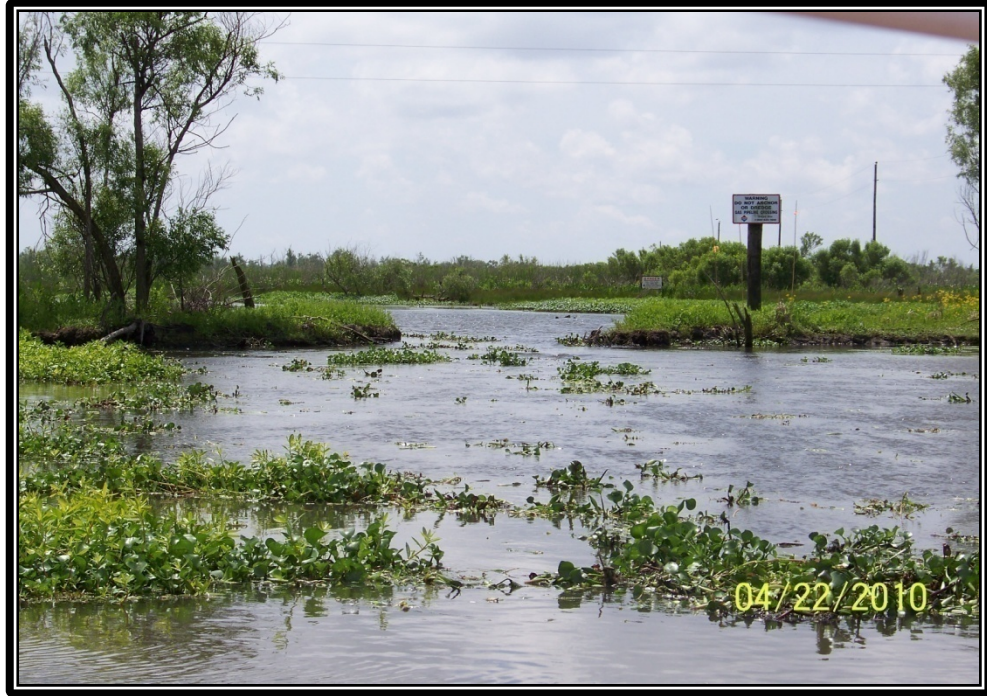
Photo No.59 – view of breach located along Brady Canal near the intersection of Carencro Bayou.

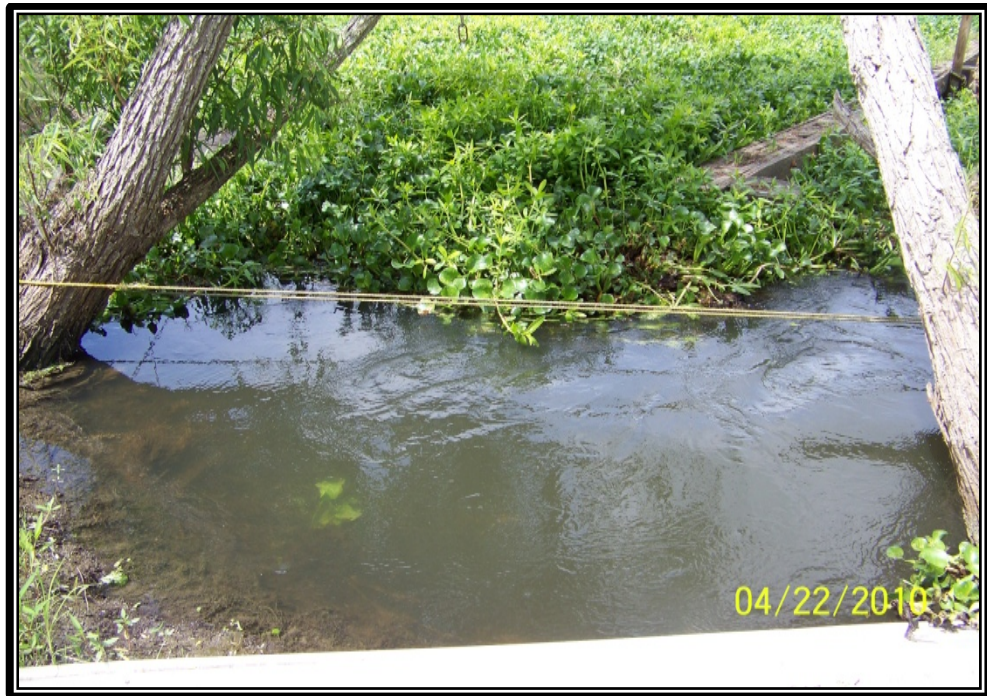
Photo No.60 – view of breach located adjacent to an existing bulkhead at the intersection of Brady Canal and Carencro Bayou.
