2009 Annual Inspection Report

Fritchie Marsh Restoration

State Project Number PO-06
Priority Project List 2

July 1, 2009
St. Tammany Parish

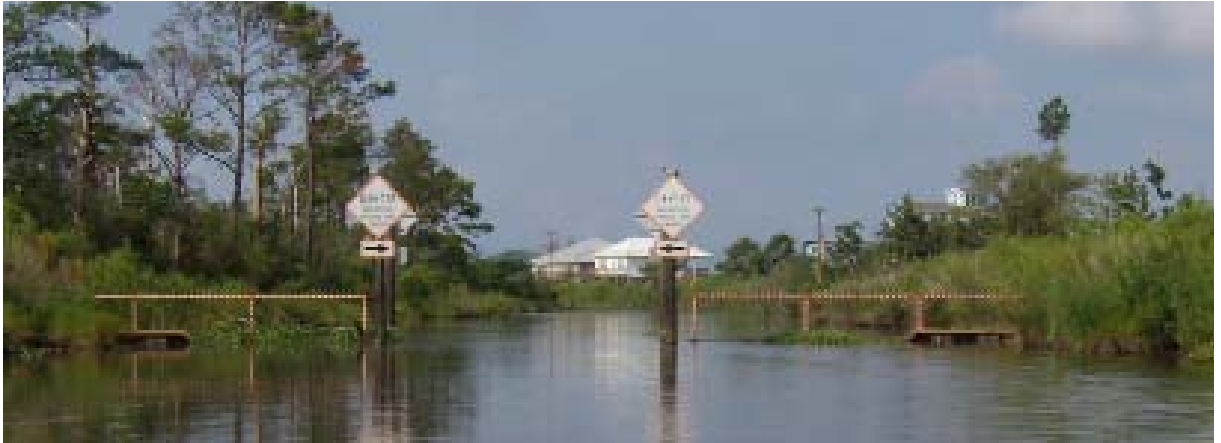
The W-14 Weir is in excellent condition as shown in the photographs below. There is some deterioration of the coal tar epoxy paint on the sheet piling and some limited rusting of the sheet pile cap; however this is

minimal. The galvanized pile cap, railings, and signs are in good condition. No maintenance is necessary on this structure.

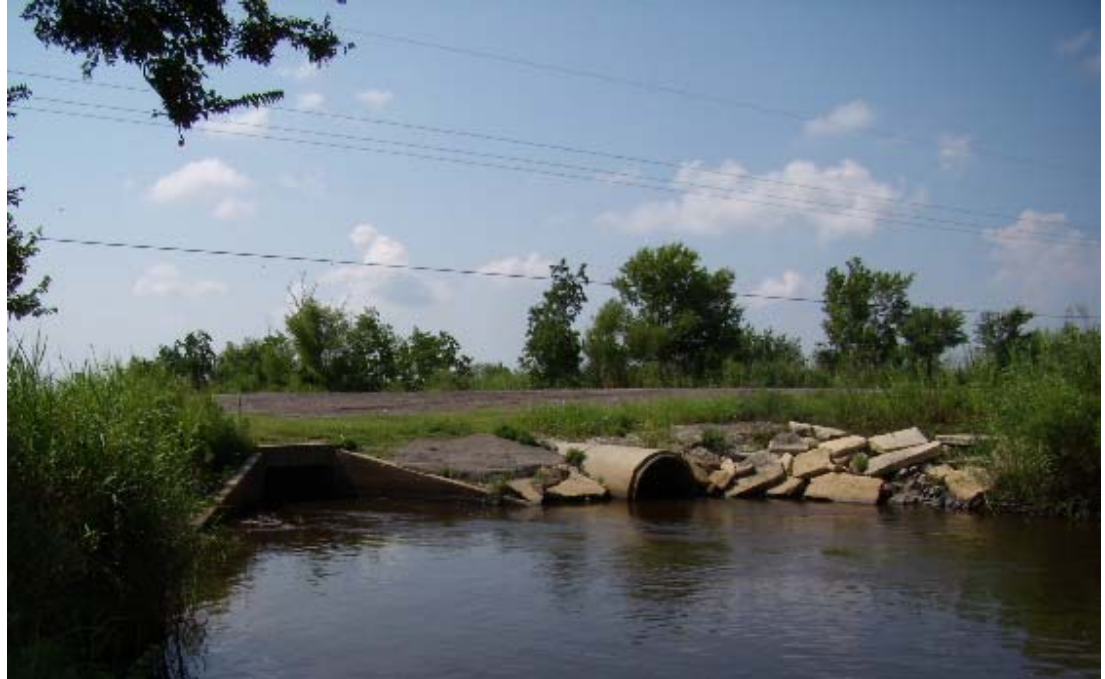
WEST END of RCP Pipe @ Hwy 90

From visual observations, it appears that the 60" RCP bored under US Highway 90 is stable and has not experienced any movement since construction was completed. Rubble (broken concrete) has been placed on the west side of the structure as shown in photograph below; however the structure appears stable. No maintenance is recommended.

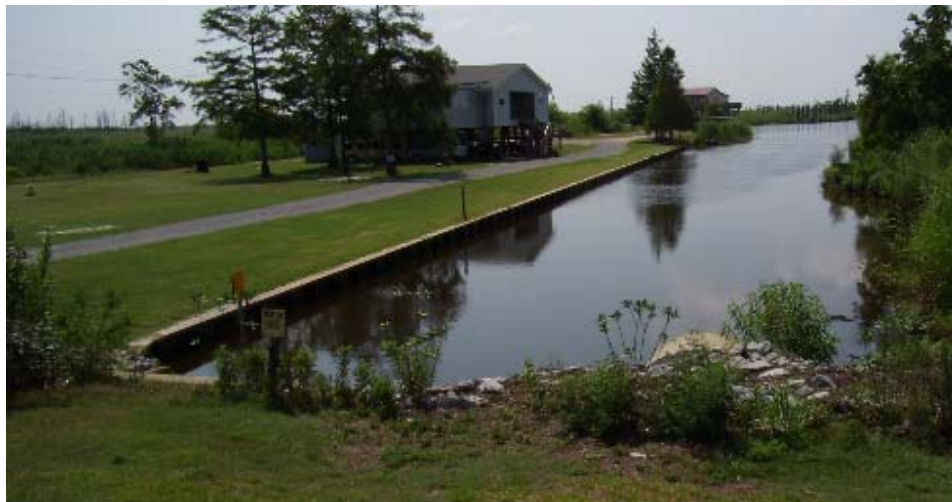
From visual observations, the bulkhead on the east side of Hwy 90 on the north side of Salt Bayou is in excellent condition. There is no evidence of movement of the bulkhead and the sheet piling and cap are in good condition. No maintenance is recommended.

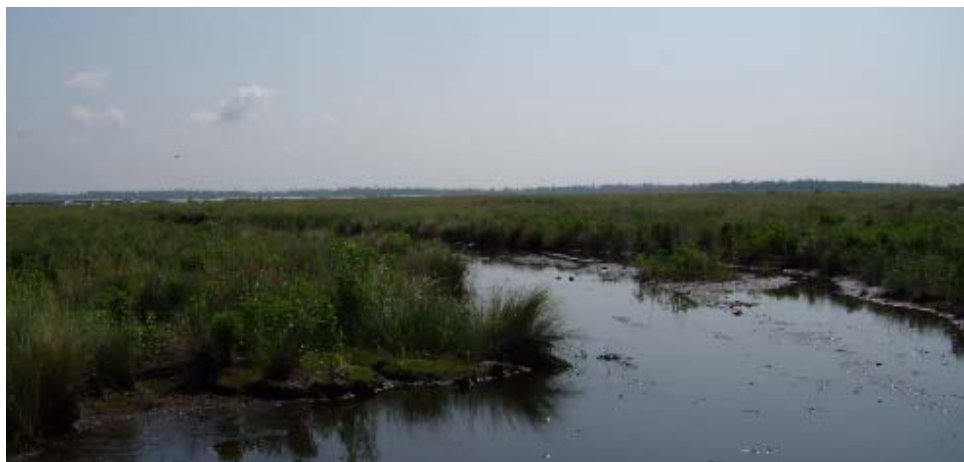
SATL BAYOU @ SB2 FACING EAST

There are considerable segments of Salt Bayou that are nearly completely silted in. Attachment 1 indicates several way points that were taken along Salt Bayou that will be referenced below.

Moving from west along Salt Bayou from Hwy 90, the channel section is near the original excavated section up to the waypoint SB6. There are two significant cuts in the bayou bank to the south within this reach. It was observed that significant flow was moving out of Salt Bayou into the open water areas south of the bayou at each of these cuts. From waypoint SB6 moving westward, the channel continues to shallow until at waypoint SB7 the bottom elevation of the channel is -1.5'. From SB7 the channel continues to shallow until SB3 where the channel has basically completely silted in (no water depth). This continues from SB3 to SB2. The channel begins to deepen west of SB2 until a bottom elevation of -2.5' was measured at SB8. The channel continues to deepen toward the west, and a bottom elevation of -4.2' was measured at SB9. SB-9 is also the location of a CRMS station, and the water elevation was measured on the staff gage at the station at elevation +0.5' at the time of the site visit.

Since it appears the original project objectives of moving water into the marsh along Salt Bayou is still being met, and the uncertainty of the proposed project to the north, it is recommended that no action be taken regarding Salt Bayou at this time.

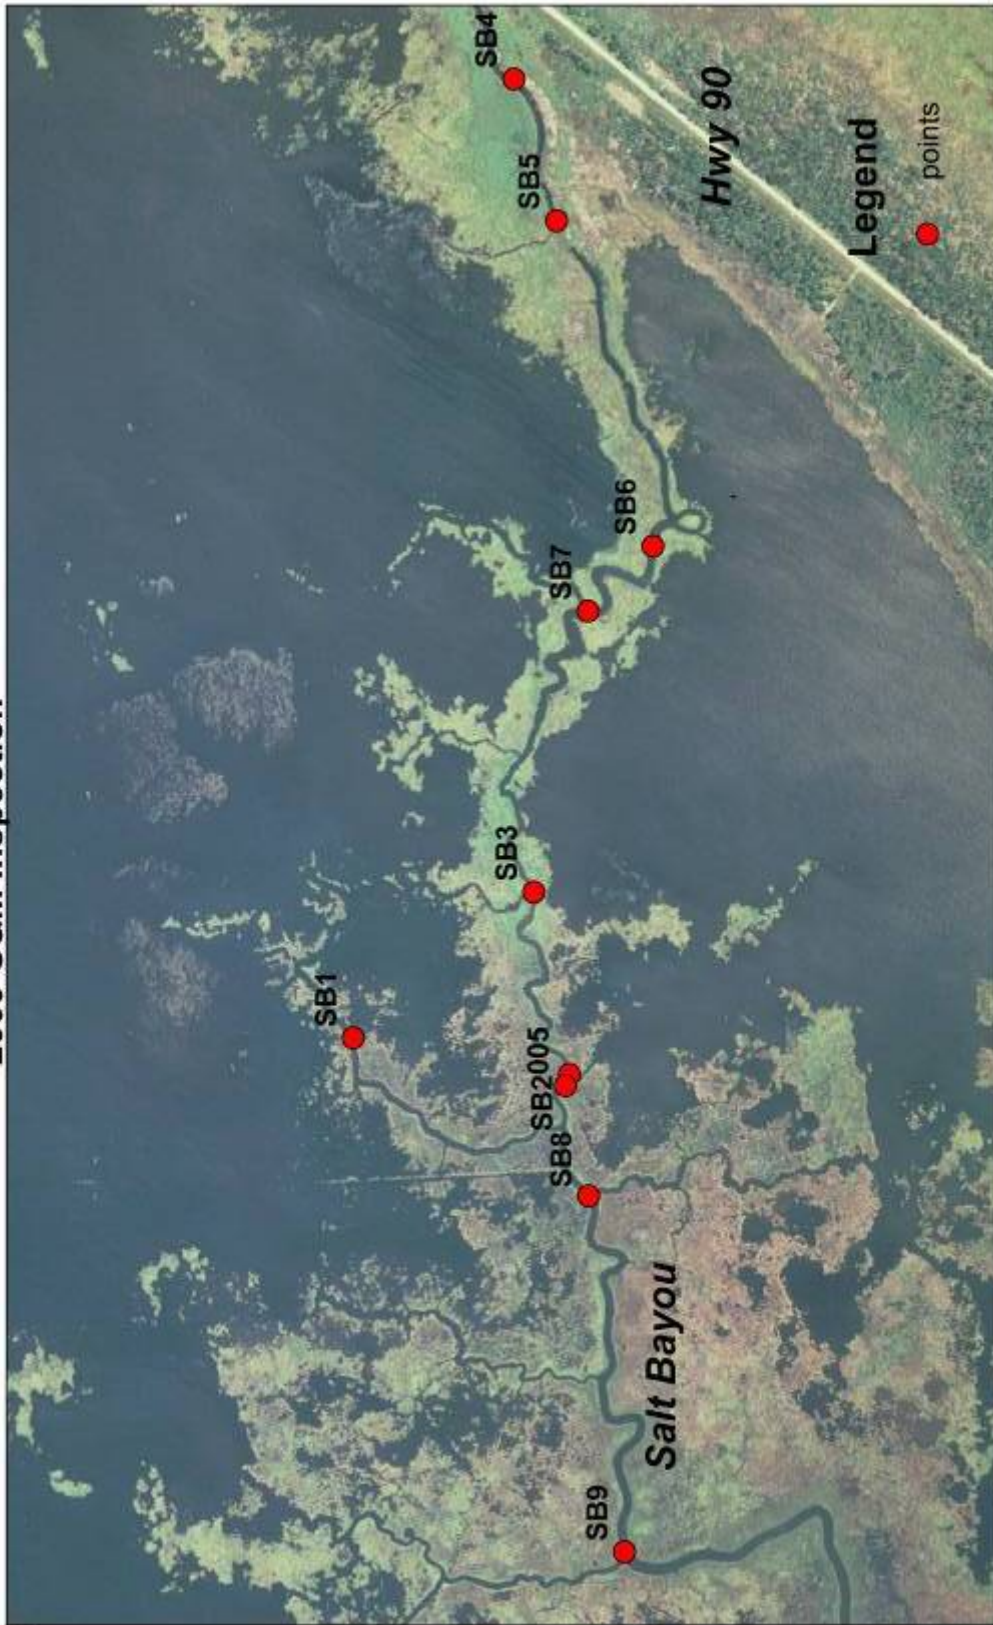
ATTACHMENT 1

One of the main concerns is the condition of Salt Bayou. The original intent of the project measure where Salt Bayou was excavated west from Hwy 90 approximately 5000' was to allow for greater inflow from the east. The water was intended to flow into the marsh areas adjacent to Salt Bayou, and not flow straight through Salt Bayou to Lake Ponchartrain. Even though segments of Salt Bayou are completely silted in, it appears the project intent is still being met. From the field observations, it appears that a significant amount of flow from Salt Bayou is moving through the broken marsh to the south of the bayou in the areas around SB 6 and SB7. The water seems to be re-entering Salt Bayou from the south around SB8.

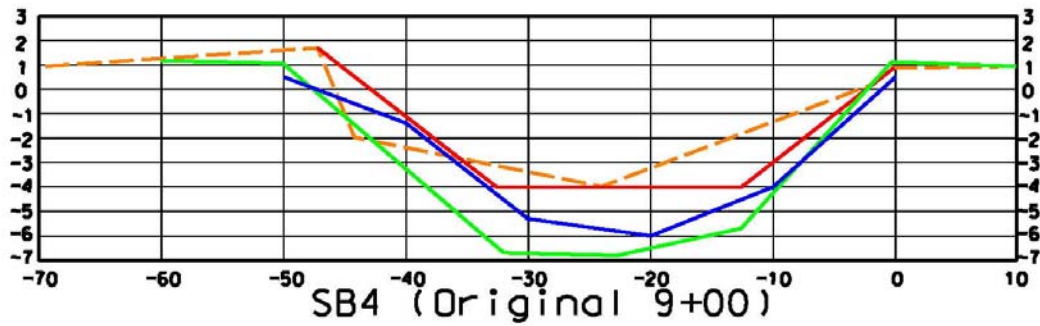
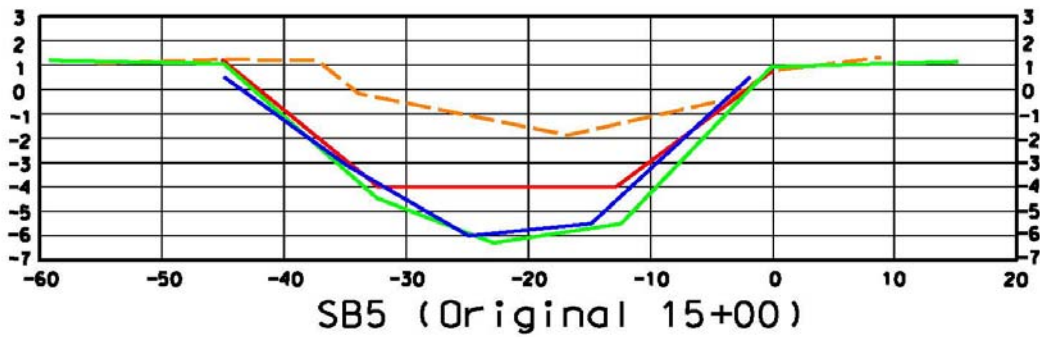
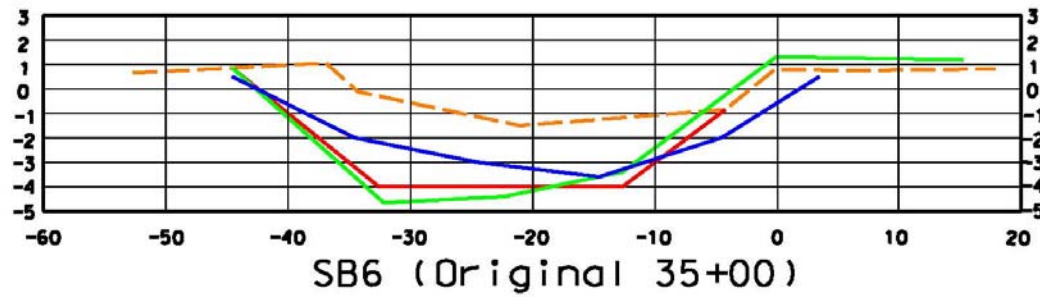
SALT BAYOU CROSS SECTIONS (7/9/09)

The original channel excavation extended from the west side of Hwy 90 to location identified on the map as SB3. The original excavation was planned for 20' bottom width at elevation -4.0' and 2.5 horizontal to 1 vertical side slopes. Attachment 2 shows three cross sections that were taken during the site visit compared to the original design and as built sections.
