# **2009 Annual Inspection Report**

## **Hopedale Hydrologic Restoration**

State Project Number PO-24  
Priority Project List 8

July 1, 2009  
St. Bernard Parish

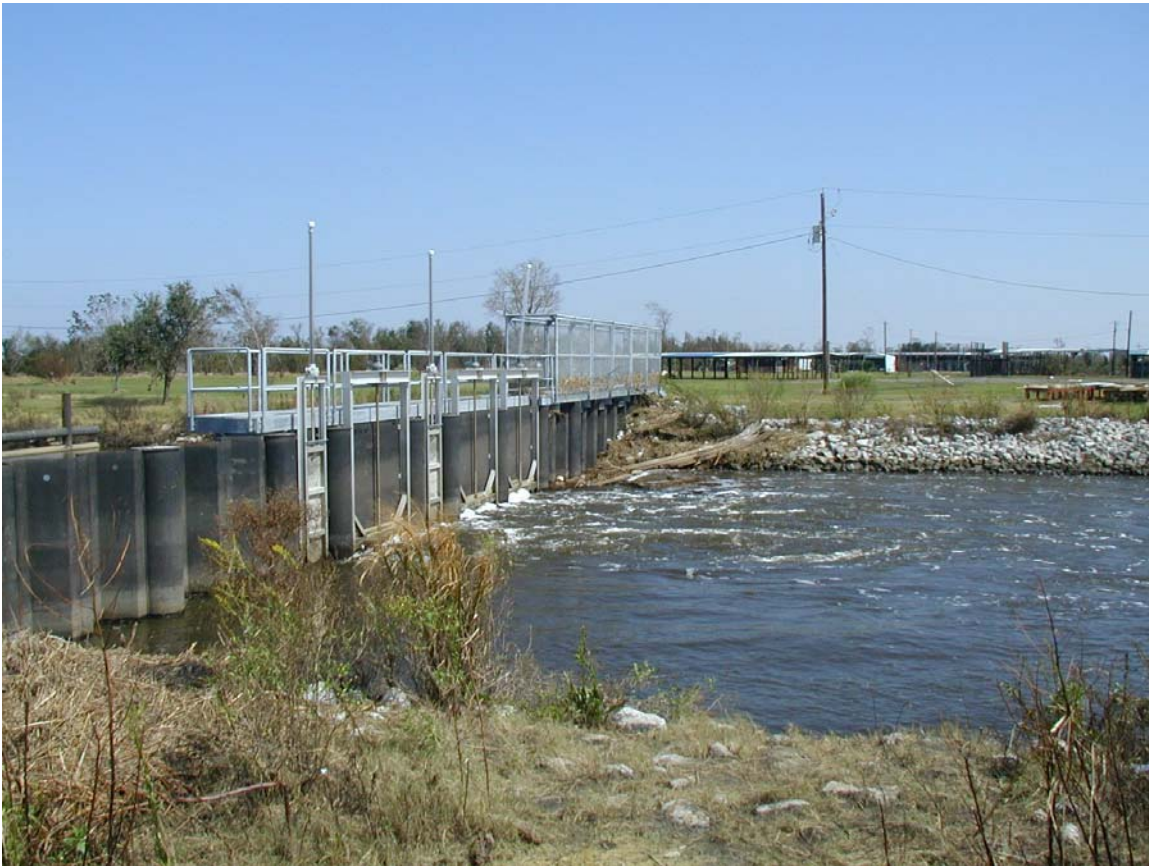
**Photo #1 – Water Control Structure.**

The fish gates were opened at the time of the inspection in accordance with the Operation and Maintenance Plan. The flow through the project structure was generated from an approximated 1.0 ft. of head. The damage to the structure was minimal and consisted of two missing vinyl gate stem covers.

Item	Condition	Pysical Damage	Corrosion	Photo #	Observations and Remarks
Swing Gates 84" D	Good	None	None		
Fish Gates 24" x 84"	Good	None	None		
Handrails Grating Hardware etc.	Good	None	None	1	Two gate stem covers missing.
Galv. Pile Caps	Good	None	None		
Signage /Supports	Good	None	None		
Riprap	Good	None	None		
Silt/Fill	Good	None	None

- Replace two vinyl gate stem covers.
