Coastal Protection and Restoration Authority of Louisiana

2009 Annual Inspection Report

Jonathan Davis Wetland Protection

State Project Number BA-20
Priority Project List 2

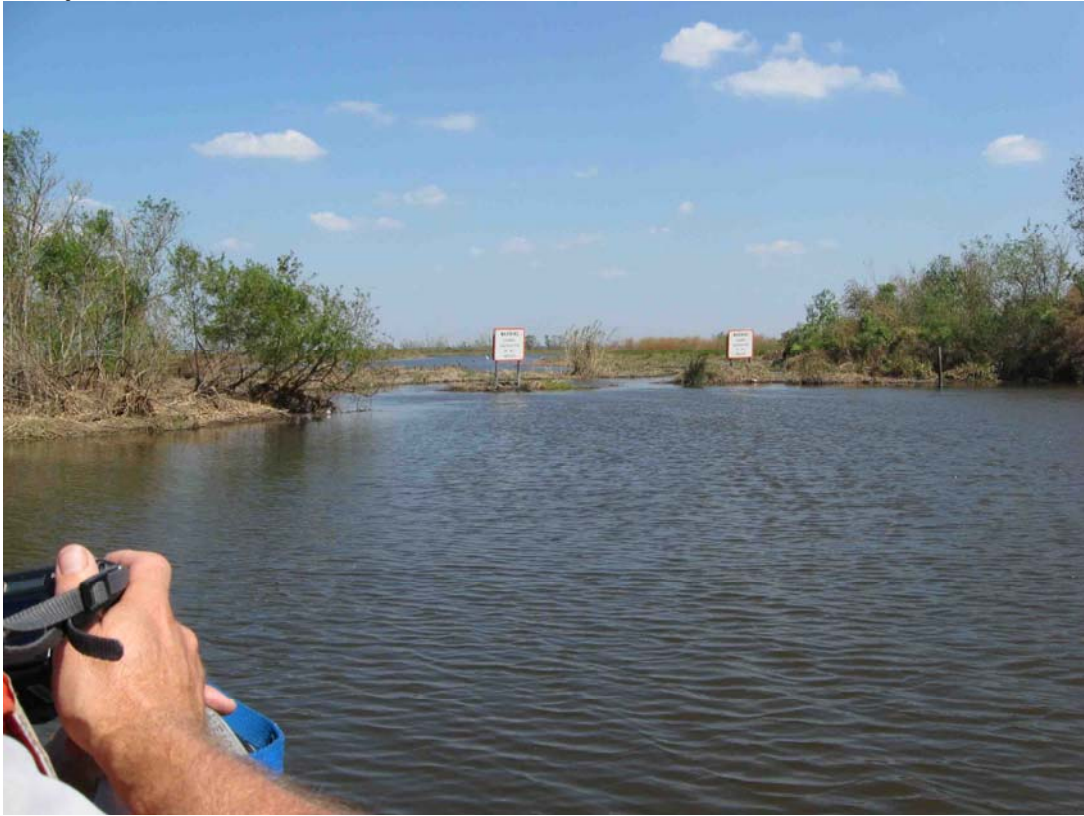
Photo #1 – Structure #14 (Note Gaps)

Upon a visual inspection, we noticed a large breaches on the west side of the structure and in the center or the structure. (Photo #1). Due to poor soil conditions, this structure has experienced significant settlement problems since the time it was constructed. Several attempts were made during construction to stabilize the structure by placing several lifts of rock, but the structure continued to settle. It is agreed that this structure requires maintenance work.

- The repairs noted at each structure will be included in the plans for Construction Unit 4 if funding is available after the CU4 contract has been awarded; otherwise a future maintenance event will be scheduled to complete this work.

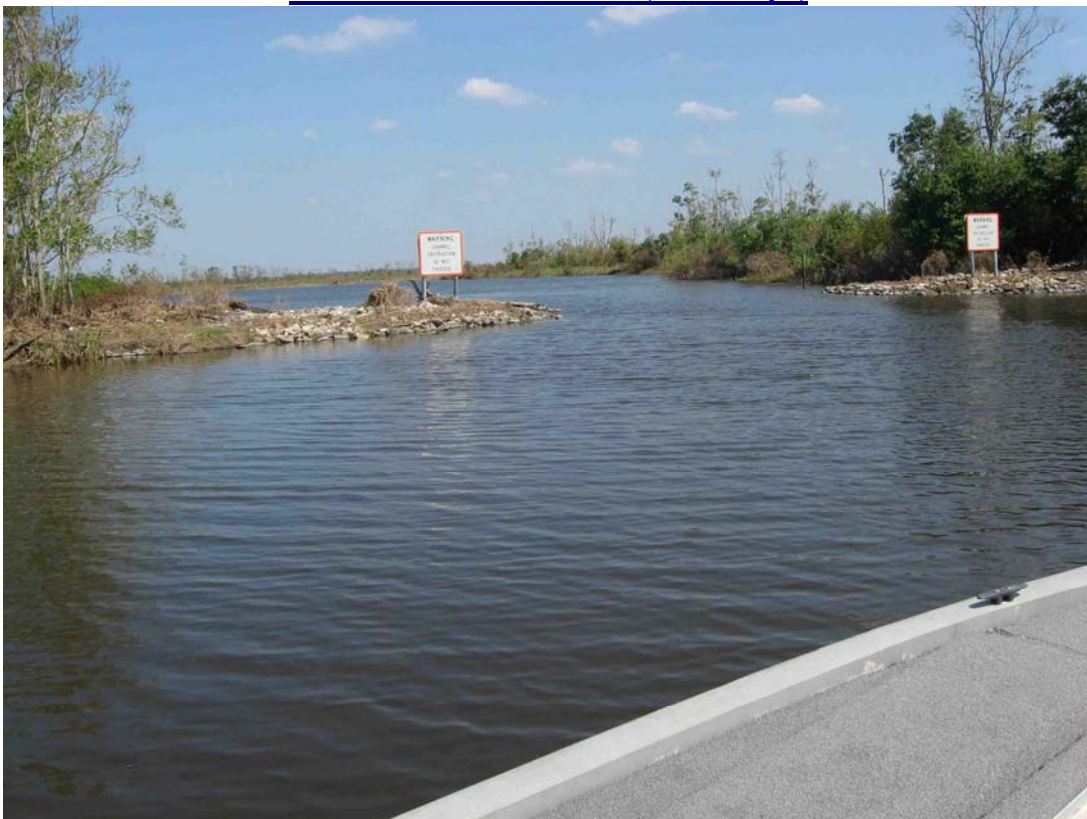
Photo #2 – Structure #15

Structure 15 appeared to be in good condition at the time of the inspection with little or no noticeable settlement of the rock weir (Photo #2). Signs and supports were also in good condition. The original design of this structure was modified to include a boat bay to accommodate oilfield activities and navigation on the interior marsh of the structure. This structure will be modified during a future maintenance event so that it represents the original design more accurately.

Item	Condition	Physical Damage	Corrosion	Photo #	Observations and Remarks
Signage and supports	Good			2	Observations: There have been no changes since the last inspection. The work to be done through the CU4 Construction Contract has not been completed due to contract issues.
Armored Plug	Good			2	
Rock weir	Good			2	Remarks: The original design of this structure was modified to a rock weir with boat bay to accommodate oilfield activities and navigation on the interior of the structure. During above mentioned maintenance this structure will be converted to a rock
Earthen Embankment	Good			2	
Construction Unit No.1 Structure Description: 132 linear ft. of rock rip-rap armored weir with a 50 ft. wide boat bay located in a pipeline channel north of Bayou Perot, west of Bayou Barataria and east of the GIWW and Site 14. The crest of the rock weir was constructed to an elevation of +4.0 ft. NGVD. The invert of the boat bay is at and elevation of -3.0 ft. The rock filled weir contains 1,248 tons of rock fill with and 728 tons of rock rip-rap armor. Two (2) aluminum warning signs are located through the rock armored embankment on each side of the boat bay.

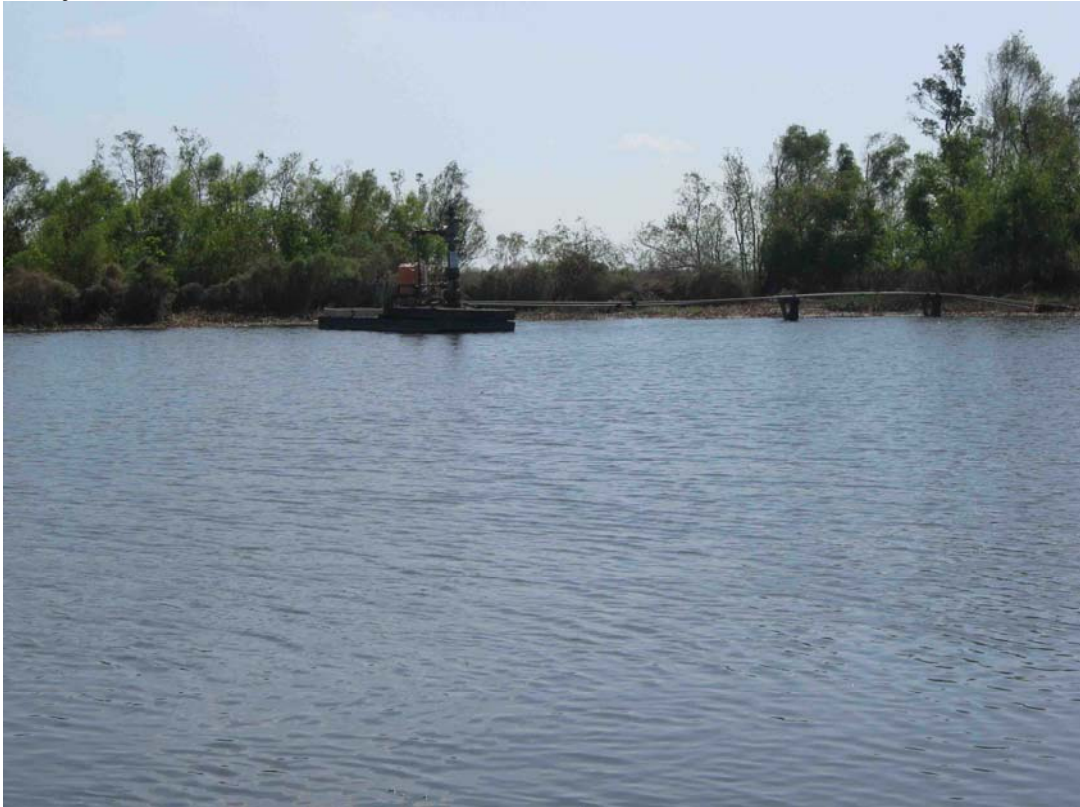
Photo #3 – Structure #16

Structure 16 appeared to be in good condition with exception of a low area on the south side of the channel plug (Photo #3). Maintenance work is required at this structure.

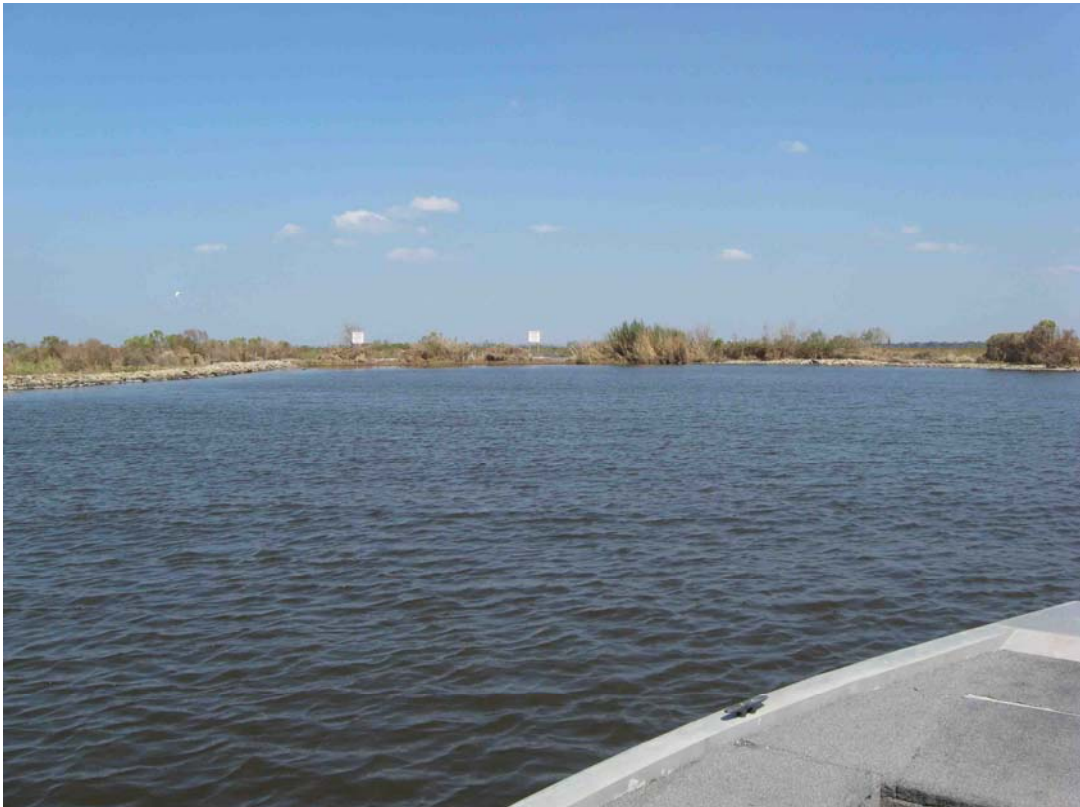
Photo #4 – Structure #20

The structure appeared to be in good condition with no signs of settlement of the rock weir. The warning signs and supports were also in good condition. (Photo #4) NRCS and OCPR agree that this structure will not require maintenance.
