**State of Louisiana
Office of Coastal Protection and
Restoration
Operations Division**

2009 Annual Inspection Report

**CAERNARVON OUTFALL
MANAGEMENT
(BS-03a)**

August 5, 2009
Plaquemines Parish

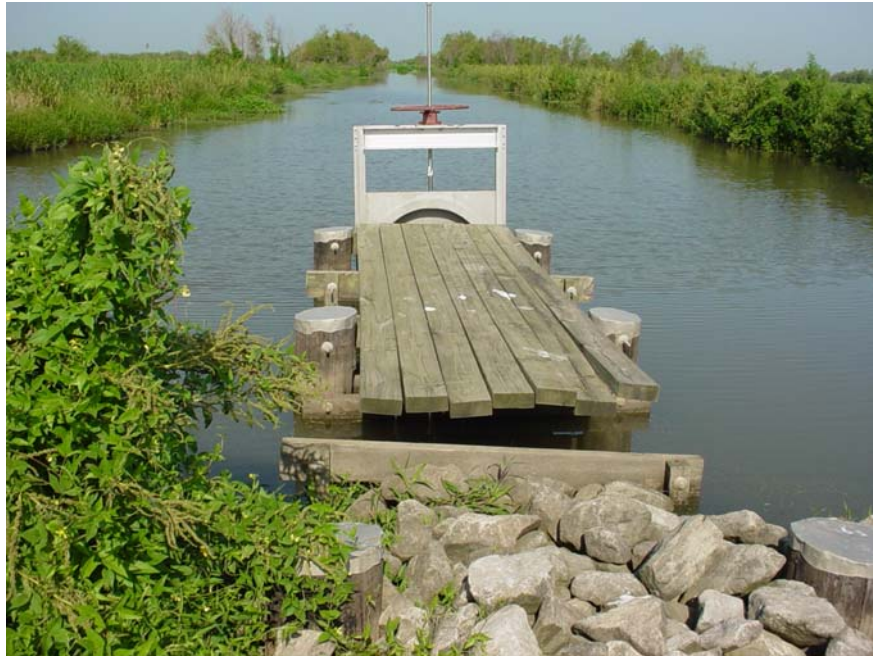
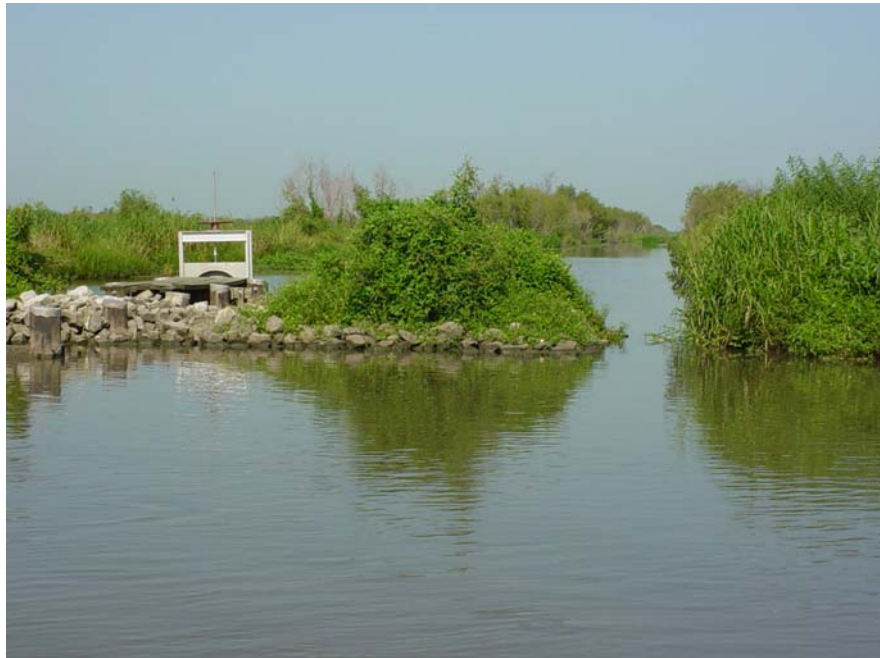
- A. Site/Structure # 13** – Water is moving into the marsh where it appeared that a few rocks were still displaced on the north end of the closure accented by some scouring of the embankment at the tie-in. This gap in the closure allows water to flow freely in and out of the project area at that point. The combination gate was in the up/open operating position to allow maximum uninterrupted tidal exchange into the marsh. The plan is to place the combination gate in the down/closed position and allow the flap gate to automatically control the marsh side water levels. The timber walkway still lays separated from its support beam at one end. (See Photo 1 & 2)

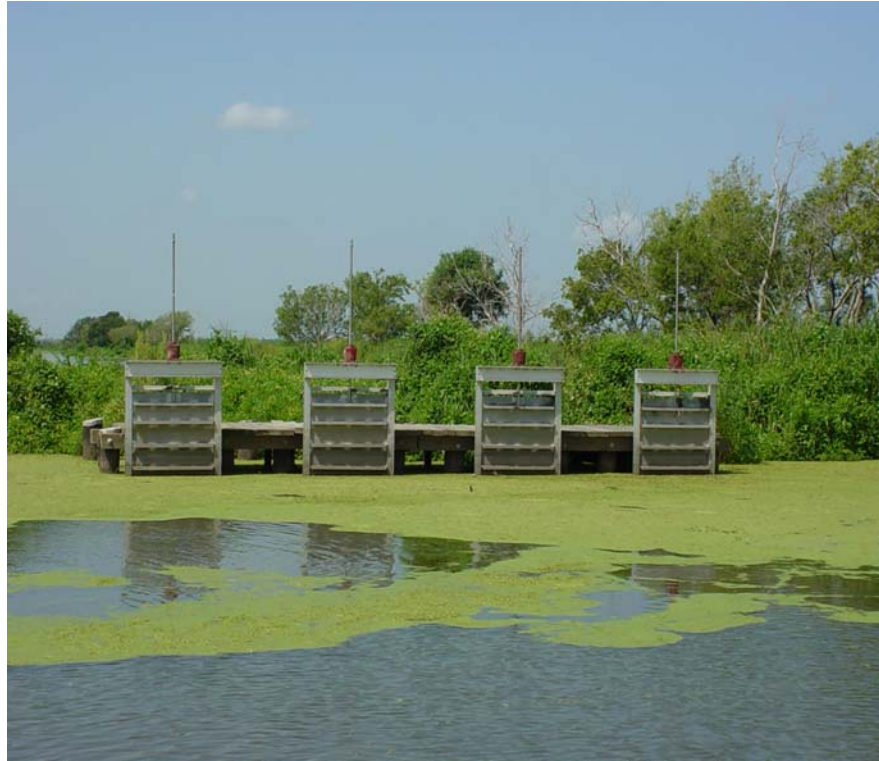
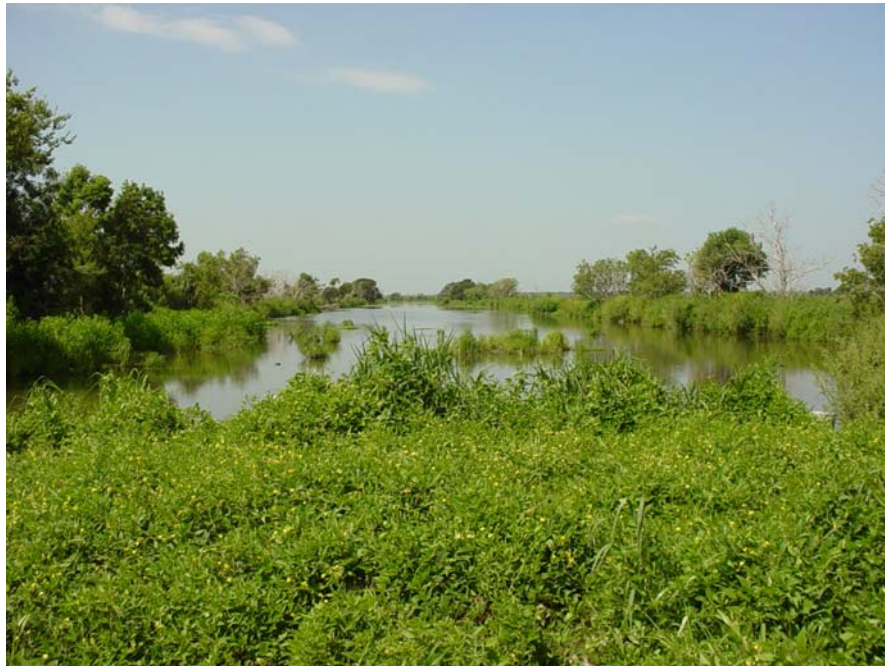
- C. Site/Structure # 26** – The structure has been completely cleaned of any storm debris since the last inspection by the O&M contractor. The gates were in the open position and water flow was visible despite the low diversion flow rate and the partial blockage in the Delacroix Canal. It was evident that no structure blockage remains from the storm debris. Like all other canal closures, heavy seasonal vegetation (deer pea) covers the earthen/rock closures that house the culverts. (See Photo 3 & 4)

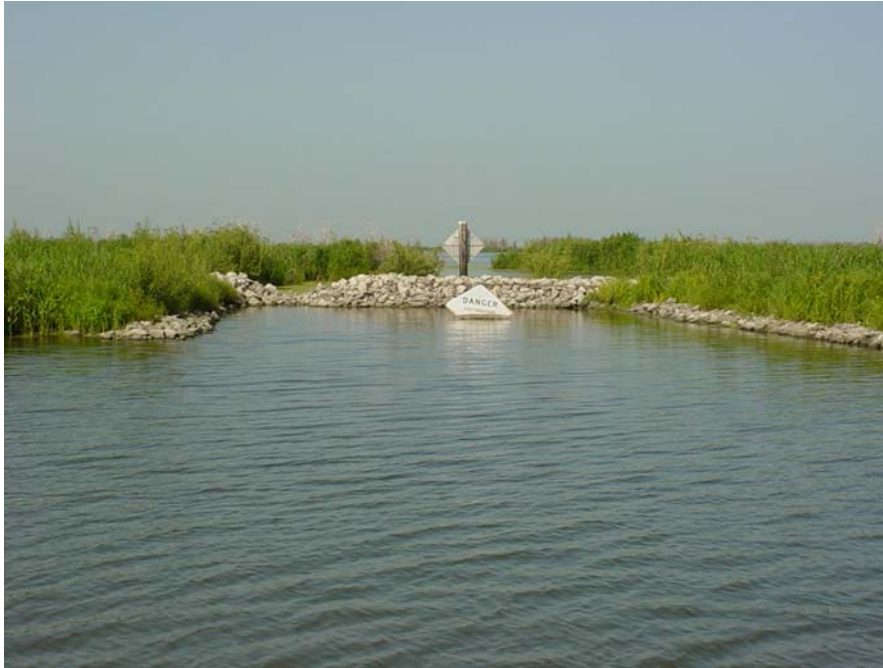
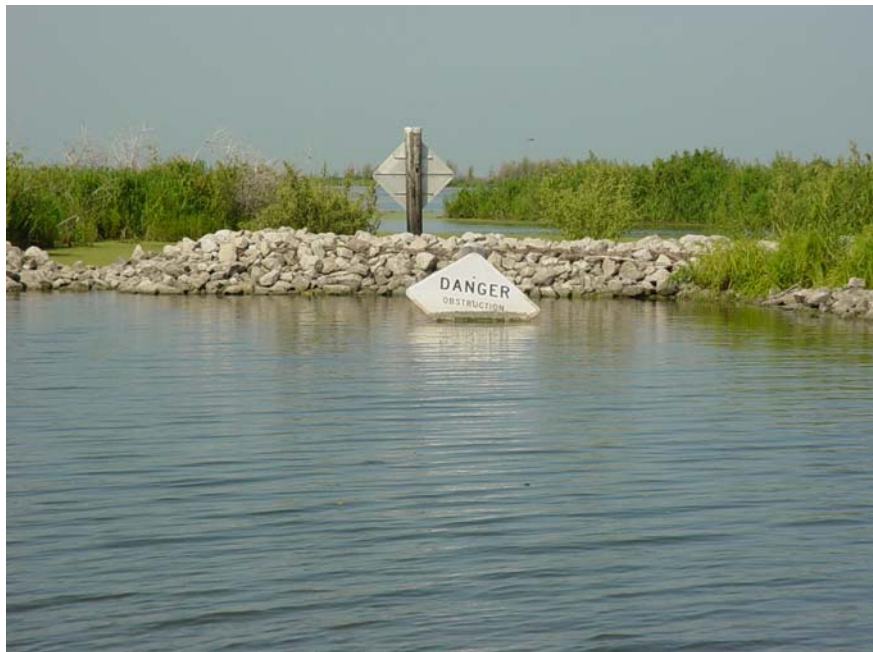
- D. Site/Structure # 32** –Overall condition was good with the exception of the area that was vandalized in early 2003. That area was partially repaired by the 2003 inspection team; however, that repair was again vandalized to the existing depth. The canal closure still functions during low to medium flows from the main structure. This structure was constructed to keep diversion water from entering Lake Leary from the western lake rim; Katrina devastated that portion of the lake rim rendering this structure ineffective until such time that the lake rim is repaired. (See Photo 5 & 6)

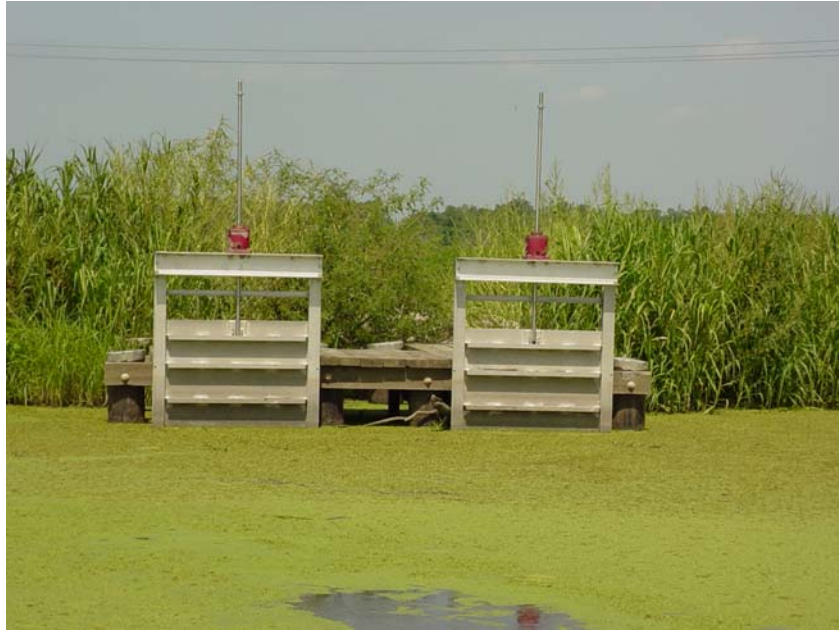
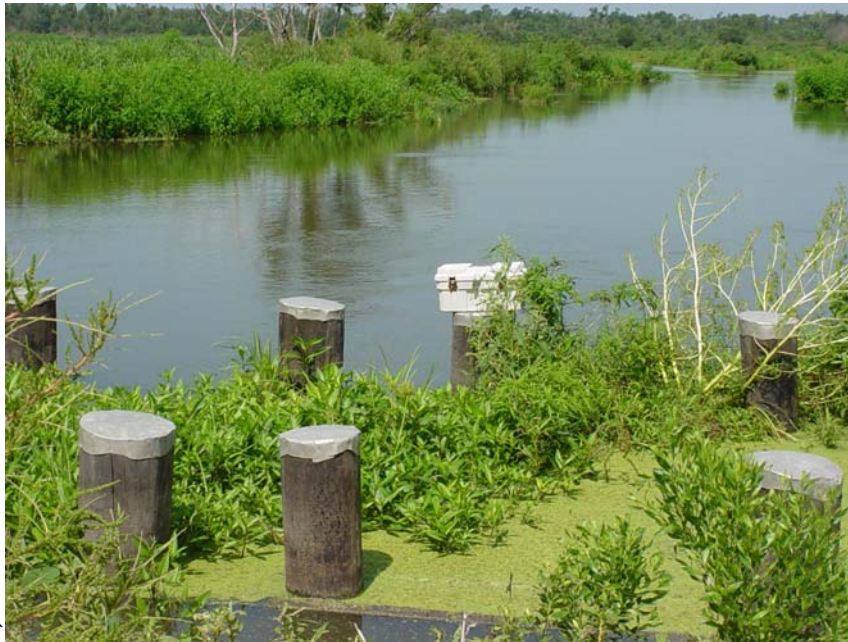
- E. Site/ Structure # 40** – The structure has been cleared of storm debris. The gates remain in the open position. Water flow was moderately visible entering the marsh side due to the present low flow rate at the main structure. The culverts at this site were flushed out prior to the last inspection and remain clean. The interior channel that leads to the site was relatively clear of debris and hyacinths. Most of the unwanted water hyacinth was destroyed from the high salinities brought in by Gustav and Ike. (See Photo 7 & 8)

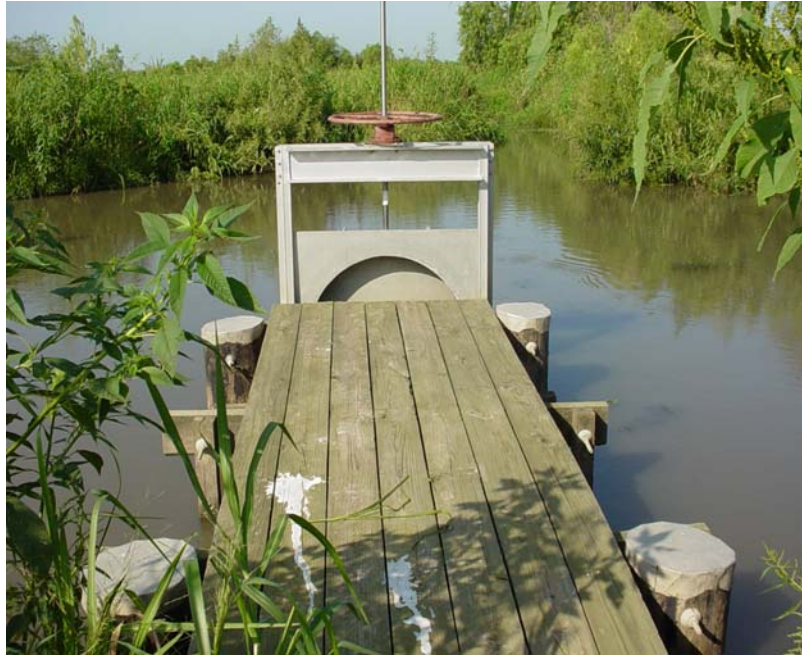
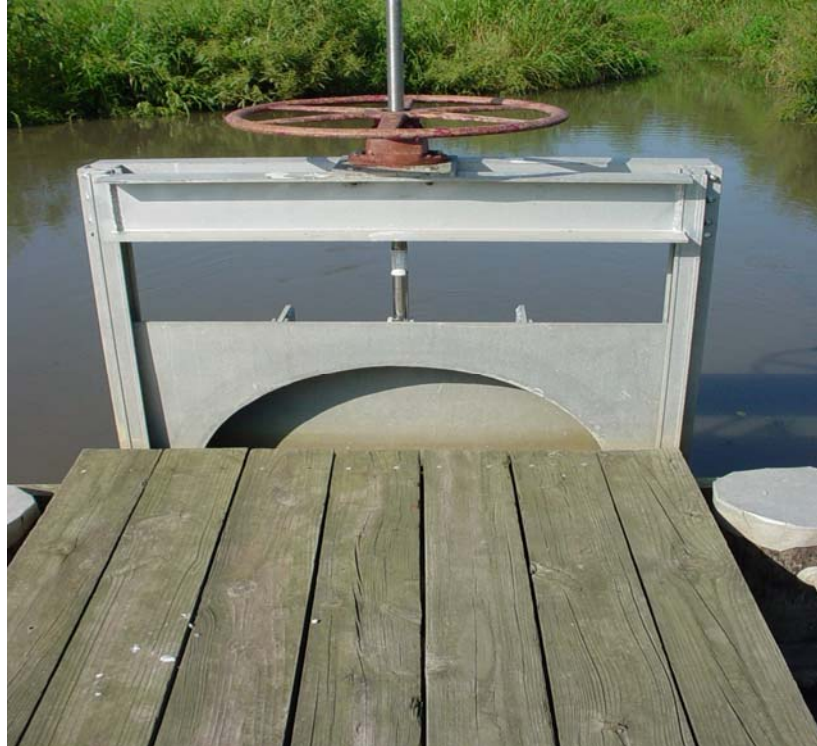
- F. Site/Structure # 50** – The combination gate was in the up/open position. The plan is to lower/close the combination gate and allow the flap gate to automatically control the inside marsh levels. Small amount of water movement was noticed through the structure to the interior marsh. The timber walkway remains slightly bowed, and remains free of any storm debris. (See Photo 9 & 10)

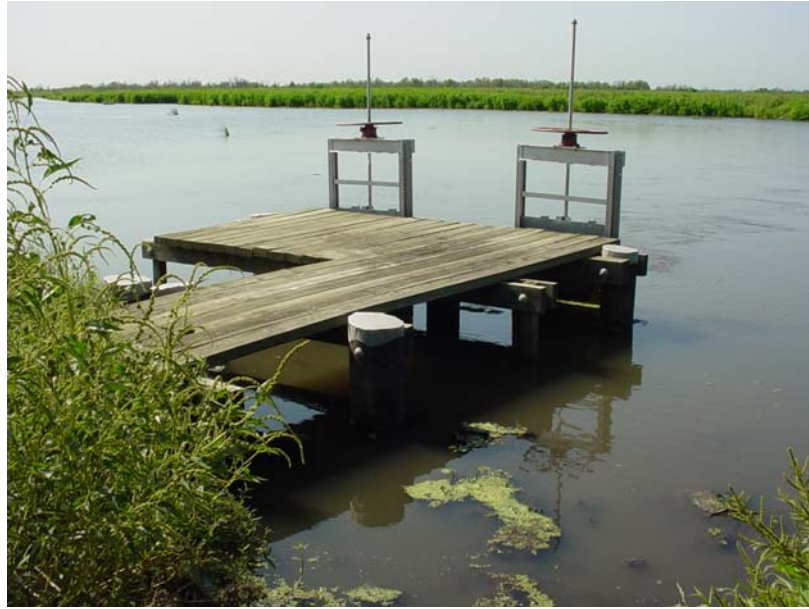
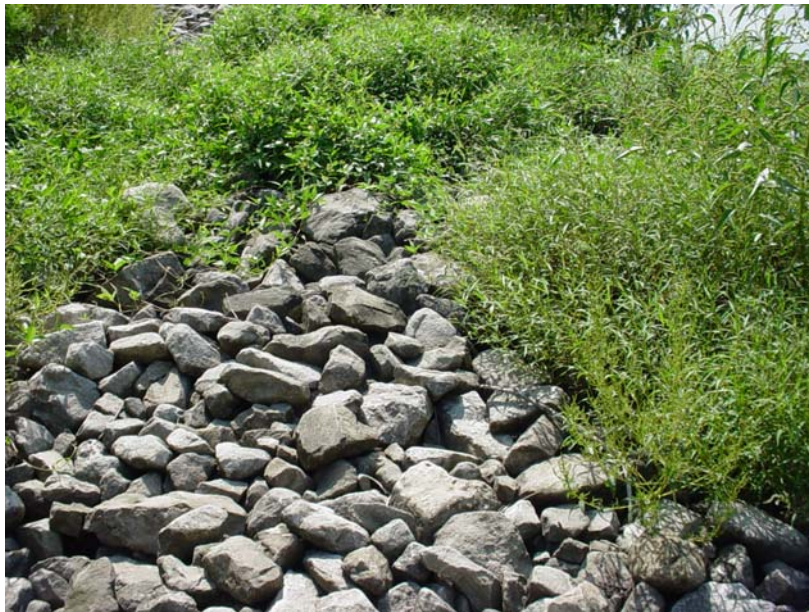
- G. Site/Structure #52** – The two combination gates were in the up/open position. There appeared to be a movement on the water surface near the inlet indicating some water flow into the marsh. The combination gates will be closed to allow the flap gates to automatically adjust the water

levels on the marsh side. There is a small breach of the spoil bank to the right and left of the plug allowing some flow from the canal to the marsh depending on the tidal exchange. (See Photo 11 & 12)

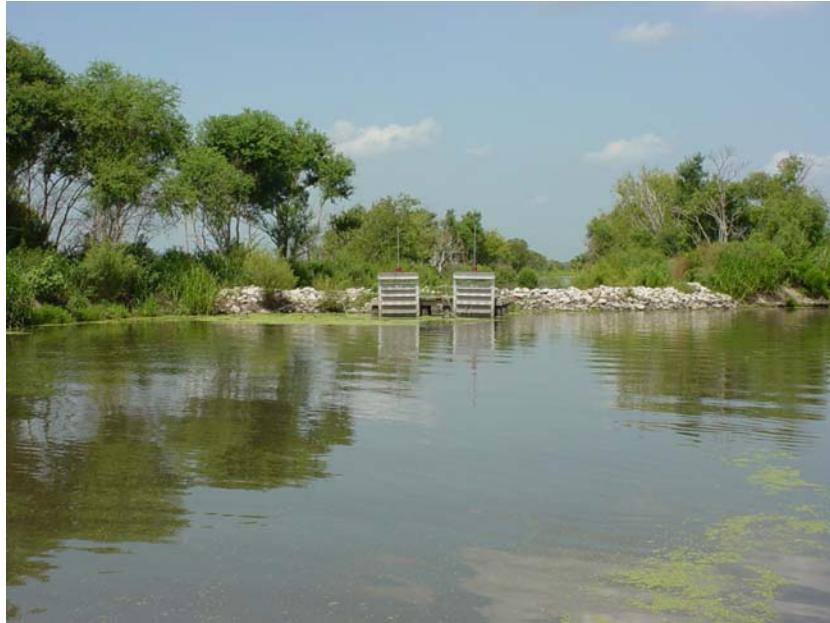
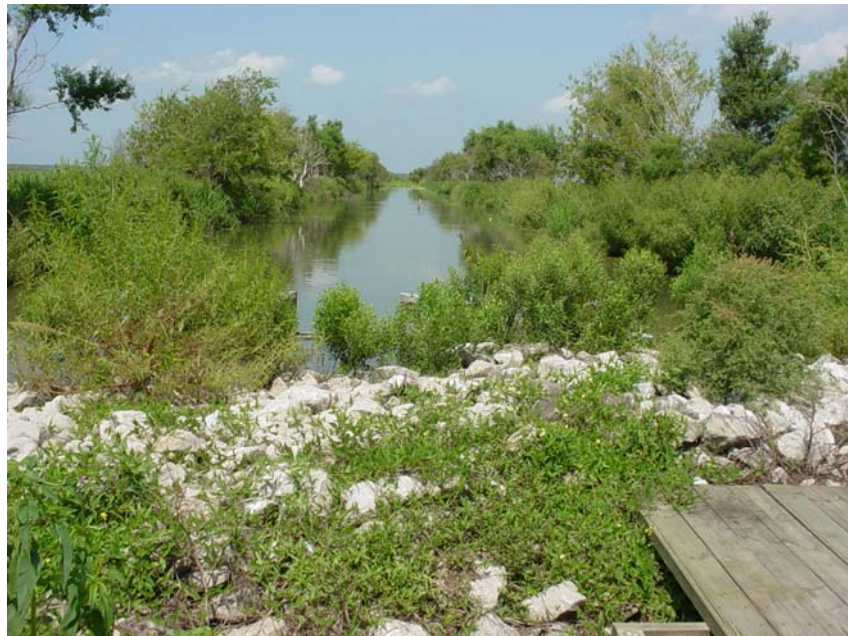
- H. Site/Structure # 54** – The structure has been cleared of all storm debris, and the gates remain in the open position. Water flow was visible indicating that the culverts are still clear after being flushed out after Katrina. The channel leading to the earthen/rock closure is relatively clear as is the closure itself. (See Photo 13 & 14)

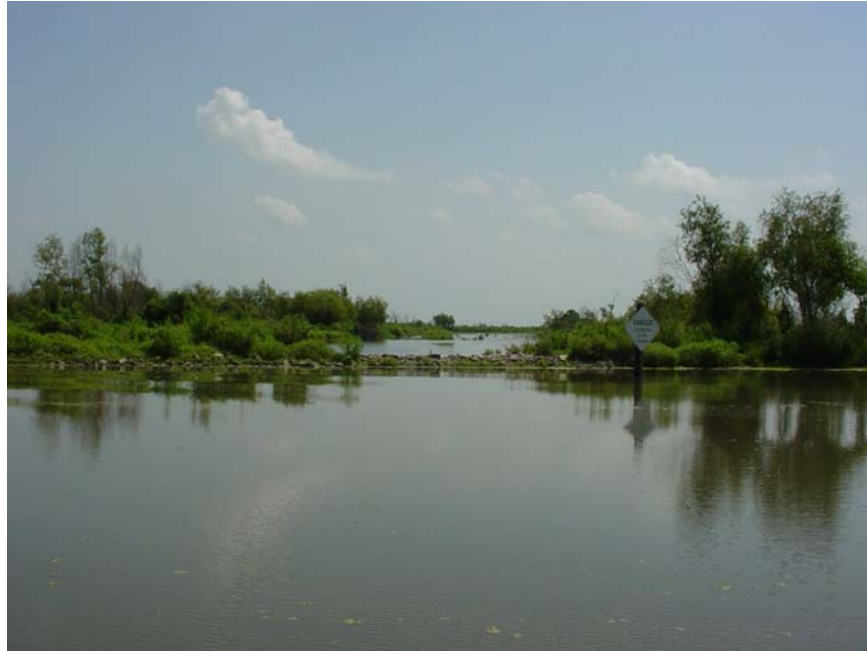
Photo No.15, Site 56

- I. Site/ Structure # 56** - No additional subsidence was noted in this rock structure since the last inspection. Small amount of debris with vegetation remains on the entire rock closure. Soon after construction, the middle section of the plug subsided approximately 0.5 ft. more than the sides. The warning signs that were damaged during the storm were previously reset; however, one of the signs appears to be leaning. (See Photo 15)

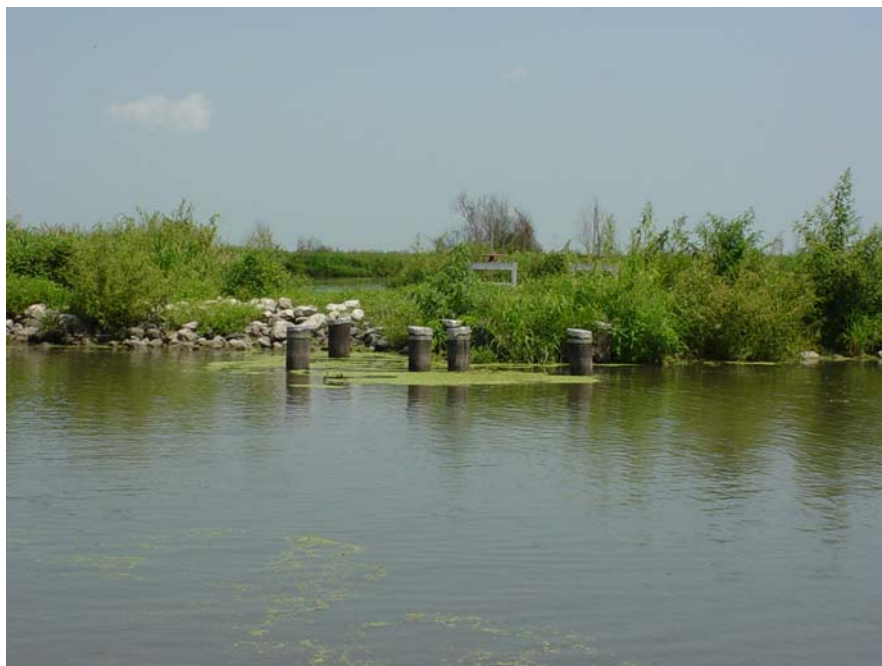
Photo No. 16, Site 60

- L. Site/Structure # 60** – The gate structure is completely cleared from any storm debris. At the time of the inspection, the two combination gates were in the up/open position but will be closed to allow the flap gate to control the marsh water levels. Water flow was slightly visible going into the marsh, indicated by a small eddy at the canal side of the culverts. The culverts at this site were cleared prior to the 2008 annual inspection, and remain clear. Thick vegetation has covered most all of the canal closure and the majority of the earthen/rock closure that house the culverts. (See Photo 16)
