**State of Louisiana  
Department of Coastal Protection and  
Restoration  
Operations Division**

**2009 Annual Inspection Report**

**DELTA WIDE CREVASSES  
(MR-09)**

State Project Number MR-09  
Priority Project List 6

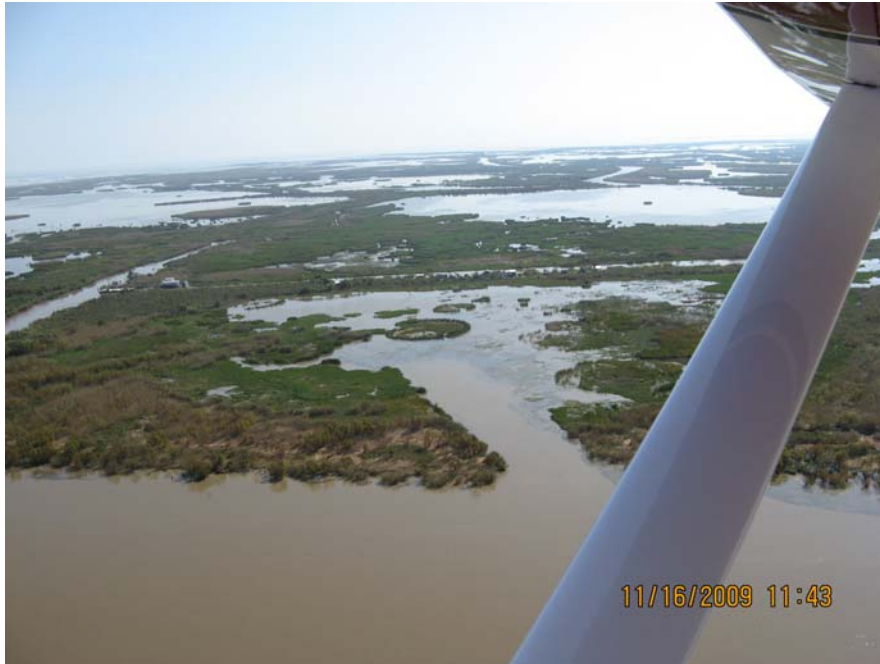
- A. Crevasse No. NC-1: (1,000 ft. X 100 ft. X -8.0 ft. NAVD 88) This 2005 new-crevasse appears to be in good to excellent condition. Visible flows indicate that it has retained most of its originally constructed depth. River water is flowing very well through the channel carrying large amounts of sediment, and the spoil from the dredging of the crevasse has vegetated throughout the deposited bay area.

Crevasse No. NC-1, (view 1) Looking into crevasse from Pass-a-Loutre, notice rings of roseau in center of photo.

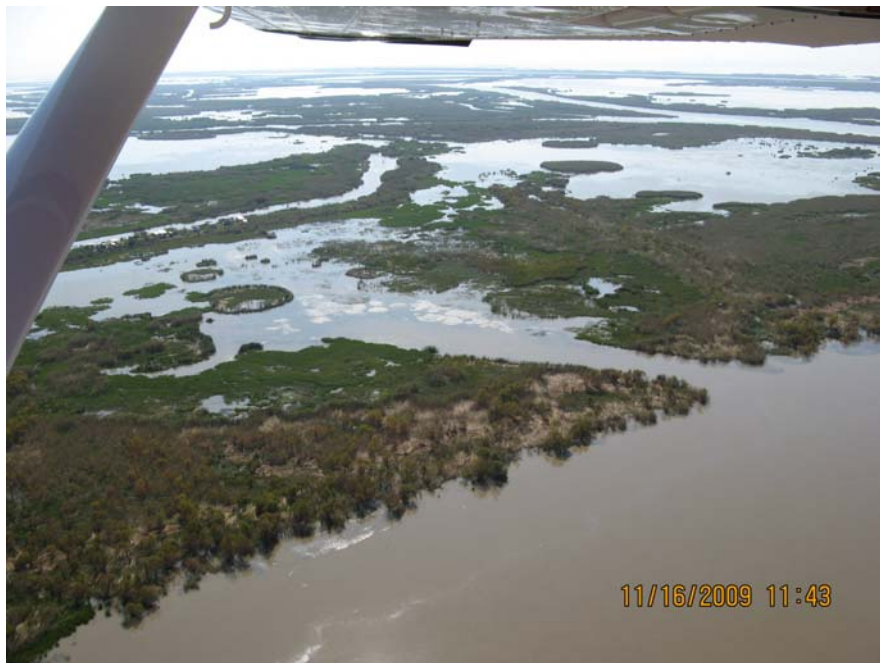
Crevasse No. NC-1, (view 2) Looking west. Vegetated Spoil area in center of view.

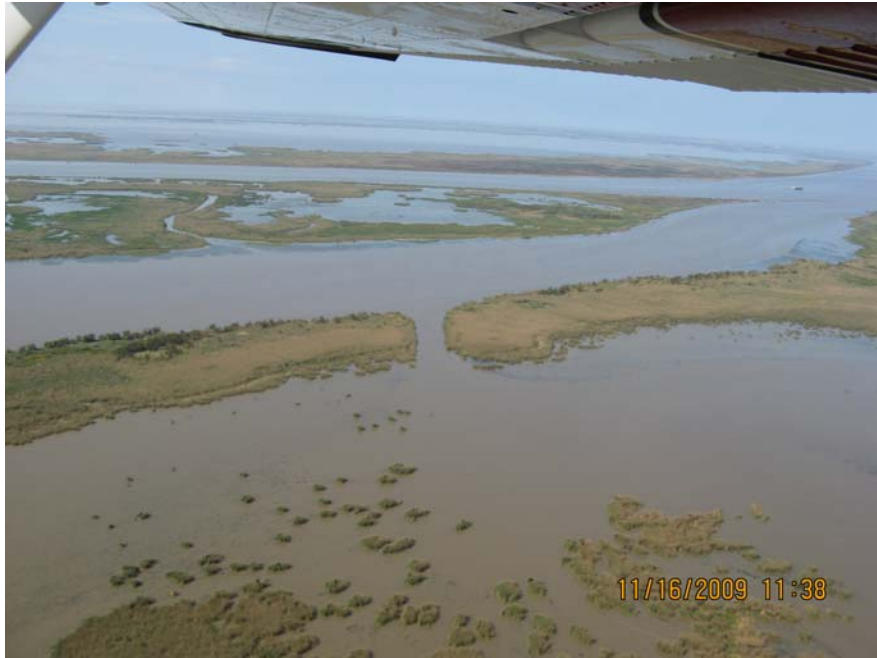
- B. Crevasse No. NC-3: (1,400 ft. X 100 ft. X -8.0 ft. NAVD 88) This is the second of the two new 2005 crevasses and the only one cut on Main Pass. It is functioning very well, and flowing with a very swift current bringing much needed sediments into the interior bays. The crevasse appears to be maintaining a good depth throughout its channel length and the spoil from the crevasse dredging has completely vegetated. LDWF reports small amount of shoaling at the mouth.

Crevasse No. NC-3, (view 1) Looking out to South Pass.  
Southwest Pass and West Bay are in background.

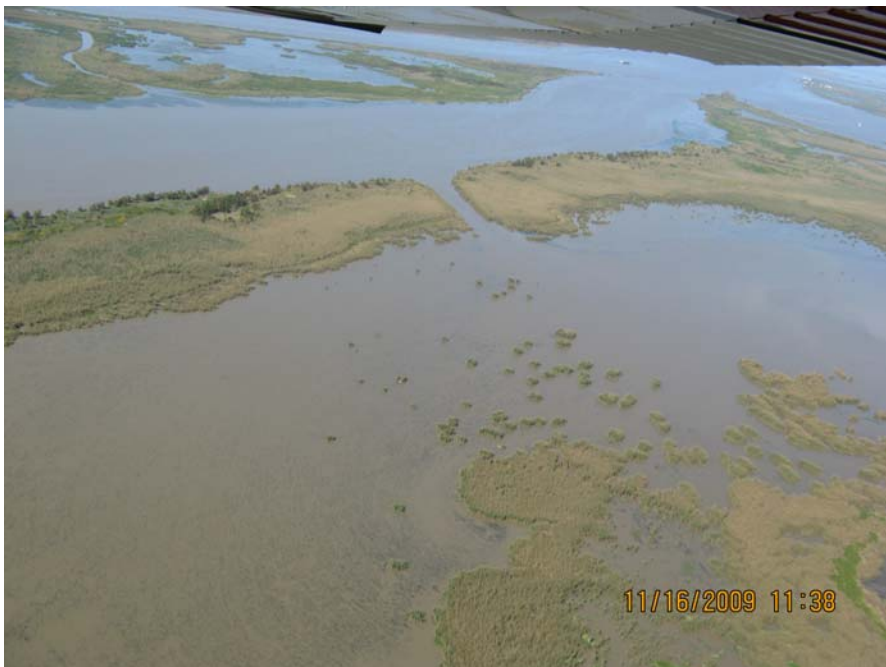
Crevasse No. NC-3, (view 2), Vegetated crevasse dredging  
spoil in bay area, foreground.

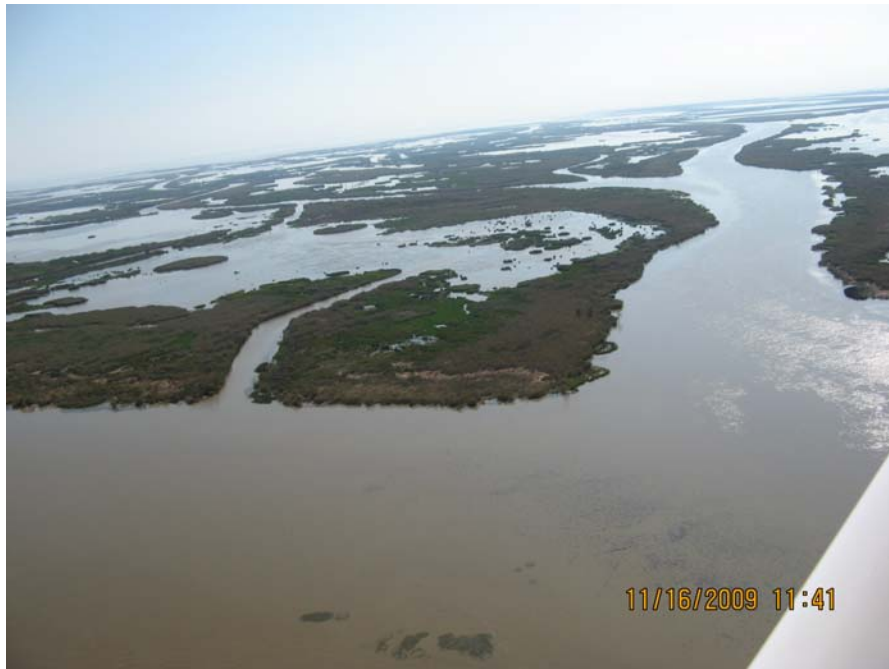
- C. Crevasse No. 9: (2,200 ft. X 75 ft. X -8.0 ft. NAVD 88) Good flow is being maintained in this dog-leg shaped previously dredged crevasse (1999). Its location allows for swift currents during the present high river stages. The spoil deposition from this cut is very heavily vegetated and seems to have kept its constructed height above the bays.

Crevasse No. 9, (view 1) Looking south. Notice bay area, heavily vegetated spoil from crevasse dredging.

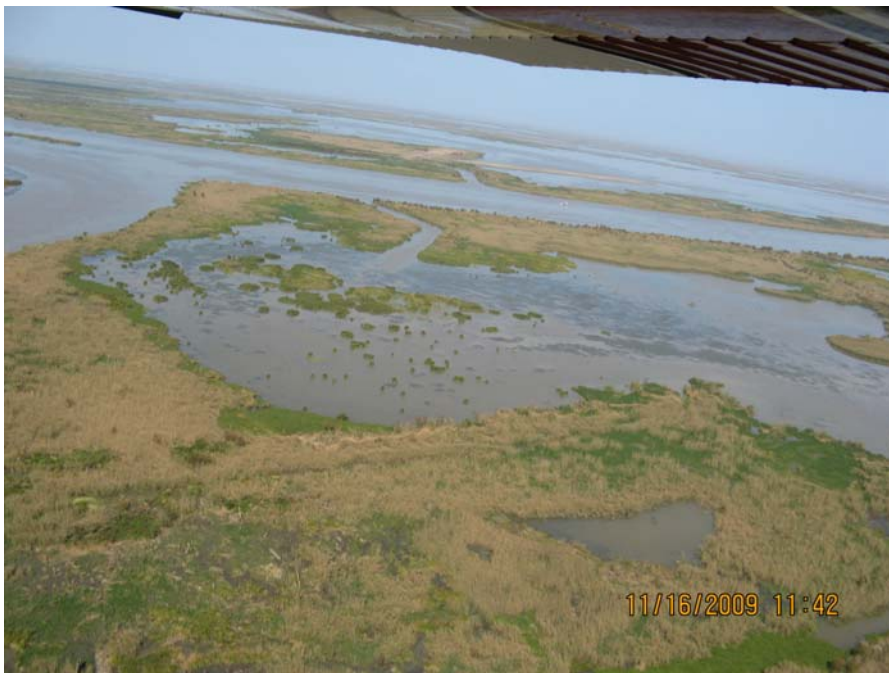
Crevasse No. 9, (view 2) Vegetated spoil deposition in bay Area, and also large amounts of heavy sediments.

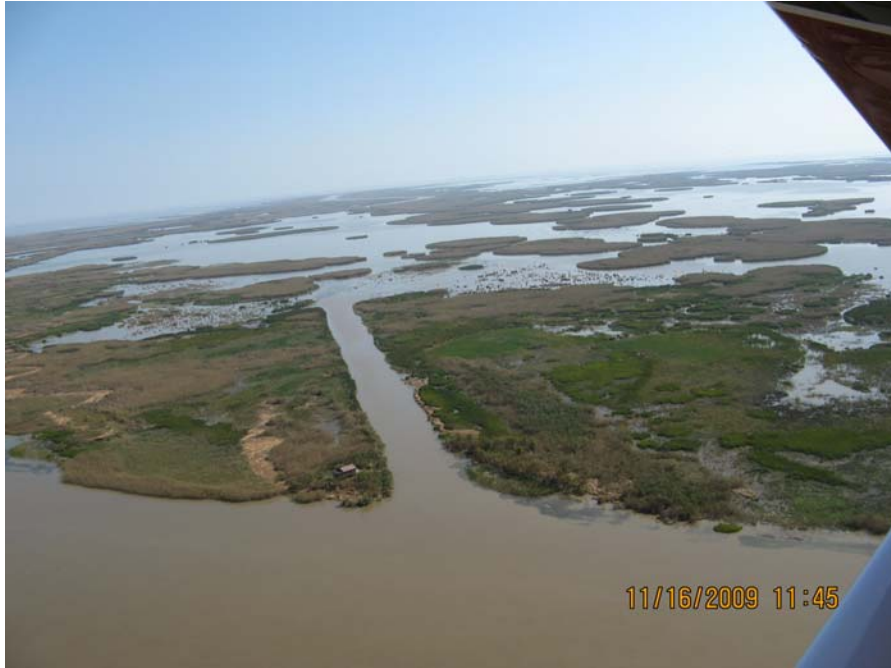
- D. Crevasse No. 11: (2,600 ft. X 100 ft. X -8.0 ft. NAVD 88) This re-dredged crevasse (1999) has maintained a good flow throughout its length. It appears to have maintained its depth throughout and the current in this cut is more than adequate. All of the spoil deposited in the inner lagoon areas has vegetated very heavily and appears to be in excellent condition. The present high water is allowing much sediment to enter the interior marshes.

Crevasse No. 11, (view 1) From Pasa-a-loutre looking into Crevasse.

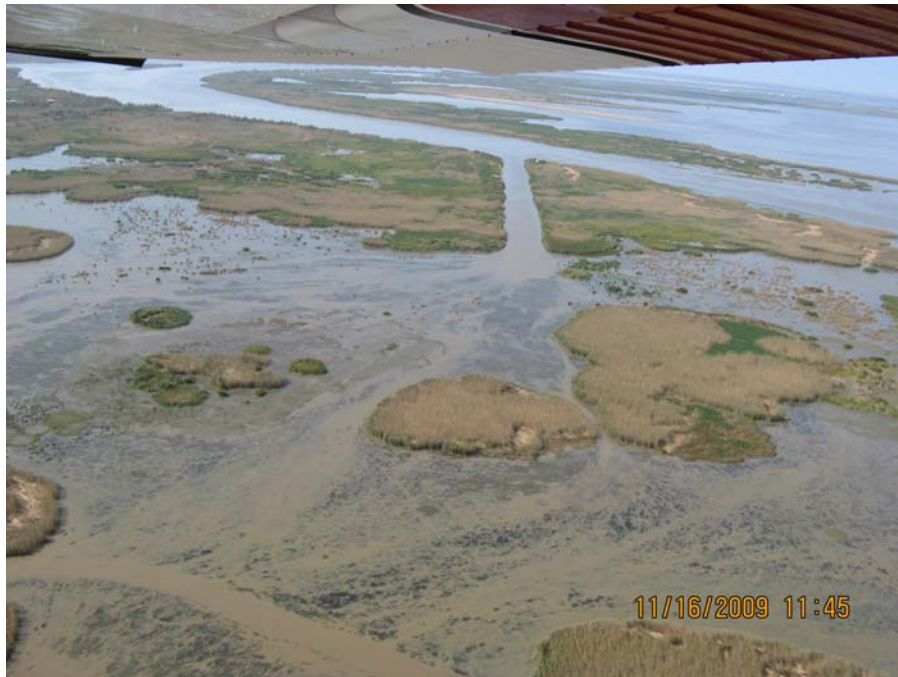
Crevasse No. 11, (view 2) Crevasse end looking at spoil area vegetation and huge amounts of sediments from the pass.

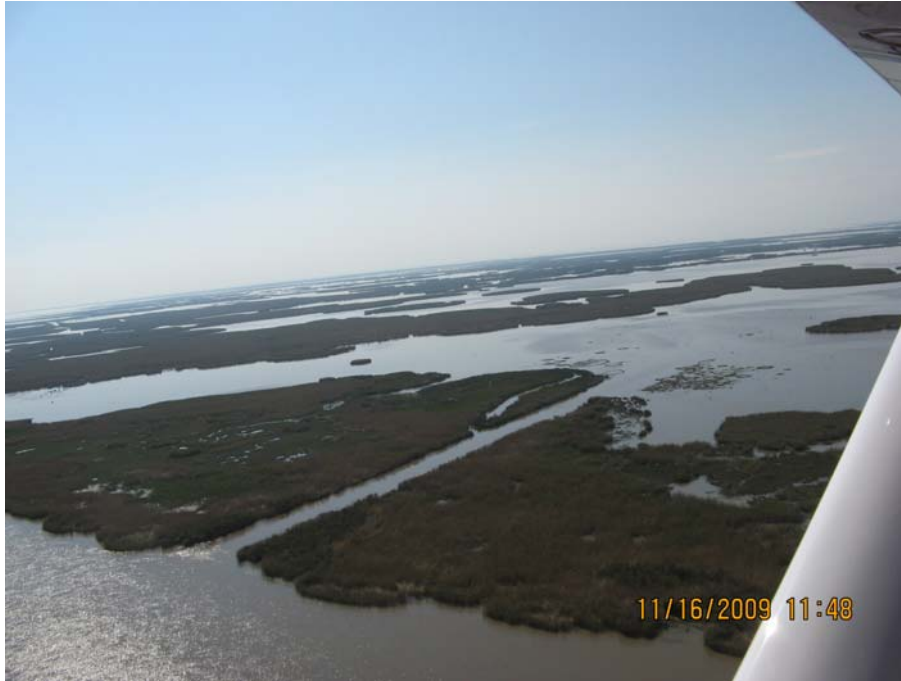
- E. Crevasse No. 12: (2,000 ft. X 75 ft. X -8.0 ft. NAVD 88) Despite being located off of the main channel, this crevasse appears to be functioning very well. There is sufficient current to carry sediments to the inner section of the bays and lagoons and the spoil from the dredging is heavily vegetated. Swift flows indicate that

there remains good depth throughout the cut. This crevasse also had been previously dredged (1999).

Crevasse No. 12, (view 1) Looking into interior bay from Channel showing large amounts of vegetation in early stage.

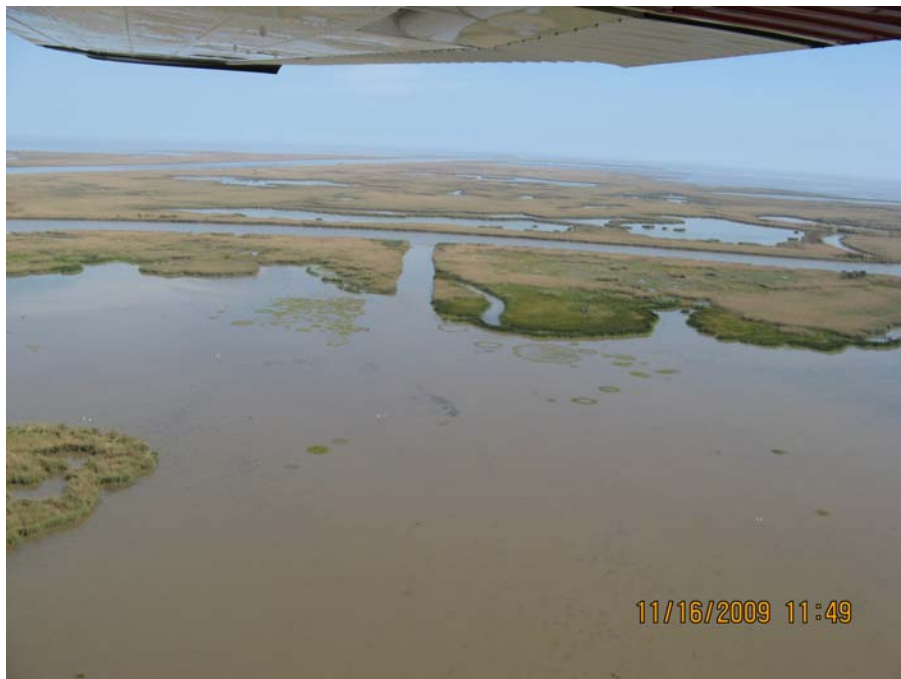
Crevasse No. 12, (view 2) Inside crevasse looking towards feeder channel. Notice material buildup in center of view.

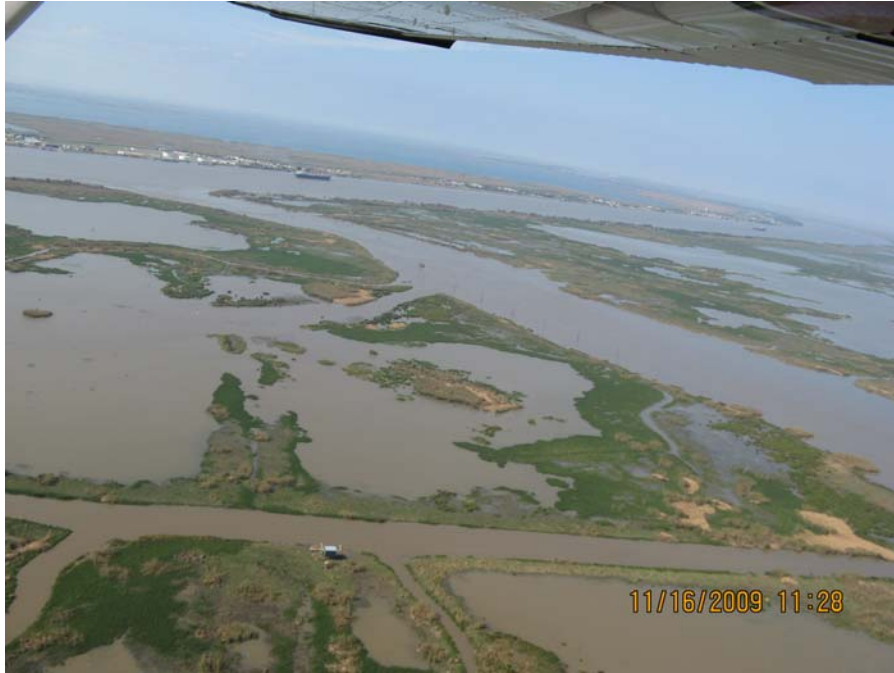
- F. Crevasse No. 81: (1,200 ft. X 100 ft. X -8.0 ft. NAVD 88) This crevasse is located off of Baptiste Colette in the Delta Wildlife Management Area. The current in the crevasse is strong, since it is located in close proximity to the Mississippi River. Even though last years soundings indicate that the mouth of this crevasse has silted up from the large amounts of sediments that is carried into the cut by the river currents, there is still enough current seems to be carrying plenty sediments into the interior marsh area. The last inspection indicated that there was 3 to 4 feet of draft that exists at the mouth of the crevasse.

Crevasse No. 81, (view 1) Looking upriver from inside the bay towards Baptiste Collette channel.

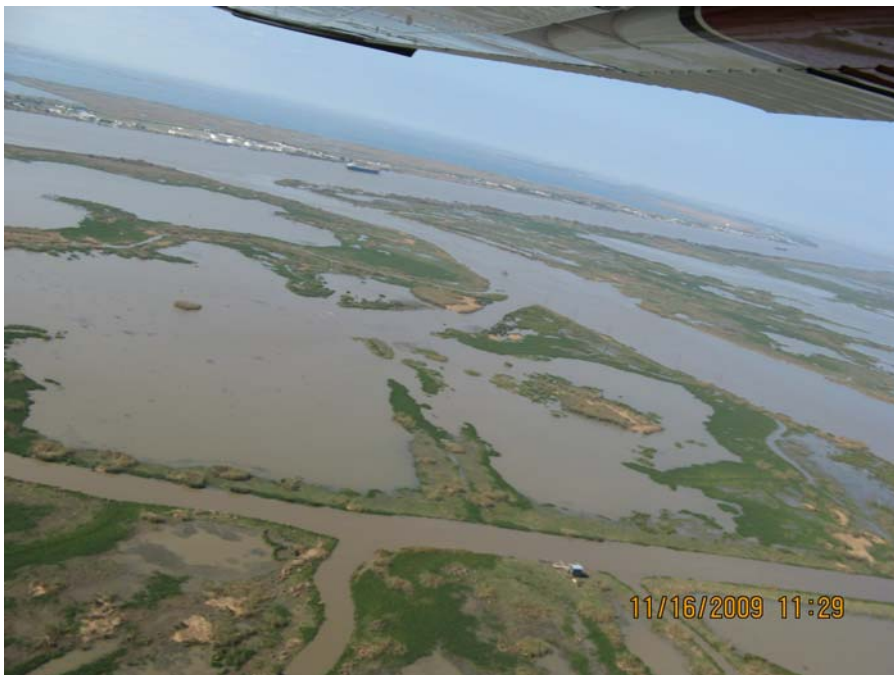
Crevasse No. 81, (view 2) Inside crevasse showing heavy vegetated spoil area and newly deposited sediments.
