2008/2009 Annual Inspection Report

HUMBLE CANAL HYDROLOGIC RESTORATION PROJECT (ME-11)

State Project Number ME-11
Priority Project List 8

October 1, 2008
Cameron Parish

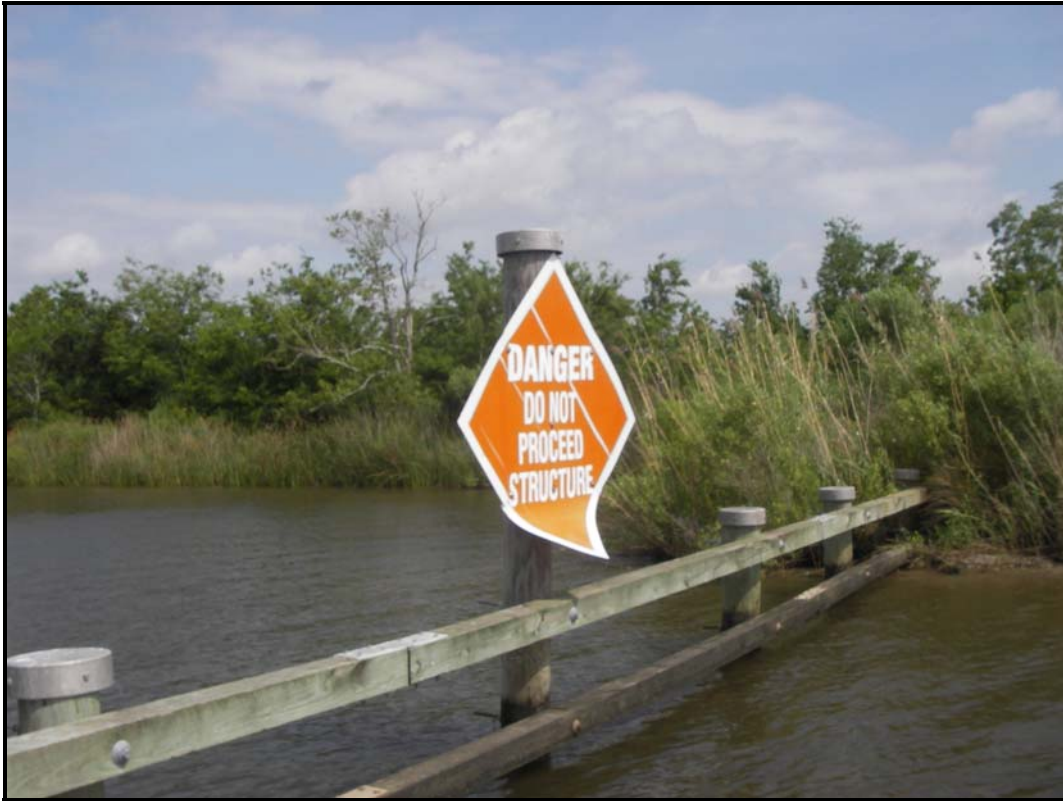
The structure is in excellent condition and does not appear to have suffered any additional damage from Hurricane Ike. Some shrinkage of the sign lettering has occurred and the signs are slightly bent from Hurricane Rita damage. Bank tie-ins, pile caps, hardware, etc. is in excellent condition. Maintenance is required at this time to replace the signs. (Photos: Appendix B, Photo 1)

Photo 1, Marine barrier with signage.

Item	Condition	Physical Damage	Corrosion	Photo #	Observations and Remarks
Steel Bulkhead / Caps	good				
Steel Grating					
Stop Logs	N/A				
Hardware	good				
Timber Piles	good				
Timber Wales	good				
Galv. Pile Caps	good				
Cables	N/A				
Signage /Supports	good			1	Signs slightly bent from Hurricane RITA damage and should be replaced..
Rip Rap (fill)	N/A				
Eathern Embankment	N/A

- Repair and/or replace miscellaneous hardware.
- Add crushed stone on top of structure.
- Repair hyacinth guard.
- Replace warning signs on marine barrier.

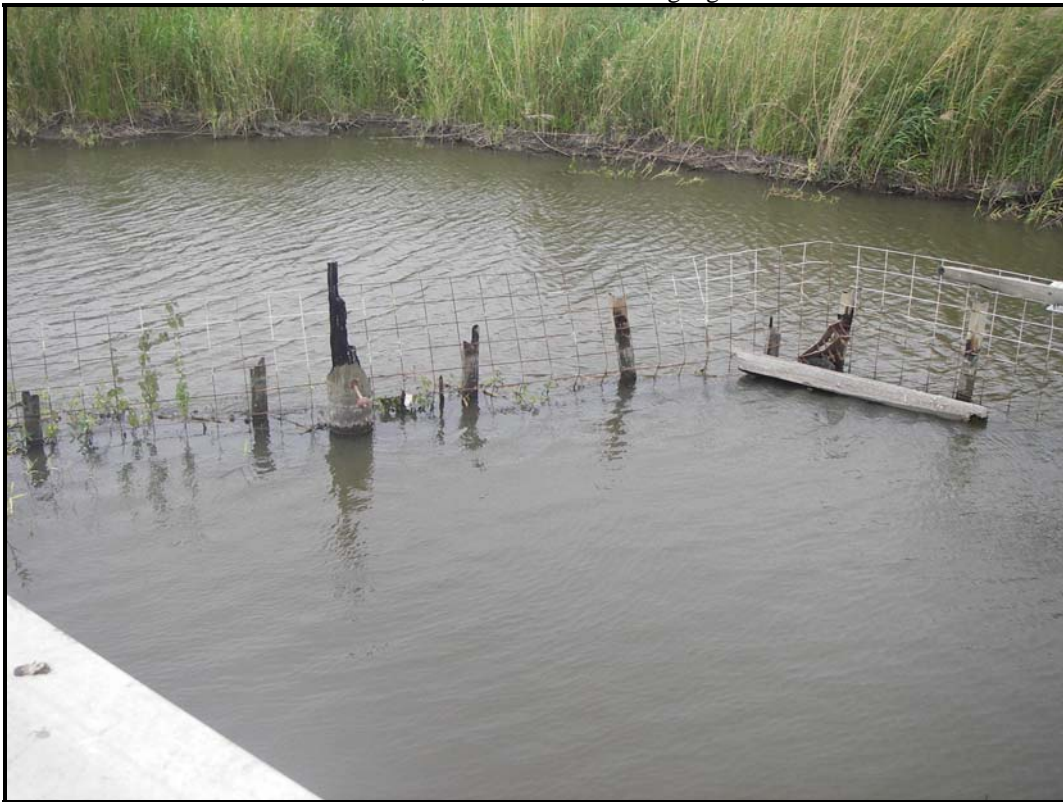
This feature is in good condition; however several pilings, walers and vertical wooden members have been burned when the adjacent camp debris from Hurricane Rita recently caught fire. Maintenance to repair this damage is needed. (Photos: Appendix B, Photo 2)

Photo 2, Inlet side showing burn damage to hyacinth fence.

Item	Condition	Physical Damage	Corrosion	Photo #	Observations and Remarks
Steel Bulkhead / Caps	good				
Steel Grating	N/A				
Stop Logs	N/A				
Hardware	good				
Timber Piles	fair			2	Some of the piles have been burned.
Timber Wales	fair			2	Some of the walers have been burned.
Galv. Pile Caps	good				
Cables	N/A				
Signage / Supports	N/A				
Rip Rap (fill)	N/A				
Earthen Embankment	N/A

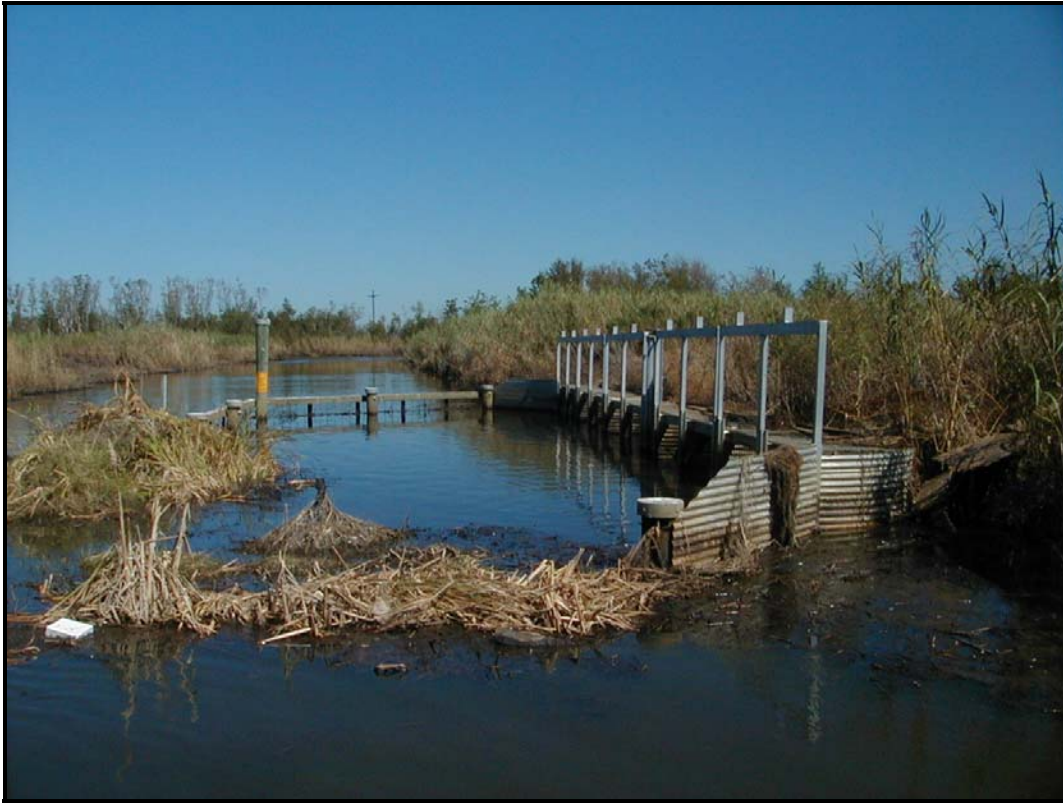
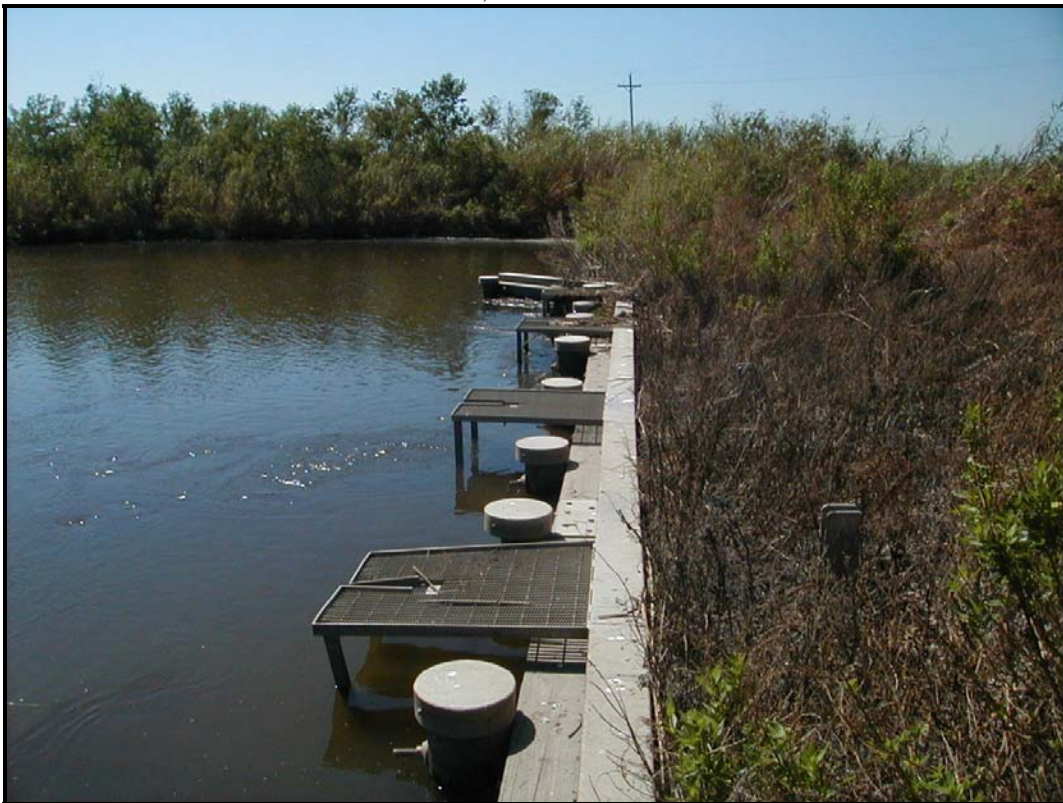
Overall, the structure is in good post construction condition. The inspection noted the erosion of the structure embankment behind each wing wall and over the structure identified in the previous O& M Inspections. Miscellaneous structure maintenance such as replacement of bolts and flap gate locking arms will be required. The camp building debris adjacent to the structure has burned since the last inspection and has caused damage to the hyacinth guard as noted above. (Photos: Appendix B, Photo 3 & 4)

Photo No. 3, Inlet side of structure

Photo No. 4, Outlet side of structure

Item	Condition	Pysical Damage	Corrosion	Photo #	Observations and Remarks
Steel Bulkhead / Caps	good				
Steel Grating	good				
Stop Logs	good			3 & 4	Stoplogs on this structure are made of aluminum and should last practically forever.
Hardware	fair			3 & 4	Some of the hardware needs to be replaced or repaired.
Timber Piles	good				
Timber Wales	good				
Galv. Pile Caps	good				
Cables/ lifting device	good				
Signage /Supports	N/A				
Rip Rap (fill) (foreshore dike)	good				
Eathern Embankment	good			3 & 4	Erosion has occurred behind each wingwall and over the structure.
Inlet Channel/Plug	good
