**2008/2009 Annual Inspection
Report**

**FRESHWATER BAYOU CANAL
BANK STABILIZATION
PROJECT
(ME-13)**

State Project Number ME-13
Priority Project List 5

October 9, 2008
Vermilion Parish

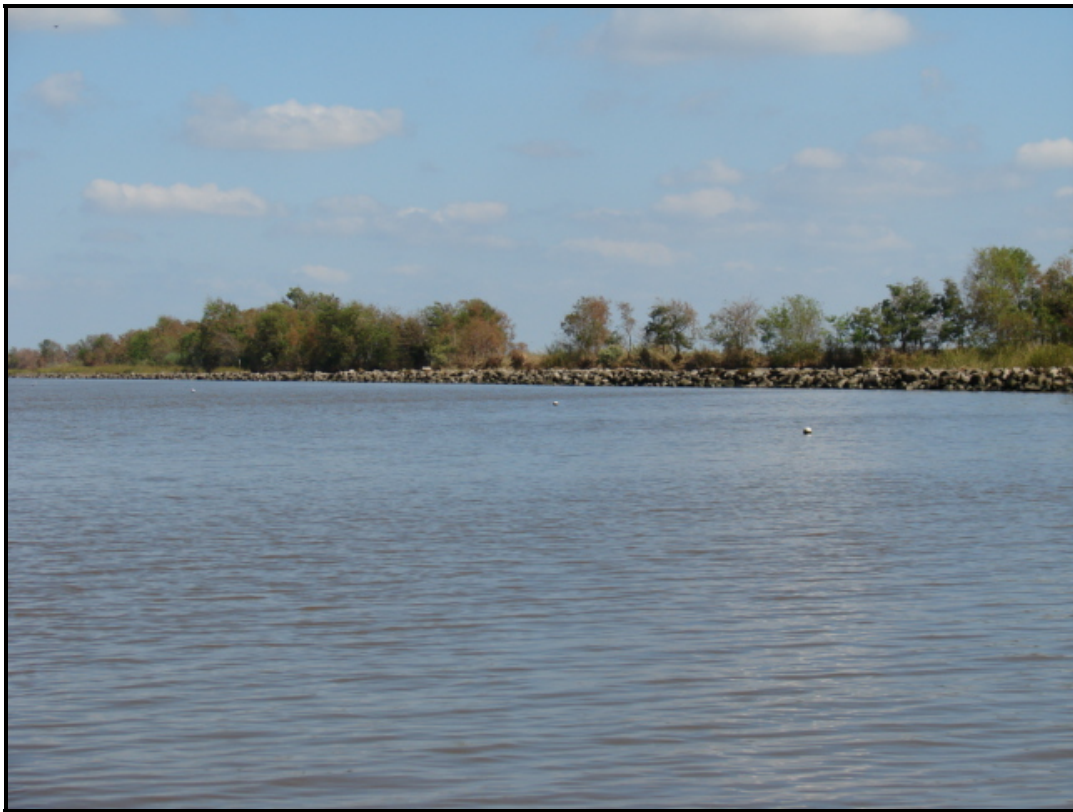
The inspection revealed the 9,130 linear feet of foreshore rock dike repaired in the 2005 maintenance project is in good condition and does not appear to have suffered any damages from Hurricane Ike. The additional 7,000 linear feet of foreshore rock dike identified by field surveys in the 2003/2004 O&M inspection as being below elevation 4.0' NAVD but above elevation 2.0' NAVD, which was not addressed due to budget limitations has not deteriorated further. (Photos: Appendix B, Photo 1)

Photo No. 1, Typical rock dike

Item	Condition	Physical Damage	Corrosion	Photo #	Observations and Remarks
Steel Bulkhead / Caps	N/A				
Steel Grating	N/A				
Stop Logs	N/A				
Hardware	N/A				
Timber Piles	N/A				
Timber Wales	N/A				
Galv. Pile Caps	N/A				
Cables	N/A				
Signage / Supports	N/A				
Rip Rap (fill) (foreshore dike)	Good			1	Recent maintenance work to restore dike to constructed elevation is still in good condition.
Earthen Embankment	N/A

Overall the Freshwater Bayou Canal Bank Stabilization Project is in good condition and appears to have stabilized the erosion of the Freshwater Bayou Canal Bankline. The above mentioned 7,000 linear feet of foreshore rock will continue to be monitored for deterioration in future O & M Inspections.
