Freshwater Bayou Bank Stabilization Summary Data and Graphics

Freshwater Bayou Bank Stabilization (ME-13)

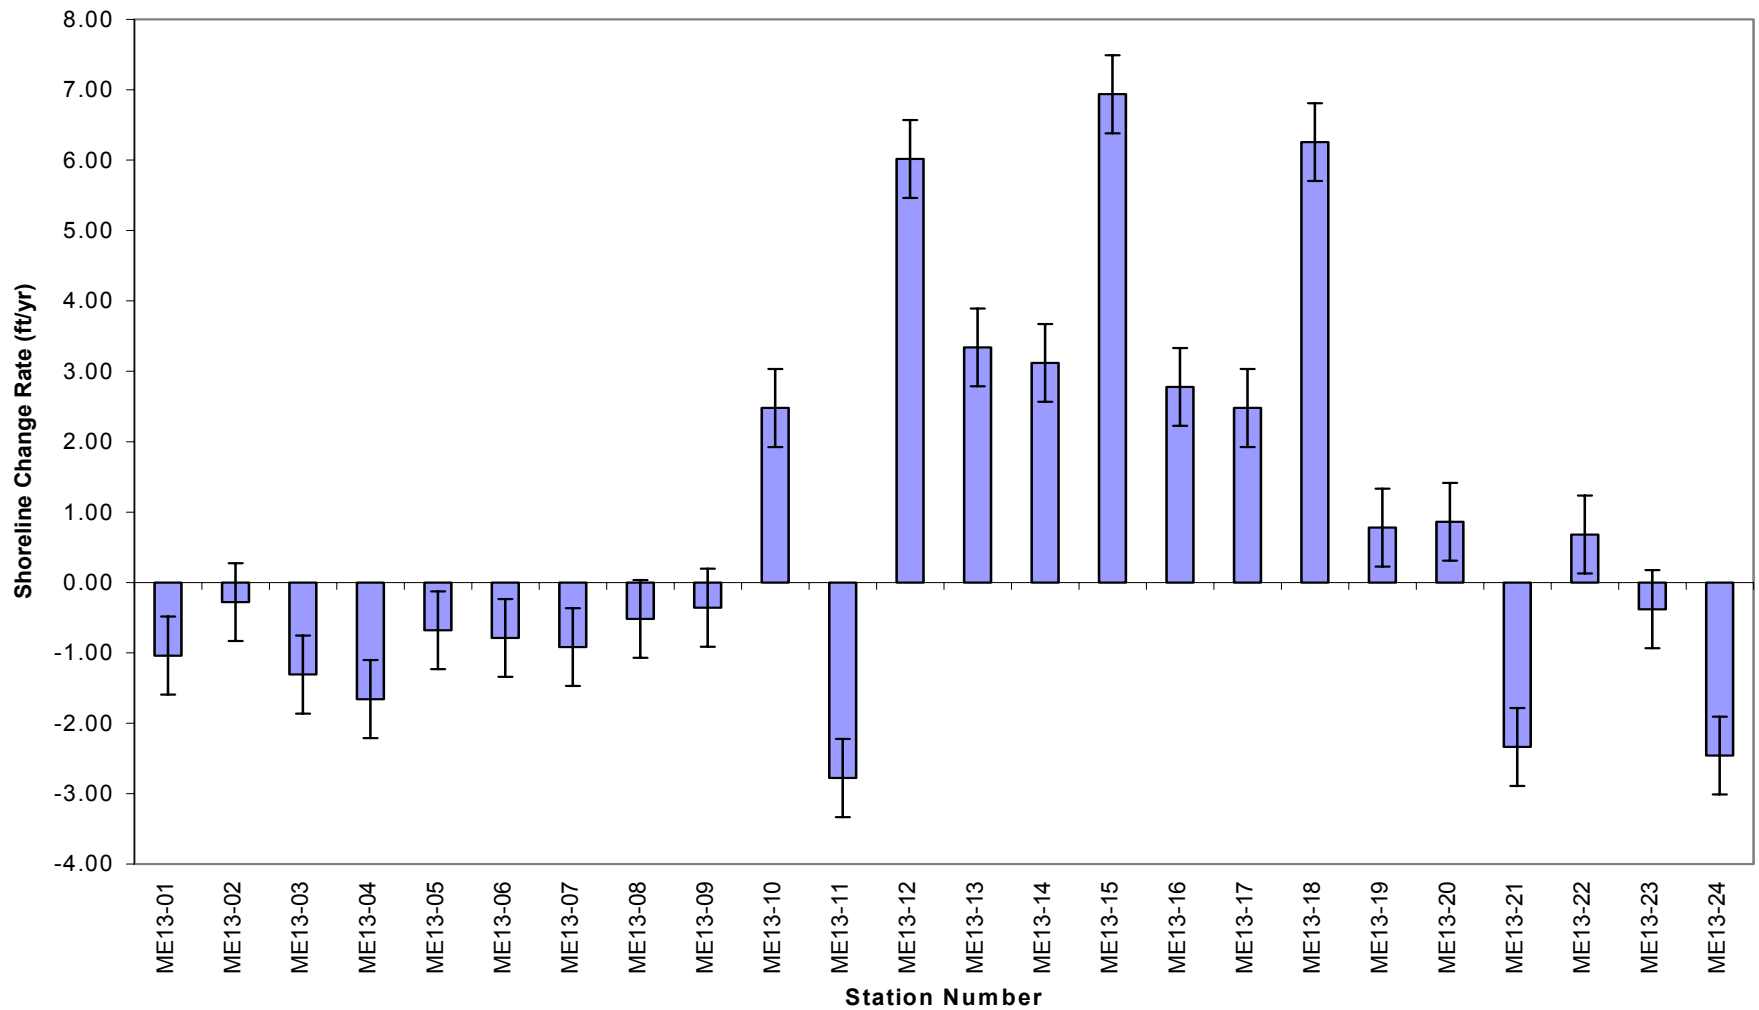
Figure 4. Shoreline change rate (ft/yr) along Freshwater Bayou Canal at the ME-13 project area stations for the July 23, 1998 – July 21, 2003 time period. Error bars represent ± 1 standard error of the mean of all stations.

- The project area shoreline prograded at an average rate of 0.84 ft/yr (0.26 m/yr) (figures 4 and 5, table 3) and the reference area shorelines eroded at an average rate of -11.94 ft/yr (-3.64 m/yr) (figures 6 and 7, table 4) indicating that the ME-13 project rock dike has significantly reduced wave erosion of the protected segment of canal bank for the past five years.
- The variability in shoreline change along the project area shoreline was highly significantly different than the variability along the reference area shorelines ($p < 0.0001$) for this time period.
- The highest rate of shoreline retreat has occurred at the north end of reference areas R2 (north unit) at station ME13-25R, where the shoreline retreated 89.0 ft (27.1 m) between July 23, 1998 and July 21, 2003 (figure 15).

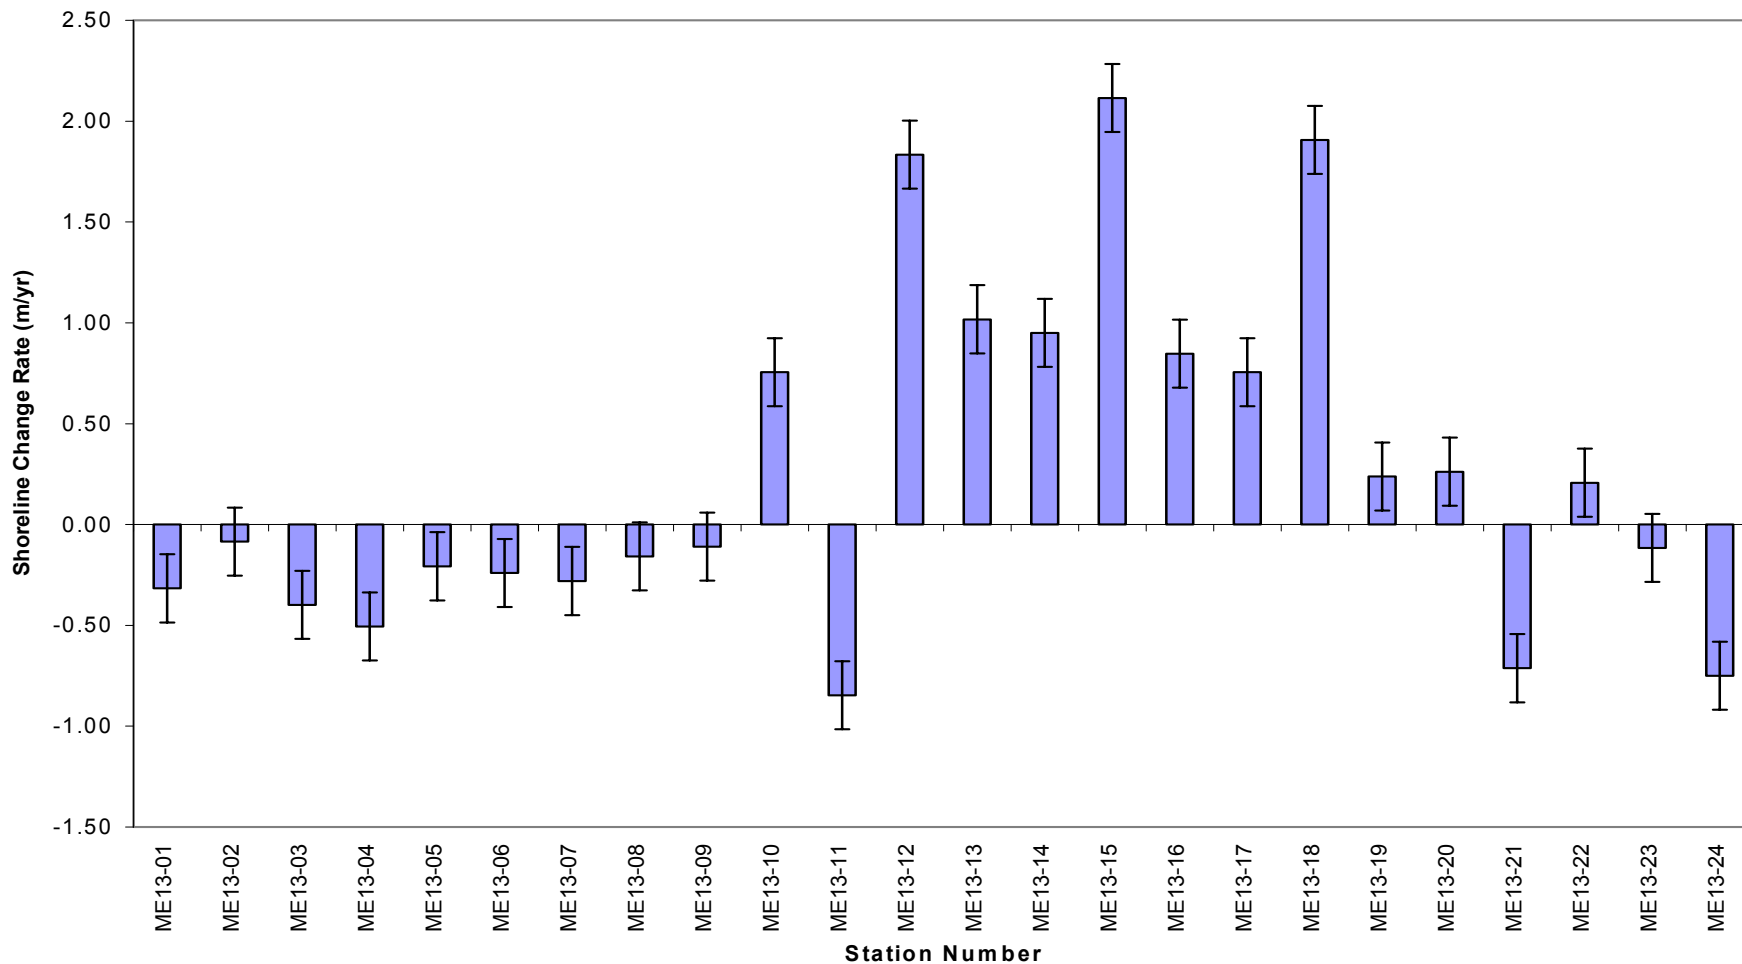
Figure 5. Shoreline change rate (m/yr) along Freshwater Bayou Canal at the ME-13 project area stations for the July 23, 1998 – July 21, 2003 time period. Error bars represent ± 1 standard error of the mean of all stations.

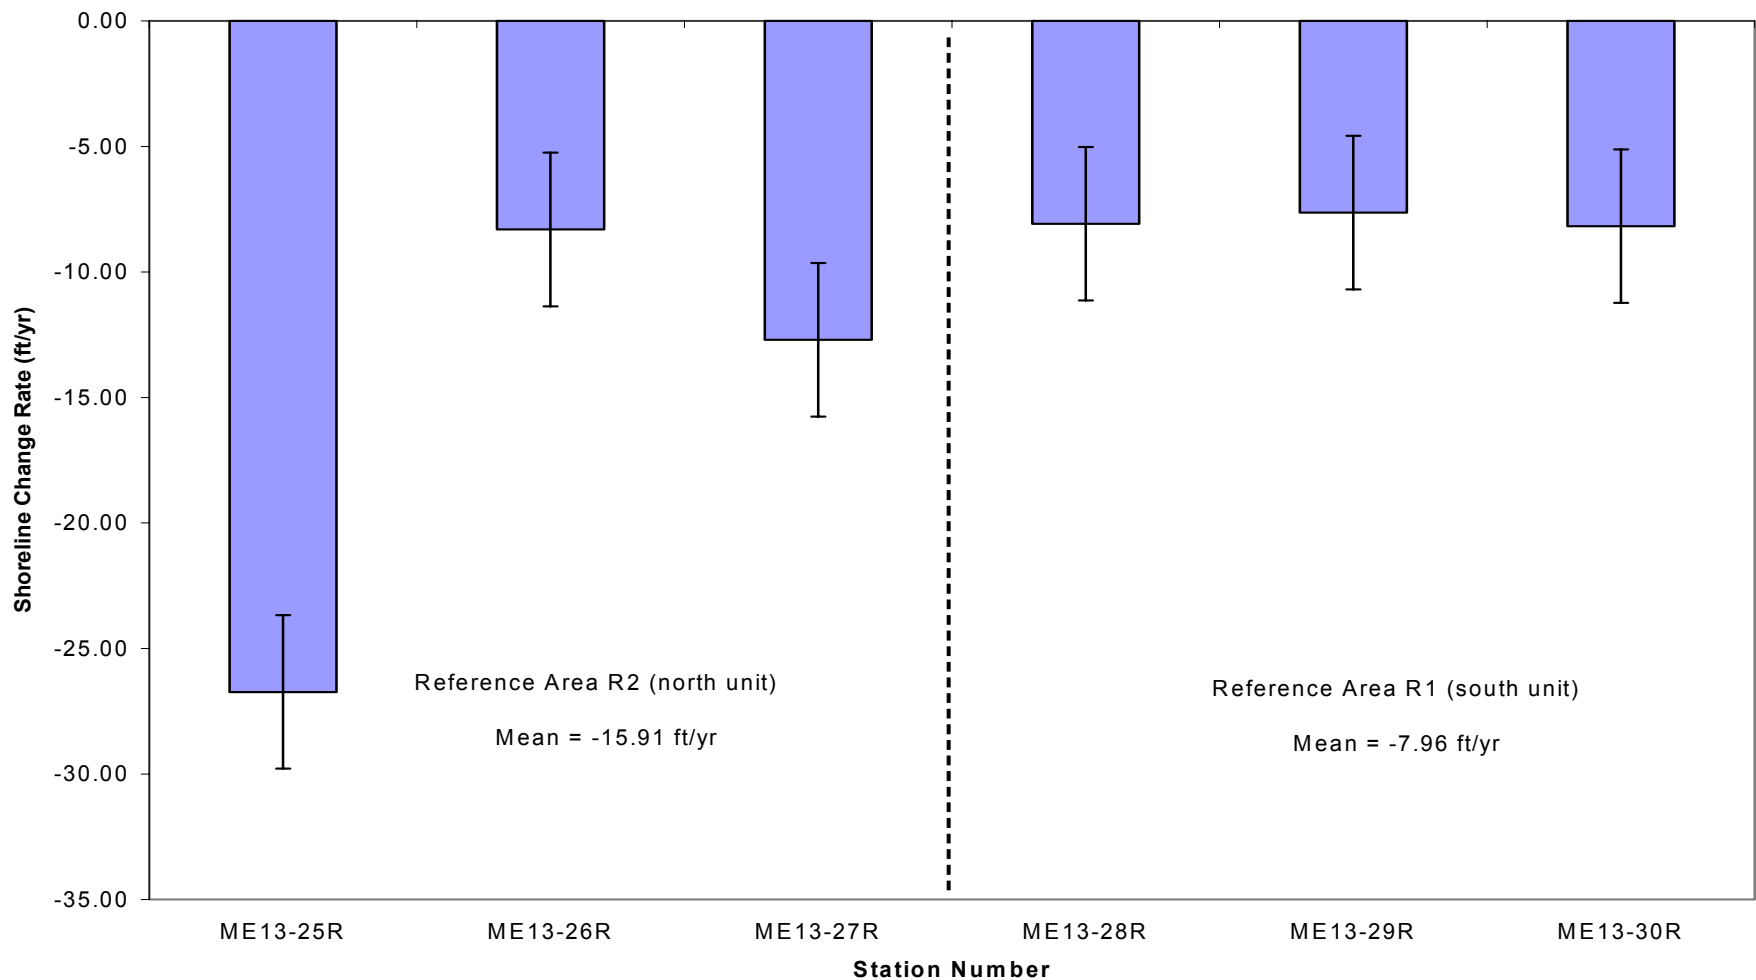
Figure 6. Shoreline change rate (ft/yr) along Freshwater Bayou Canal at the ME-13 reference area monitoring stations for the 23 July 1998 – 21 July 2003 time period. Error bars represent ± 1 standard error of the mean of all 6 stations.

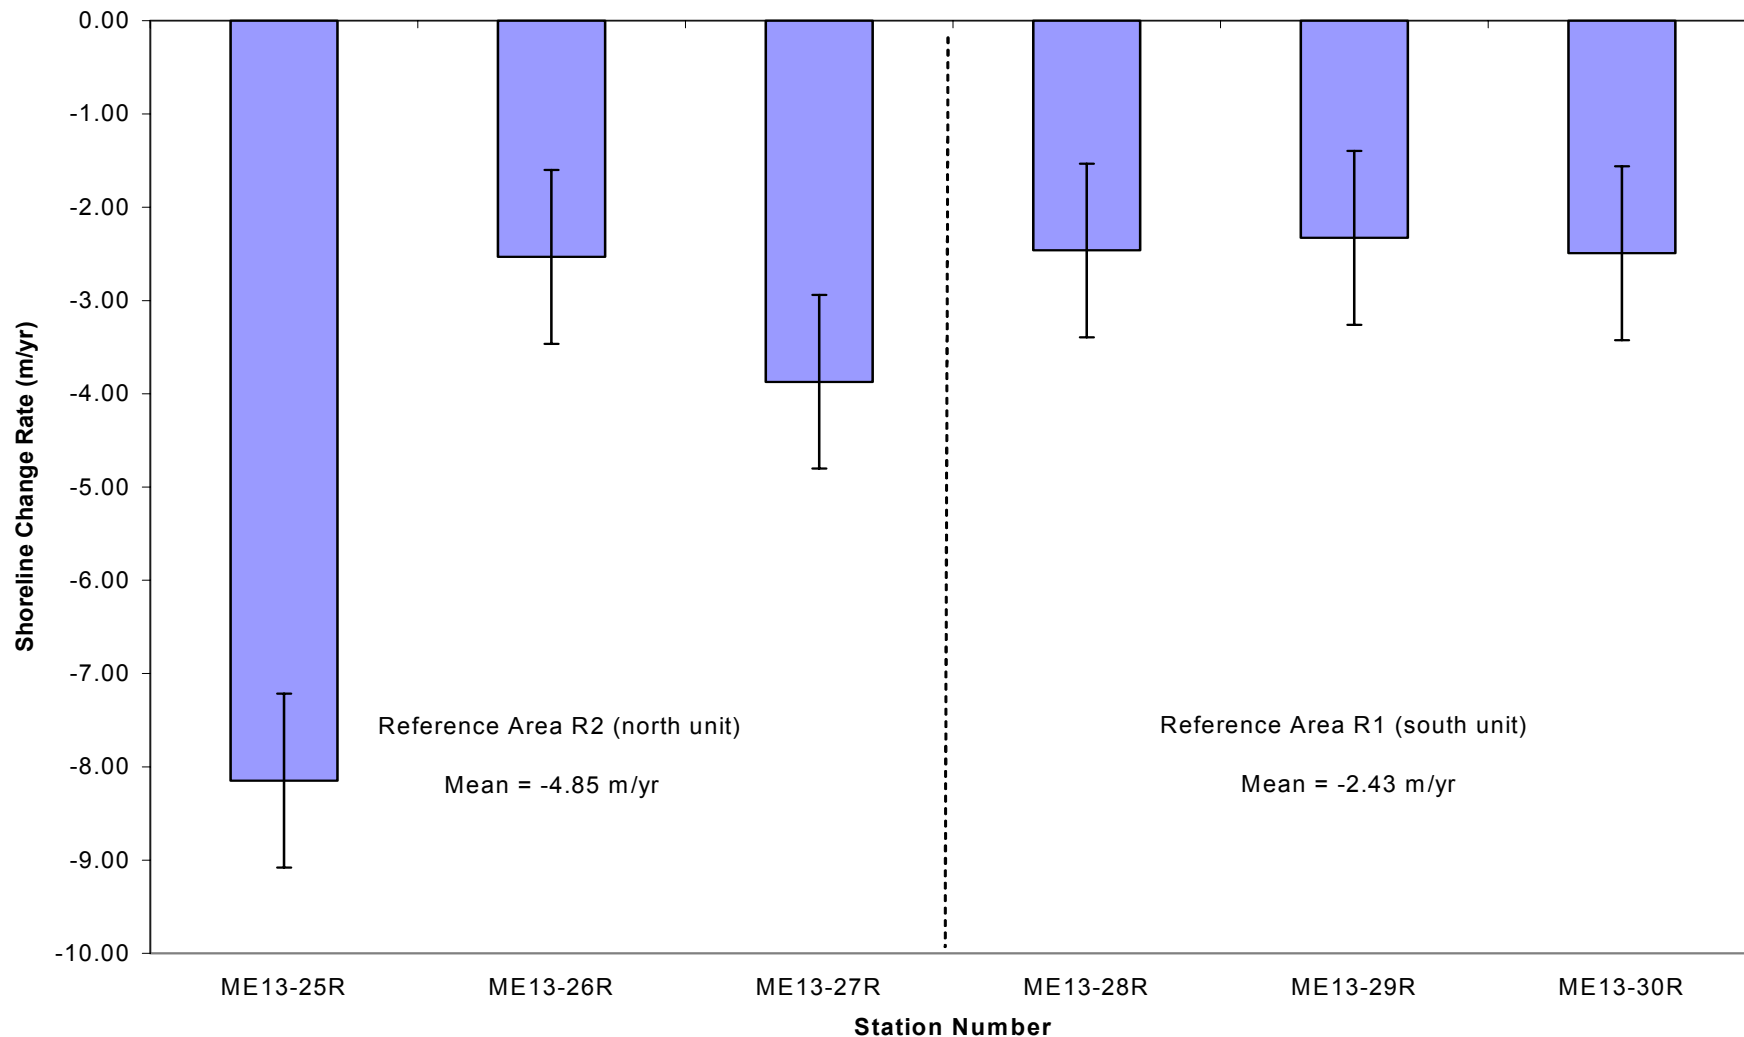
Figure 7. Shoreline change rate (m/yr) along Freshwater Bayou Canal at the ME-13 reference area monitoring stations for the 23 July 1998 – 21 July 2003 time period. Error bars represent ± 1 standard error of the mean of all 6 stations.

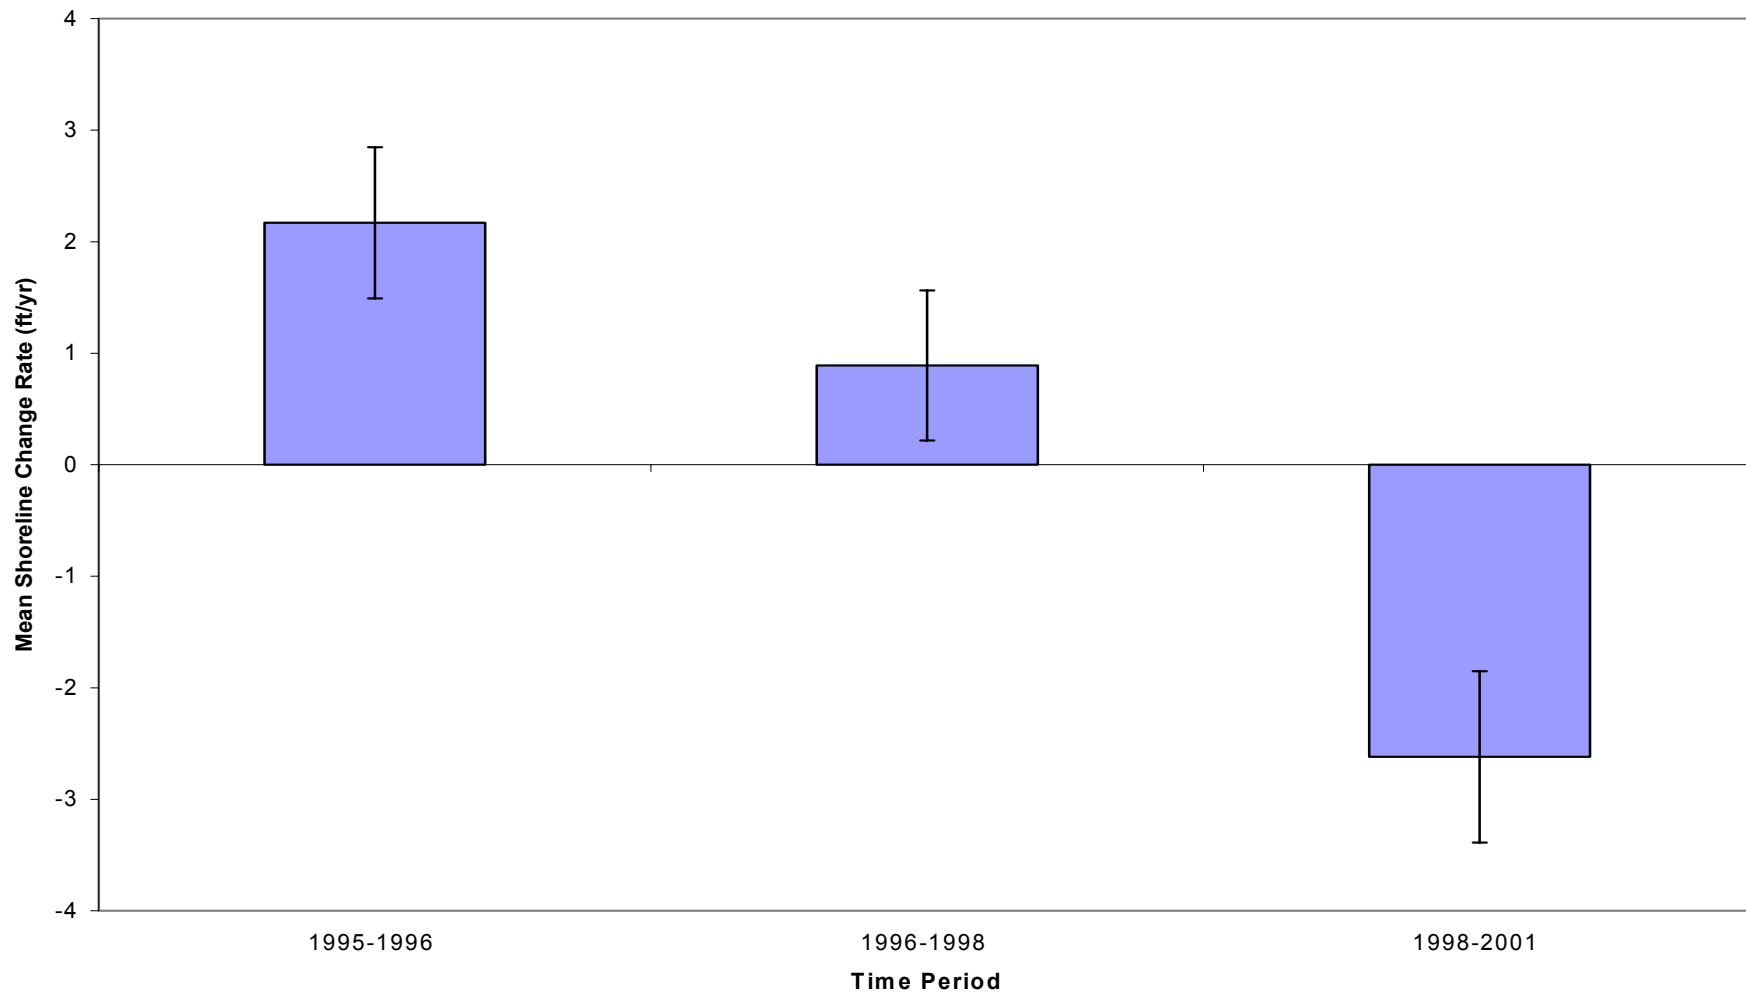
Figure 12. Mean shoreline change rate (ft/yr) along Freshwater Bayou Canal behind the ME-04 project rock dike from June 12, 1995 – May 15, 2001. Error bars represent ± 1 standard error of the mean of all 24 project area stations.

- Previous data from the two reference areas collected between April 27, 1995 and May 15, 2001 for the Freshwater Bayou Wetlands Protection (ME-04) project, document mean shoreline change rates of -6.69 ft/yr (-2.04 m/yr) from 1995-1996, -11.15 ft/yr (-3.40 m/yr) from 1996-1998, and -9.17 ft/yr (-2.79 m/yr) from 1998-2001 (figures 10 and 11). Between 1995-1996, the shoreline retreat rate was greater along the reference area R1 (south unit) shoreline, but from 1996-2003 the retreat rate has been greater along the reference area R2 (north unit) shoreline (figures 10 and 11).
- Over this same time period, the Freshwater Bayou Canal shoreline segment behind the ME-04 rock dike (on the opposing bank of FBC) prograded +2.17 ft/yr (+0.66 m/yr) from 1995-1996, prograded +0.89 ft/yr (+0.27 m/yr) from 1996-1998, but eroded -2.89 ft/yr (-2.79 m/yr) from 1998-2001 (figures 12 and 13).

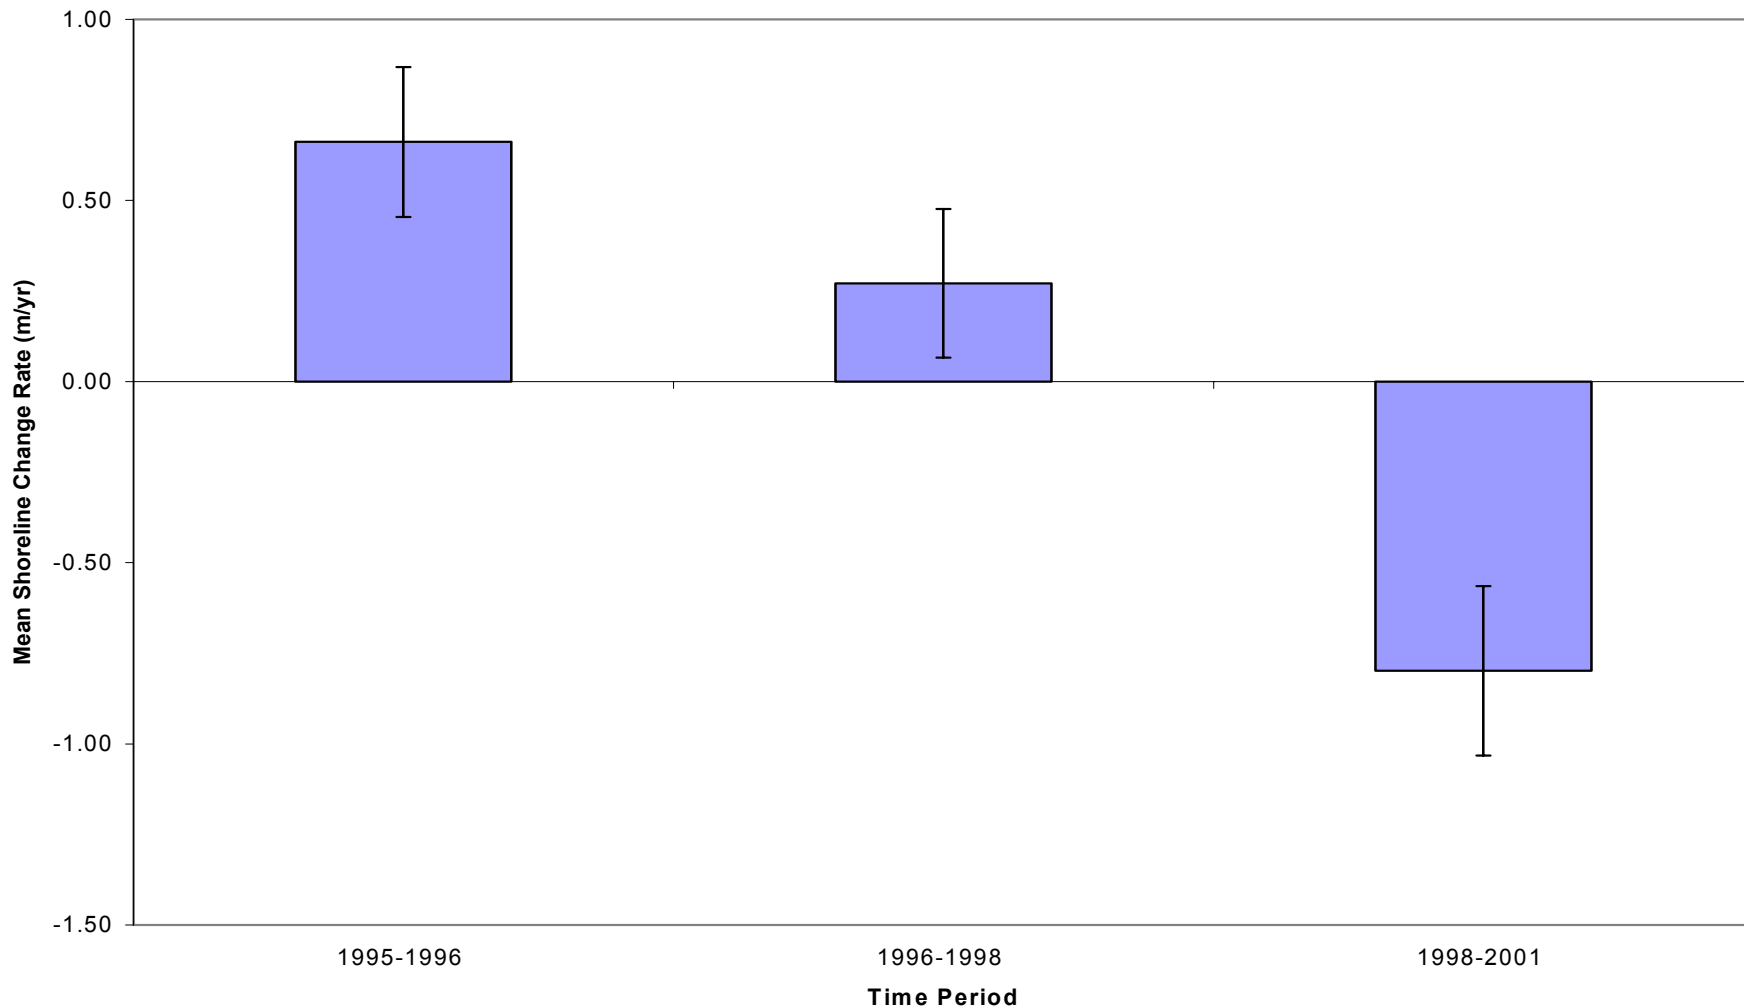
Figure 13. Mean shoreline change rate (m/yr) along Freshwater Bayou Canal behind the ME-04 project rock dike from June 12, 1995 – May 15, 2001. Error bars represent ± 1 standard error of the mean of all 24 project area stations.

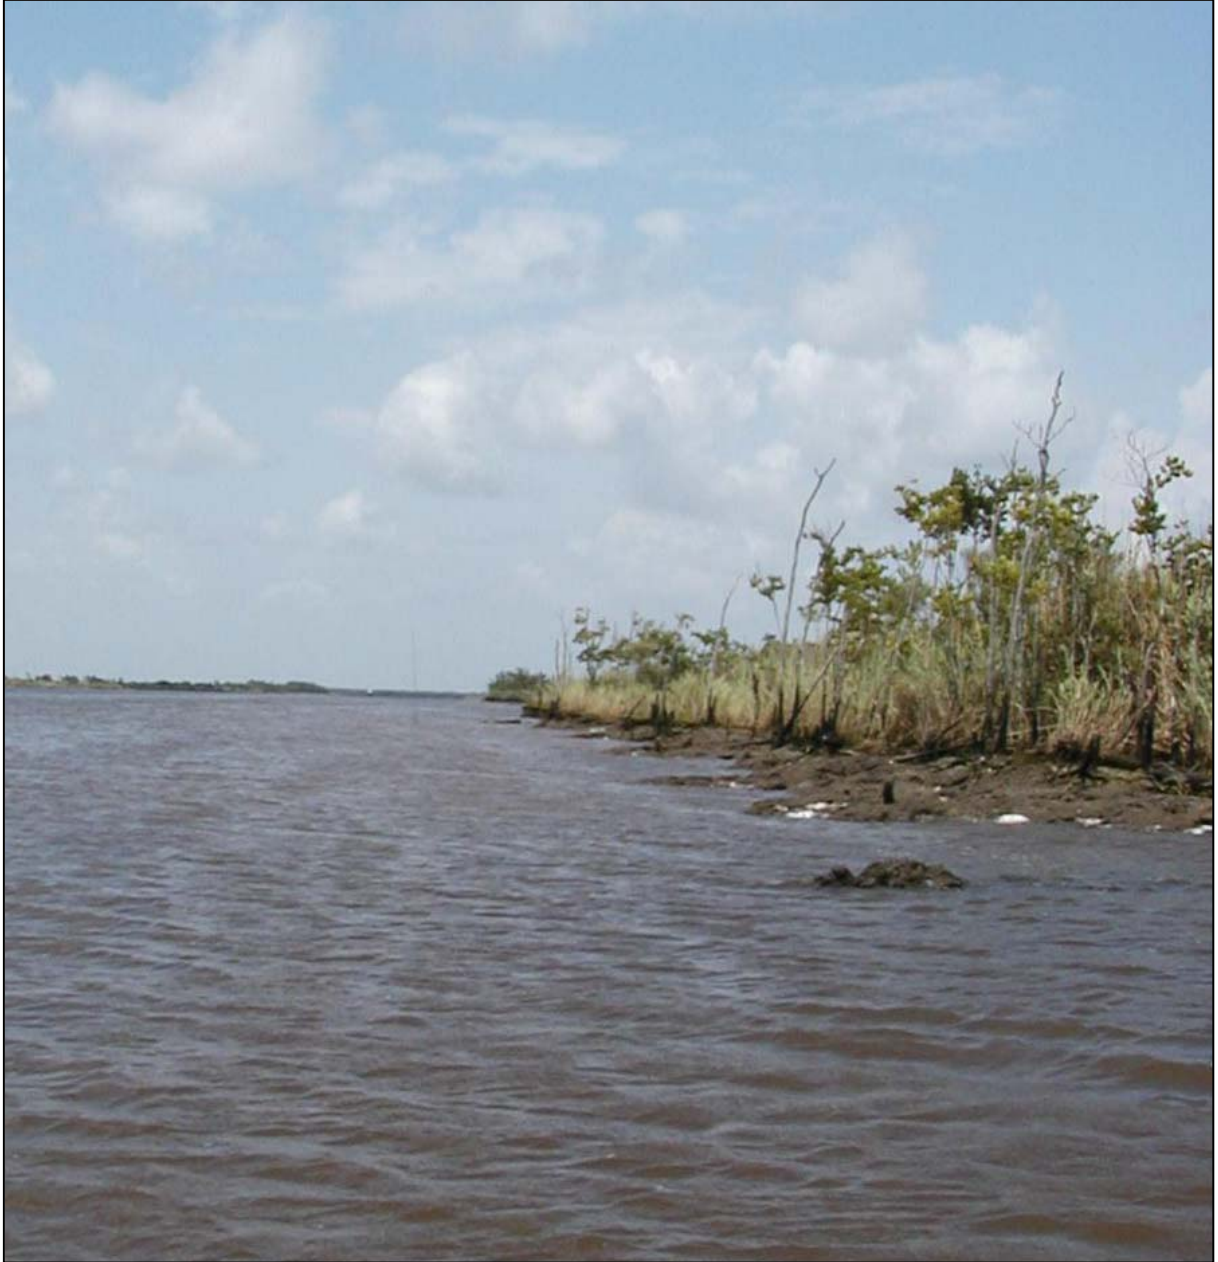
Figure 14. View of the Freshwater Bayou Canal shoreline along reference area R1 (south unit) taken on July 21, 2003. Note the scalloped shoreline profile characterized by small coves and headlands. Fallen trees in this area are repeatedly rammed against the remaining live trees along the shoreline by boat wake-induced wave action.

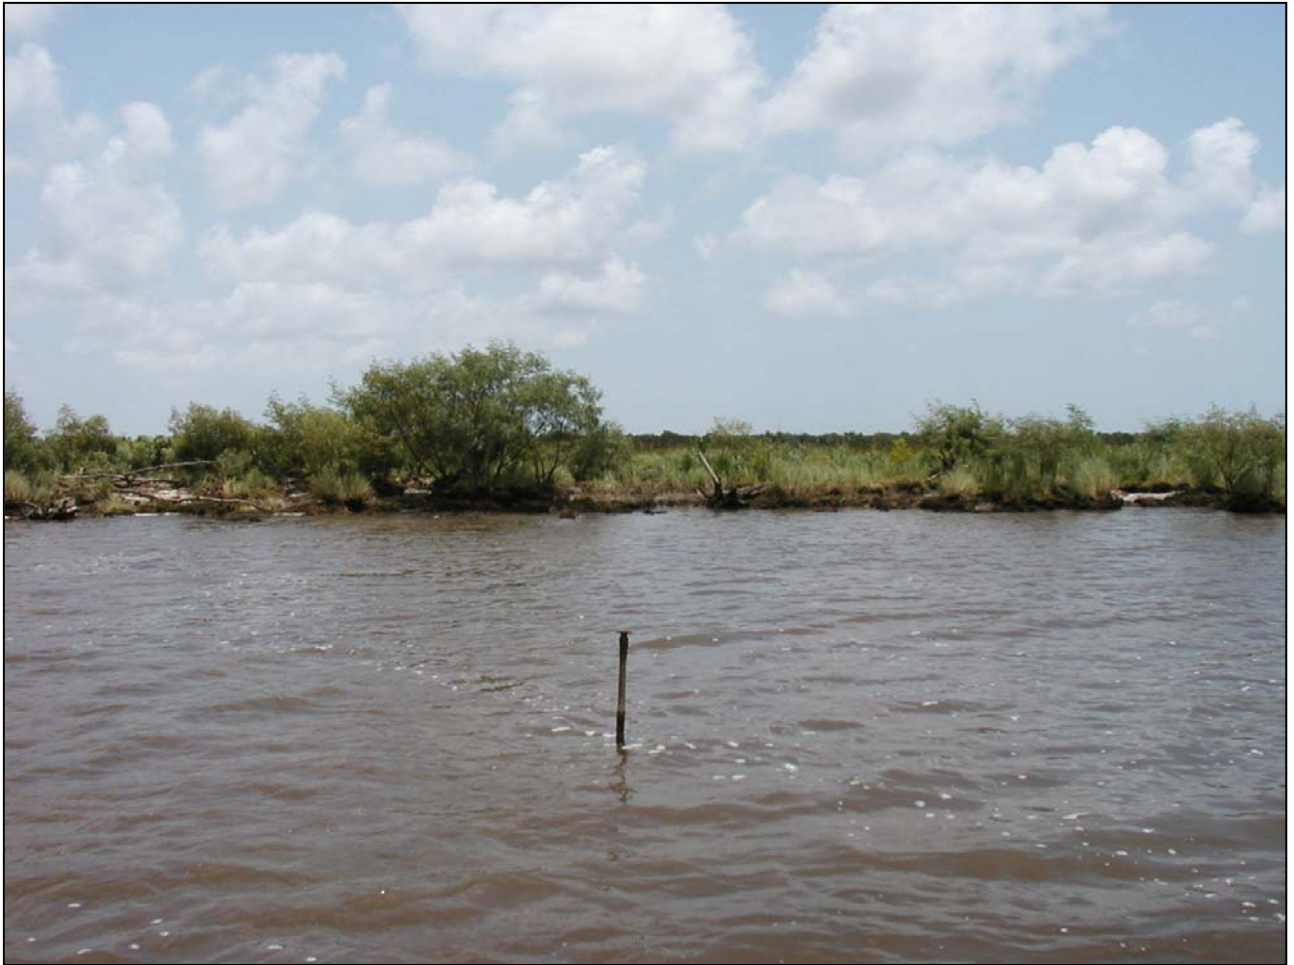
Figure 15. View of the Freshwater Bayou Canal shoreline at reference area R2 (north unit) monitoring station ME13-25R taken on July 21, 2003. Note the current shoreline position which is 89.0 ft (27.1 m) inland from the survey hub visible in the open water in the foreground. The hub was placed 44.7 feet (13.6 m) inland from the shoreline when it was installed in 1998.

Figure 15. View of the Freshwater Bayou Canal shoreline at reference area R2 (north unit) monitoring station ME13-25R taken on July 21, 2003. Note the current shoreline position which is 89.0 ft (27.1 m) inland from the survey hub in open water in the foreground. The hub was placed 44.7 feet (13.6 m) inland from the shoreline when it was installed in 1998.

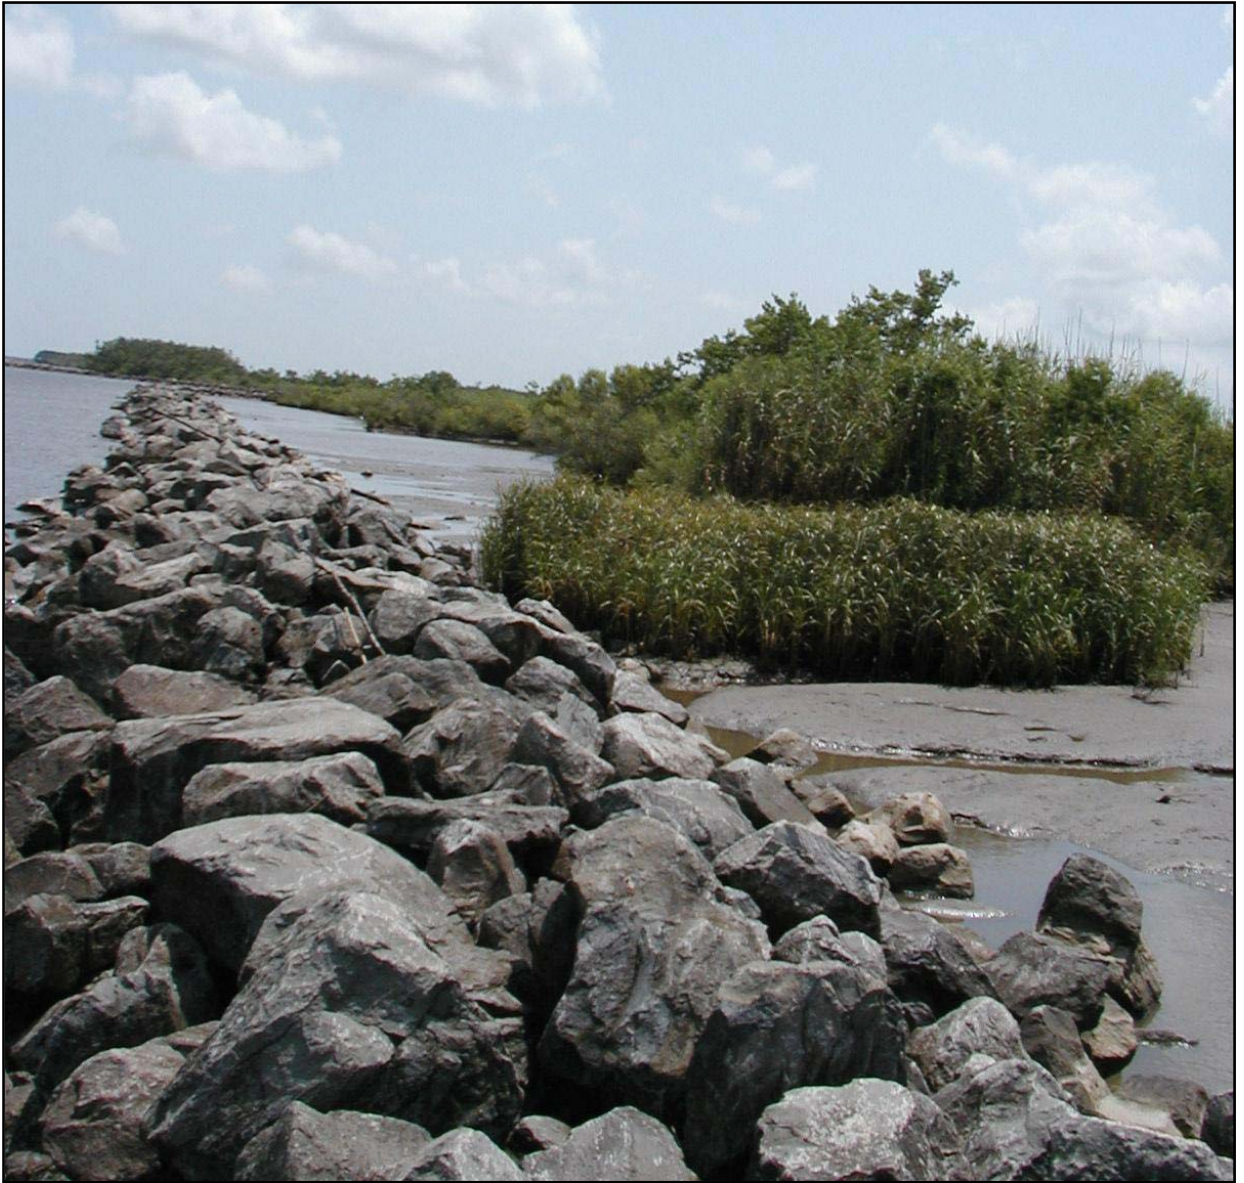
Figure 16. View of the Freshwater Bayou Canal shoreline behind the ME-13 rock dike, looking south from monitoring station ME13-01, as observed on July 21, 2003. Note the healthy condition of the native vegetation along the shoreline and colonizing the shelf of sediment accumulating between the shoreline and rock dike.

- Variation in the shoreline retreat rate along the project and reference area shorelines may be related to the erodibility of the substrate. Additionally, variability in the project area may also be related to crown height of the rock dike, which may require periodic additions of rock to be maintained. Marsh soils erode more rapidly than spoil bank soils, which erode more rapidly than shell ridges. In unprotected areas, variation in substrate erodibility produces a scalloped shoreline profile with small coves and headlands (figure 14). In protected areas, sediment accumulates along shorelines behind rock dikes, which tend to prograde towards the rock dike, and can even meet the rock dike with accumulated sediment which can revegetate naturally (figure 16).

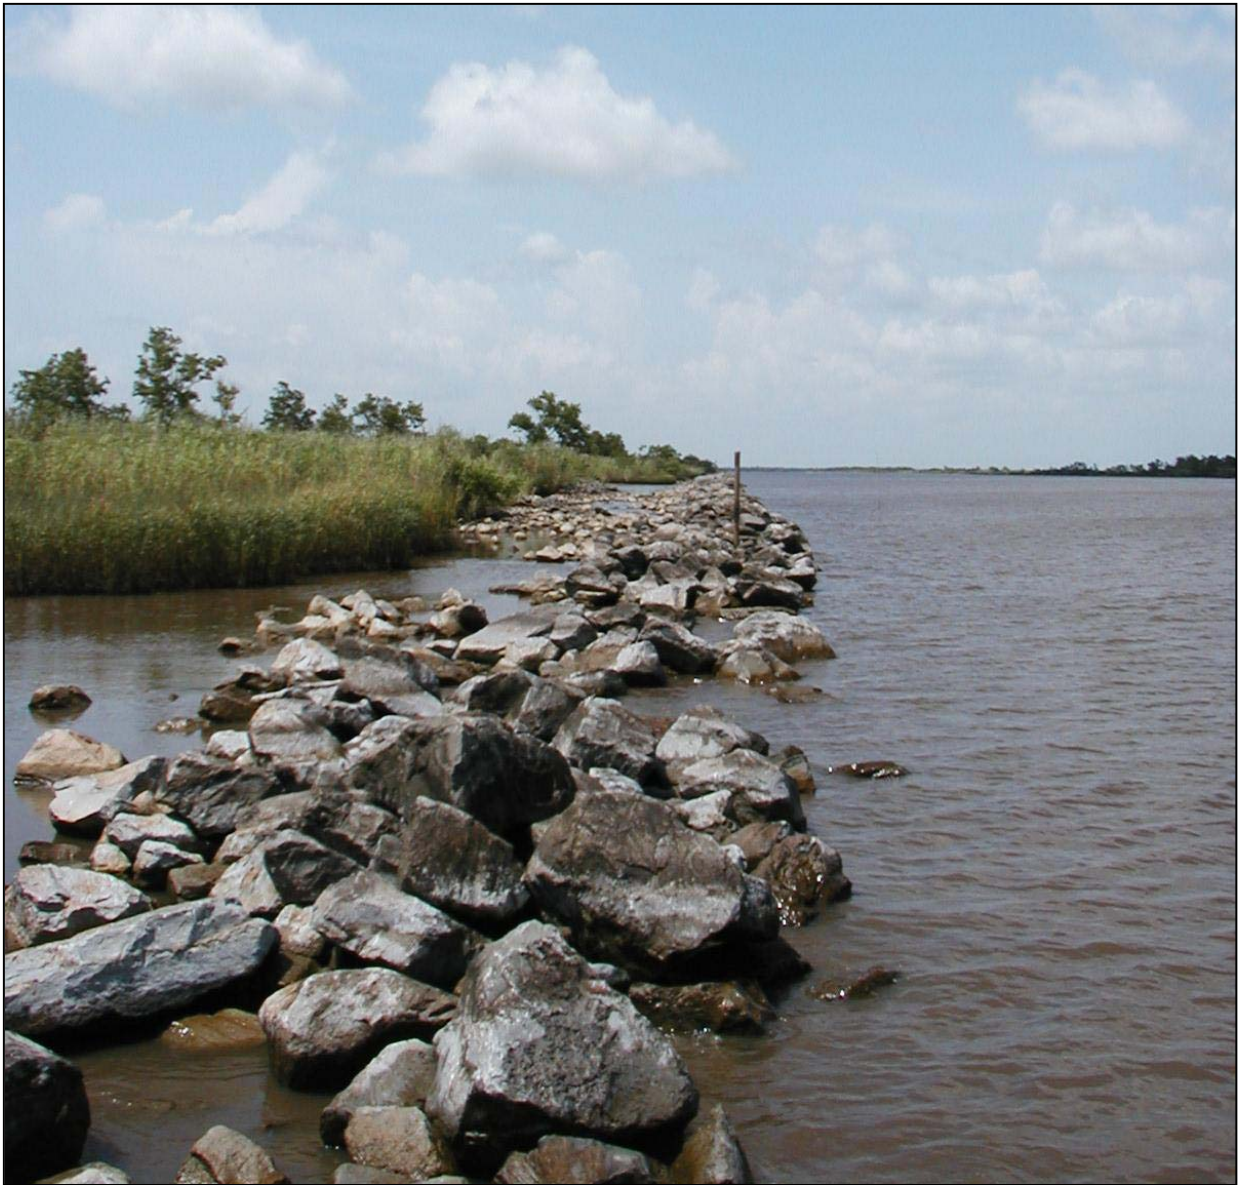
Figure 17. View of the ME-13 rock dike looking north towards station ME13-12 at settlement plate no. 12, taken on July 21, 2003. The dip in the rock dike in front of the settlement plate post will require maintenance to bring this section of dike back up to the specified crown height.

- Maintenance is needed at several locations to bring the ME-13 rock dike structure up to the specified crown height, including a low spot near station ME13-08 at settlement plate 8, and just south of station ME13-12 and settlement plate 12 (see figure 17).
