**2007/2008 Annual Inspection
Report**

**HOLLY BEACH SAND
MANAGEMENT PROJECT
(CS-31)**

State Project Number CS-31
Priority Project List 11

October 30, 2007
Cameron Parish

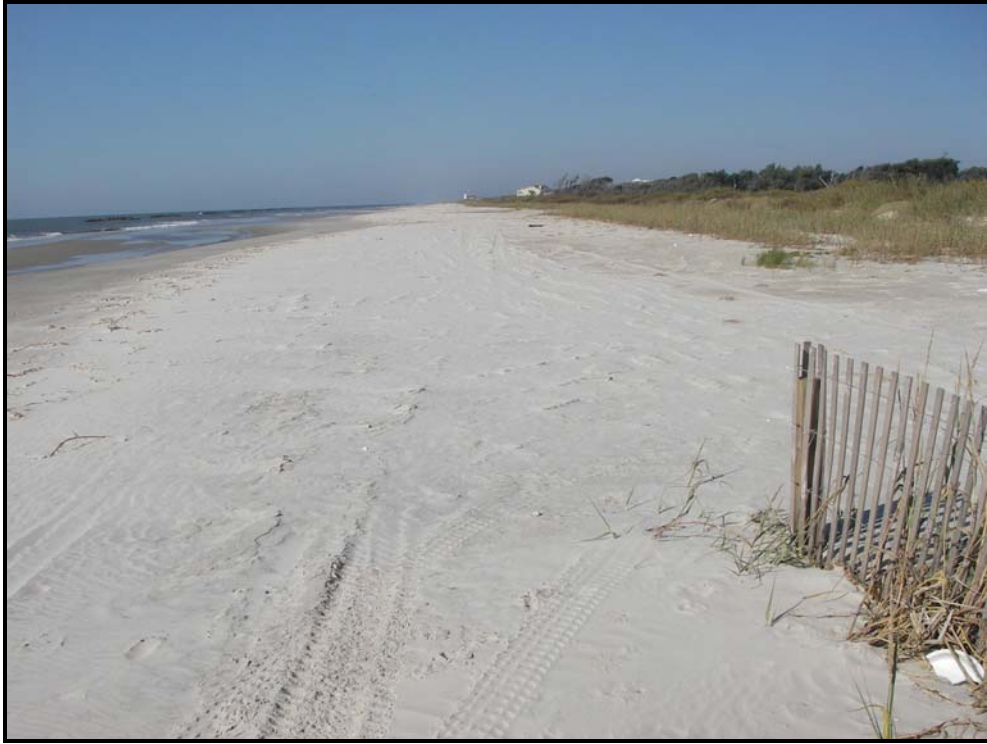
The entire reach of the 28,000 linear feet of the beach fill area appeared generally clean and had areas of scattered debris. The recent Hurricane HUBERTO which made landfall in east Texas on September 13, 2007 pushed debris against the sand fence or carried same away via westerly currents. The sand fill was judged to be in excellent shape, with the majority of the “plateau area” that was initially constructed still in place. Beyond the western end of the project, we observed that some significant amounts of sand material had been deposited onto areas adjacent to the beach as per visual observation and recent 2005 aerial photography. (Photos: Appendix B, Photos 1 & 3).

Photo 1, View of sand enhancement project, looking west beyond project limits. (10-30-2007)

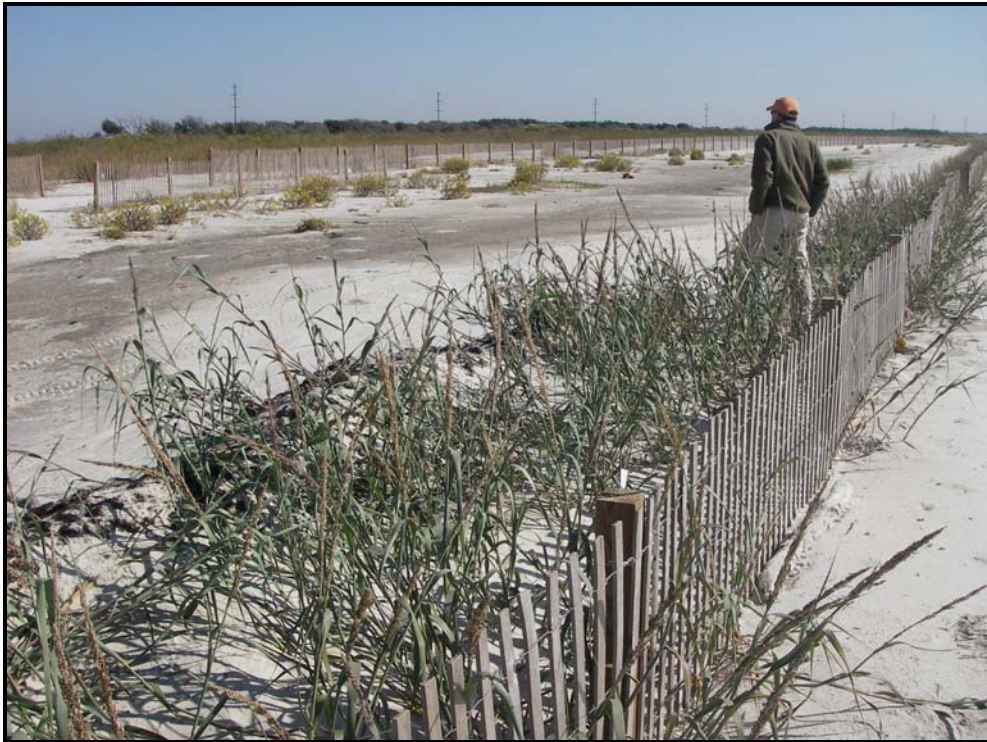
The entire initially installed sand fence was destroyed by Hurricane RITA and a Sand Fence Repair Maintenance Project to replace 46,000 linear feet was performed as noted above in Section IV. The primary fence is currently in good condition with only a few minor areas having damage to the fence. The secondary fence from the western end of the project to approximately mid-point of the project area is in good condition. However, the remaining secondary fence from mid-point of the project to the eastern end has sustained damage from high water events, in particular the high surge from Hurricane HUBERTO in September, 2007. In some areas the fence is laying down, in other areas the entire fence and some posts are missing. Sand dunes have developed in front of and behind the primary fence along most of the project. Sand is accumulating and developing a plateau in some areas between the secondary and primary fence locations, where approximately one-half of the secondary fence is covered with sand. The vegetative plants located adjacent to both fence alignments are doing well and helping to trap sand and develop small dunes. (Photos: Appendix B, Photos 2, 3, 4 & 5).

Photo 2, Close up view of beach head with vegetative plants adjacent to the fence. (10-30-2007)

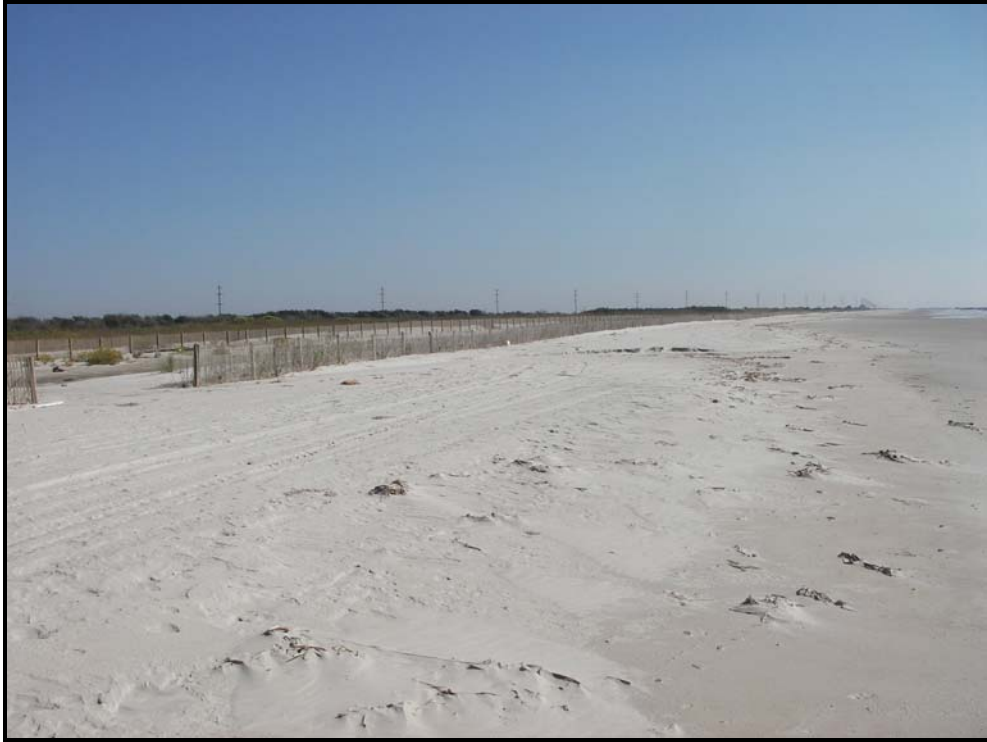
Photo 3, View of primary and secondary fence located on western end of the project. (10-30-2007)

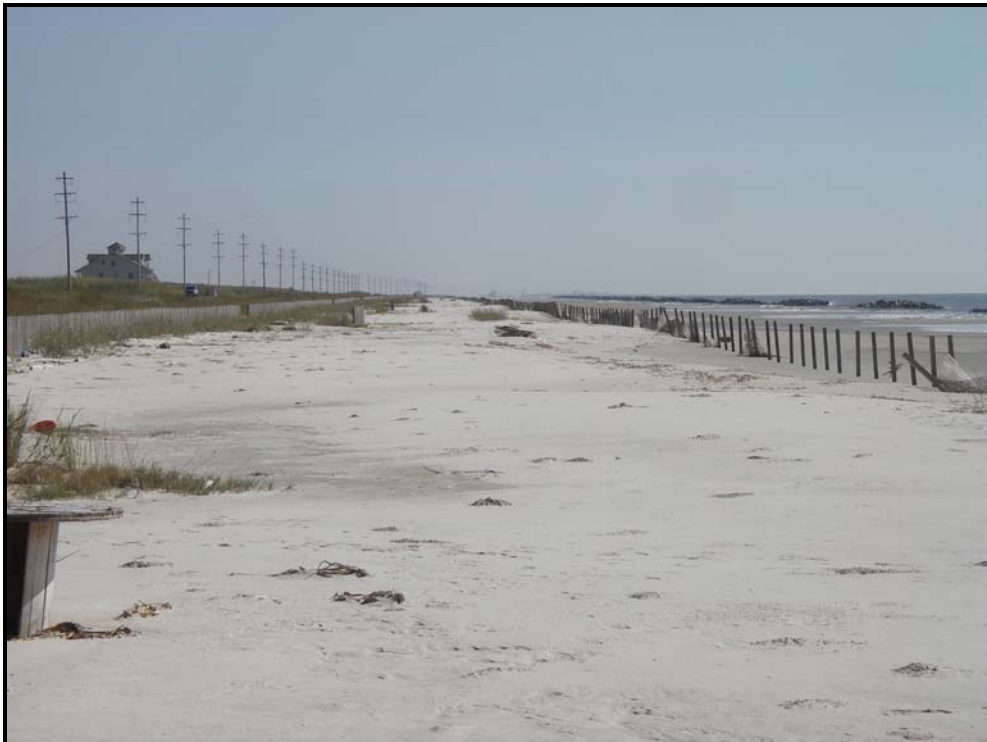
Photo 4, Secondary fence (from mid-project eastward) has sustained damage from high tide events. (10-30-2007)

Overall, the Holly Beach Sand Management Project is in good condition and functioning as designed with problems as noted above. The beach plateau is still functional after the sand erosion from Hurricane Rita. Although some parts of the secondary fence have sustained damage and may not be functioning, it was agreed that no maintenance would be performed at this time. Such that this area of secondary fence is located closest to the waters edge, or wet sand line, it is susceptible to damage by high water events, which will probably occur again. It was discussed to monitor the situation for one more year and then make a decision to relocate the fence further back, away from the water or perhaps leave the damaged fence as is and install vegetative plantings between the primary and secondary fencing.

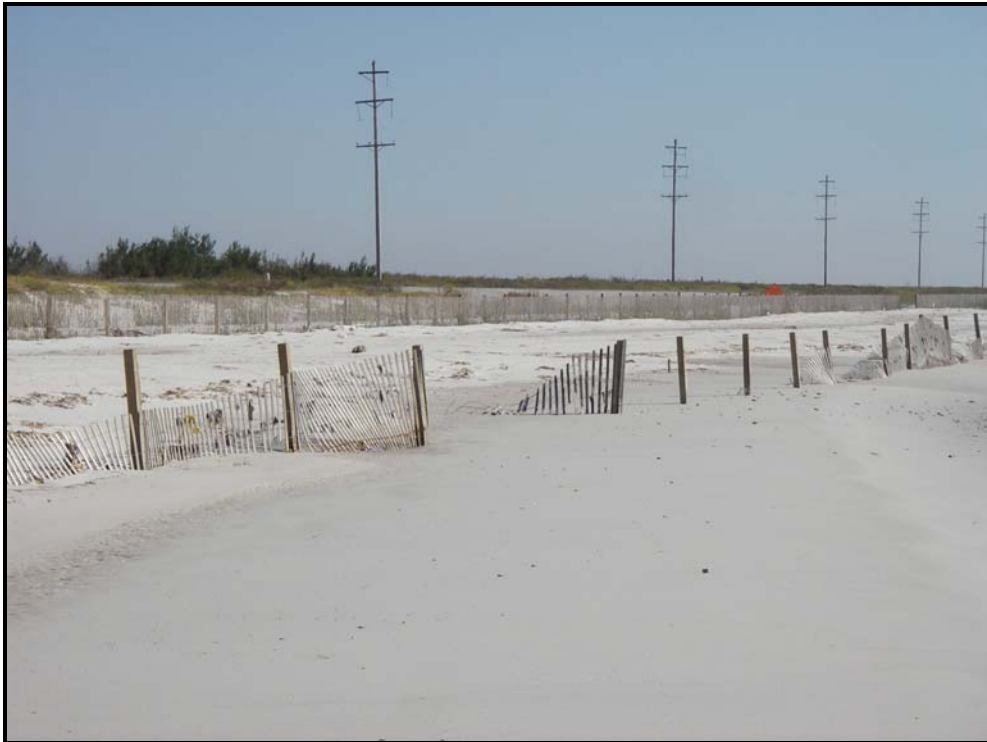
Photo 5, Close up view of damaged secondary fence looking eastward. (10-30-2007)
