**2007/2008 Annual Inspection  
Report**

**FRESHWATER BAYOU  
WETLANDS PROJECT  
(ME-04)**

State Project Number ME-04  
Priority Project List 3

April 24, 2008  
Vermilion Parish

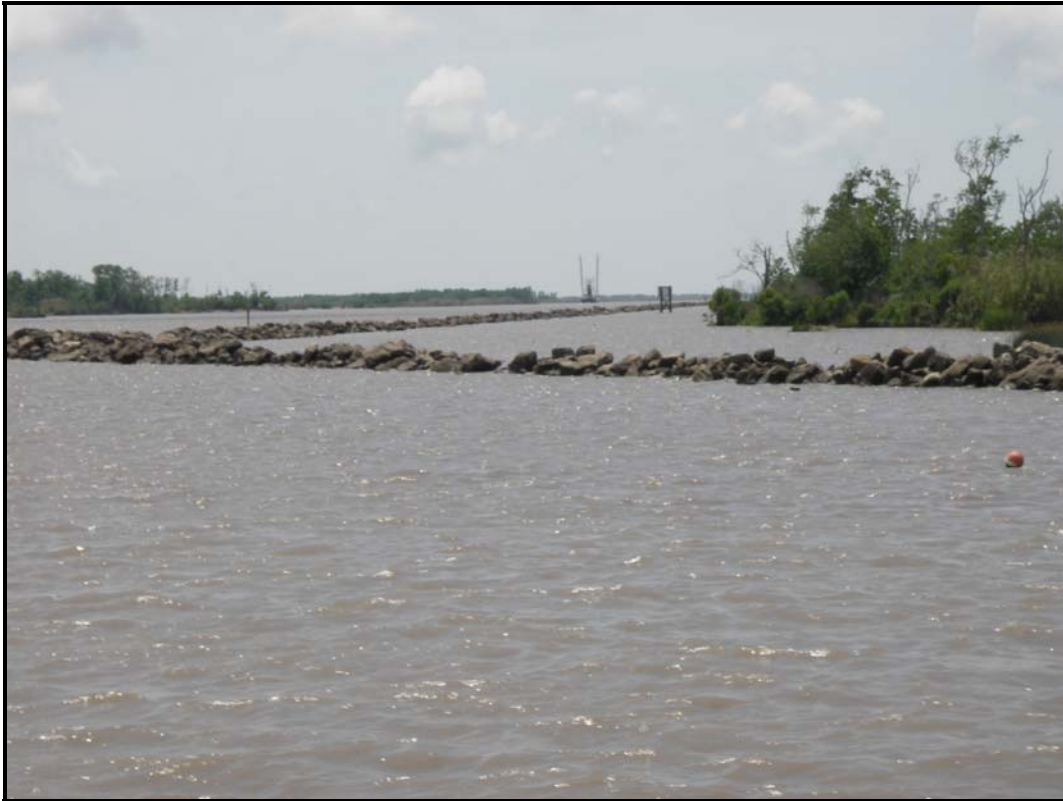
The inspection revealed the 11,420 linear feet of foreshore dike repaired in the 2005 maintenance project is in good condition. The additional 2,000 linear feet of foreshore rock dike identified in the 2003/2004 O & M Inspection as being below elevation 4.0' NAVD, but above elevation 2.0' NAVD, which was not addressed due to budget limitations has not deteriorated further. (Photos: Appendix B, Photos 1 & 2)

**Photo 1**, northern end of rock dike tie-in

Overall the Freshwater Bayou Wetland Project is in good condition and appears to have stabilized the erosion of the Freshwater Bayou Canal Bank line. The above mentioned 2,000 linear feet of foreshore rock will continued to be monitored for deterioration in future O& M Inspections.

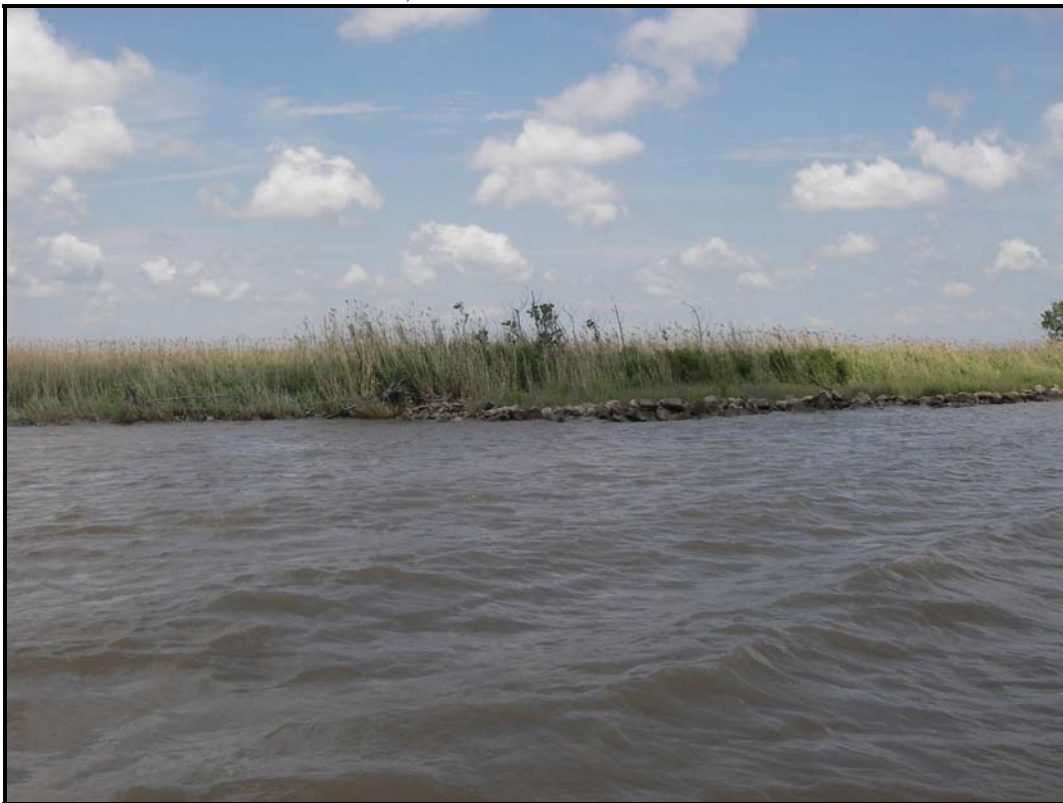
**Photo 2**, southern end of rock dike tie-in
