**Coastal Protection and Restoration  
Authority of Louisiana**

**2009/2010 Annual Inspection  
Report**

**CAMERON/CREOLE  
WATERSHED HYDROLOGIC  
RESTORATION PROJECT  
(CS-17)**

April 6, 2010  
Cameron Parish

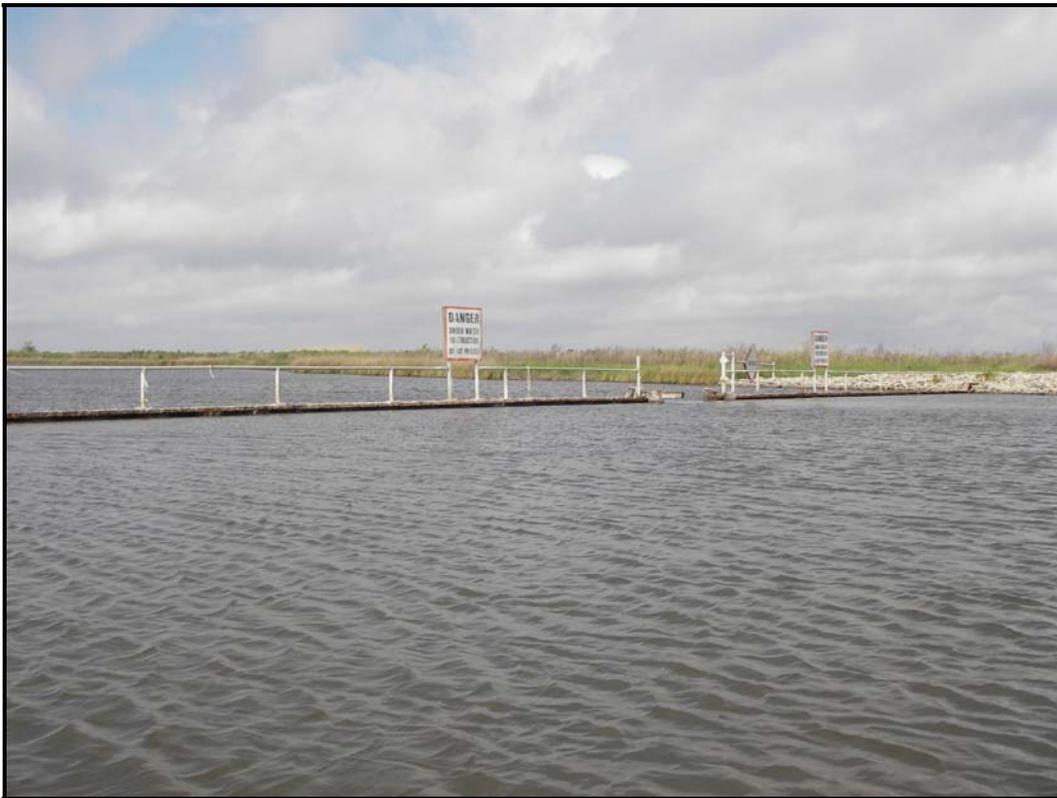
Overall this structure is in good condition. The west boat guide has been removed from the structure assumed to be by vandals. Warning signs, swing gate and top rail are still visible. The recent maintenance event performed in 2009 to armor the ends of the sheet pile wall has been effective and looks in good condition. The sheet pile wall is showing signs of deterioration and will be monitored during future inspections. (Photos: Appendix B, Photos 1-3).

**Photo 1,** Grand Bayou Weir, view looking south.

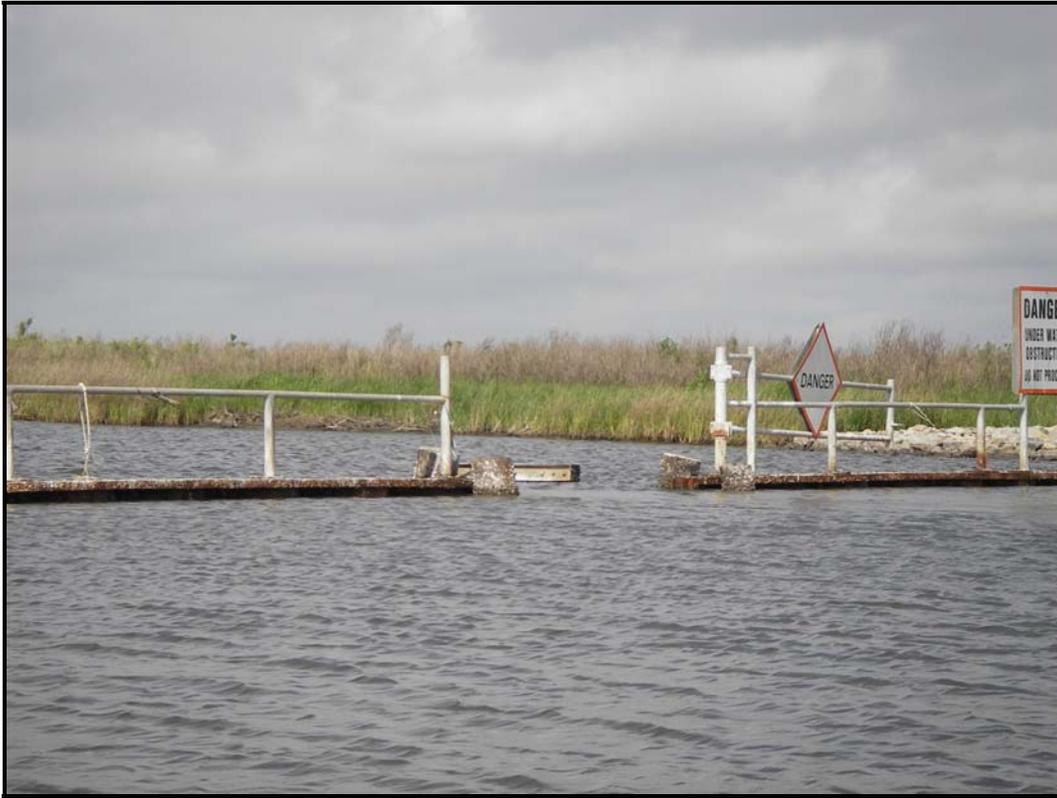
**Photo 2**, Grand Bayou Weir, close up view showing missing boat guide.

What are the conditions of the existing levees? Fair  
 Are there any noticable breaches? None  
 Settlement of rock plugs and rock weirs? None  
 Position of stoplogs at the time of the inspection? N/A  
 Are there any signs of vandalism? Removal of boat bay guide

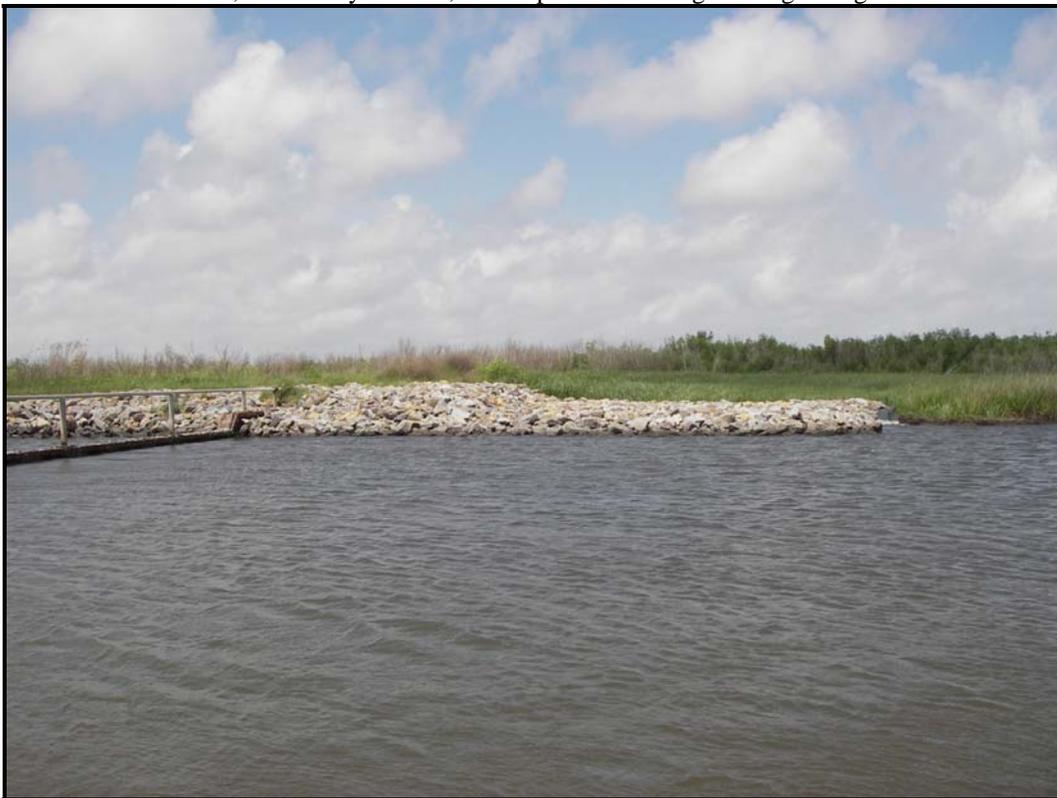
**Photo 3**, Grand Bayou Weir, view showing rock armor on west side.

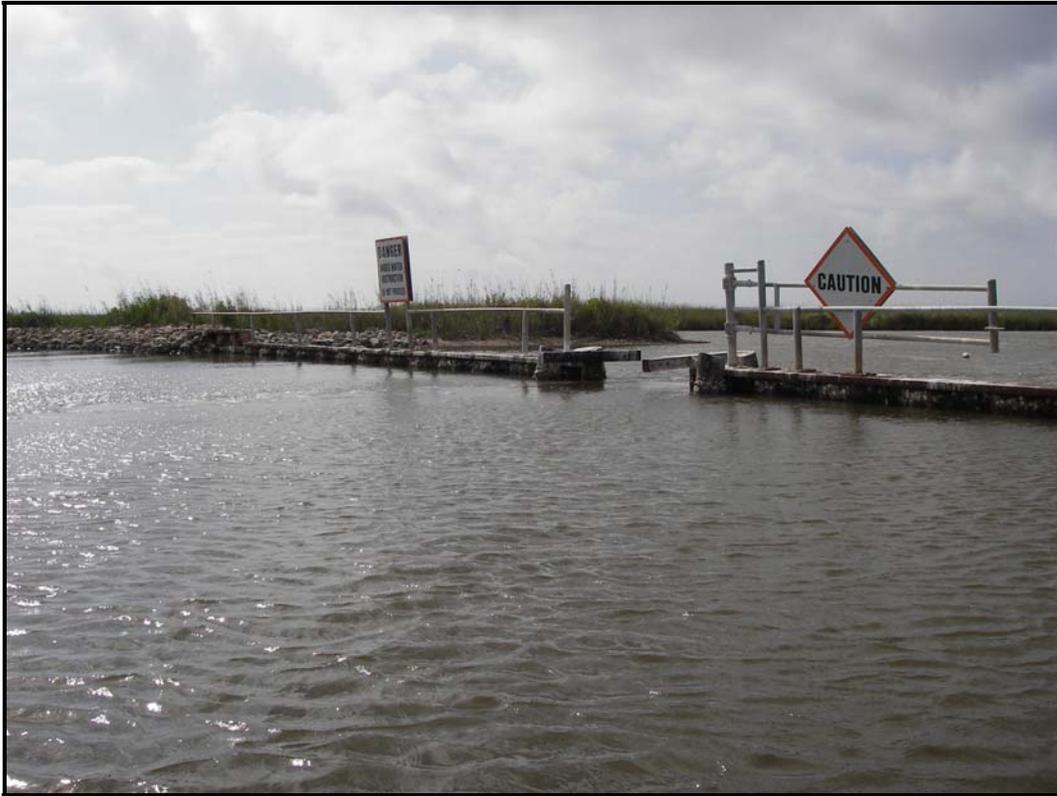
Overall the structure is in good condition. Both boat guides remain on the structure. Warning signs and top railing are still visible. The recent maintenance event performed in 2009 to armor the ends of the sheet pile wall has been effective and looks in good condition. The sheet pile wall is showing signs of deterioration and will be monitored during future inspections. (Photos: Appendix B, Photos 4-6).

**Photo 4**, Mangrove Weir, view looking south.

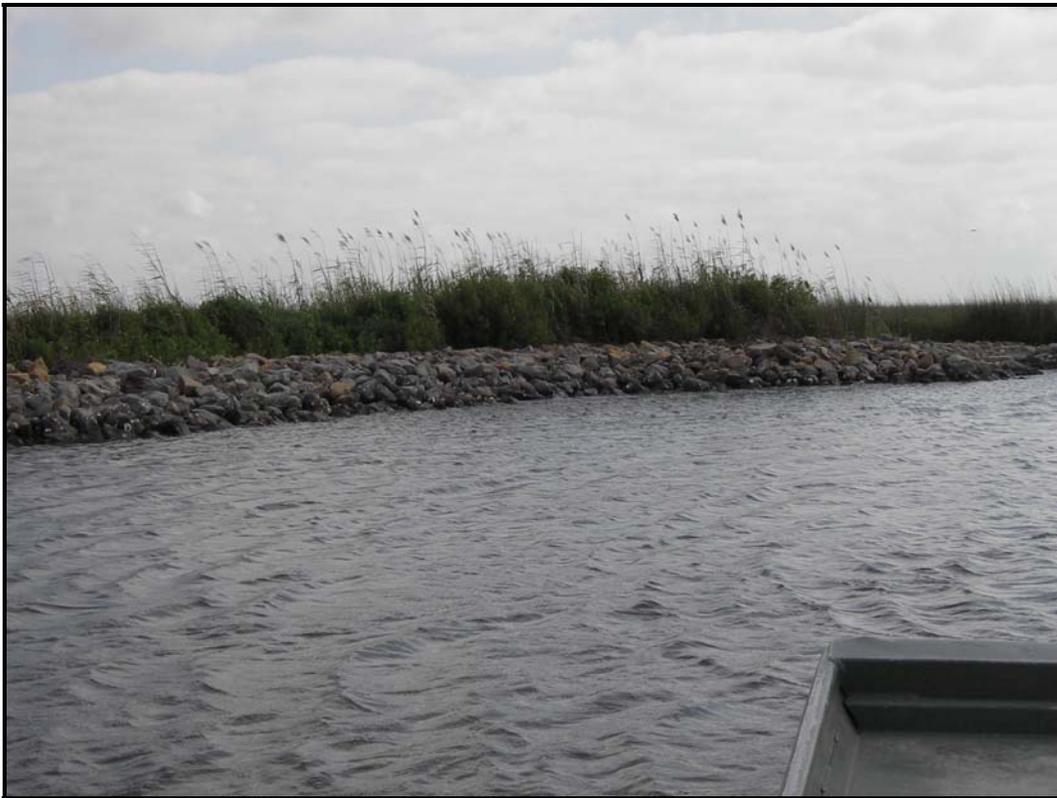
**Photo No. 5**, Mangrove Weir, view of rock armor east side.

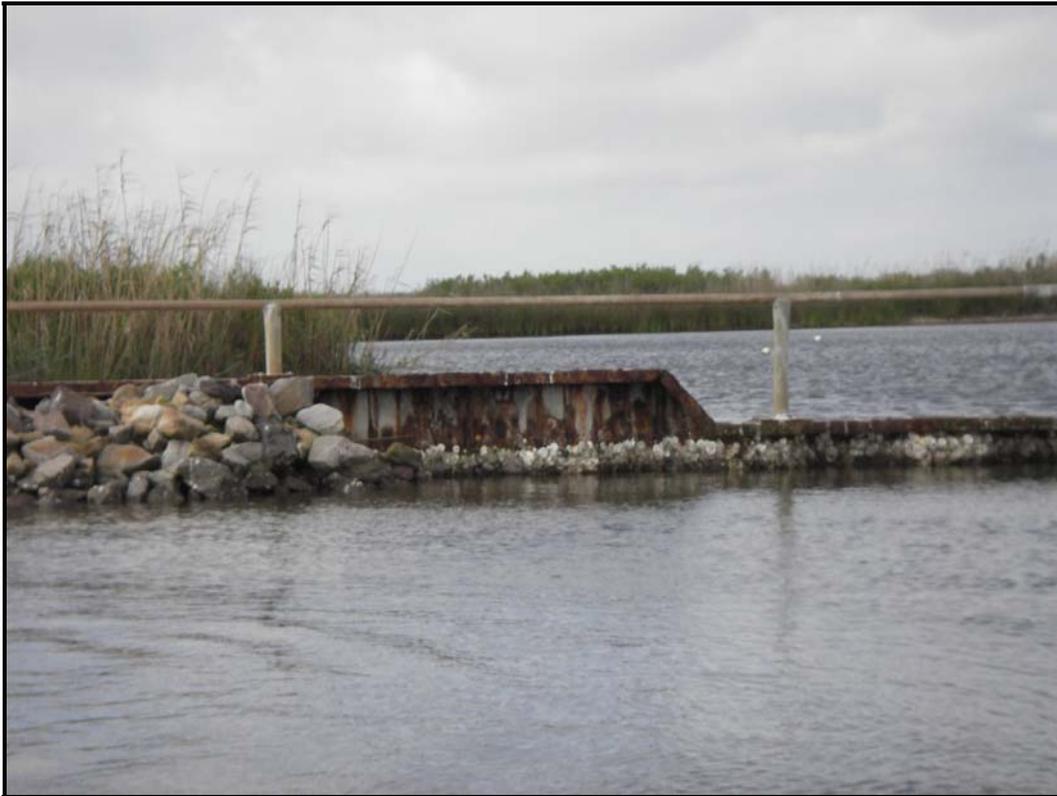
**Photo No. 6,** Mangrove Weir, view of sheet pile wall.
