**2009/2010 Annual Inspection  
Report**

**SABINE REFUGE PROTECTION  
PROJECT (CS-18)**

State Project Number CS-18  
Priority Project List 1

March 18, 2010  
Cameron Parish

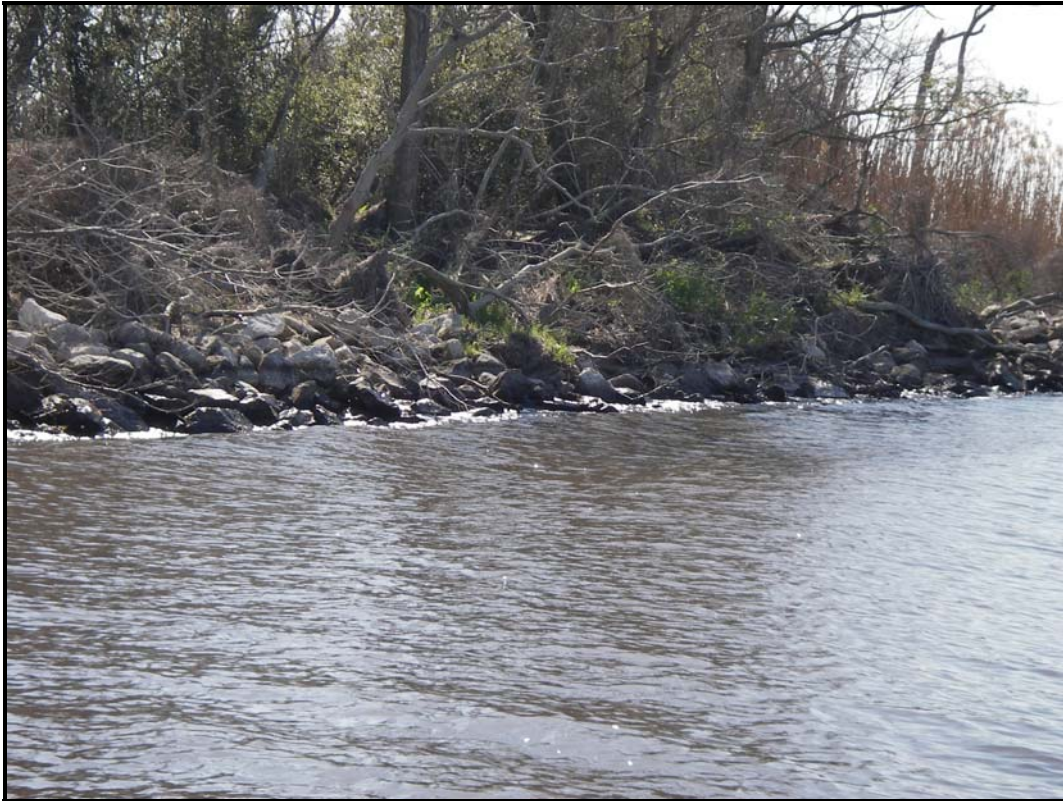
The rock breakwater along the Burton Sutton Canal was inspected along its entire reach. The water level in the Burton Sutton Canal was estimated to be +0.75 NAVD88. The dike is in excellent post construction condition. No need for any maintenance in the foreseeable future. (Photos: Appendix B, Photos 1 - 2)

**Photo 1**—southern tie-in on Burton Sutton Canal

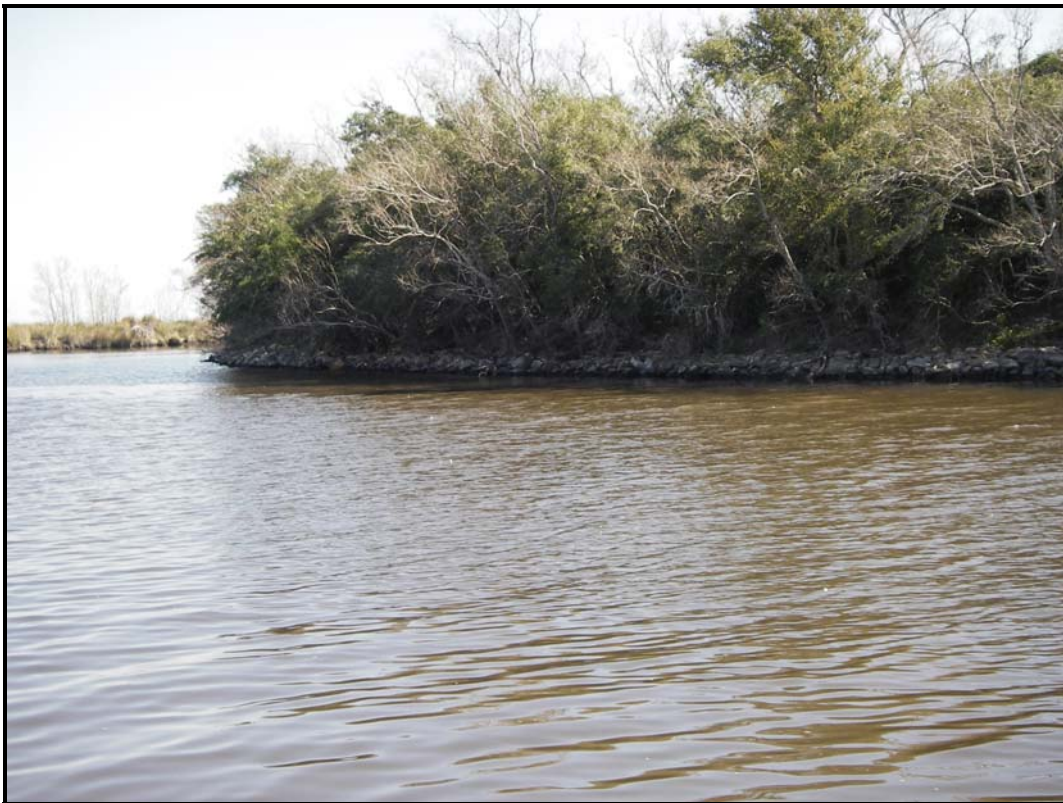
**Photo 2**—northern tie-in on Burton Sutton Canal
