**Coastal Protection and Restoration
Authority of Louisiana**

**2009/2010 Annual Inspection
Report**

**HWY. 384 HYDROLOGIC
RESTORATION PROJECT
(CS-21)**

November 12, 2009
Cameron Parish

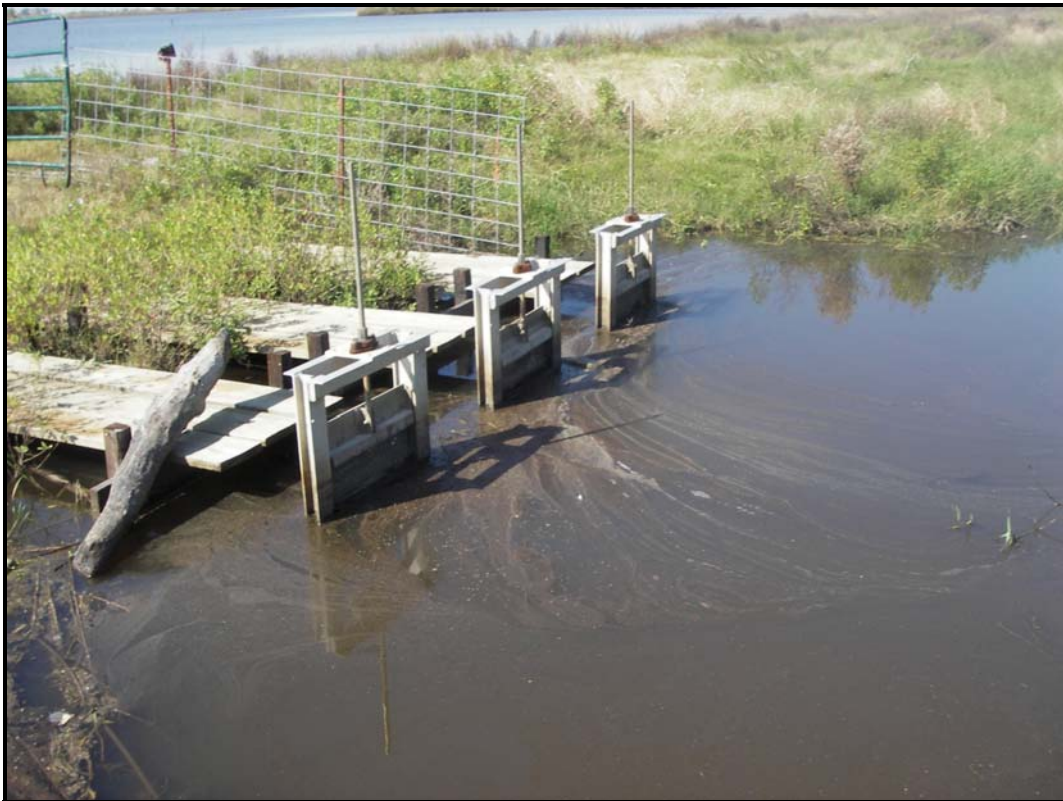
The structure is in good condition. Water level on the outside was elevation +1.65 NAVD88 and the level inside could not be determined because the staff gage was not readable. The inside staff gage will need to be replaced. Rock placed on the bank during the maintenance event of June 2002 is stable and in no need of repair. Two of the outlet flapgates were locked open with small nails. The operations contractor was contacted to unlock the flaps. The hyacinth fence is in good condition; however there is trash accumulating on the outside of the fence which needs to be removed. The road/levee leading up to the structure is in good condition since it was repaired in June 2006. The recently installed Portable Multi-Parameter Water Quality Troll 9500 – 29r operation sonde was not functioning and the operations contractor was also contacted to trouble shoot the problem. The solar panel should be cleaned and bird excluder devices installed. (Photos: Appendix B, Photos 1-3).

Photo No. 1, Structure No.1, inlet side.

- Structure No. 1 – install bird excluder device on solar panel, replace staff gage, remove trash from outside of the hyacinth fence.
- Structure No. 12 – replace metal pile cap covers, install bird excluder device on solar panel.
- Structure No. 8 (Rock Plug) – install staff gauges both lake and marsh sides.

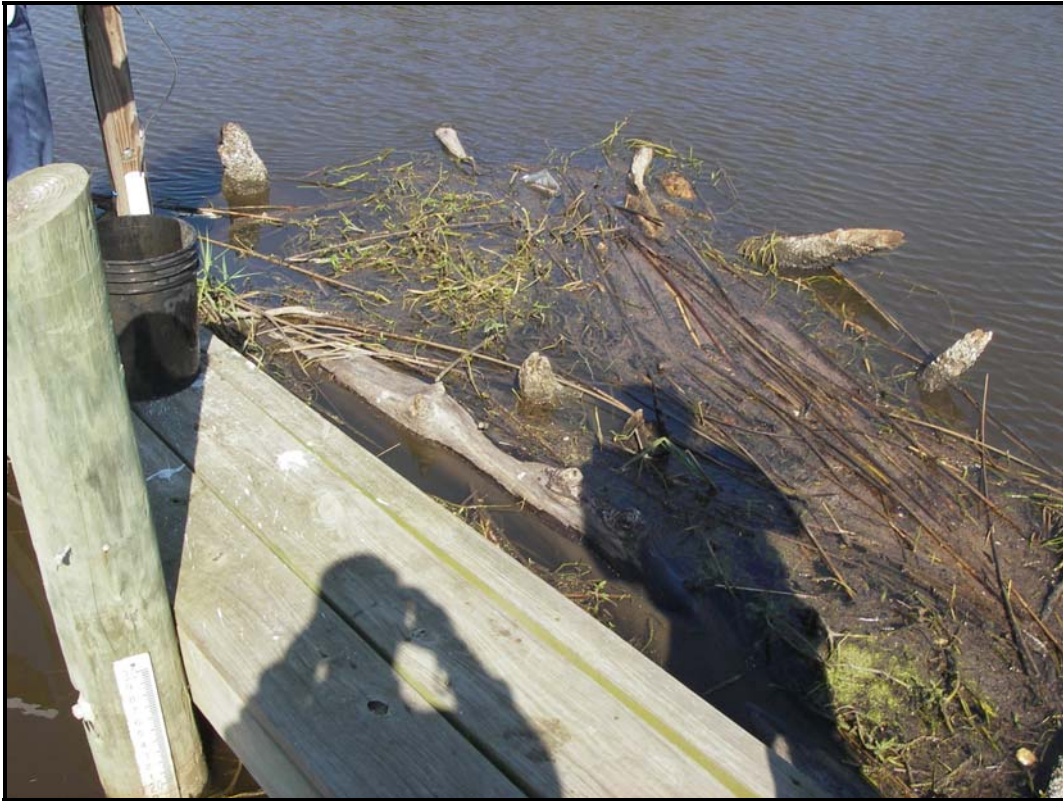
Photo No. 2, Structure No.1, trash along fence.

Item	Condition	Physical Damage	Corrosion	Photo #	Observations and Remarks
Steel Bulkhead / Caps	N/A				
Flapgates/Outlet Pipe	Good			2	2 of 3 flaps locked open with small nails.
Stop Logs	N/A				
Hardware/Sluiceways	Good			1	
Hyacinth Fence	Fair			1	Trash accumulating on outside of hyacinth fence.
Timber Piles	N/A				
Timber Wales	N/A				
Galv. Pile Caps	N/A				
Cables	N/A				
Signage /Supports	N/A				
Staff Gages	Poor				Staff gage outlet side of structure not readable.
Rip Rap (fill)	Good				
WQ Troll 9500 - 29r	Good				Currently not working, will be checked out.
Earthen Embankment					
Access Roadway	Good

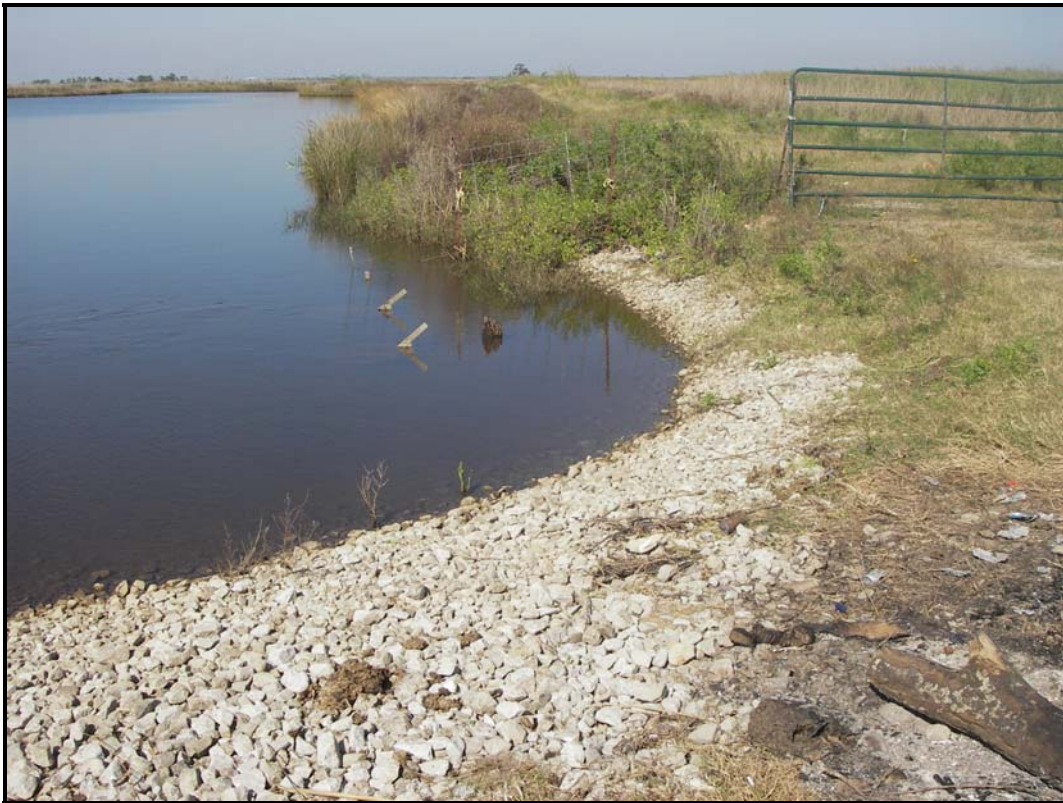
Photo No.3, Structure No.1, outlet side.

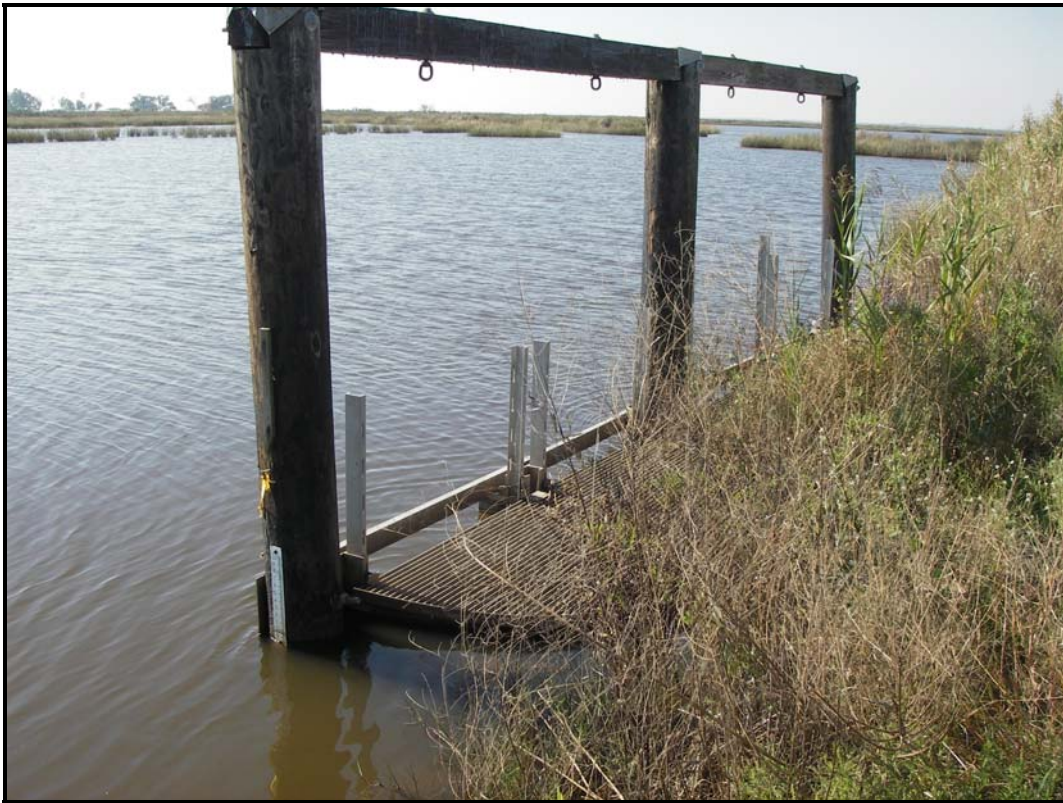
The structure is in good shape and the inlet and outlet sides appear undamaged. Water level on the outside was elevation +1.8 NAVD88 and the level inside was +1.6 NAVD88. Pile caps on the outlet side and the padlocks on the stop log locking devices have rusted and will eventually need to be replaced. Rock that was placed during the maintenance of Nov. 2000 is stable. The road/levee leading up to the structure is in good condition since it was repaired in June 2006. (Photos: Appendix B, Photos 4-5).

Photo No. 4, Structure No. 12, inlet side.

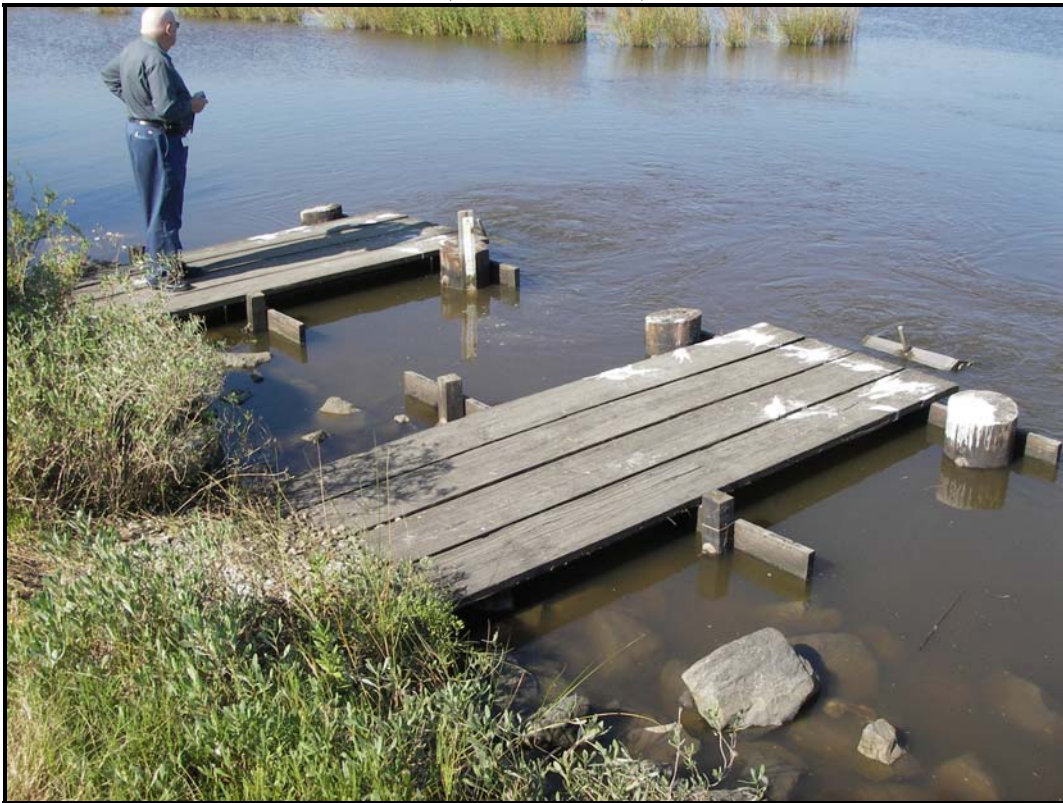
Photo No. 5, Structure No. 12, outlet side.

Item	Condition	Physical Damage	Corrosion	Photo #	Observations and Remarks
Steel Bulkhead / Caps	N/A				
Steel Grating	Good			4	
Stop Logs	Good				
Hardware/Flapgates	Good				
Timber Piles	Good				
Timber Wales	N/A				
Galv. Pile Caps	Fair			5	Pile caps on outlet structure are corroded and will eventually need to be replaced.
Cables	N/A				
Signage /Supports	N/A				
Staff Gages	Fair				
Rip Rap (fill)	Good				
WQ Troll 9500 - 15r	Good				
Earthen Embankment					
Access Roadway	Good

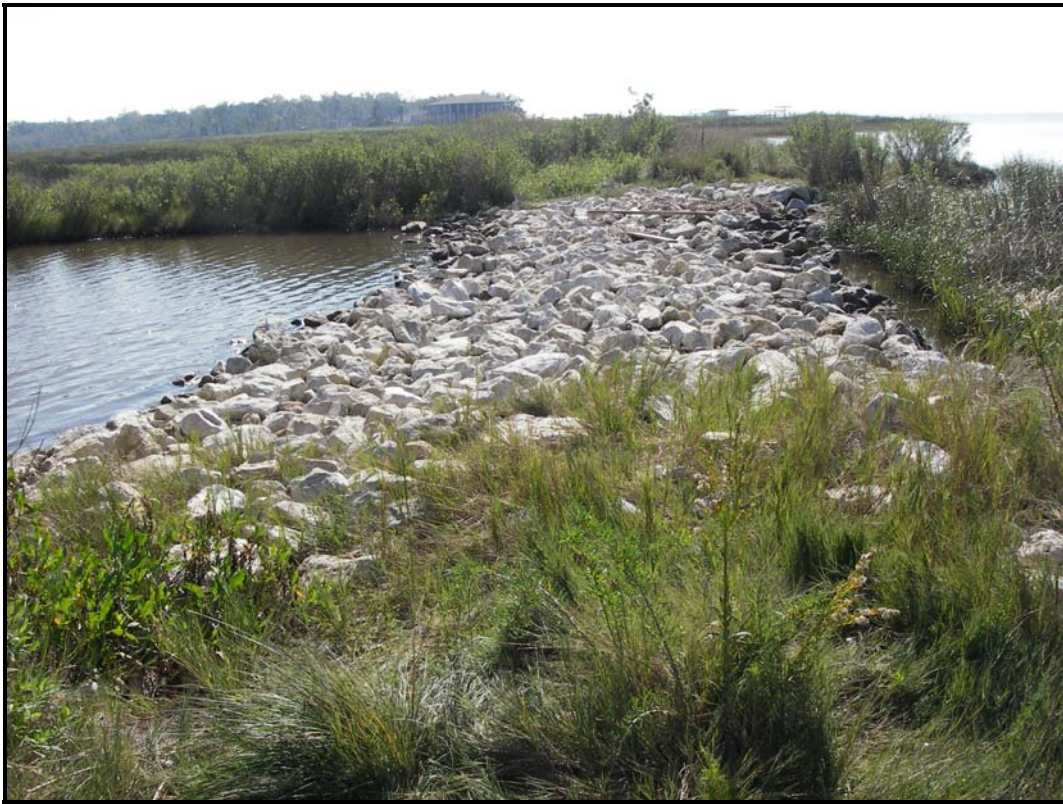
The rock plug is in good condition. Water levels could not be determined because the outside staff gage is missing and the inside staff gage was leaning and not readable. Both staff gages will need to be replaced. The recently completed maintenance work in May 2005 to repair the plug from vandalism held up well under the high storm surge waters. The interior area of the rock plug is showing signs of new vegetative growth in locations that were previously open water. The lakeside of the rock plug is also vegetating. (Photos: Appendix B, Photo 6).

Photo No. 6, Structure No. 8, rock plug showing accretion occurring on lake side.
