**2009/2010 Annual Inspection  
Report**

**SABINE REFUGE STRUCTURE  
REPLACEMENT PROJECT  
(CS-23)**

State Project Number CS-23  
Priority Project List 3

October 20, 2009  
Cameron Parish

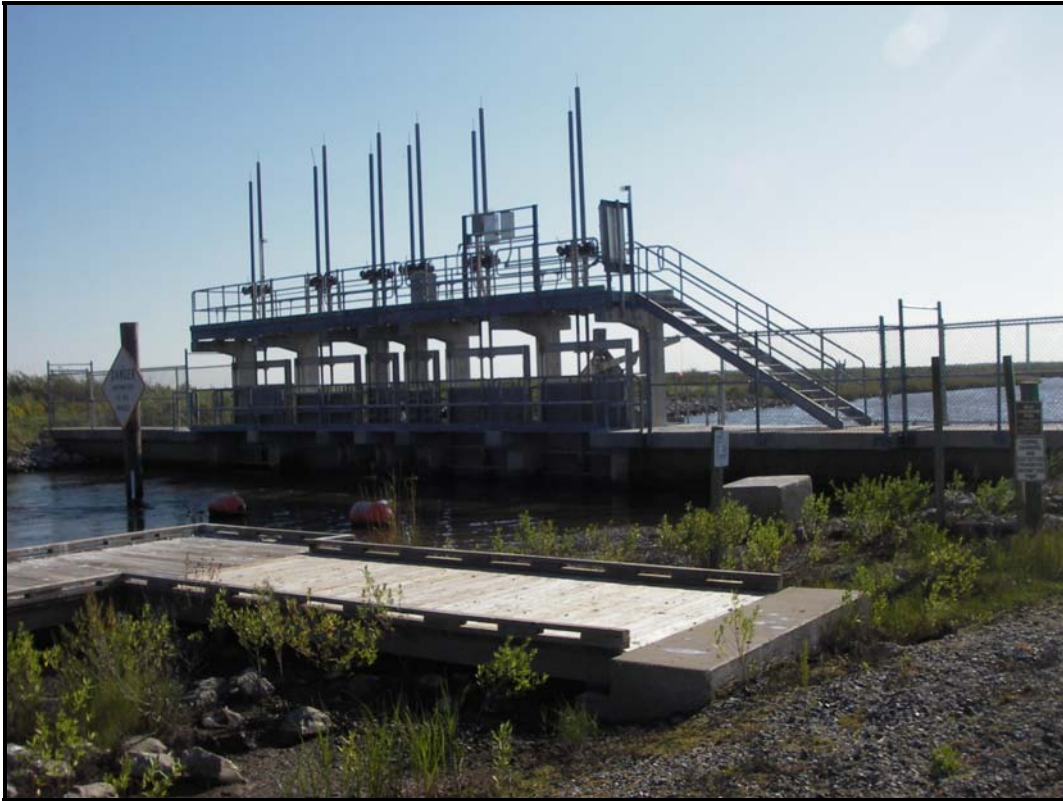
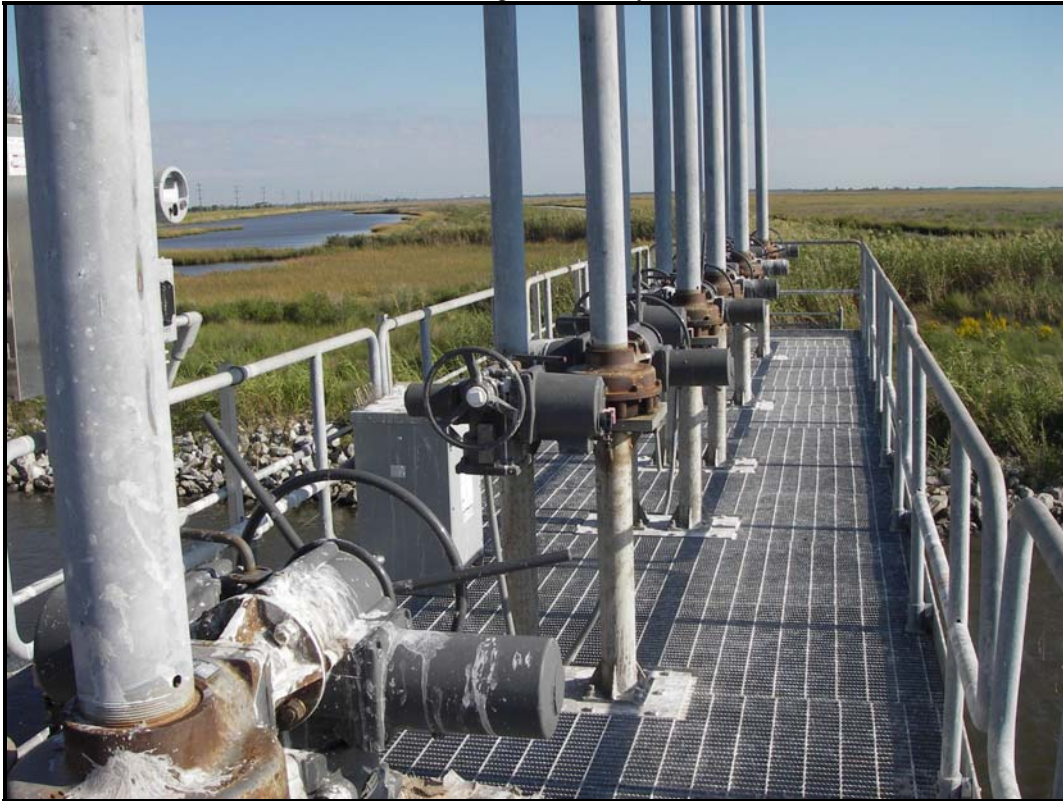
The chain link fencing has recently been replaced after Hurricane Ike. The remainder of the structure is in the same condition as post Hurricane Rita and Hurricane Ike. Some electrical repairs have been made by TVA in 2007. (Photos: Appendix B, Photos 1 - 2)

Item	Condition	Physical Damage	Corrosion	Photo #	Observations and Remarks
Steel Bulkhead / Caps	N/A				
Steel Grating	Good				
Gates	Fair	Yes		1 & 2	Alignment problems.
Electrical	Good				All electrical components recently upgraded by TVA.
Hardware	Poor				
Fencing					
Timber Piles	Good				
Timber Wales	N/A				
Actuators	Fair				All actuators will have to be taken apart and serviced.
Cables	Good				
Signage / Supports	Good				
Rip Rap	Good				
Rock Dike					
W.W. Reinf.					
Earthen Embankment	N/A

Overall, the Sabine Refuge Structure Replacement Project is in poor condition with all of the structures sustaining damage from Hurricane Ike. USFWS has used separate Federal funding through a third party, Tennessee Valley Authority (TVA) for some electrical system replacement. OCPR will prepare a maintenance contract for remaining O&M items not performed by TVA including actuator replacement, gate seal removal, stem gate articulation joints, pedestal alignment, stem nut replacement and possible stem thread size changes. Jeff Davis Electrical restored service to the area with true three phase power. This eliminates the need for the rotary converters which should eliminate the electrical problems. A maintenance project will be bid in summer 2010 which will include the following:

- Convert single stem gates to dual stem
- Install structural steel platform

- Install new Rotork actuators and gear boxes
- Reinstall electrical components

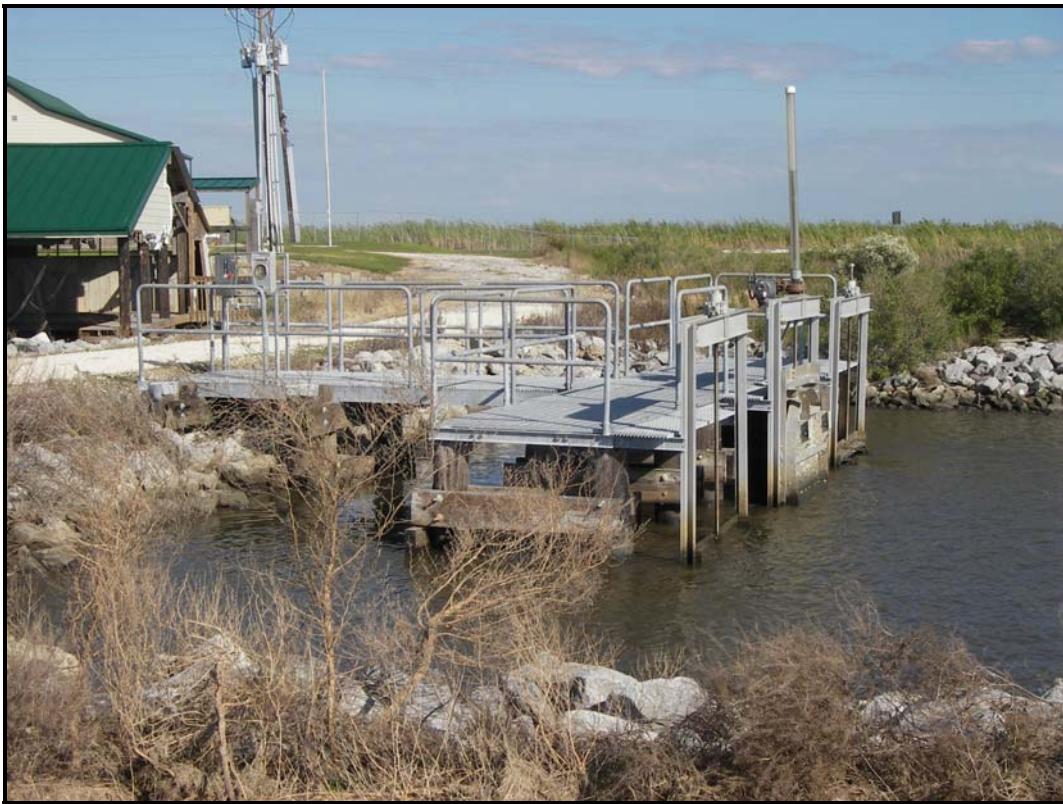
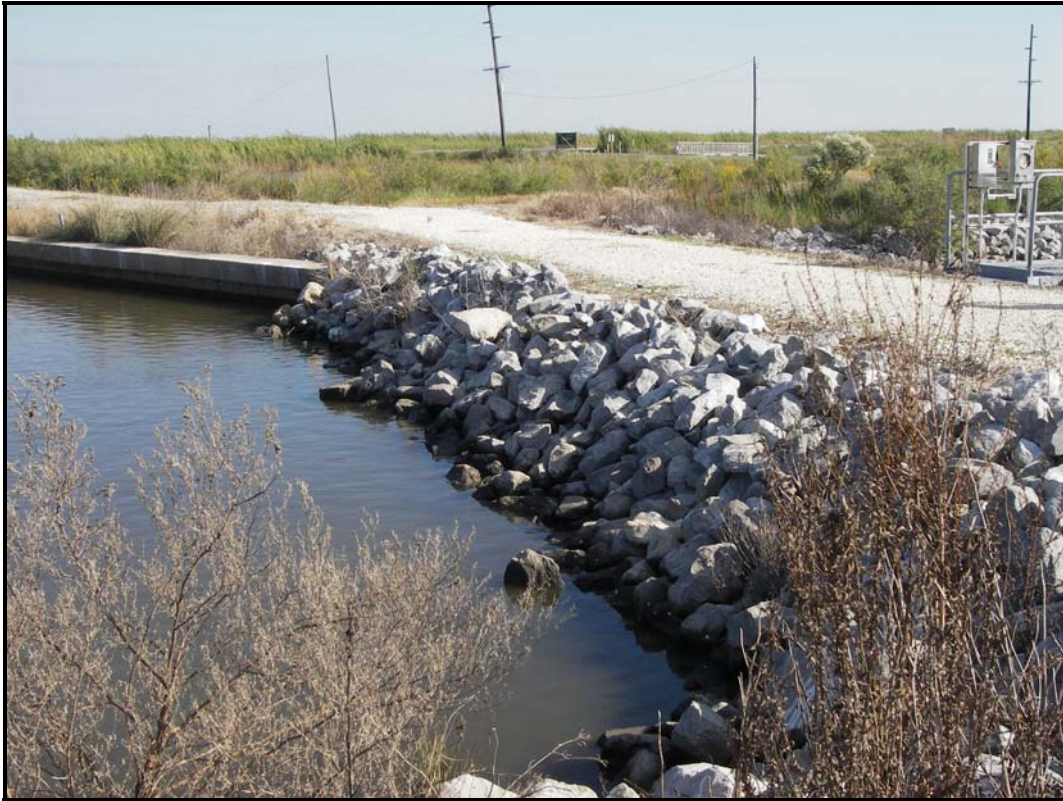
This site went completely under water as described in General Observations above. The center gate appears to be leaning slightly. No other damages appear to be present than those that existed pre-storm and which were being worked on by TVA. (Photos: Appendix B, Photos 3-4).

Item	Condition	Physical Damage	Corrosion	Photo #	Observations and Remarks
Steel Bulkhead / Caps	N/A				
Steel Grating	Good				
Gates	Fair	Probable		3 & 4	Possible alignment problems with gates and/or stems.
Electrical	Poor	Yes			All electrical components demolished.
Hardware	Good				
Timber Piles	Good				
Timber Wales	Good				
Actuators	Fair	Yes			The actuator will have to be taken apart and serviced.
Cables	N/A				
Signage / Supports	N/A				
Rip Rap					
Rock Dike	Good				
W.W. Reinf.					
Earthen Embankment	N/A

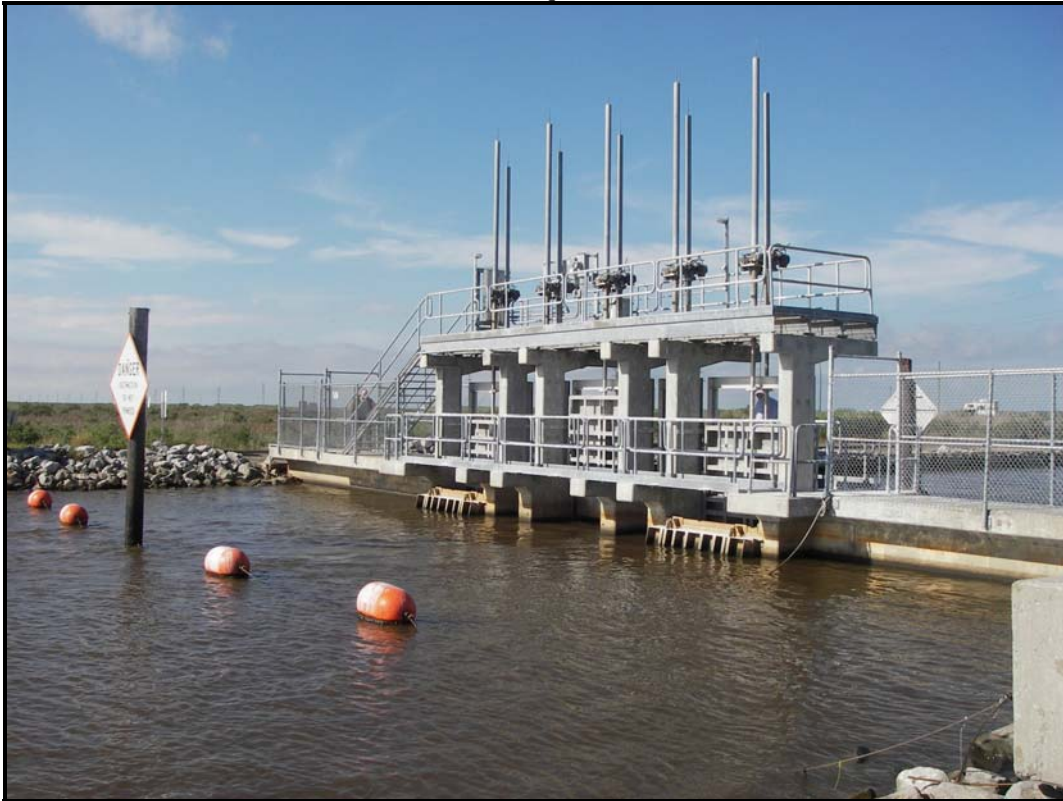
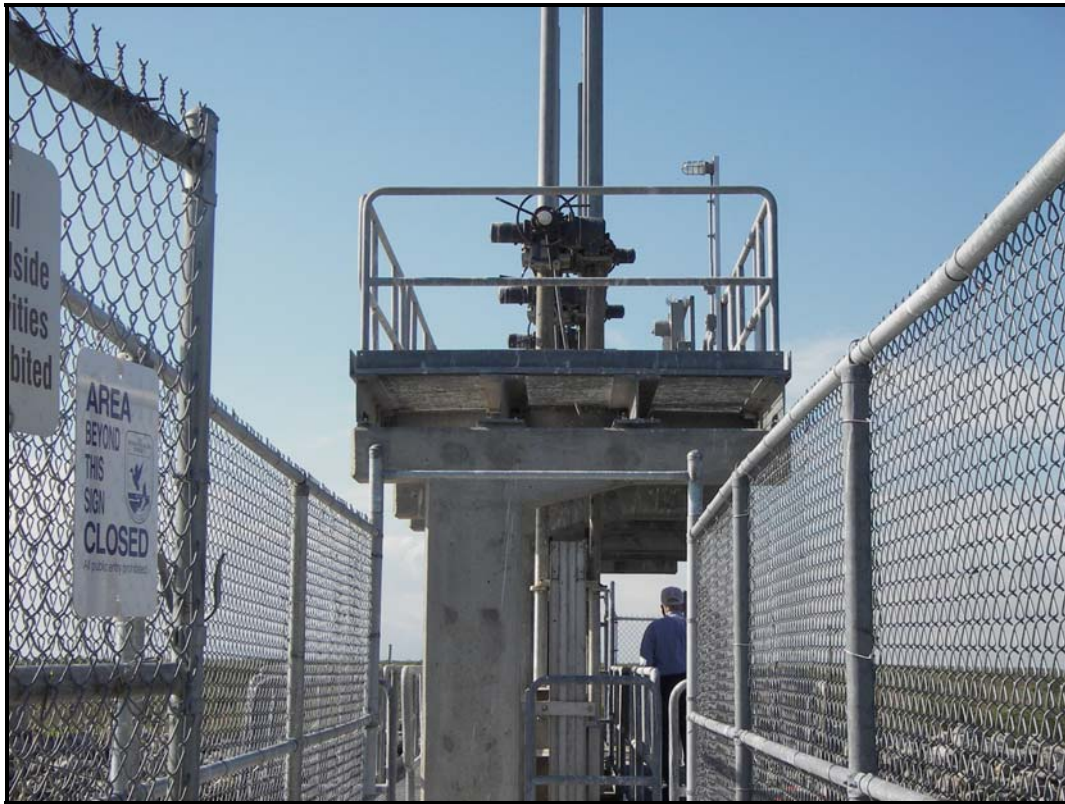
The chain link fencing has recently been replaced after Hurricane Ike. The remainder of the structure is in the same condition as post Hurricane Rita and Hurricane Ike. Some electrical repairs have been made by TVA in 2007. (Photos: Appendix B, Photos 5-6).

Item	Condition	Physical Damage	Corrosion	Photo #	Observations and Remarks
Steel Bulkhead / Caps	N/A				
Steel Grating	Good				
Gates	Fair	Yes		5 & 6	Alignment problems.
Electrical	Good	Yes			All electrical components recently upgraded by TVA.
Hardware/Stairs	Good				
Fencing	Poor				
Timber Piles	Good				
Timber Wales	N/A				
Actuators	Fair				All actuators will have to be taken apart and serviced.
Cables	Good				
Signage / Supports	Good				
Rip Rap					
Rock Dike	Good				
W.W. Reinf.					
Earthen Embankment	N/A
