2009/2010 Annual Inspection Report

HUMBLE CANAL HYDROLOGIC RESTORATION PROJECT (ME-11)

State Project Number ME-11
Priority Project List 8

November 6, 2009
Cameron Parish

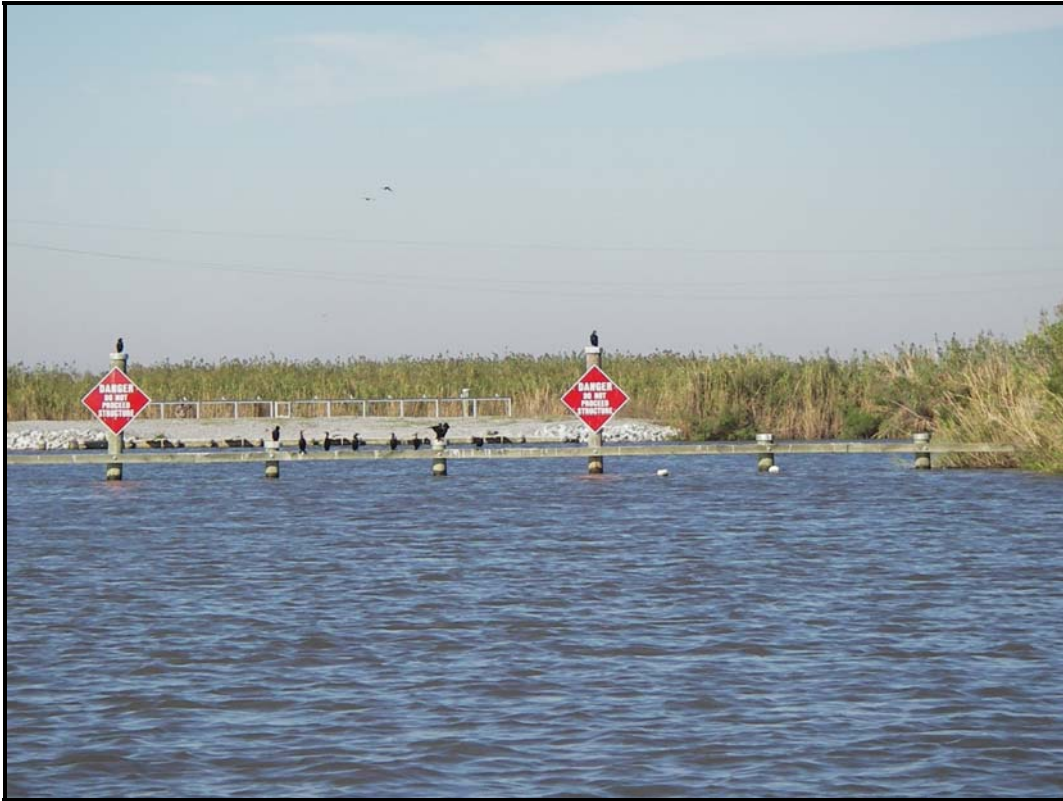
The structure is in excellent condition and the warning signs were recently replaced as part of a maintenance event. (Photos: Appendix B, Photo 1)

Photo 1, Marine barrier with signage.

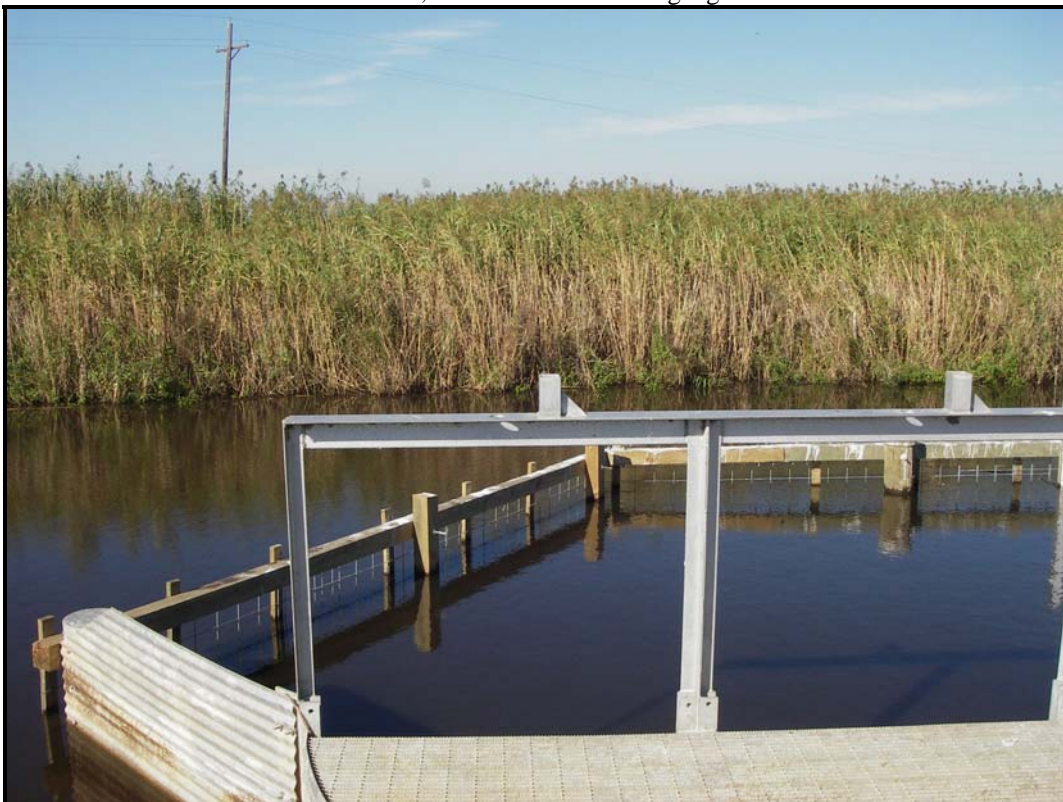
This feature is in good condition and also was part of the recent maintenance event to replace all of the wire fence material as well as repair of the hyacinth wooden pilings and bracing. (Photos: Appendix B, Photo 2)

Photo 2, Inlet side showing repairs to hyacinth fence.

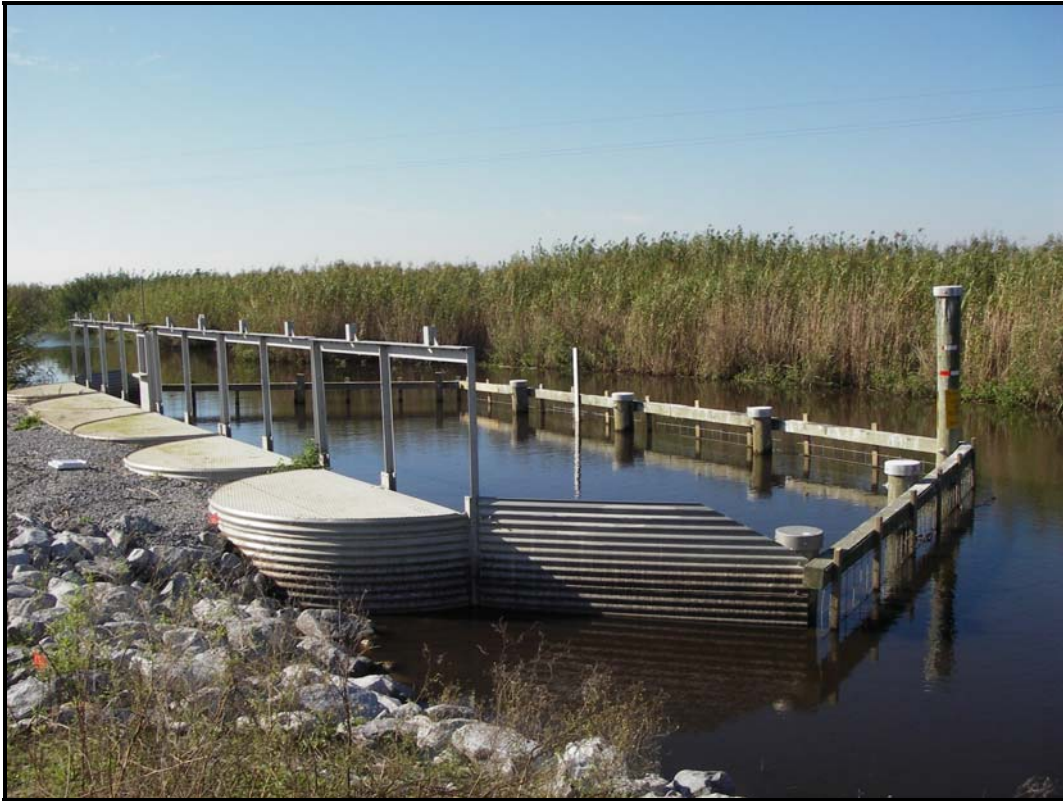
Overall, the structure is in good post construction condition. As part of the recent maintenance event rock armor was placed on the ends of the wingwalls on the inlet and outlet side of the structure. Crushed stone aggregate was also placed on the top portion of the structure. M & M Electric hired the services of a diver to check and clear out all flapgates. Several items were found wedged in the gates including a portion of an old lifting arm. Miscellaneous repairs were made to the flap gates, stoplogs and locking arms. Southside Machine fabricated an aluminum storage box for locking arms and stoplogs and was placed on Miami Corporation property off of Little Chenier Road. This storage box was added to the contract as a means to prevent vandalism. (Photos: Appendix B, Photo 3 & 4)

Photo No. 3, Inlet side of structure

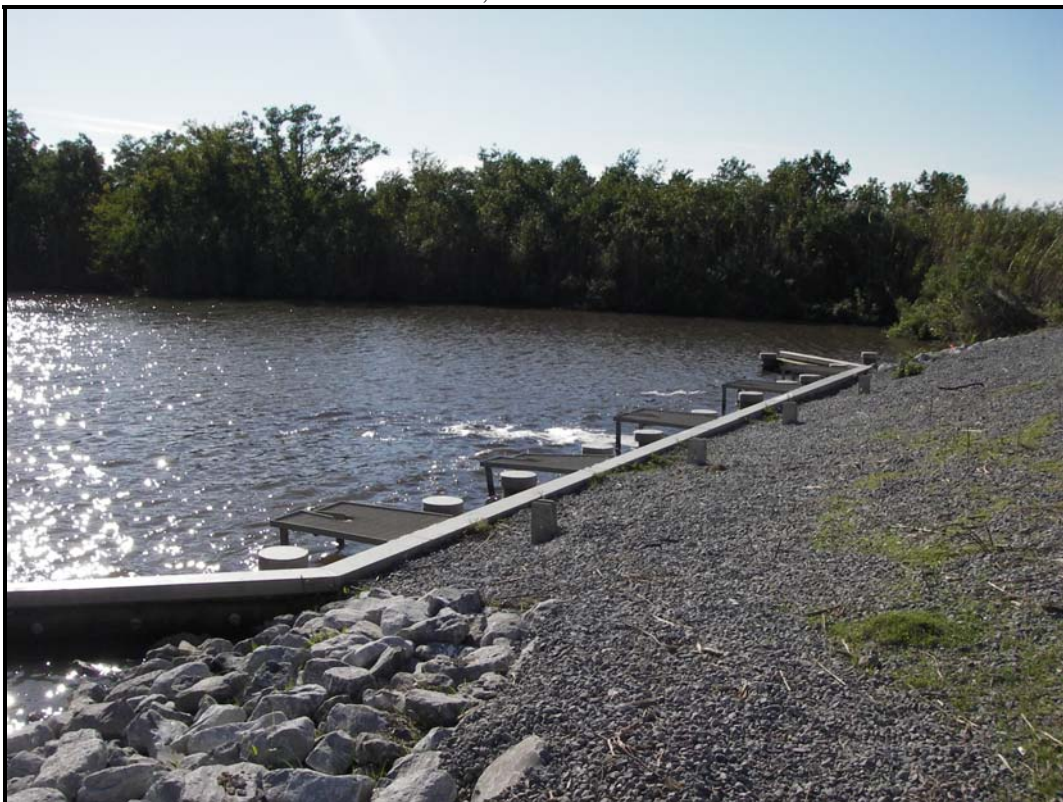
Photo No. 4, Outlet side of structure

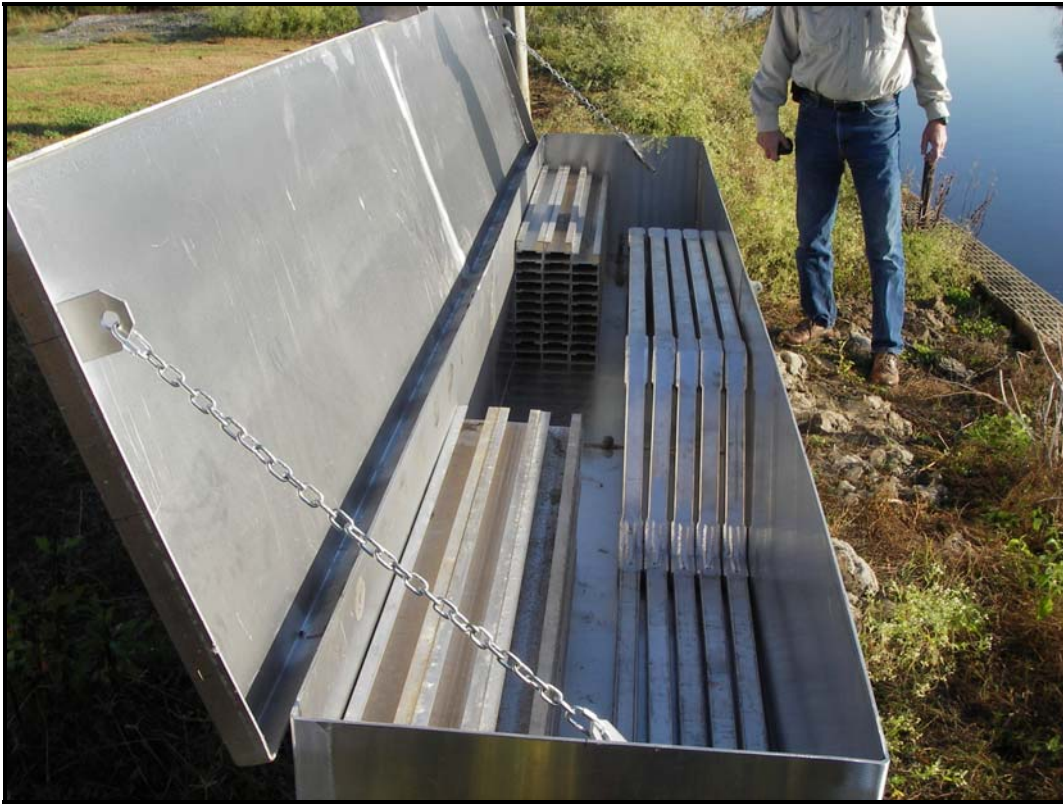
Photo No. 5, Storage box for locking arms and stop logs
