Coastal Protection and Restoration Authority of Louisiana

2009/2010 Annual Inspection Report

BOSTON CANAL/VERMILION BAY SHORE RESTORATION PROJECT (TV-09)

January 14, 2010
Vermilion Parish

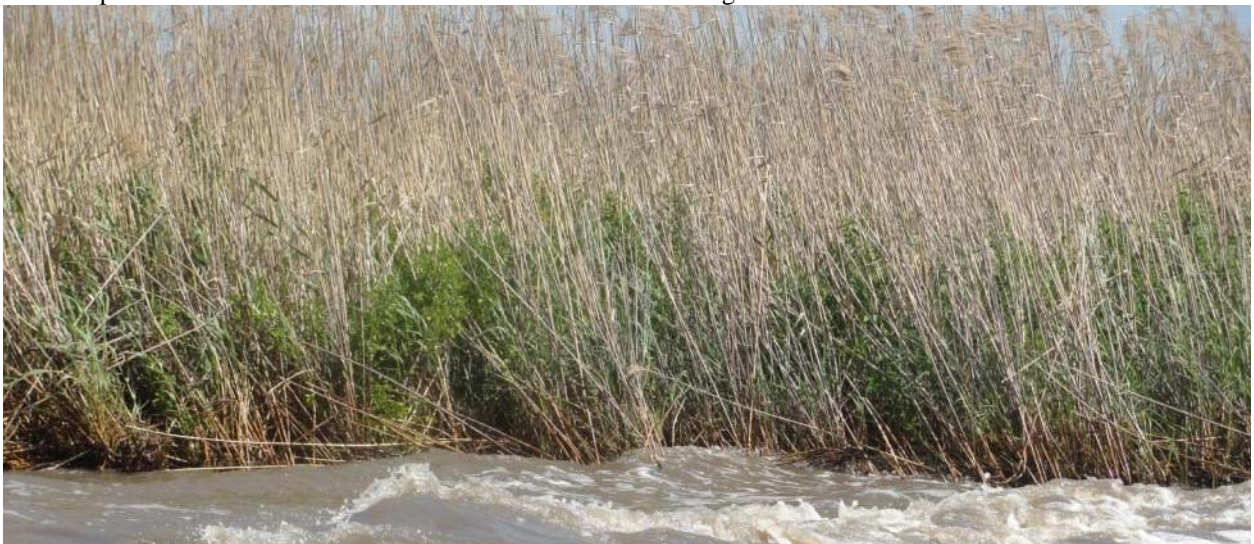
An example of the occasional small breaks seen in the smooth cordgrass buffer in this stretch:

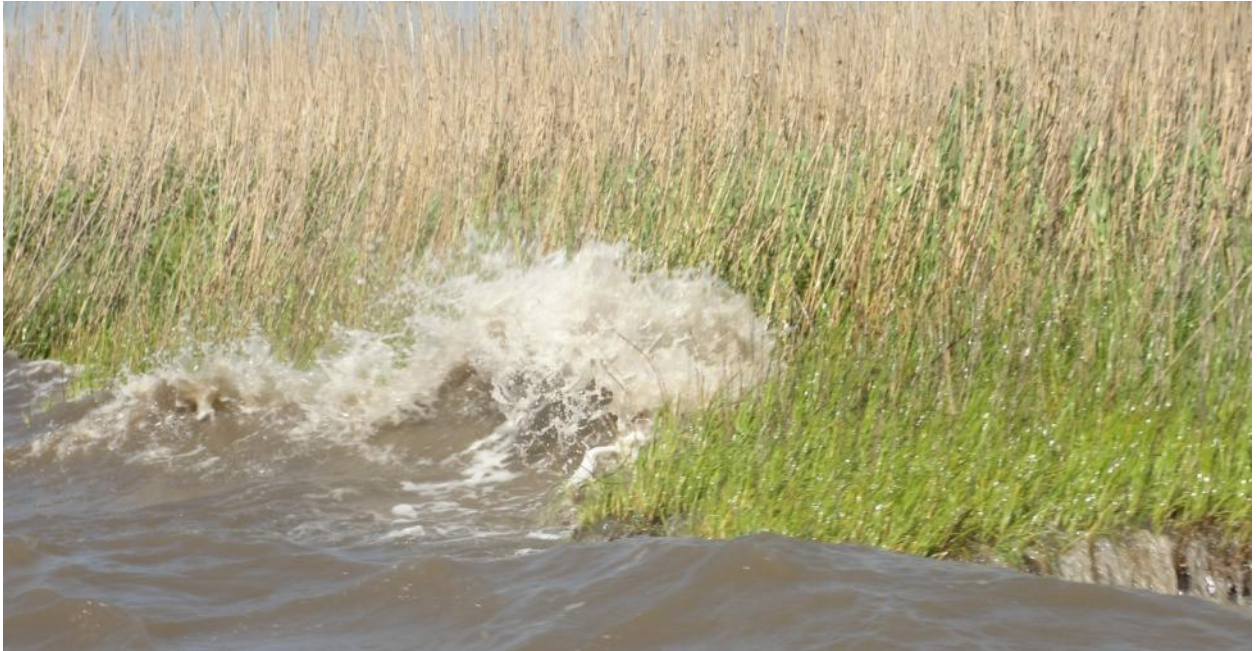
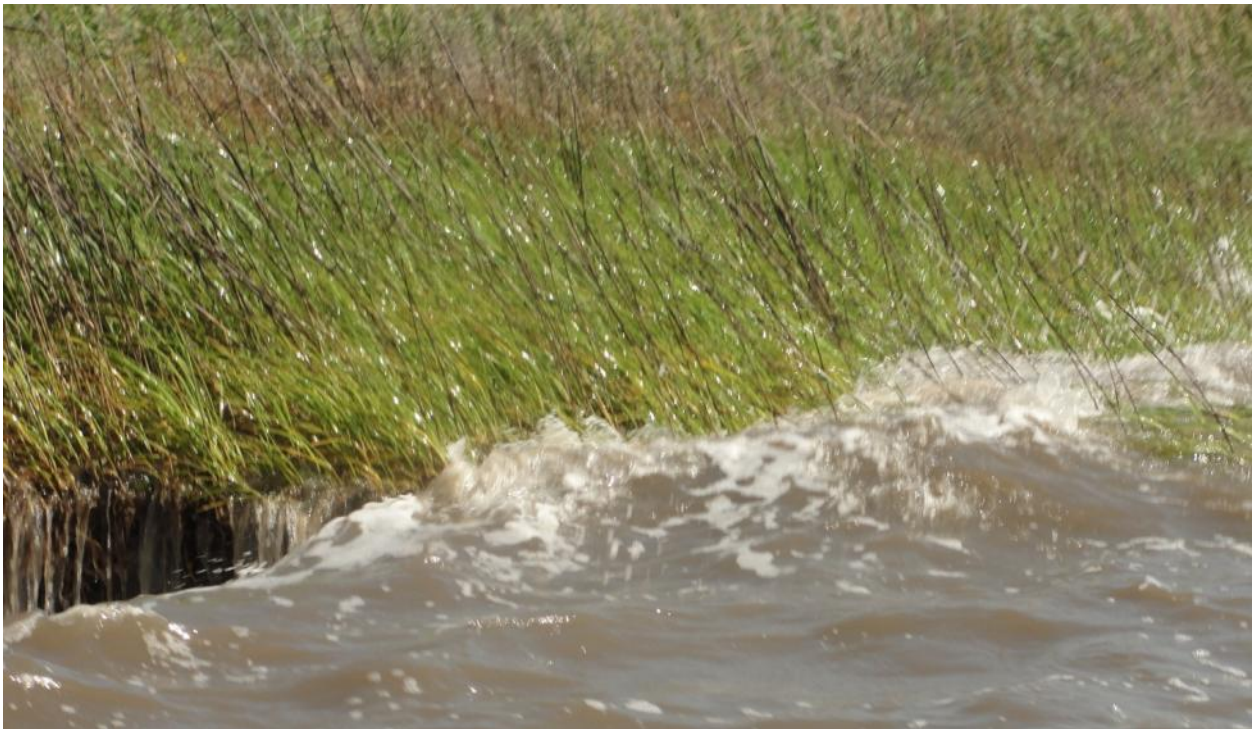
This shoreline is obviously subject to high wave energy:

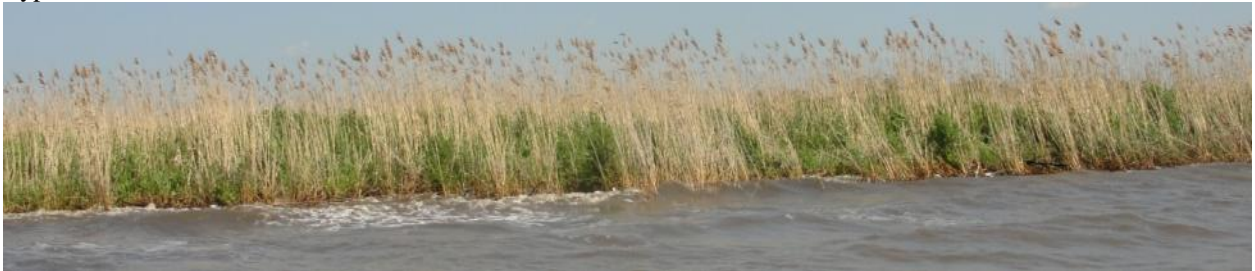
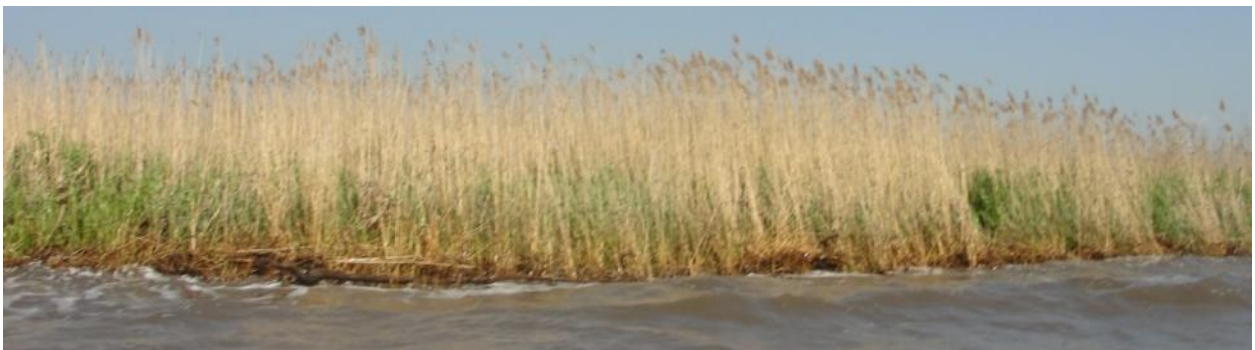
WP328 – start of a large break in the smooth cordgrass community along shoreline

WP329 – end of break in smooth cordgrass community along shoreline (approx. 1,100 lf)

WP330 – start of stretch of higher erosion & lack of smooth cordgr – just east of Boston Canal.

WP331 – @ west side of mouth of Boston Canal – smooth cordgrass veg buffer missing (approx. 1,450 lf)

Typical shoreline between WP328 & WP329 and WP330 & WP331 where no buffer exists:

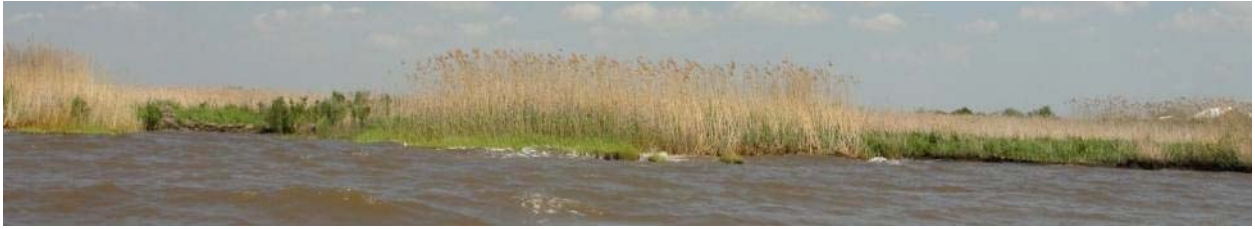
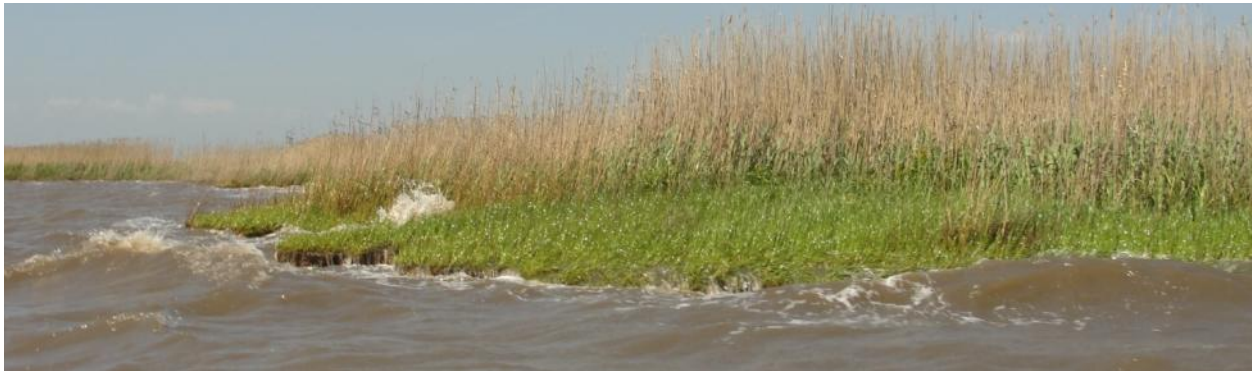
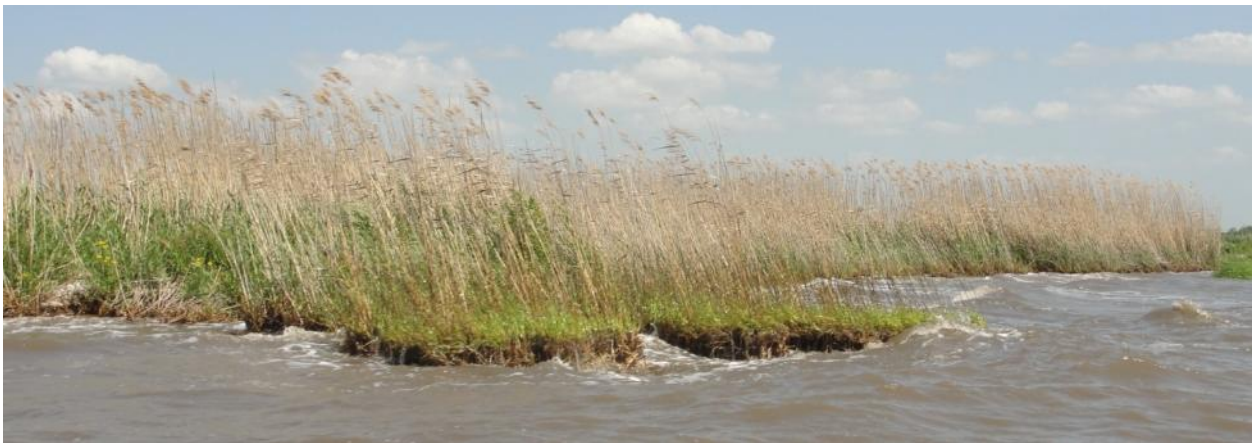
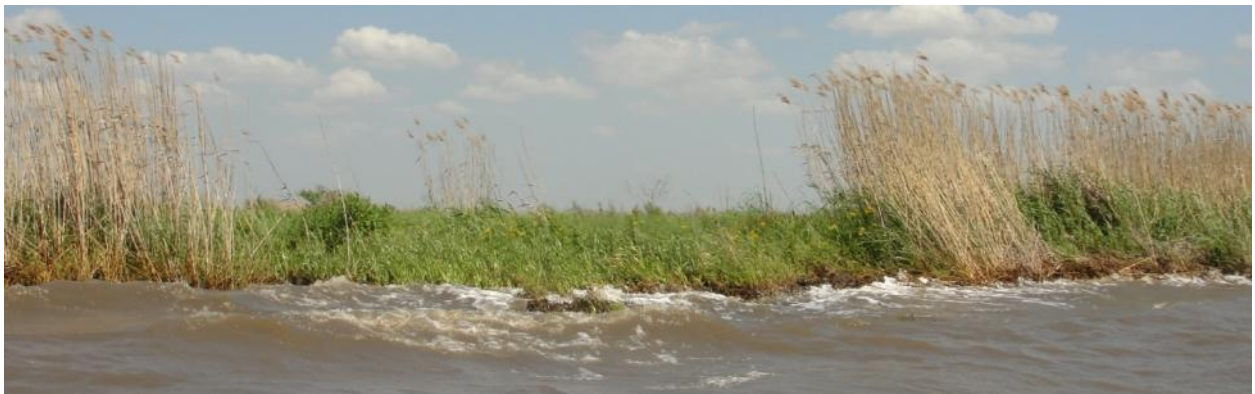
WP332 – @ west side of mouth of Boston Canal – salinity 8.6ppt; begin just small stretches or clumps of smooth cordgrass buffer left in this reach;

WP333 – end of breaks in smooth cordgrass veg buffer (breaks total approx. 3,300 lf):

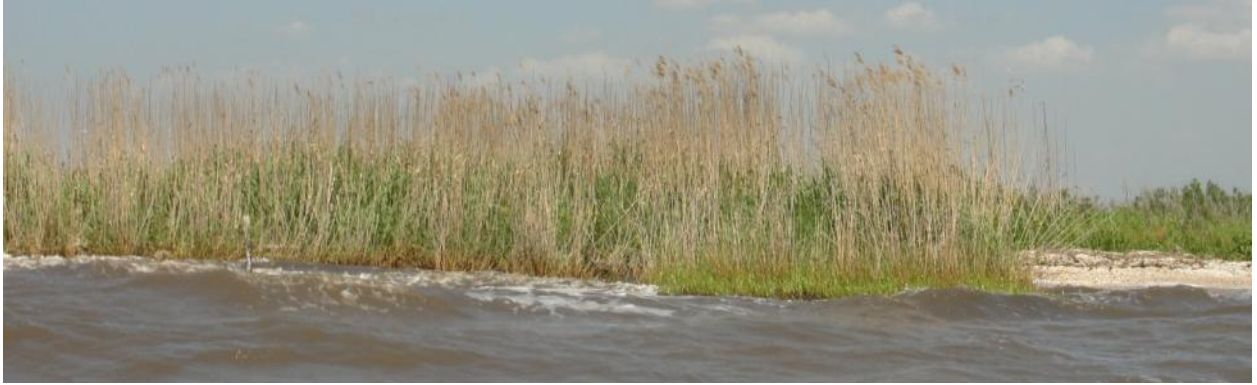
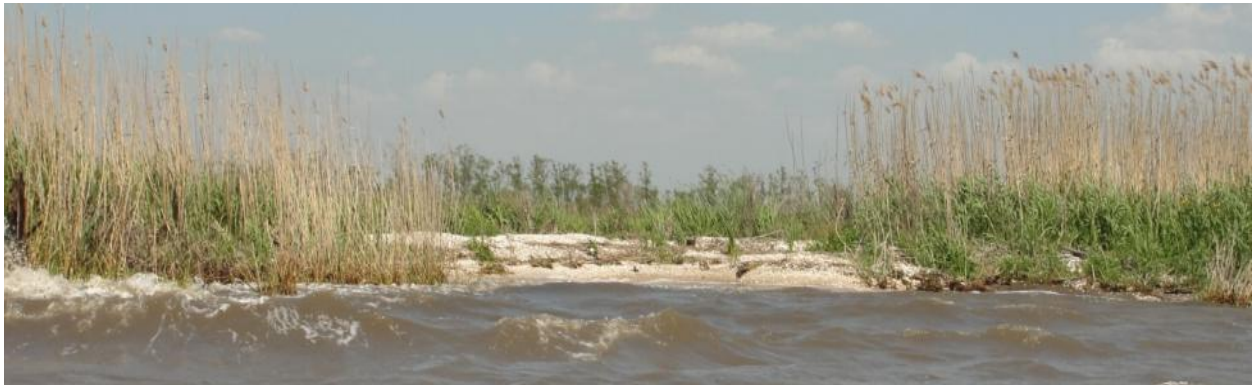
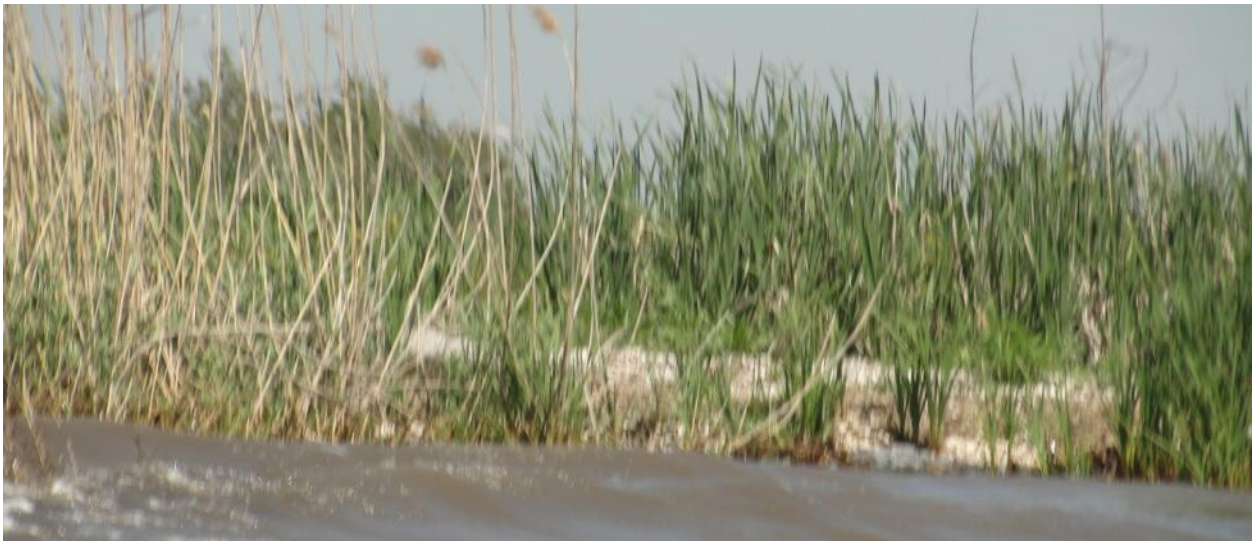
WP335 – east of pipeline crossing – a good bit of smooth cordgrass missing for a stretch

WP336 – lots of shell in this area with a lot of smooth cordgrass veg missing (between WP335 & WP 336
probably would need to replant 50% of approx 2,500 lf)

WP337 – gap in smooth cordgrass veg (approx 500 lf)

Examples of where mainly shell & Roseau are present where smooth cordgrass is missing:

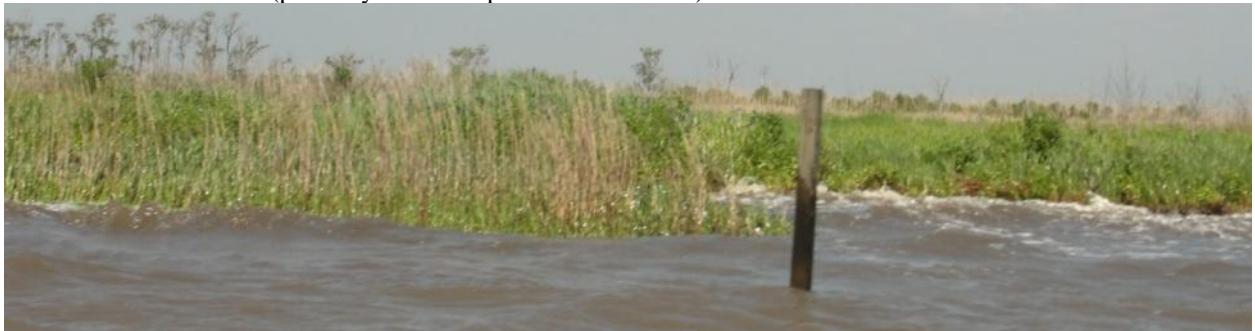
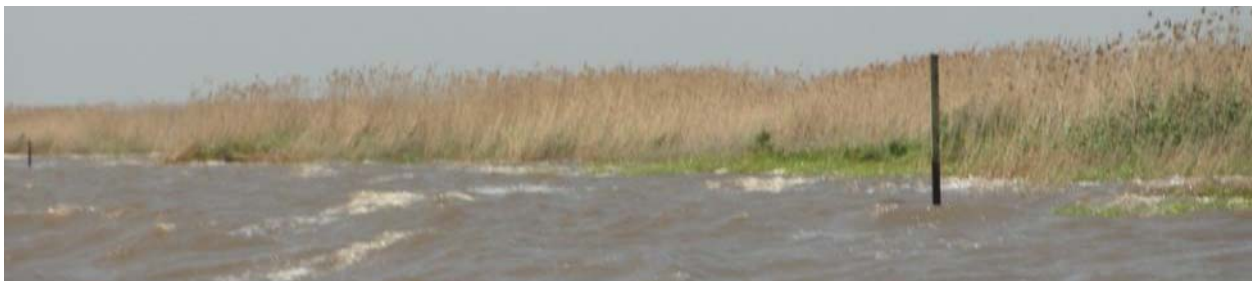
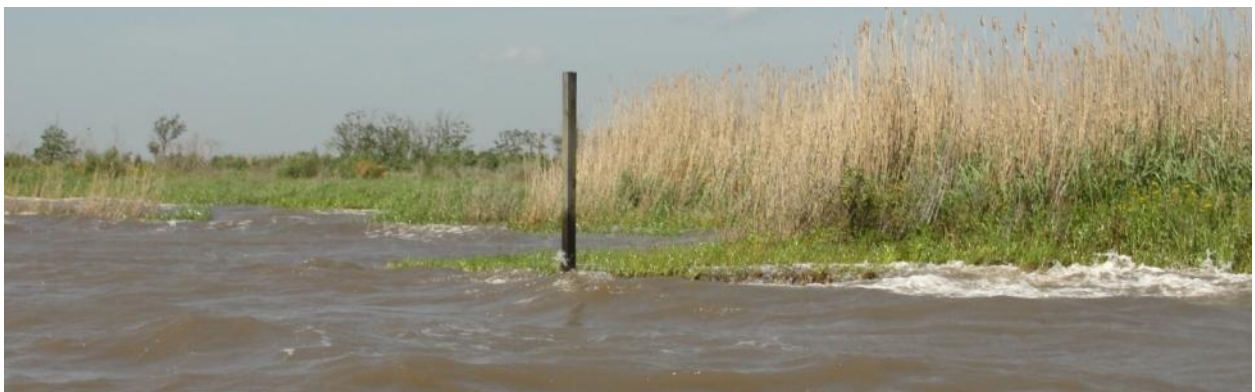
WP338 – start of a long extent of missing veg buffer with some smooth cordgrass present in just small clusters;
more posts were found off of the shoreline along here.
From WP338 to WP340 (probably need to replant 75% of 870 lf):

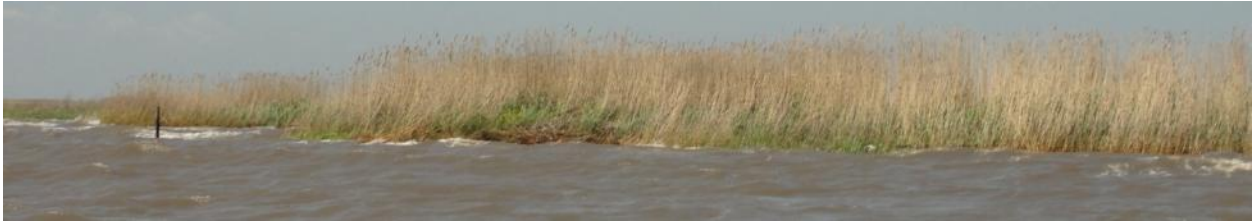
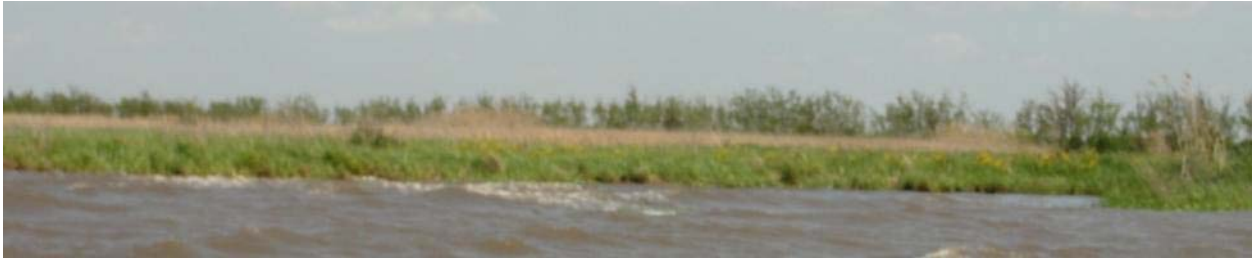
WP339 – shoreline with small clusters of smooth cordgrass continues:

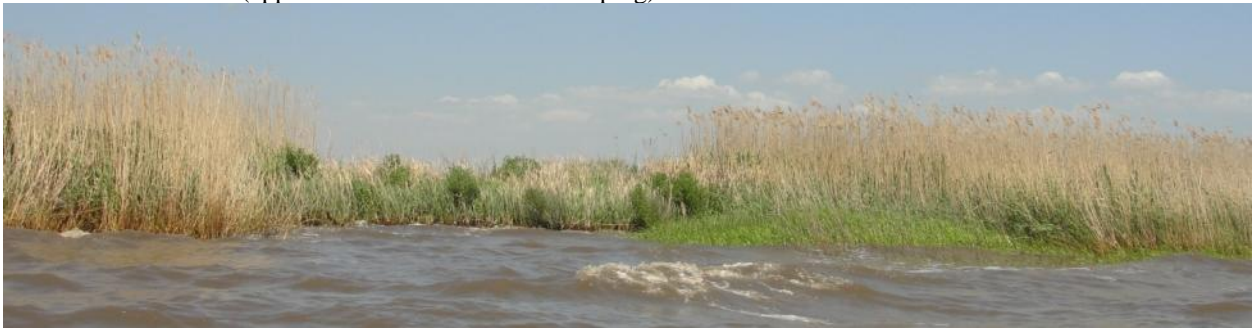
WP340 – end of break in smooth cordgrass community along shoreline;
WP341 – more trees present along the shoreline in this area with big gaps in smooth cordgrass community along shoreline (approx 450 lf – end of old canal plug):

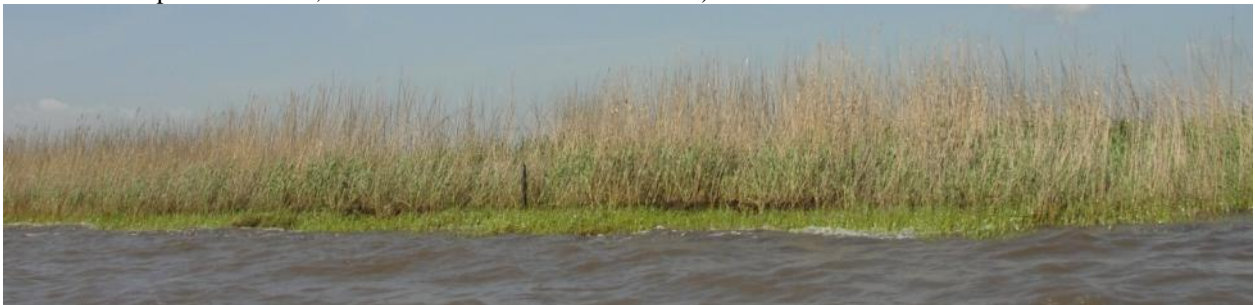
WP342 – another big gap in smooth cordgrass community along shoreline east and west of an existing pipeline crossing (probably need to replant 50% of 2,200 lf here)
WP343 – start of another stretch with smooth cordgrass community starting and stopping along shoreline
WP344 – end of the stretch with interrupted coverage –waypoint a little bit west of actual end (probably need to replant 50% of 1,700 lf between WP343 and WP344)

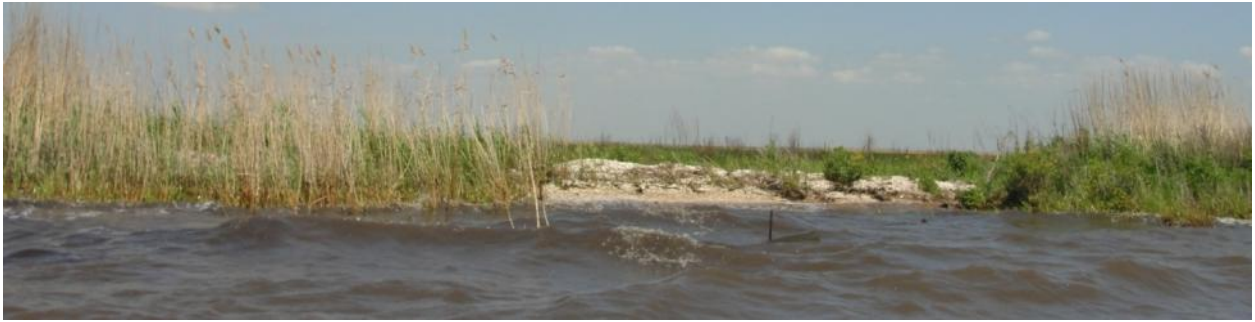
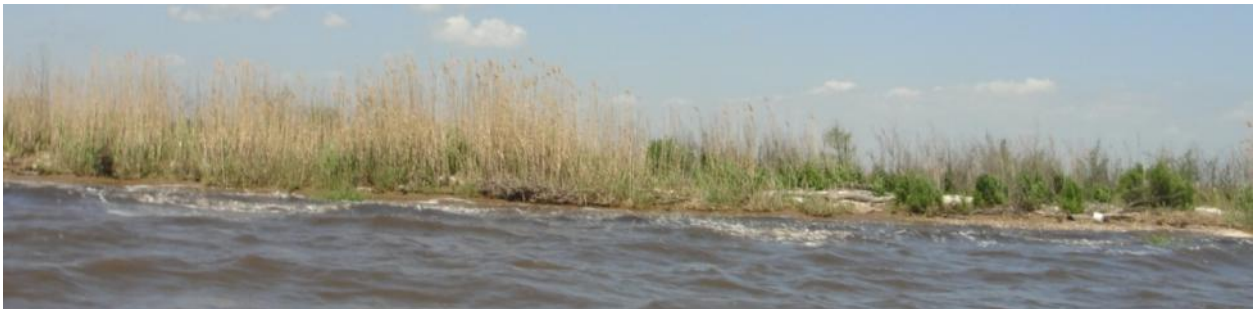
WP345 – interrupted coverage starts again
WP346 – end of stretch with interrupted coverage (need to replant approx. 50% of 1,625 lf here)
WP347 – large bare shell area east of 4-Mile Cutoff, aka Vermilion River Cutoff (approx 500 lf):

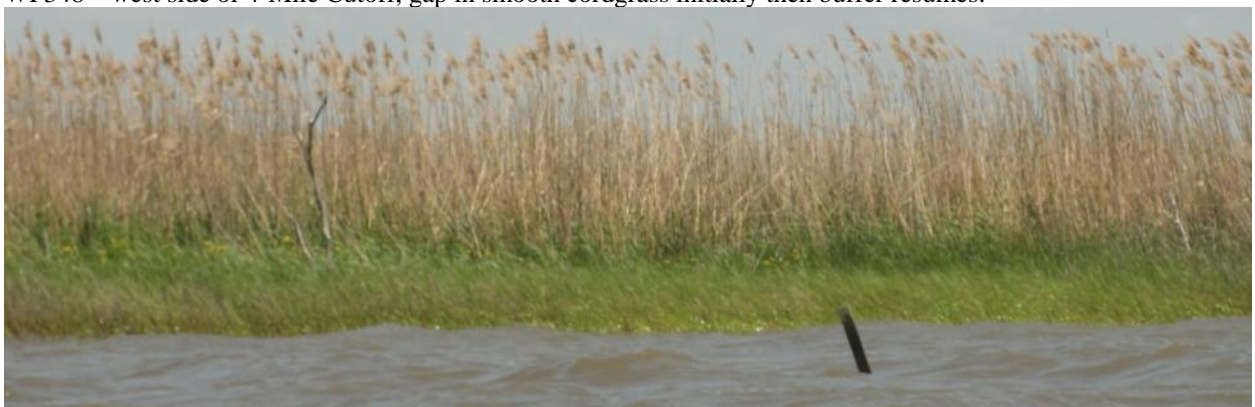
WP348 – west side of 4-Mile Cutoff, gap in smooth cordgrass initially then buffer resumes:

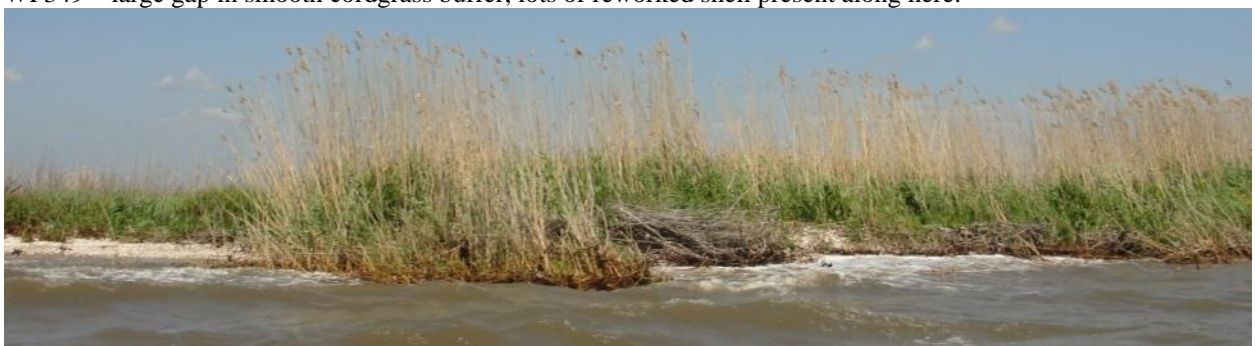
WP349 – large gap in smooth cordgrass buffer, lots of reworked shell present along here:

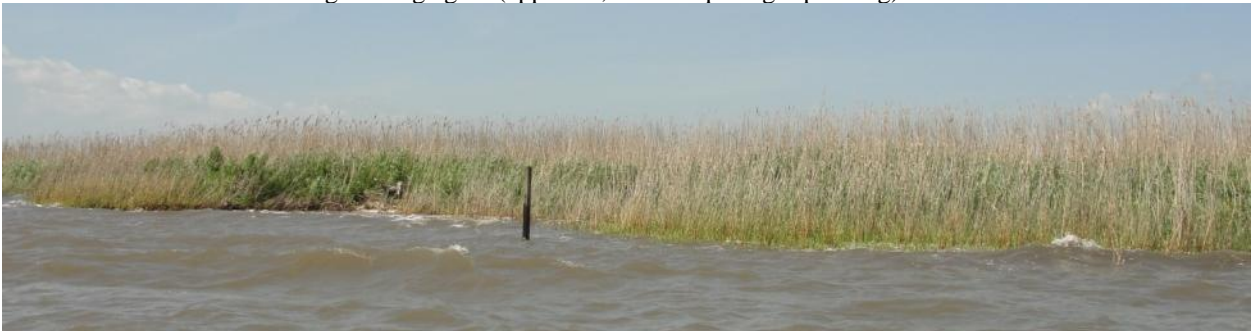
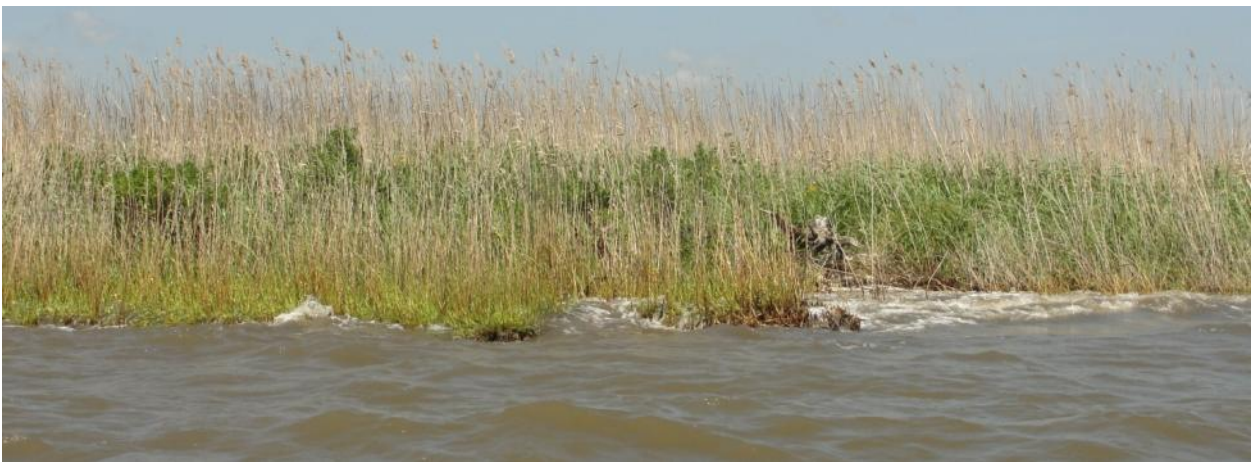
WP350 – start of a gap in smooth cordgrass veg buffer

WP351 – start of smooth cordgrass veg again (approx 1,900 lf requiring replanting):

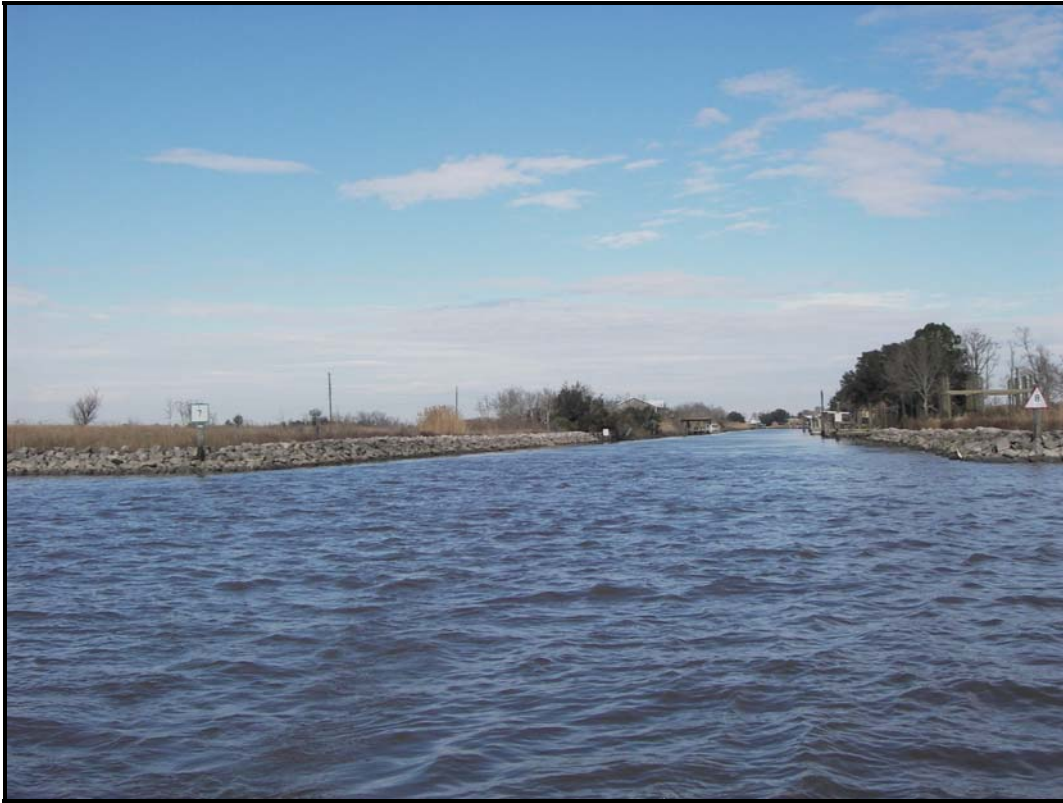
not significantly worsened. A small gap left during original construction appears to have caused this problem. While the situation is similar on the SE tie-in, it is not as severe. No gap was left on this end during construction. Recommendations made to repair these gaps during the O & M inspection of June 2003 have been reconsidered due to costs and logistics associated with such repairs. These areas have been and will continue to be closely monitored, and should the situation significantly worsen, steps will be taken to close/stabilize these areas. Signage and associated pilings are stable and functioning. (Photos: Appendix B, Photos 1 - 3)

Photo No. 1, View of Boston Canal at the bay shore looking north

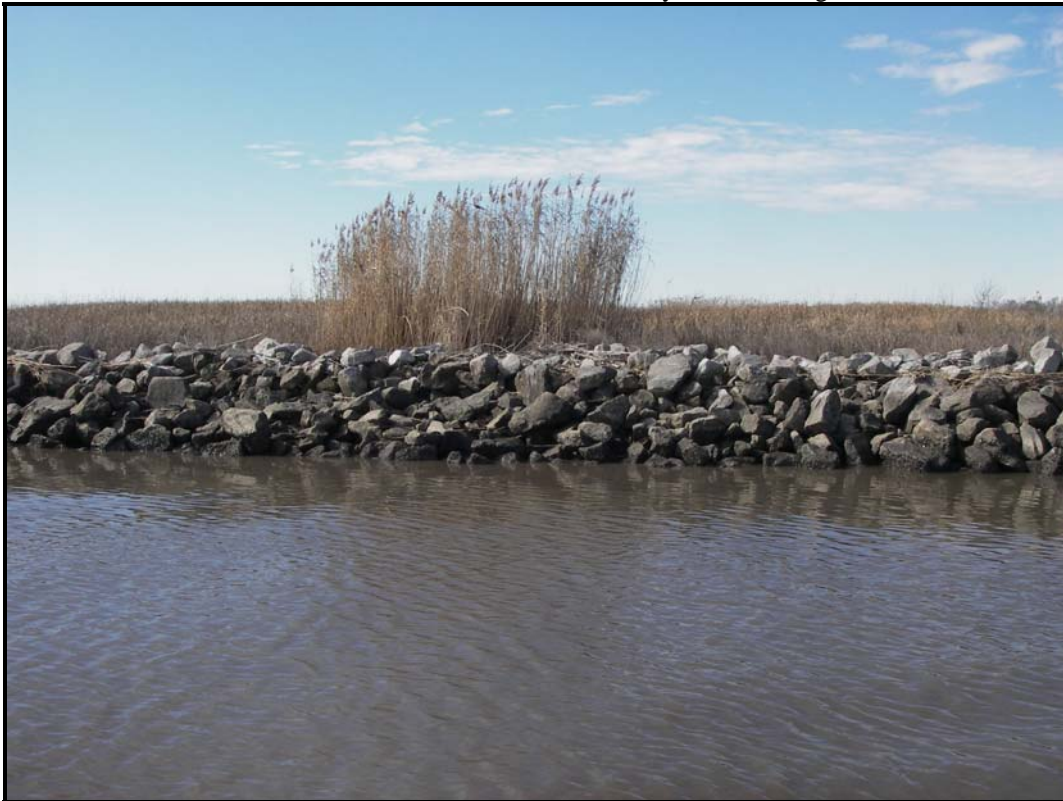
Photo No. 2, Close up view of the rock dike and vegetation behind the dike

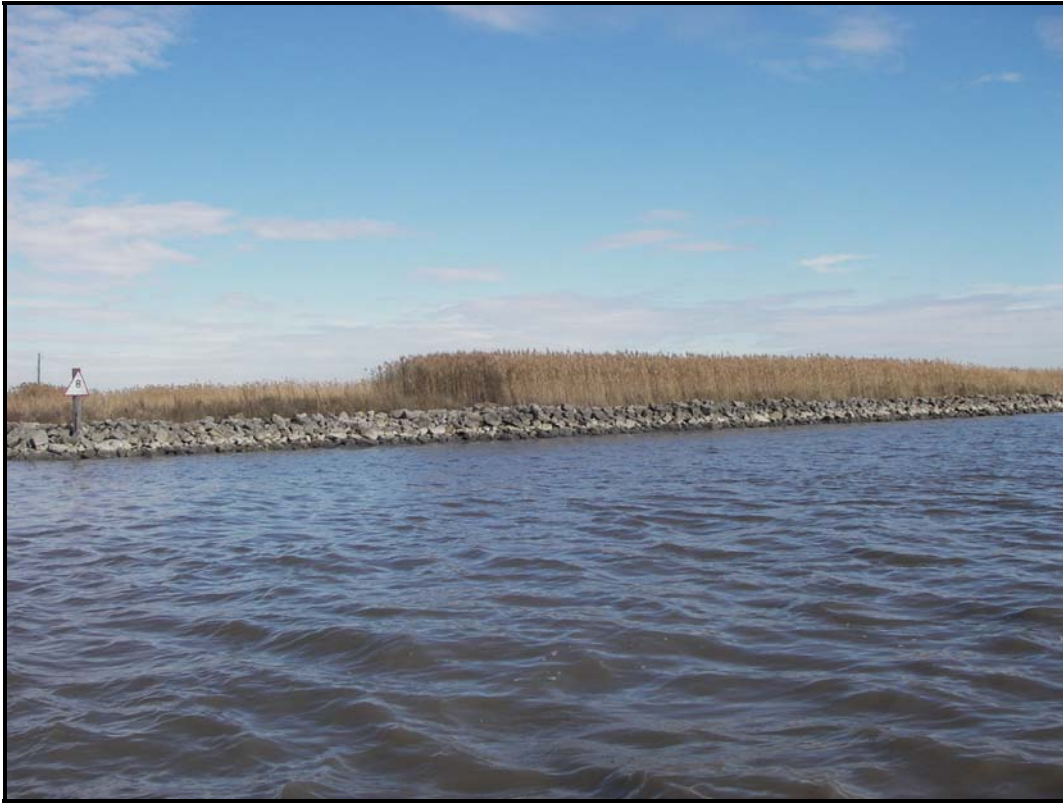
Photo No. 3, View of western rock dike

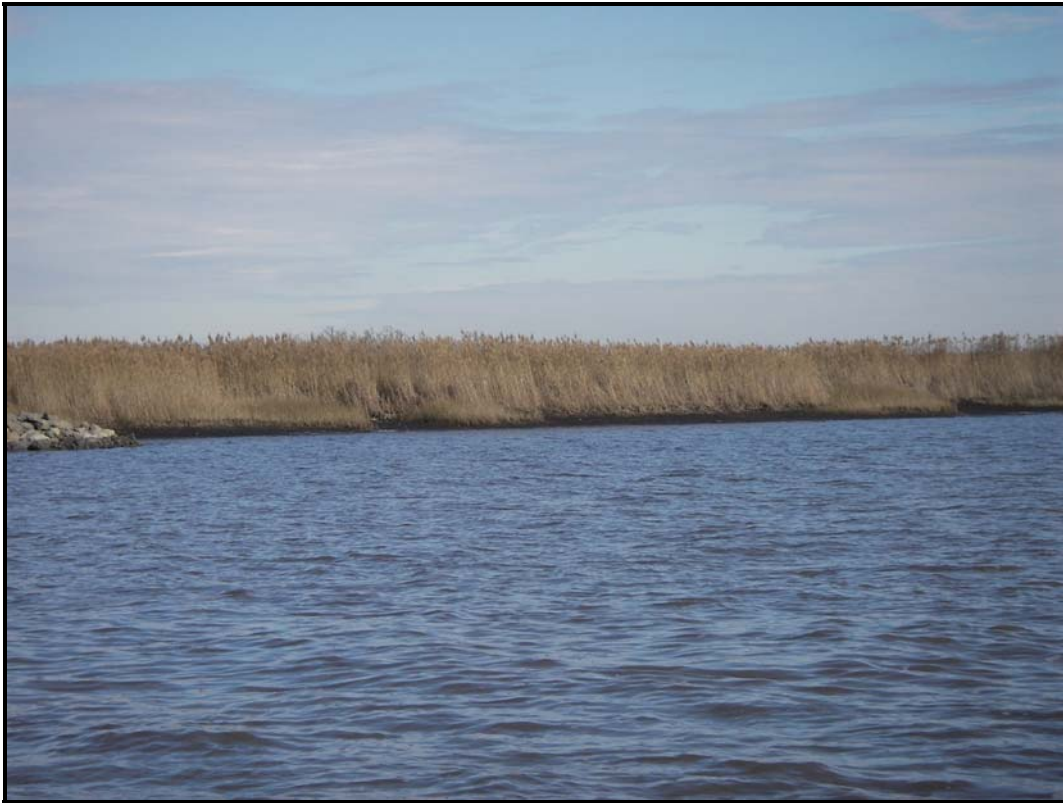
The shoreline plantings were not directly inspected on this trip due to time and wave constraints. All vegetation in the area adjacent to the mouth of the Boston Canal, including the vegetation behind the rock dikes, is in good condition. (Photos: Appendix B, Photo 4)

Photo No. 4, Typical view of vegetative plantings along the bay shore
