2009/2010 Annual Inspection Report

OAKS/AVERY CANALS HYDROLOGIC RESTORATION PROJECT

State Project Number TV-13a
Priority Project List 6

January 14, 2010
Vermilion/Iberia Parishes

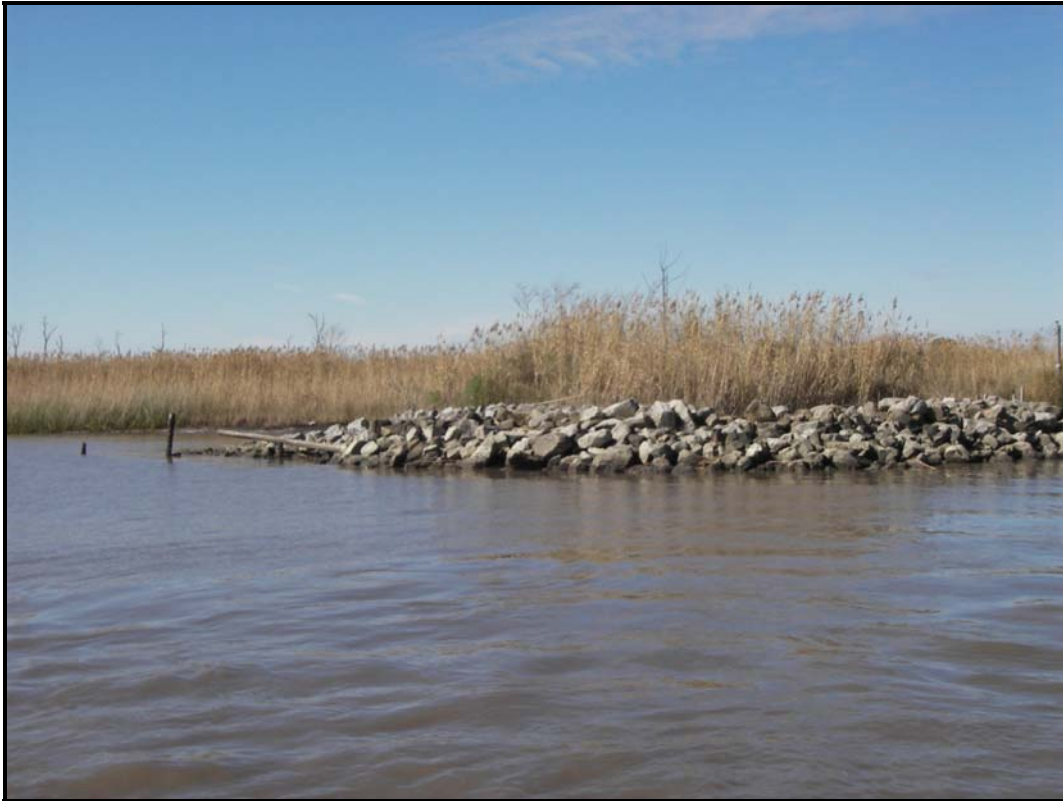
Photo No.1, Rock dike at Oaks Canal, west side

No worsening in this area was evident. The bank between the bay and Bayou Hebert is still only about 6 feet wide and has not gotten any worse. Additional rock has been added to connect the end of the existing rock paving to the rock island protecting two pipelines located on the eastern side of the Oaks Canal. This work was performed by ChevronTexaco Pipeline, LLC-Erath in 2009 through CUP No. 20070581. No immediate maintenance required at this time. (Appendix B; Photos 1-3)

Item	Condition	Physical Damage	Corrosion	Photo #	Observations and Remarks
Steel Bulkhead / Caps	N/A				
Steel Grating	N/A				
Stop Logs	N/A				
Hardware	N/A				
Timber Piles	N/A				
Timber Wales	N/A				
Galv. Pile Caps	N/A				
Vegetation	N/A				
Signage / Supports	N/A				
Rip Rap (fill)	Excellent			1,2,3	Rock in excellent condition
Eathern Embankment	N/A

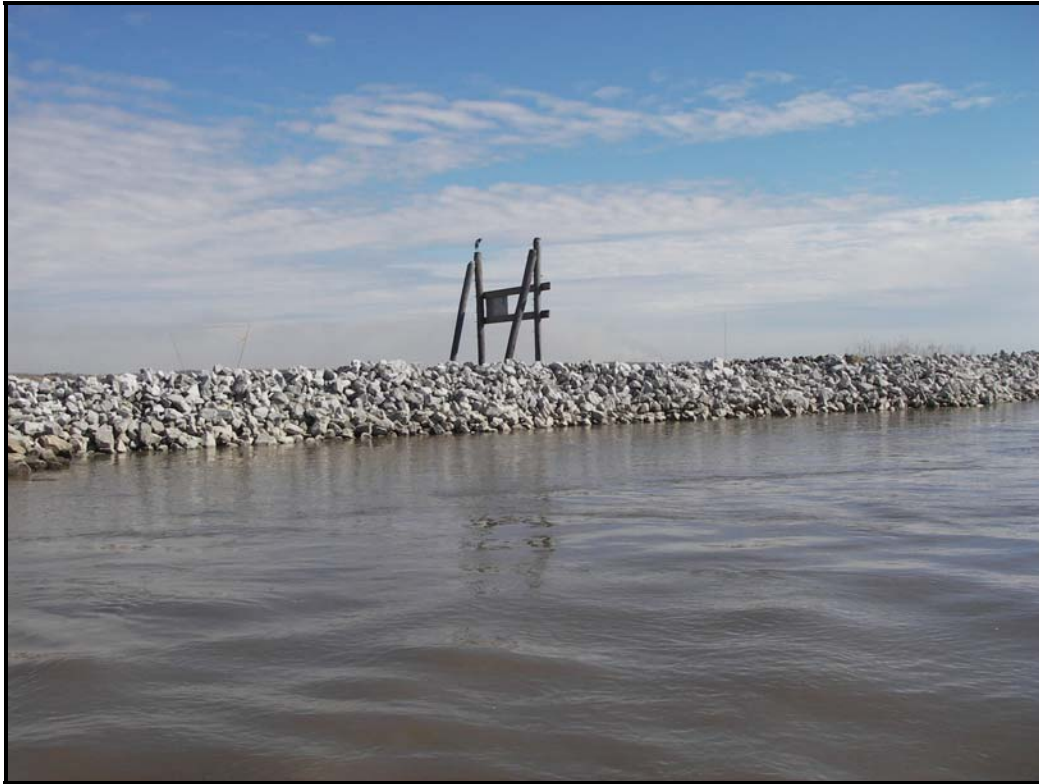
Photo No. 3. Additional rock dike built by ChevronTexaco to protect existing pipelines, located and connected to rock dike on east side of Oaks Canal

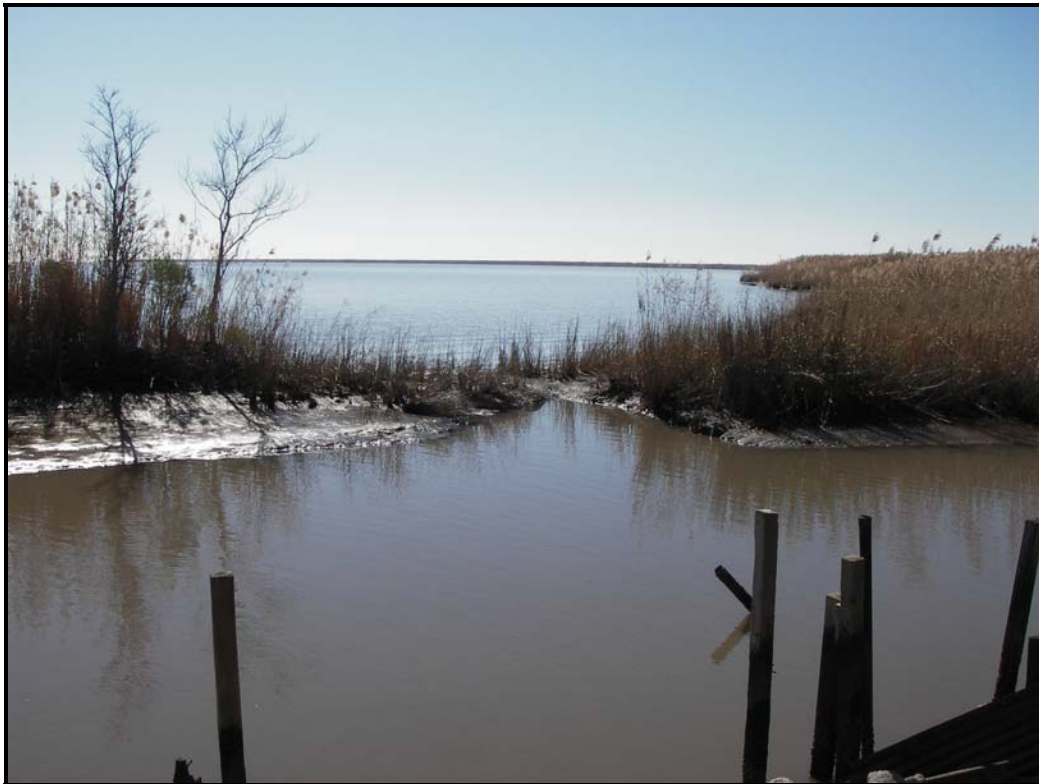
Photo No. 4. Small strip of marsh along bay shore and Bayou Hebert, west side of Oaks Canal

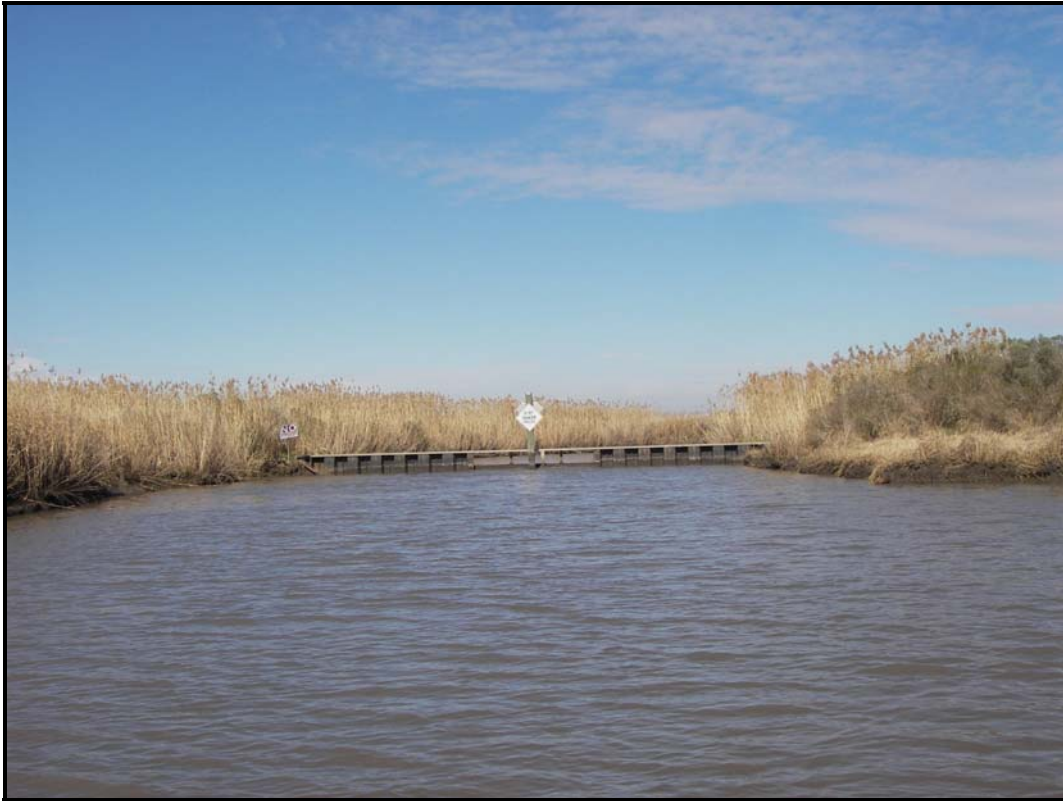
Photo No. 5, Cow Path Structure

The structure is in excellent shape. Signage is stable. Wingwalls show no signs of any erosion. Three SS bolts are missing from pile cap and will eventually need to be replaced, probably by OCPR personnel. The levee from the structure to the GIWW is stable. No maintenance required at this time. The boat lifting device installed by the landowners on the western half of the structure has been removed and is on the ground adjacent to the structure. The landowner installed channel iron to accept stoplogs is still on the structure. This will be investigated further by OCPR. (Appendix B; Photo 5)

Item	Condition	Physical Damage	Corrosion	Photo #	Observations and Remarks
Steel Bulkhead / Caps	Excellent			5	Land owners have installed stoplog brackets.
Steel Grating	N/A				
Stop Logs	N/A				
Hardware	Good			5	Three SS bolts missing from pile cap. Not critical. Landowner installed boat lifting device has been removed..
Timber Piles	N/A				
Timber Wales	N/A				
Galv. Pile Caps	Excellent				
Vegetation	N/A				
Signage /Supports	Excellent			5	
Rip Rap (fill)	N/A				
Eathern Embankment	Excellent

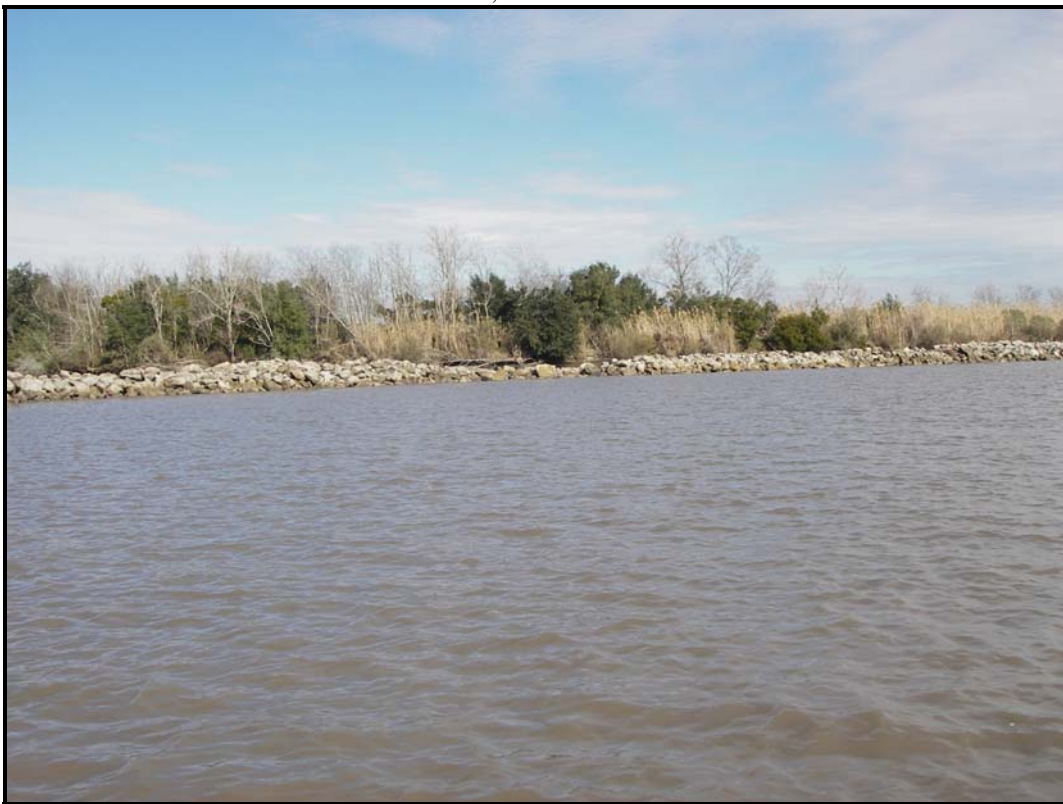
The dike is in excellent condition. Approximately 50 linear feet on the eastern end at a barge slip continues to settle but is in no need of any repairs. This low area is located at N 29° 49' 58.3" and W 91° 59' 25.9". East and west tie-ins are stable, however there is some minor erosion occurring at the east tie-in which will be monitored on future inspections. The water

Photo No. 6, Rock along north bank of GIWW showing low area

Item	Condition	Physical Damage	Corrosion	Photo #	Observations and Remarks
Steel Bulkhead / Caps	N/A				
Steel Grating	N/A				
Stop Logs	N/A				
Hardware	N/A				
Timber Piles	N/A				
Timber Wales	N/A				
Galv. Pile Caps	N/A				
Vegetation	N/A				
Signage / Supports	N/A				
Rip Rap/dike	Excellent			6	Dike is excellent post construction condition. Approx. 50 LF on eastern end hit by barge continues to settle.
Eathern Embankment	N/A

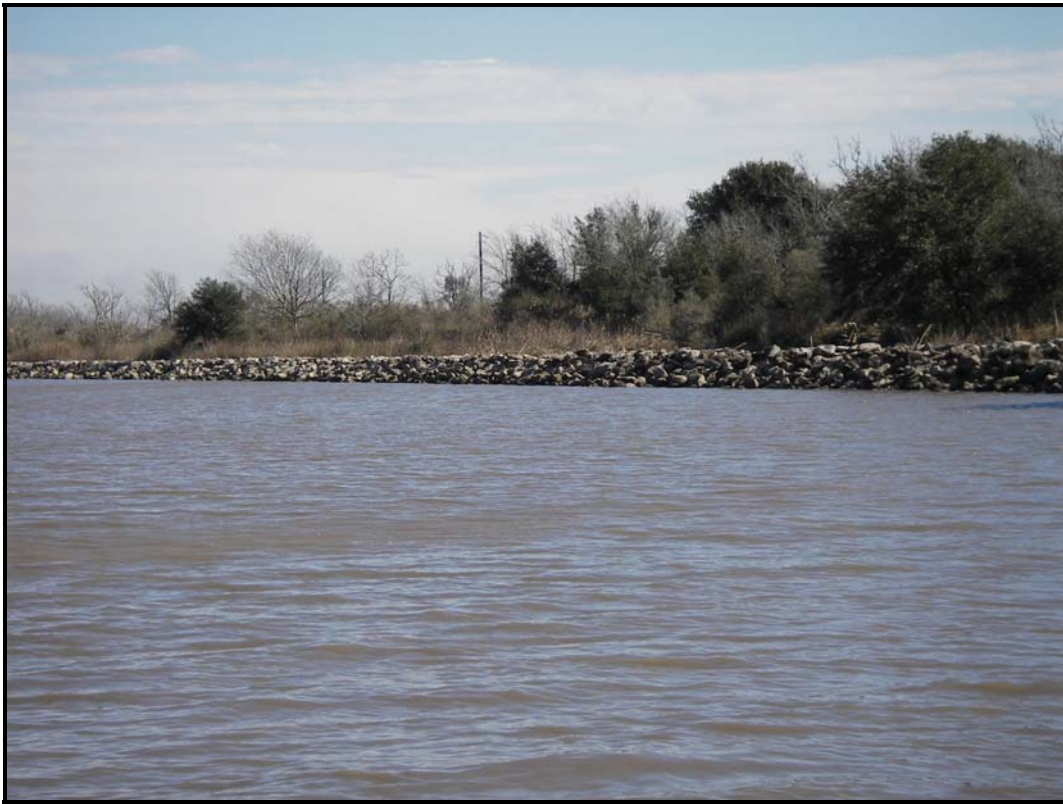
The rock dike is similar to immediate post construction condition and in no need of any repairs. (Appendix B; Photo 7)

Photo No. 7, Rock dike along south bank of GIWW

Item	Condition	Pysical Damage	Corrosion	Photo #	Observations and Remarks
Steel Bulkhead / Caps	N/A				
Steel Grating	N/A				
Stop Logs	N/A				
Hardware	N/A				
Timber Piles	N/A				
Timber Wales	N/A				
Galv. Pile Caps	N/A				
Vegetation	N/A				
Signage /Supports	N/A				
Rip Rap (fill)	Excellent			7	
Eathern Embankment	N/A
