Coastal Protection and Restoration Authority of Louisiana

2009/2010 Annual Inspection Report

MARSH ISLAND HYDROLOGIC RESTORATION PROJECT (TV-14)

State Project Number TV-14
Priority Project List 6

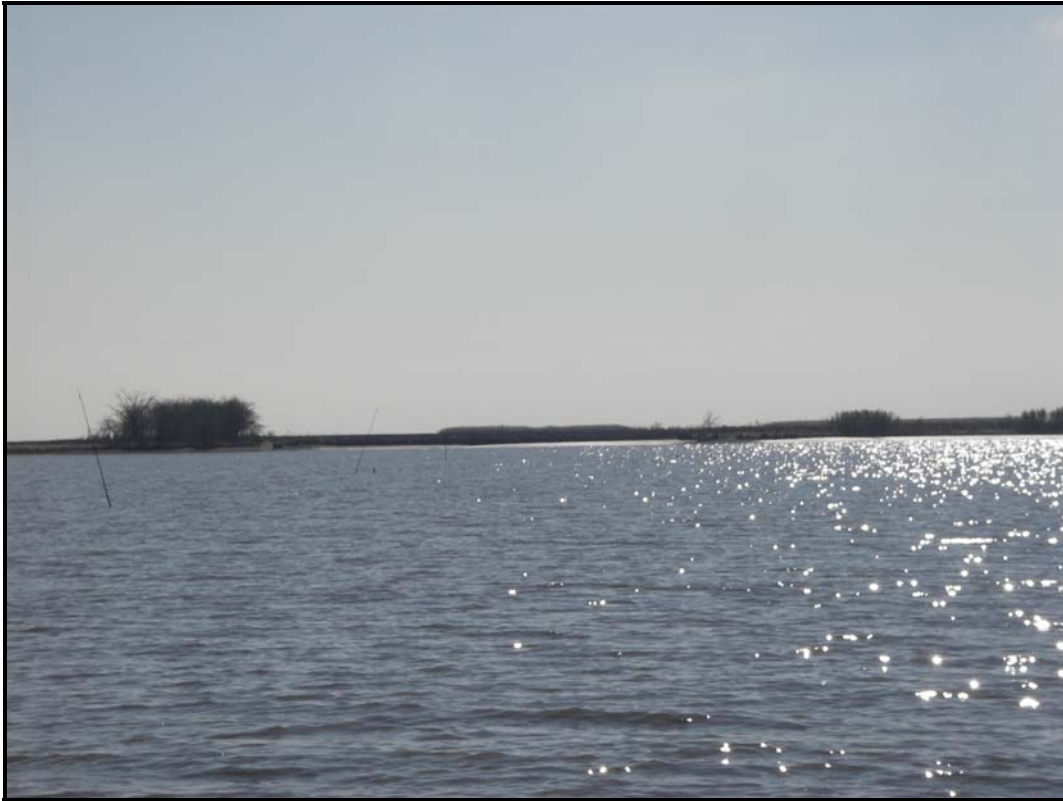
Photo No.1, Closure No.1

The erosion problems and Hurricane Rita damages have been repaired through the recent maintenance project that was completed in February 2009. The dike was capped and bank paving installed on both ends of the closure. This site is in good condition since this work was performed. This site was not accessible except from a distance due to low water. (Photos: Appendix B, Photo 1).

Item	Condition	Physical Damage	Corrosion	Photo #	Observations and Remarks
Steel Bulkhead / Caps	N/A				
Steel Grating	N/A				
Stop Logs	N/A				
Hardware	N/A				
Timber Piles	N/A				
Timber Wales	N/A				
Galv. Pile Caps	N/A				
Cables	N/A				
Signage / Supports	N/A				
Rip Rap (fill)	Good			1	
Earthen Embankment	N/A

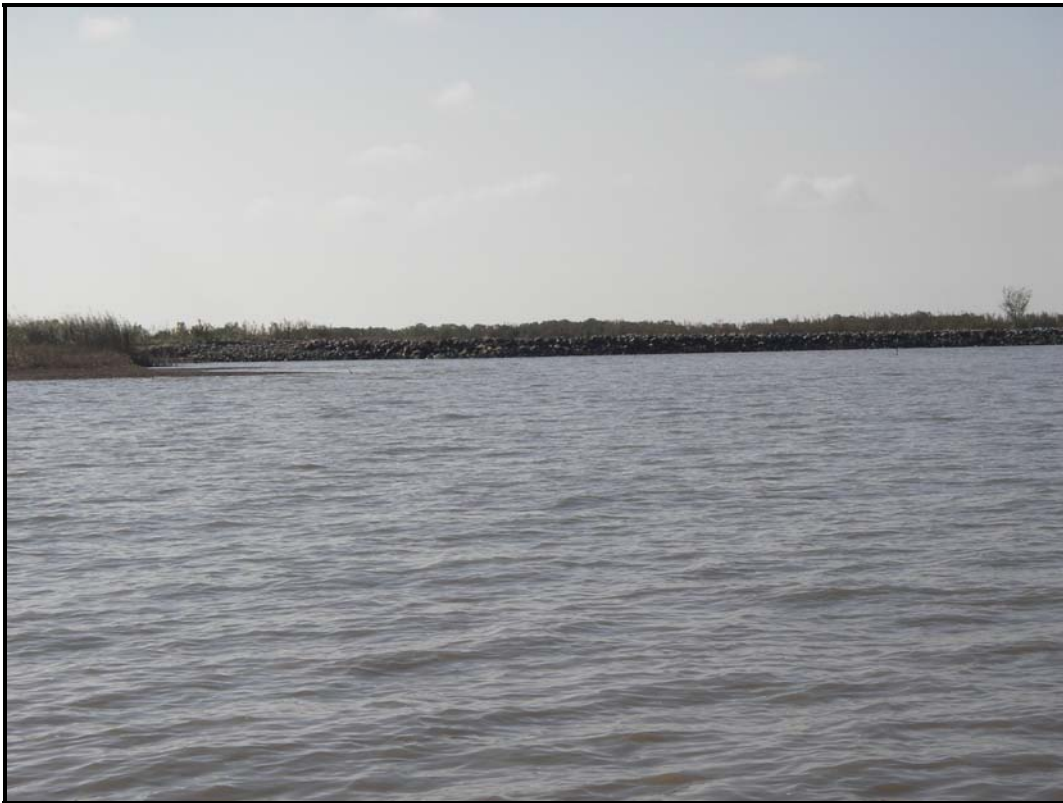
Photo No. 2, Closure No. 2

The dike was capped and bank paving installed as noted above and is in good condition since the work was performed. This site was also not accessible except from a distance due to low water. (Photos: Appendix B, Photo 2).

Item	Condition	Physical Damage	Corrosion	Photo #	Observations and Remarks
Steel Bulkhead / Caps	N/A				
Steel Grating	N/A				
Stop Logs	N/A				
Hardware	N/A				
Timber Piles	N/A				
Timber Wales	N/A				
Galv. Pile Caps	N/A				
Cables	N/A				
Signage / Supports	N/A				
Rip Rap (fill)	Good			2	
Earthen Embankment	N/A

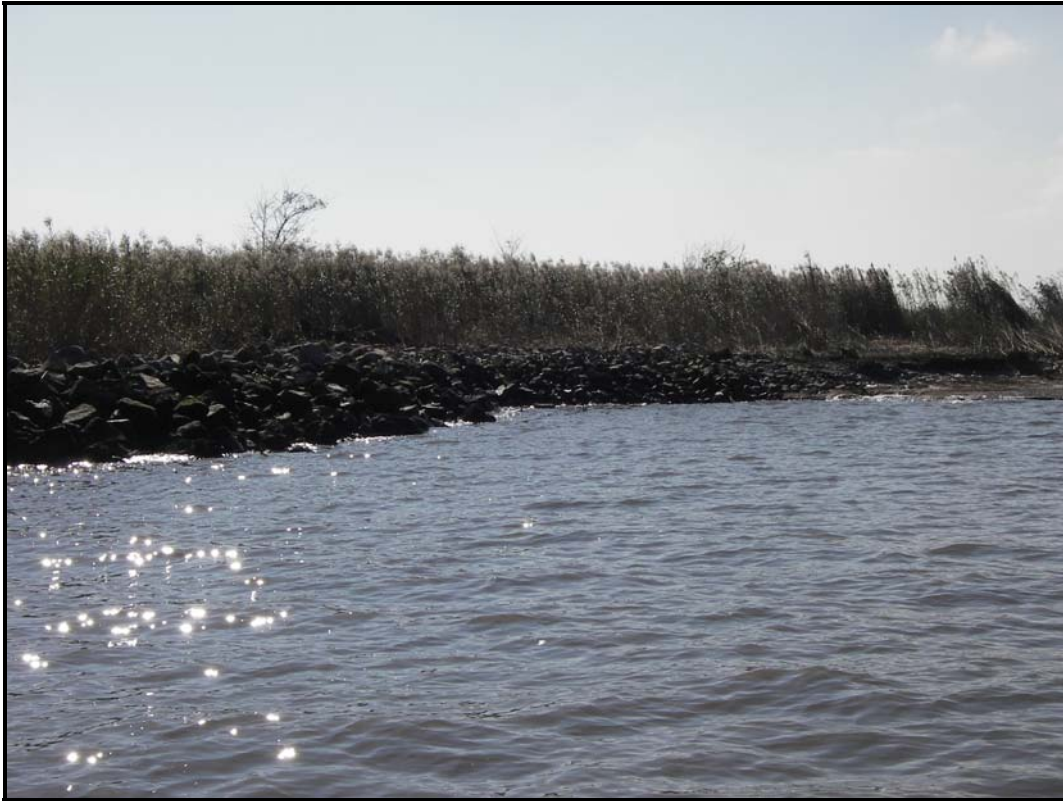
The rock closure dike appears in good condition and was extended on the western end along with installing bank paving during the recent maintenance event. Also, it was observed (and confirmed with aerial photography post Hurricane RITA) that a large open water area has developed within the marsh near the western terminus of Closure No. 3 and that the bankline between that point and the eastern end of Closure No. 2 has eroded very severely and such that the “landbridge” between Vermilion Bay on the north of Marsh Island and the northwestern portion of Lake Sand proper is now narrow and may become subject to breaching thus allowing an undesirable water connection between the two bodies of water. OCPR and COE agree that this area is in poor condition and should be considered for maintenance at some point in time. It is recommended that an additional reach of shoreline protection dike be constructed, an estimated 1,500 to 1,800 linear feet, to connect the western end of Closure No. 3 to the eastern end of Closure No. 2. This reach of bank has been recently surveyed and the estimated cost for rock dike and flotation is approximately \$800,000. OCPR and COE agreed

that due to this area being of concern but not yet critical status; and budget constraints, this maintenance work would be undertaken at a later time.(Photos: Appendix B, Photo 3).

Photo No. 3, Closure No. 3 bank paving west side

Item	Condition	Physical Damage	Corrosion	Photo #	Observations and Remarks
Steel Bulkhead / Caps	N/A				
Steel Grating	N/A				
Stop Logs	N/A				
Hardware	N/A				
Timber Piles	N/A				
Timber Wales	N/A				
Galv. Pile Caps	N/A				
Cables	N/A				
Signage / Supports	N/A				
Rip Rap (fill)	Good			3	Hurricane RITA eroded the marsh between Str. No. 2 & 3, leaving a narrow piece of marsh, and it is recommended that the shoreline between Str. 3 & 4 (+/- 1,500 to 1,800 L.F.) be armored with a rock dike.
Earthen Embankment	N/A

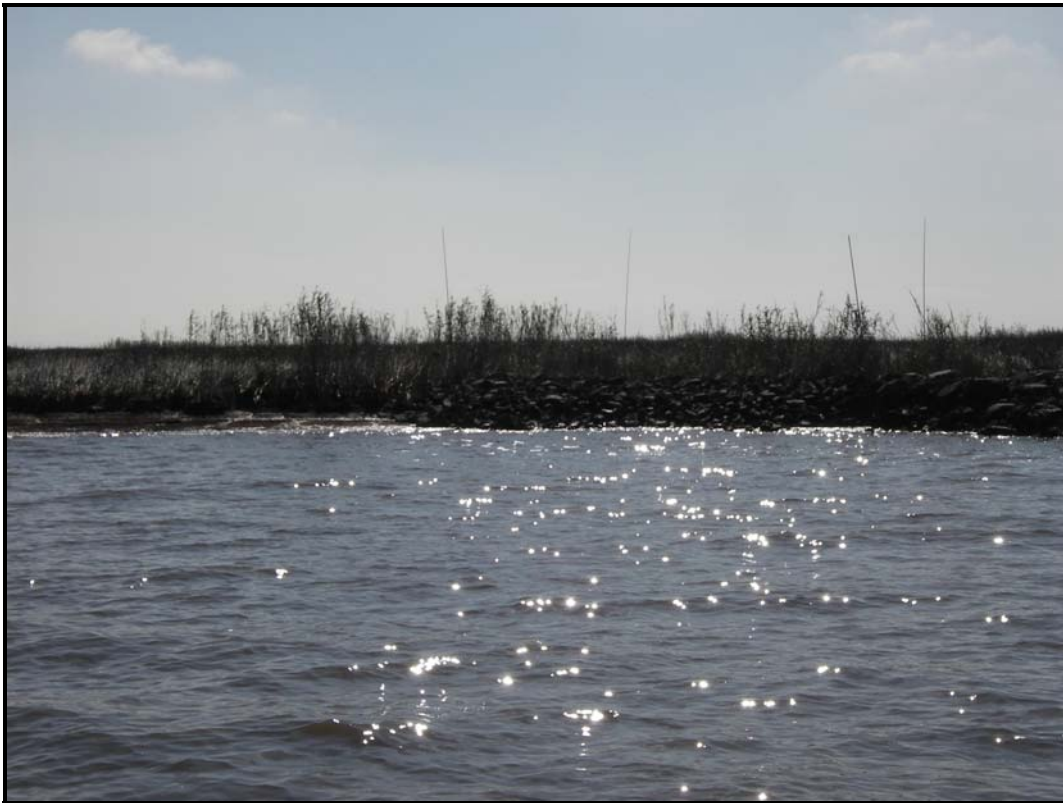
The Lake Sand Dike closure as originally constructed and recently repaired for Hurricane Rita damages, appears in good condition. The dike was capped in those areas where it was below elevation +3.0 as well as extended on the eastern end with bank paving. (Photos: Appendix B, Photos 4-5).

Photo No. 4, Closure No. 4 bank paving east side

Item	Condition	Physical Damage	Corrosion	Photo #	Observations and Remarks
Steel Bulkhead / Caps	N/A				
Steel Grating	N/A				
Stop Logs	N/A				
Hardware	N/A				
Timber Piles	N/A				
Timber Wales	N/A				
Galv. Pile Caps	N/A				
Cables	N/A				
Signage / Supports	N/A				
Rock Dike	Good			4,5	
Earthen Embankment	N/A

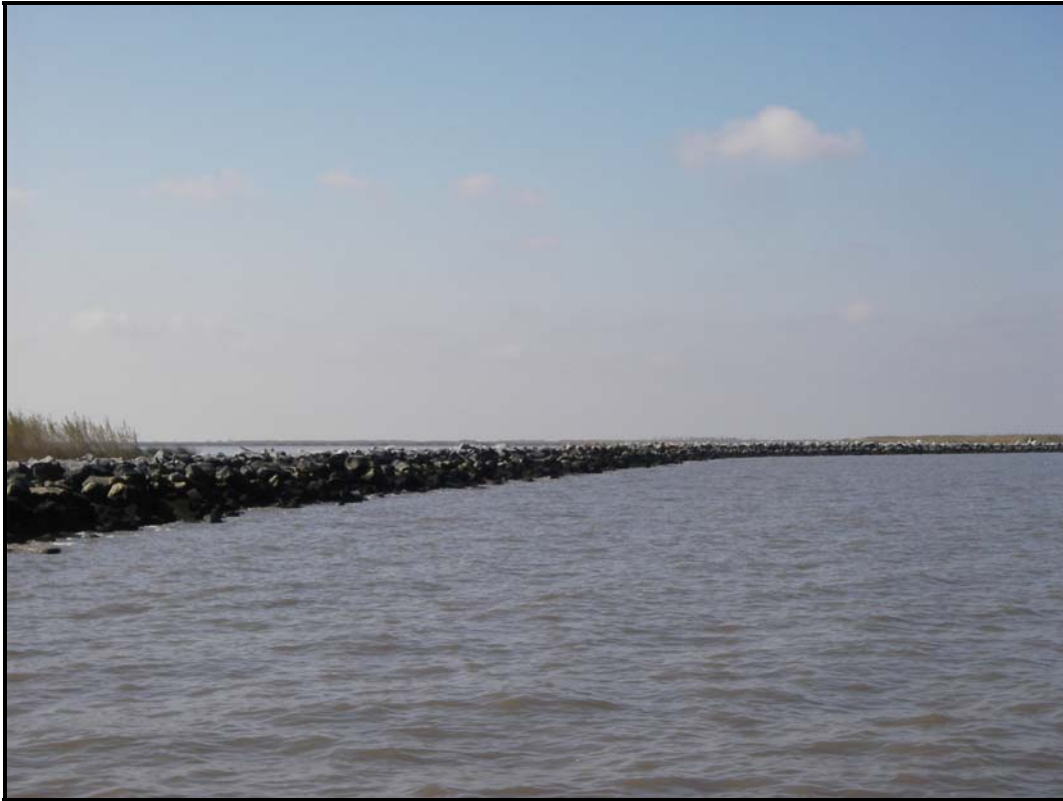
Photo No. 5, Closure No. 4 looking west

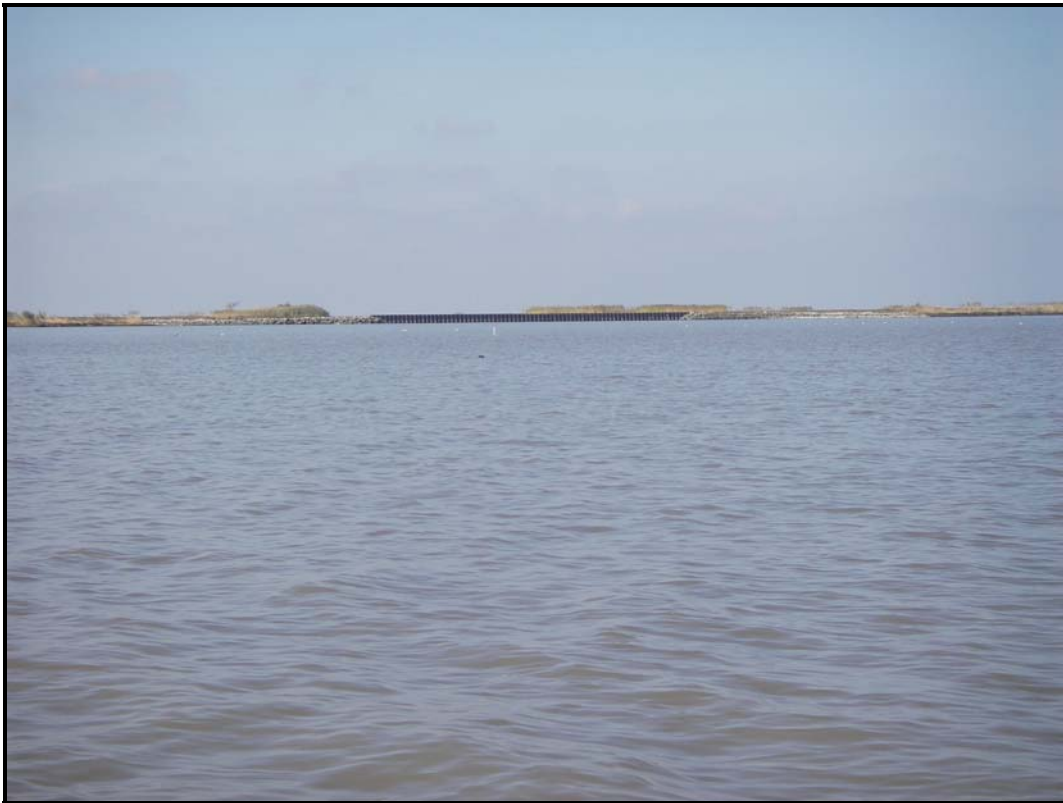
Photo No. 6, Closure No. 5

The steel sheet pile, rock riprap wingwalls, and stone bank/marsh paving placed as part of the Hurricane LILI repair project is in good condition and were apparently very effective in preventing additional damage by the erosive action of Hurricane RITA. The staff gage was re-set as part of the recent maintenance event. The overbank marsh areas paved to make same “hard” and paid for with O & M funding needs to be continually evaluated for its effectiveness. This site was also not accessible except from a distance due to low water. (Photos: Appendix B, Photo 6).

Item	Condition	Physical Damage	Corrosion	Photo #	Observations and Remarks
Steel Bulkhead / Caps	Good			6	
Steel Grating	N/A				
Stop Logs	N/A				
Hardware	N/A				
Timber Piles	N/A				
Timber Wales	N/A				
Galv. Pile Caps	N/A				
Cables	N/A				
Signage / Supports	N/A				
Rip Rap (fill)	Good			6	
Earthen Embankment	N/A

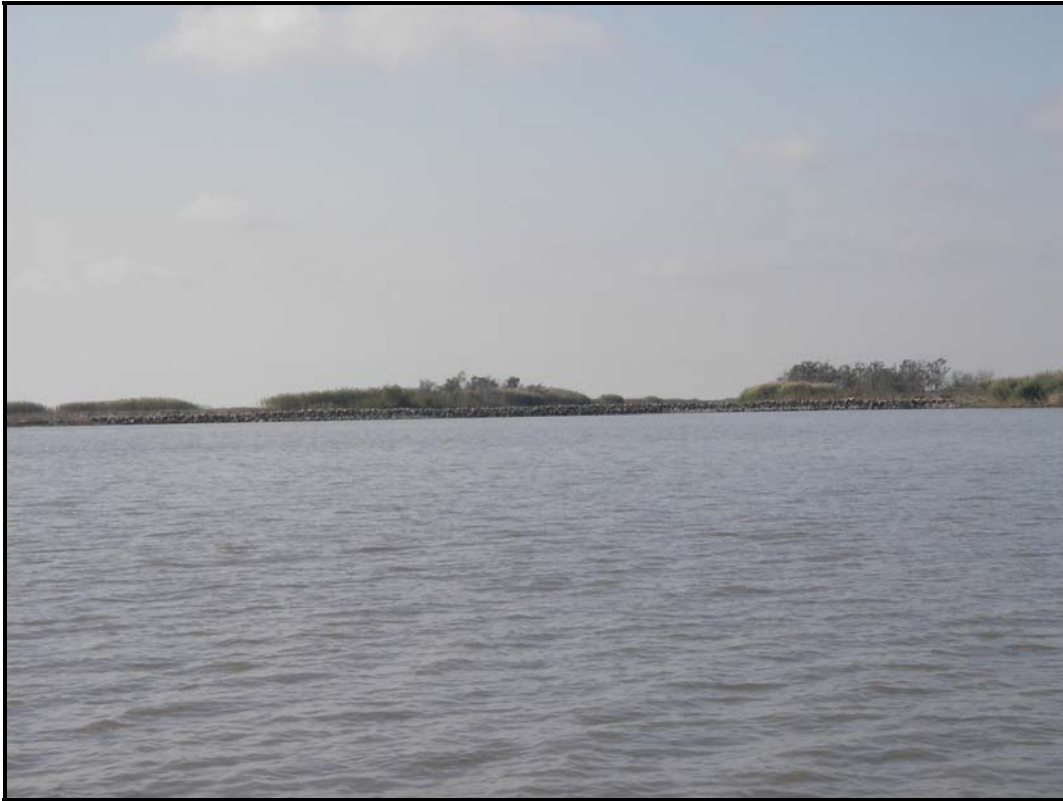
Photo No. 7, Closure No. 6

The breach on the southern end of the dike that had occurred prior to Hurricane Rita and subsequently worsened as a result of the tidal surge has been repaired as part of the recent maintenance event. The dike was extended on the northern end and bank paving was installed on both ends of the closure. This site is in good condition since the repairs have been made. This site was also not accessible except from a distance due to low water. (Photos: Appendix B, Photo 7).

Item	Condition	Physical Damage	Corrosion	Photo #	Observations and Remarks
Steel Bulkhead / Caps	N/A				
Steel Grating	N/A				
Stop Logs	N/A				
Hardware	N/A				
Timber Piles	N/A				
Timber Wales	N/A				
Galv. Pile Caps	N/A				
Cables	N/A				
Signage / Supports	N/A				
Rock Dike	Good			7	
Earthen Embankment	N/A

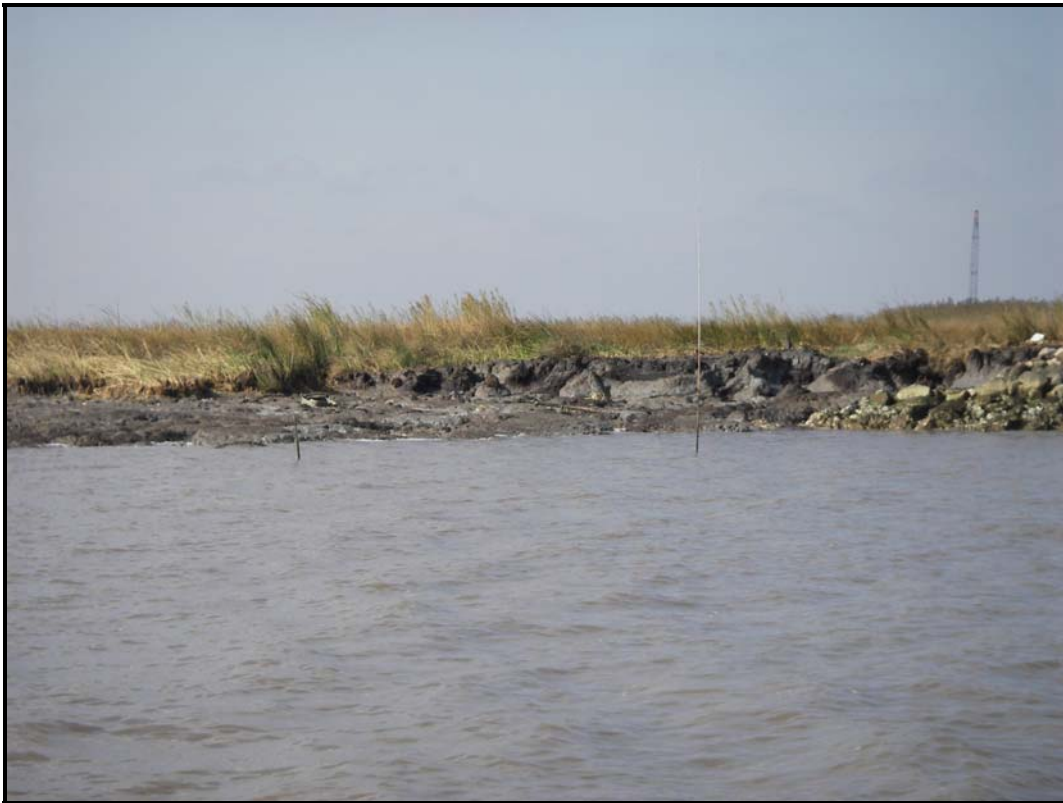
This closure site is in good condition and spoil material from the dredging of the north-south canal in 2008 was placed along the eastern end of the rock dike in an effort to stabilize this section of shore. In addition dredge spoil material was pumped behind the rock dike as part of this same access dredging and a small area of marsh creation was formed which is now starting to vegetate. (Photos: Appendix B, Photos 8-9).

Photo No. 8, Structure No. 7 spoil material connecting to rock dike

Item	Condition	Physical Damage	Corrosion	Photo #	Observations and Remarks
Steel Bulkhead / Caps	N/A				
Steel Grating	N/A				
Stop Logs	N/A				
Hardware	N/A				
Timber Piles	N/A				
Timber Wales	N/A				
Galv. Pile Caps	N/A				
Cables	N/A				
Signage / Supports	N/A				
Rock Dike	Good			8,9	
Earthen Embankment	N/A

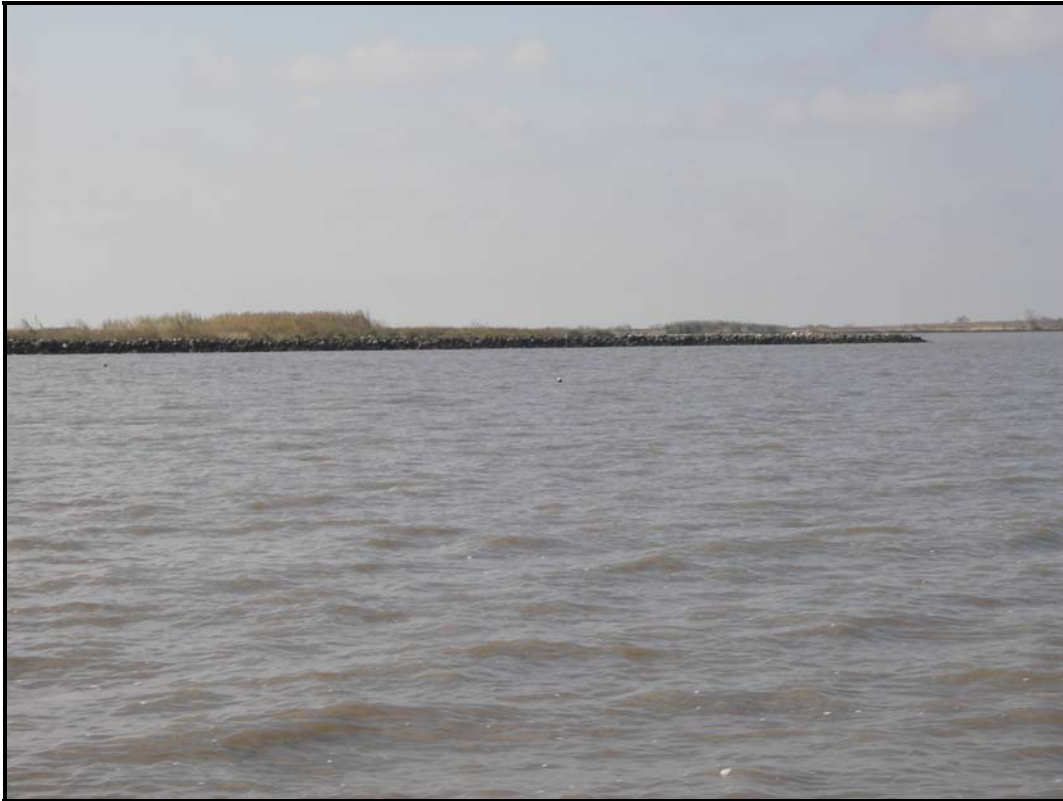
Photo No. 9, Structure No. 7 marsh creation behind rock dike starting to vegetate

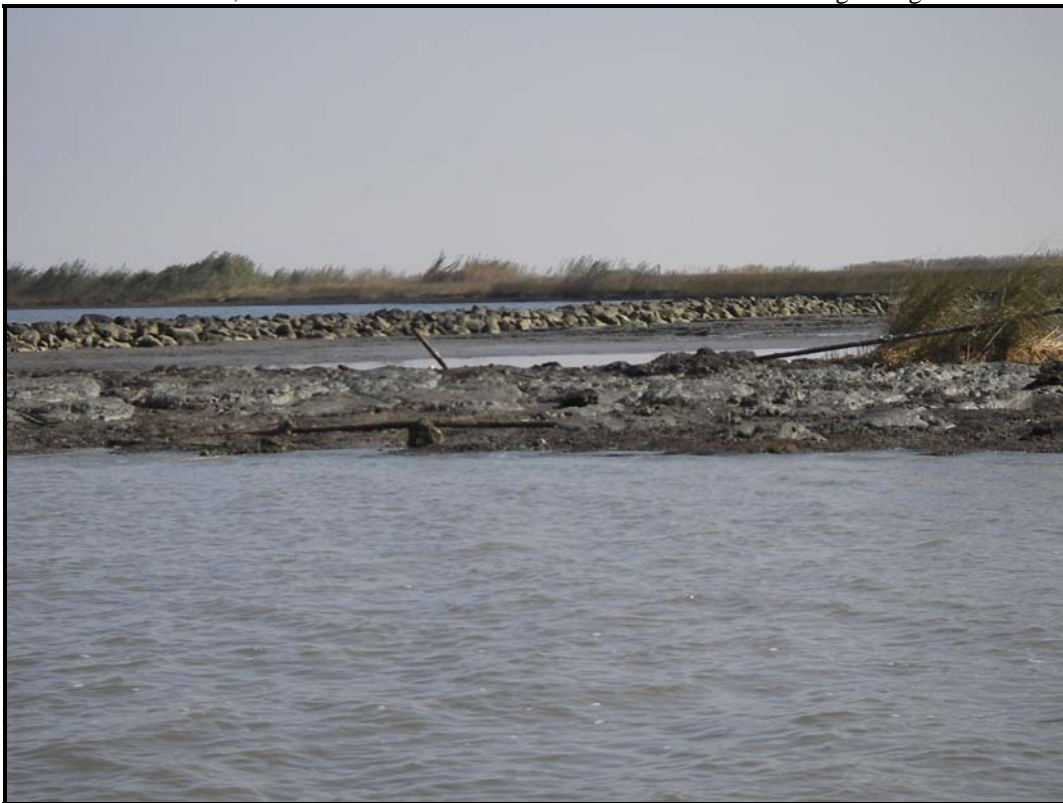
This closure site is in good condition since the existing breach on the south side of the closure was repaired as noted in the 2008 maintenance event noted above in Section IV. Spoil material was placed to close off the breach and also placed on top of the existing rock dike. Some of this spoil material has since washed away and at the low water condition on the outside of the

closure you could see water flowing through the rock. Spoil material was also placed from the north end of the rock dike towards the bay to make a connection to the existing mitigation rock dike along the bayshore. (Photos: Appendix B, Photos 10-12).

Photo No. 10, Closure No. 8 spoil material connecting to rock dike at bay shore

Item	Condition	Physical Damage	Corrosion	Photo #	Observations and Remarks
Steel Bulkhead / Caps	N/A				
Steel Grating	N/A				
Stop Logs	N/A				
Hardware	N/A				
Timber Piles	N/A				
Timber Wales	N/A				
Galv. Pile Caps	N/A				
Cables	N/A				
Signage / Supports	N/A				
Rock Plug	Good			10,11,12	
Earthen Embankment	N/A

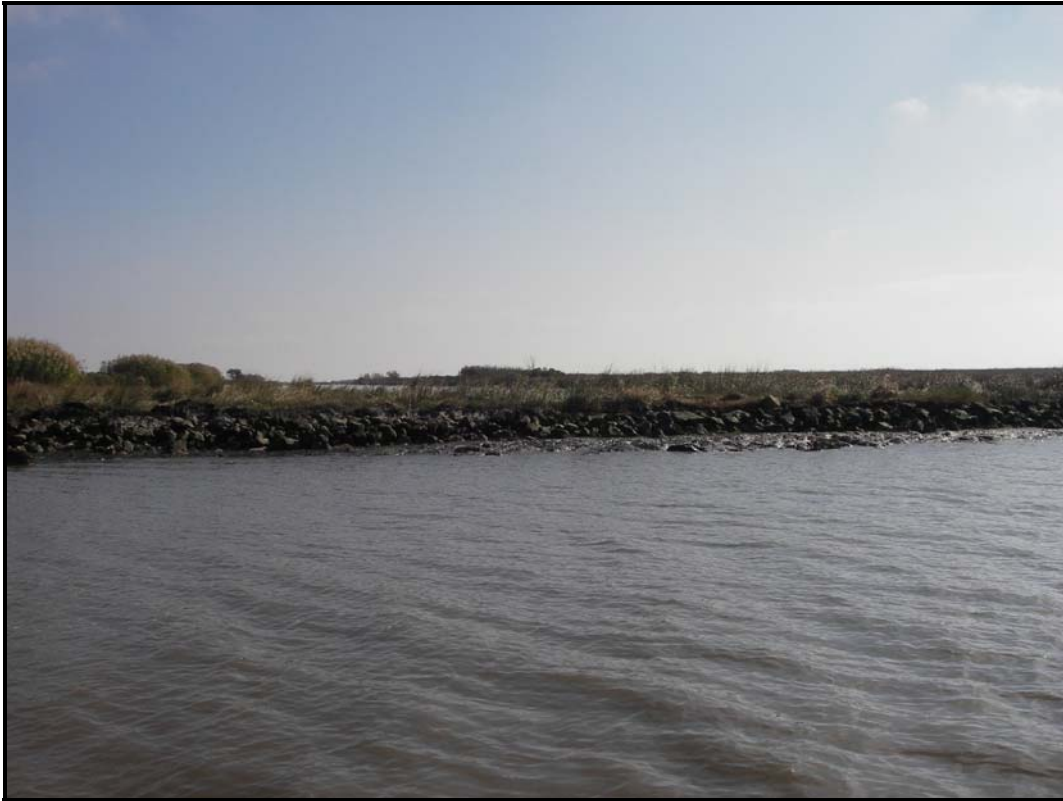
Photo No. 11, Closure No. 8 rock covered with spoil material looking east

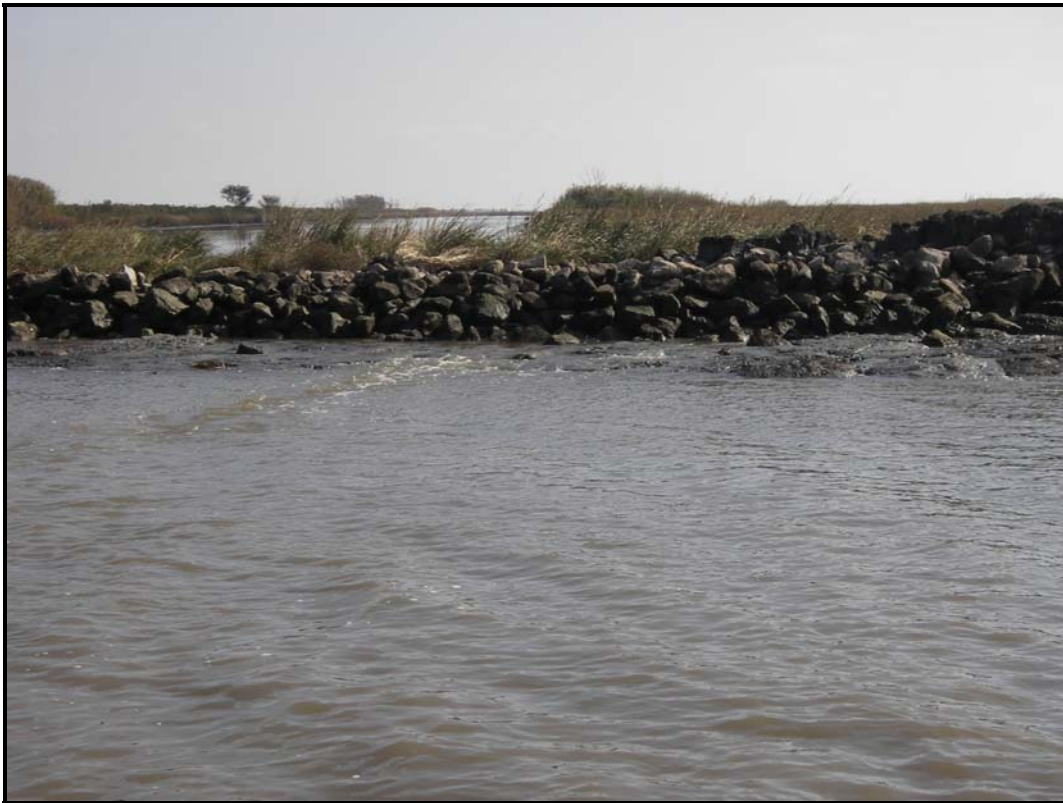
Photo No. 12, Closure No. 8, view showing water flowing through rock plug

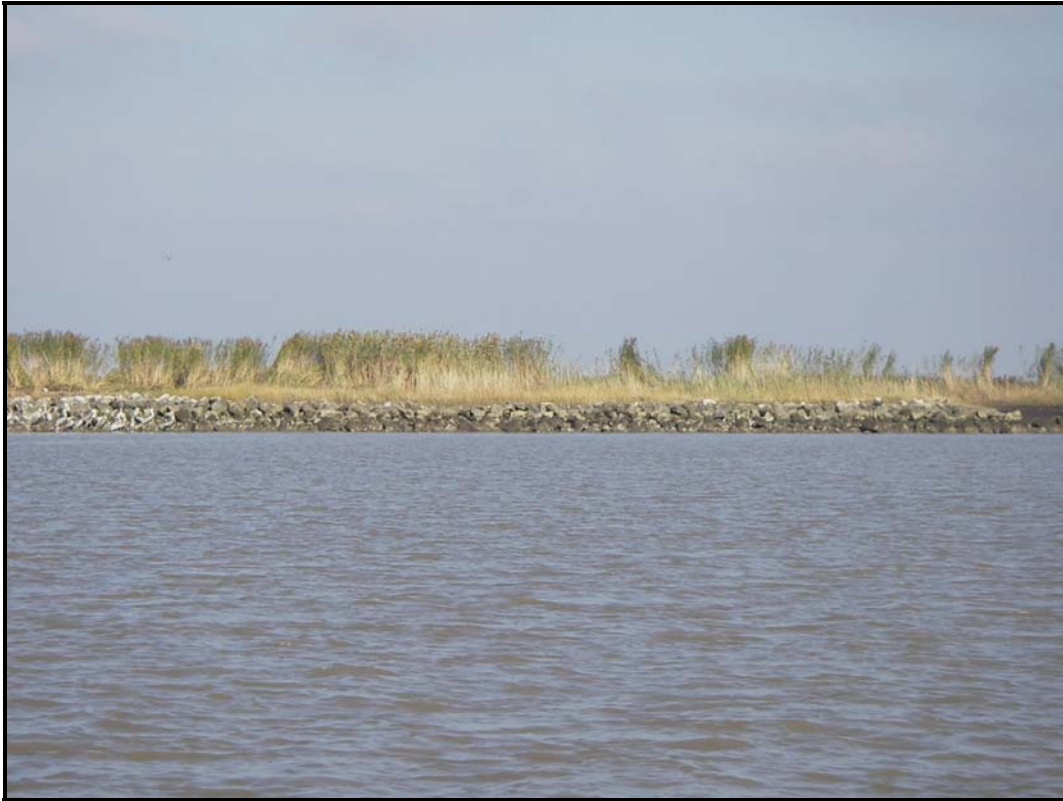
The rock riprap shoreline protection dike constructed on the south shoreline of Marsh Island was noted to now sit out further into the waters of the Gulf as discussed in the last inspection. Conditions were such that the feature was functioning well and that sediment had accreted and a growth of marsh vegetation had extended over the new fill. This rock shoreline feature will still function as a breakwater and extend the life of the earthen pipeline closure to the north. It was discussed that perhaps each end of the current rock riprap dike be extended to the east and to the west, or perhaps construct extensions on each end of the existing stone to the northwest and northeast alignment directions to the shoreline from erosion of the earthen pipeline closure. Conditions at this location need to be evaluated and a design for some east and west extensions of the current dike concluded after some study. The low water conditions during this inspection allowed a good view of the mudflat behind the rock dike and the existing bank. There does not appear to be any scour in this area. (Photos: Appendix B, Photos 13-14).

Photo No. 13, Structure No. 9 rock dike, fully exposed at low water conditions

Item	Condition	Physical Damage	Corrosion	Photo #	Observations and Remarks
Steel Bulkhead / Caps	N/A				
Steel Grating	N/A				
Stop Logs	N/A				
Hardware	N/A				
Timber Piles	N/A				
Timber Wales	N/A				
Galv. Pile Caps	N/A				
Cables	N/A				
Signage / Supports	N/A				
Rock Dike	Fair			13, 14	The mudflat behind the rock dike was exposed. The rock dike needs to be extended on each end and tie back into existing shoreline.
Earthen Embankment	N/A

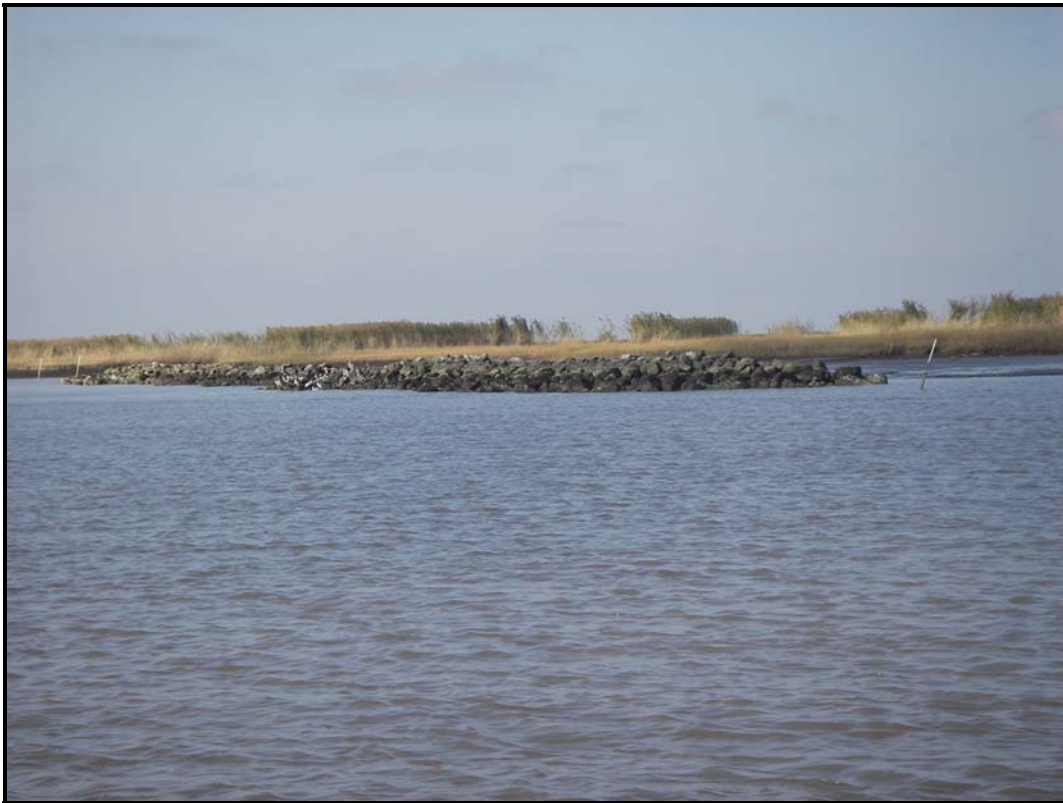
Photo No. 14, Structure No. 9, view showing mudflat behind rock dike
