**Coastal Protection and Restoration
Authority of Louisiana**

2008 Annual Inspection Report

**Barataria Barrier Island Complex
Project: Pelican Island and Pass La
Mer to Chaland Pass Restoration**

State Project Number BA-38
Priority Project List 11

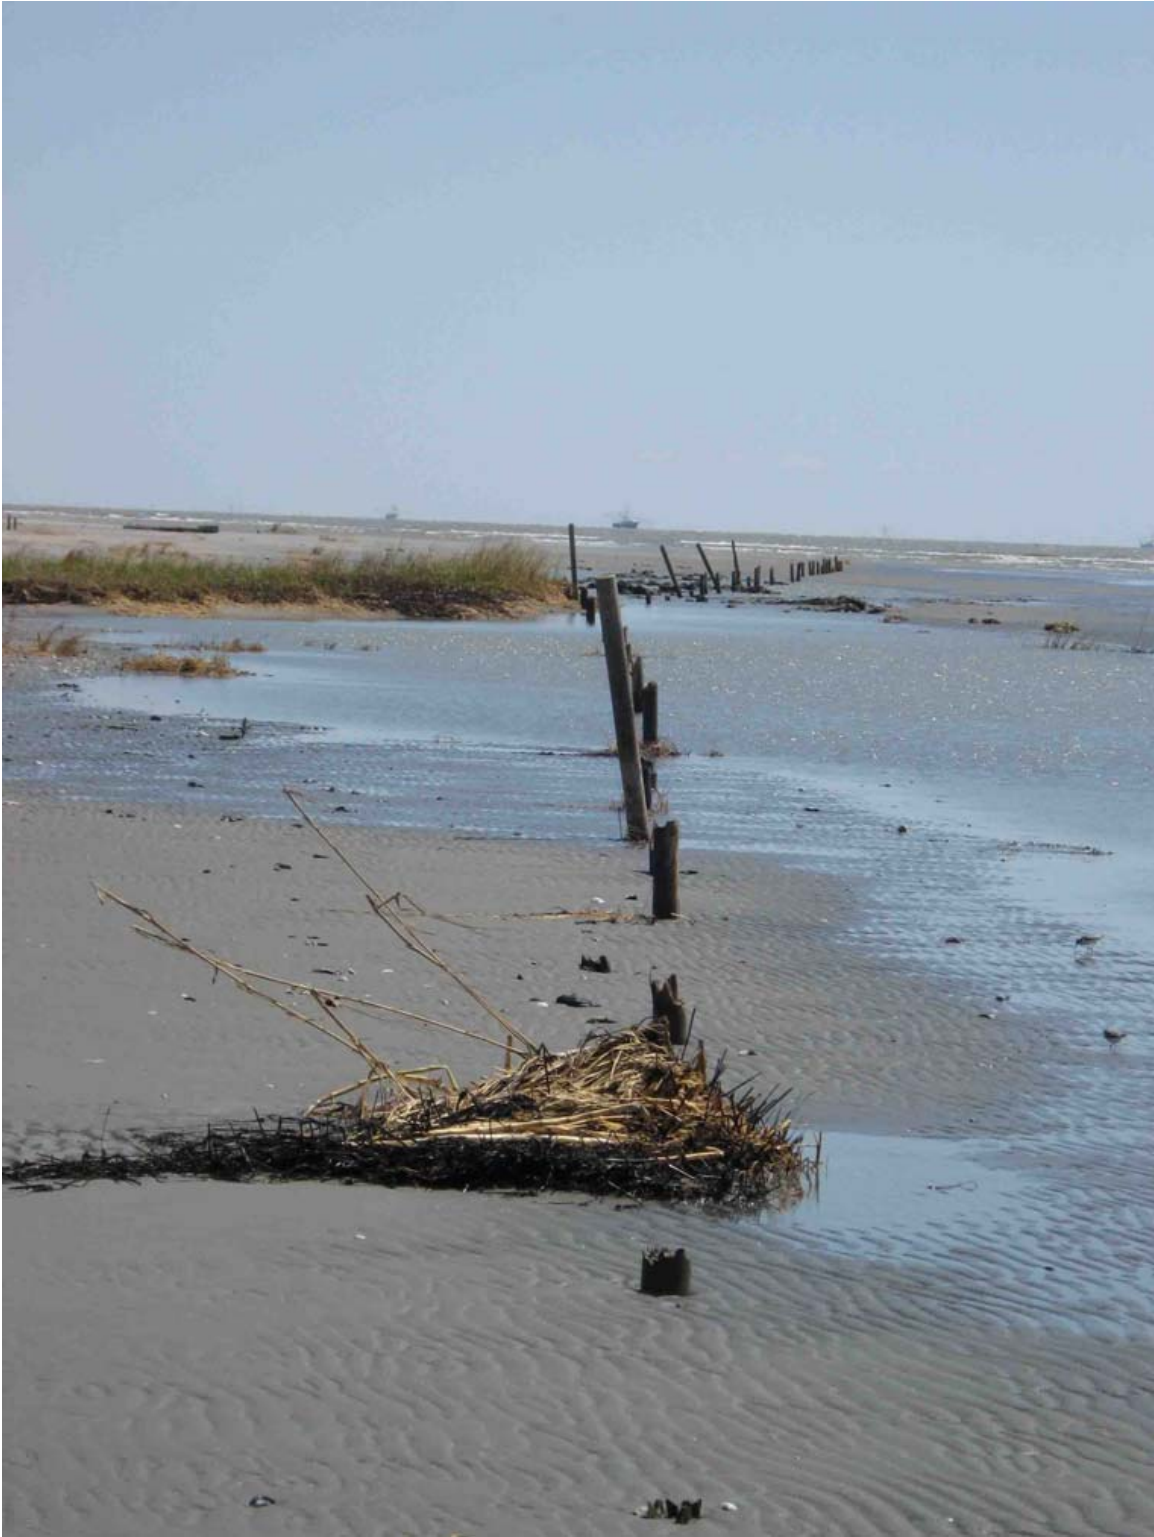
All of the sand fencing was relocated outside of the project area by the storms. (Photo #1)

Photo #1 –Damage to Sand Fence (now in surf line).

It is the recommendation of the OCPR/NOFO that the sand fencing and vegetative plantings be replaced as necessary.

- Sand Fencing and Vegetative Plantings.

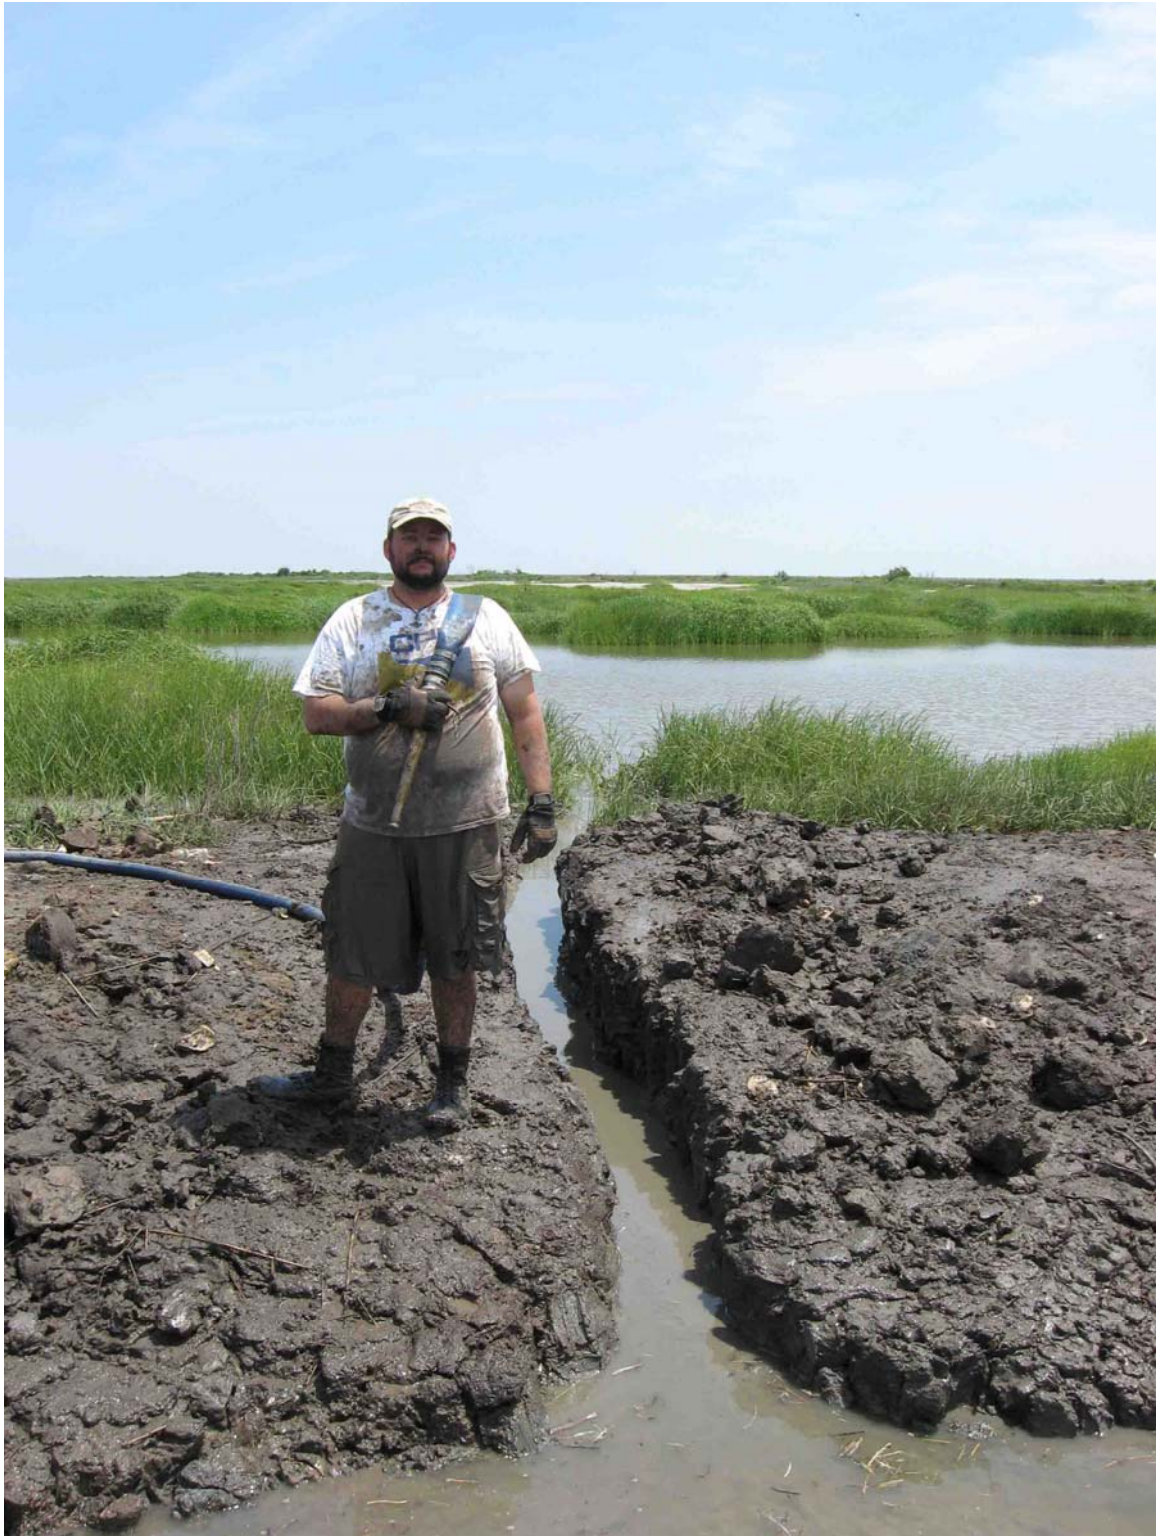
The containment dike was not degraded upon demobilization from the construction site. During the period between demobilization and this inspection the dike has been slowly degrading due to natural processes. In May, 2008, members of the OCPR and NMFS hydraulically cut 4 gaps into the containment dike using a high pressure pump. At the time of the inspection these gaps were larger and allowing water to exchange between the project area and outer marshes and canals. Photos #2 and 3)

Photo #2 – Hydraulic Dike Gapping.

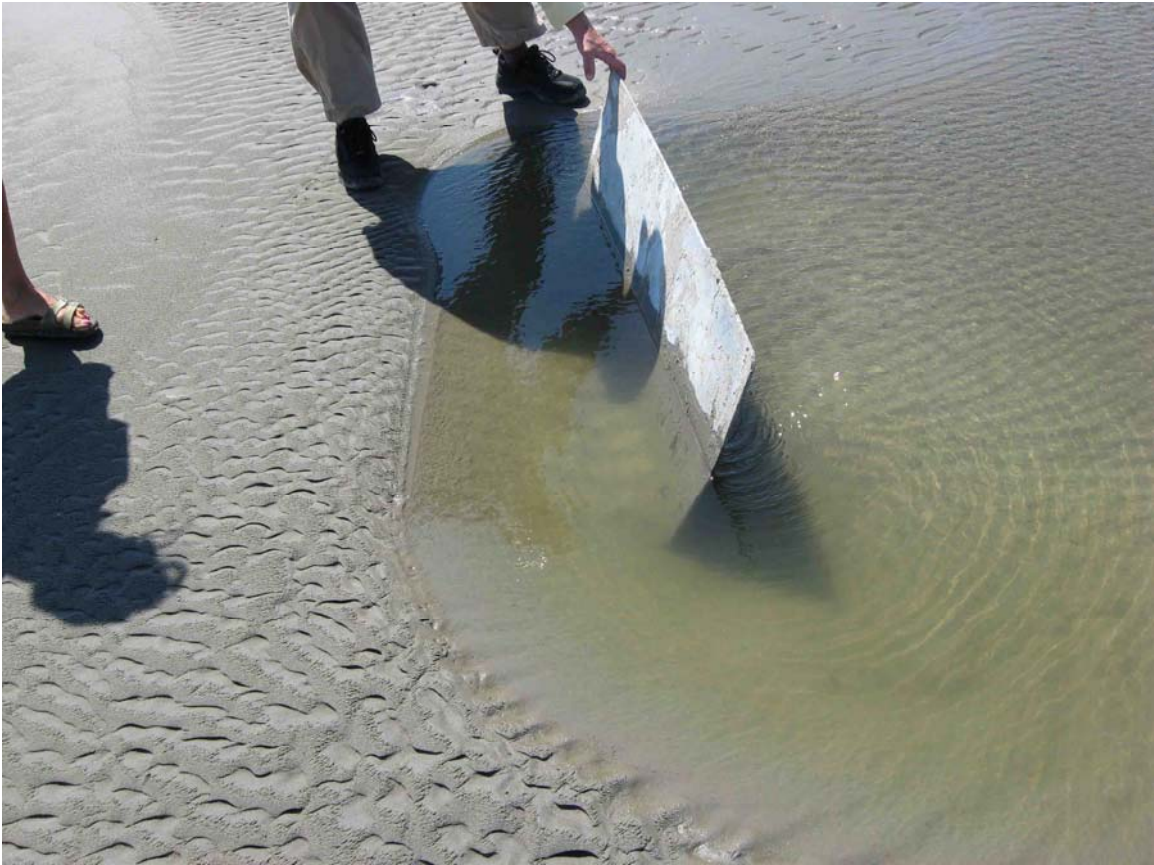
One settlement plate was turned on its side (Photo #4). The other six are undamaged.

Photo #4 – Settlement Plate (overturned).

The Chaland Headland Project area took a big hit during the 2008 hurricane season. The sand fencing will require replacement as well as the vegetative plantings since most of those were displaced. The remaining settlement plates will continue to be surveyed as scheduled while the damaged plate should be removed. A good majority of the beach material is now located within the marsh template and some can be found farther north of the project area. The project will continue to be monitored for any changes and the required maintenance work should be performed in a timely manner.
