2008 Annual Inspection Report

Jonathan Davis Wetland Protection

State Project Number BA-20
Priority Project List 2

July 13, 2009
Jefferson Parish

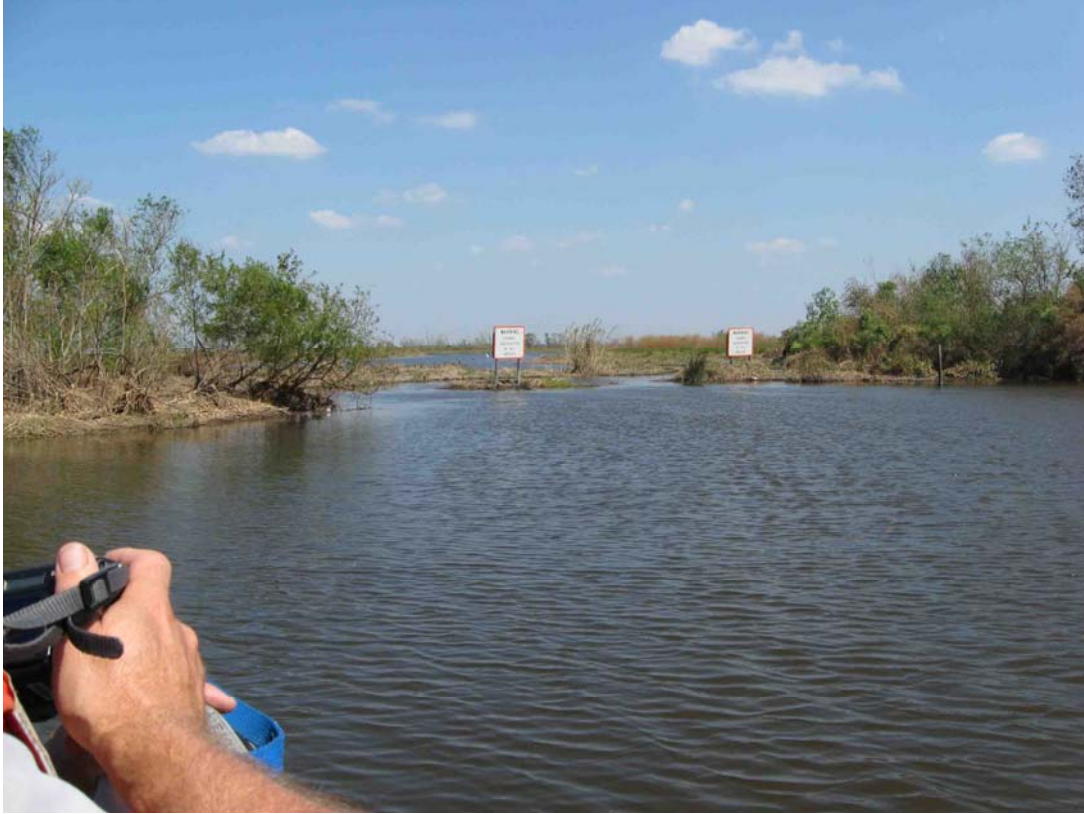
Upon a visual inspection, we noticed a large breach on the west side of the structure and in the center of the structure. (Photo #1). Due to poor soil conditions, this structure has experienced significant settlement problems since the time it was constructed. Several attempts were made during construction to stabilize the structure by placing several lifts of rock, but the structure continued to settle. The maintenance work for this structure will be performed during the construction of Construction Unit 4 (CU 4).

Photo #1 – Structure #14 (Note Gaps)

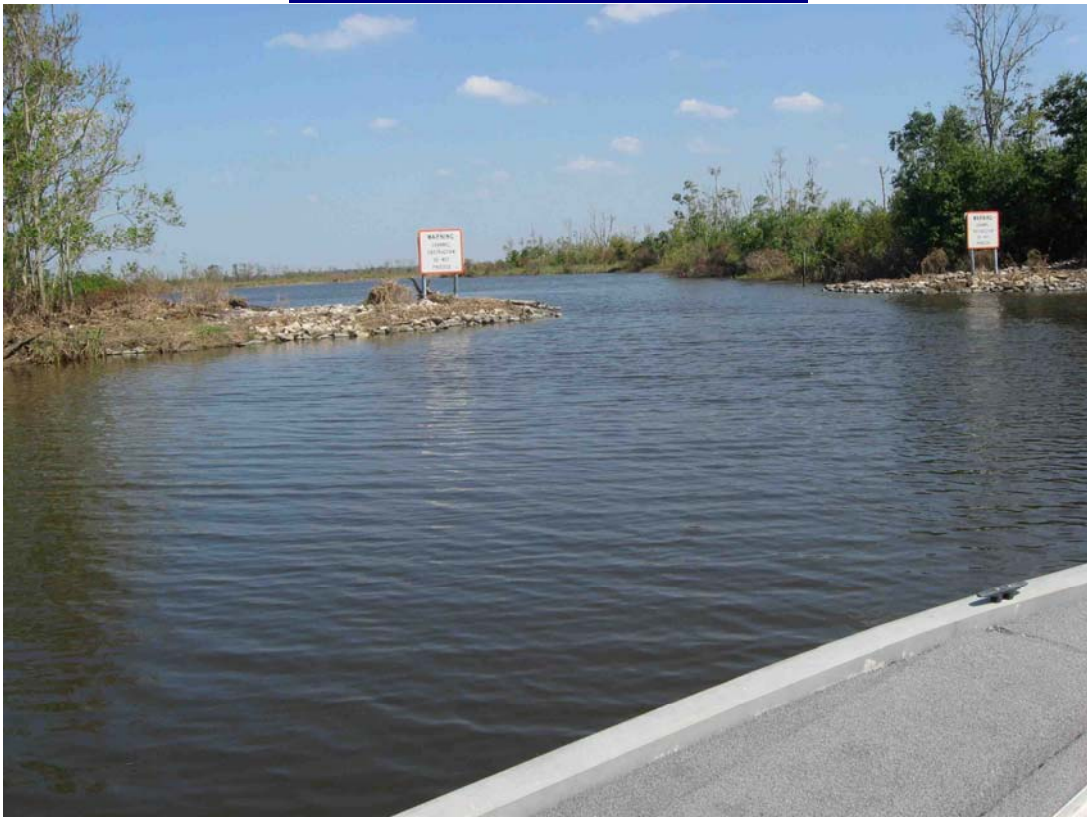
Structure 15 appeared to be in good condition at the time of the inspection with little or no noticeable settlement of the rock weir (Photo #2). Signs and supports were also in good condition. The original design of this structure was modified to include a boat bay to accommodate oilfield activities and navigation on the interior marsh of the structure. During the construction of CU 4, this structure will be modified so that it represents the original design more accurately.

Photo #2 – Structure #15

Item	Condition	Physical Damage	Corrosion	Photo #	Observations and Remarks
Signage and supports	Good			2	Observations: There have been no changes since the last inspection. The work to be done through the CU4 Construction Contract has not been completed due to contract issues.
Armored Plug	Good			2	
Rock weir	Good			2	Remarks: The original design of this structure was modified to a rock weir with boat bay to accommodate oilfield activities and navigation on the interior of the structure. During above mentioned maintenance this structure will be converted to a rock
Earthen Embankment	Good			2	
Construction Unit No.1 Structure Description: 132 linear ft. of rock rip-rap armored weir with a 50 ft. wide boat bay located in a pipeline channel north of Bayou Perot, west of Bayou Barataria and east of the GIWW and Site 14. The crest of the rock weir was constructed to an elevation of +4.0 ft. NGVD. The invert of the boat bay is at and elevation of -3.0 ft. The rock filled weir contains 1,248 tons of rock fill with and 728 tons of rock rip-rap armor. Two (2) aluminum warning signs are located through the rock armored embankment on each side of the boat bay.

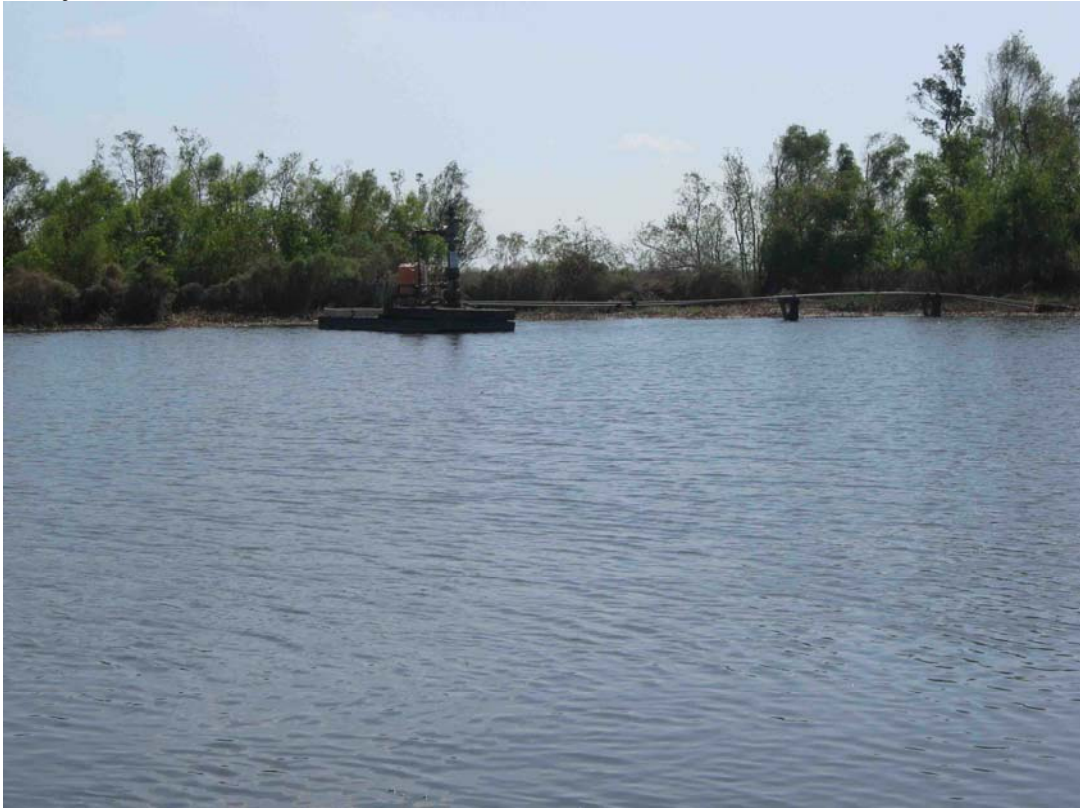
Structure 16 appeared to be in good condition with exception of a low area on the south side of the channel plug (Photo #3). The maintenance work for this structure will be performed during the construction of CU4.

Photo #3 – Structure #16

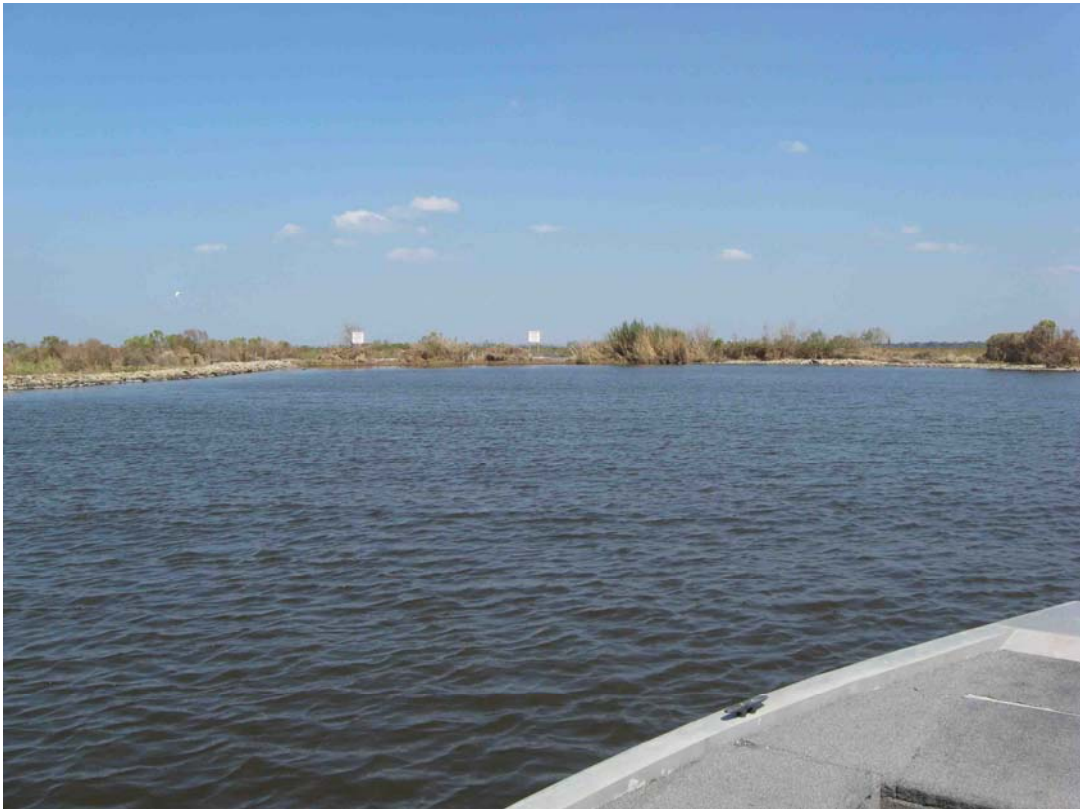
The structure appeared to be in good condition with no signs of settlement of the rock weir. The warning signs and supports were also in good condition. (Photo #4) NRCS and OCPR agree that this structure will not require maintenance.

Photo #4 – Structure #20
