2008 Annual Inspection Report

**Barataria Bay Waterway West
Bank Protection**

State Project Number BA-23
Priority Project List 4

July 13, 2009
Jefferson Parish

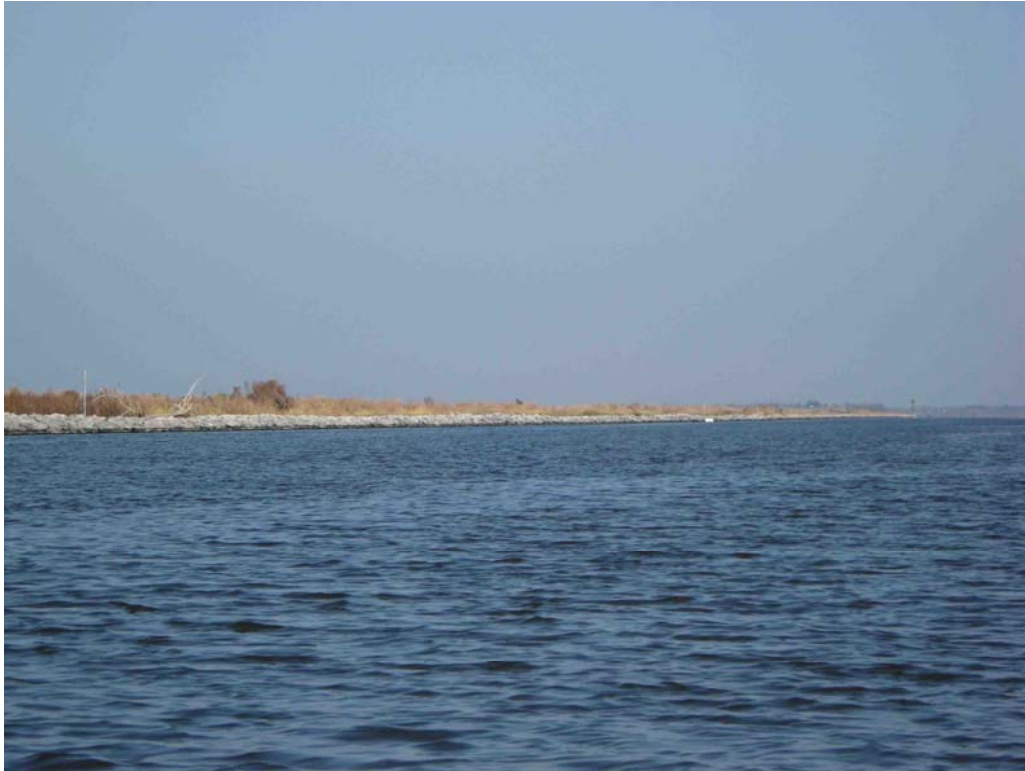
The rock structure appeared to be in good condition at the time of the inspection (Photo #1).

Photo #1 – Shoreline Protection Looking North.
