Coastal Protection and Restoration Authority of Louisiana

2008 Annual Inspection Report

DELTA MANAGEMENT AT FORT ST. PHILLIP (BS-11)

April 15, 2008
Plaquemines Parish

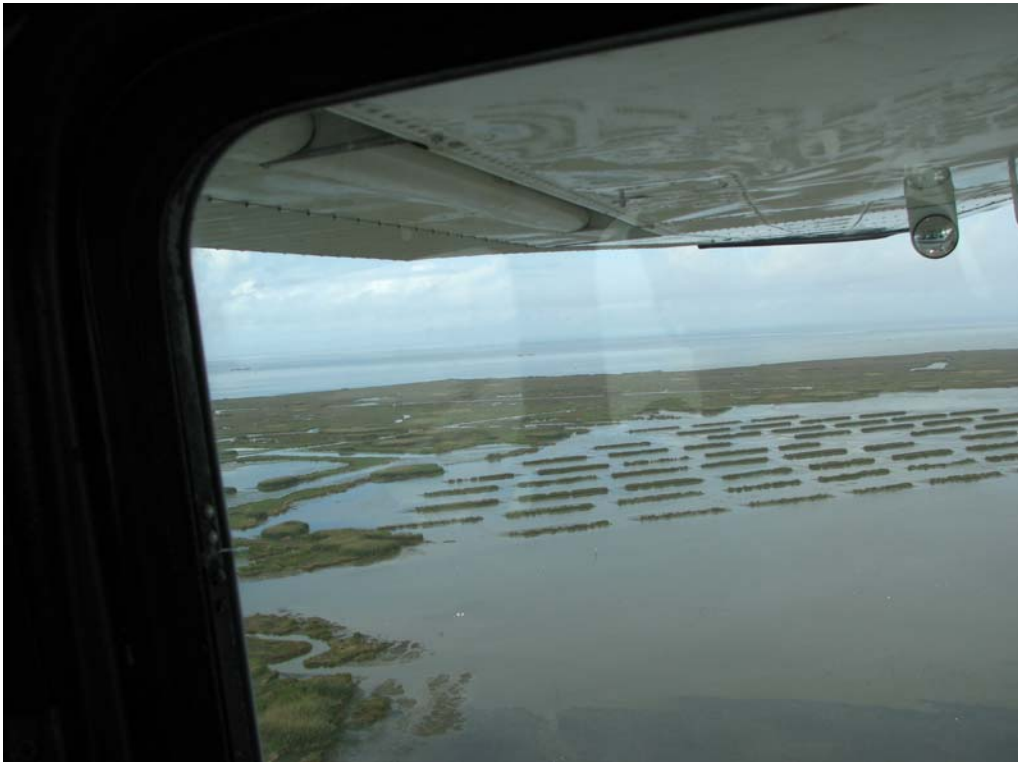
- A. Terraces: The terraces have held up very well since they were constructed in the fall of 2006. There are a few that were built on the north side with soft / unsuitable material that have developed some washout areas in their perimeter; however, most of the terraces are in excellent condition and have vegetated heavily since the time that they were planted. Tides and the river were very high at the time of the inspection, but the terrace heights above the bay showed that they had maintained mostly all of their original elevations. Swift current containing large amounts of river sediments are obvious throughout the terrace field.

Terrace Field in Bay Denesse (View 1)

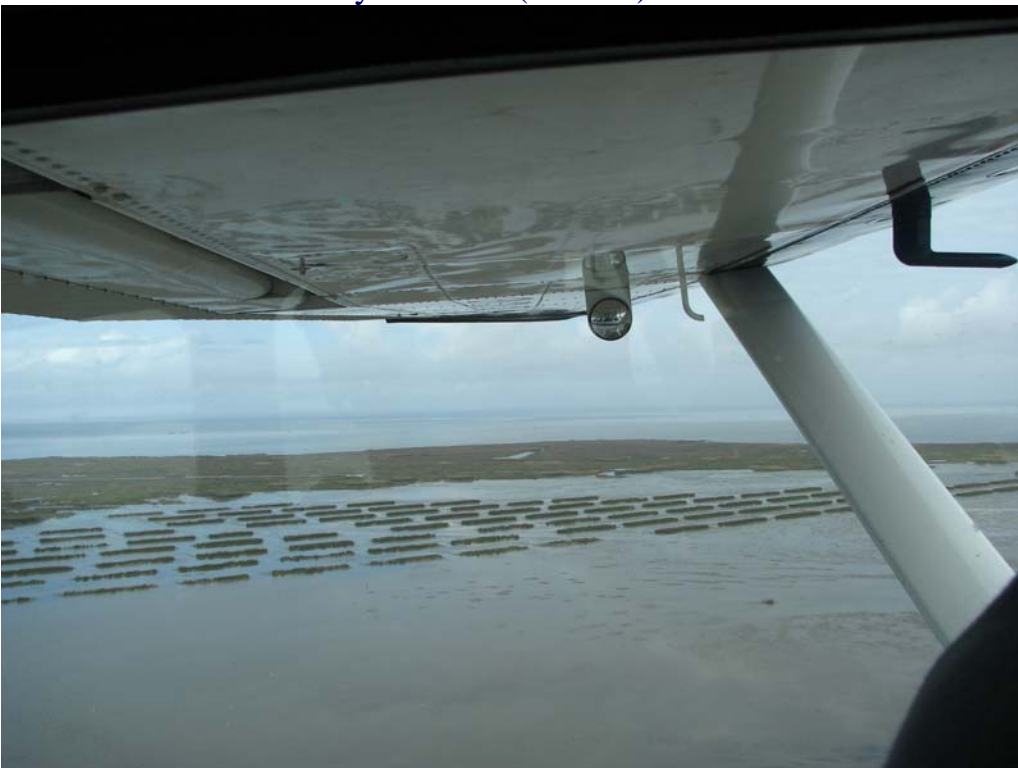
Terrace Field in Bay Denesse (View 2)

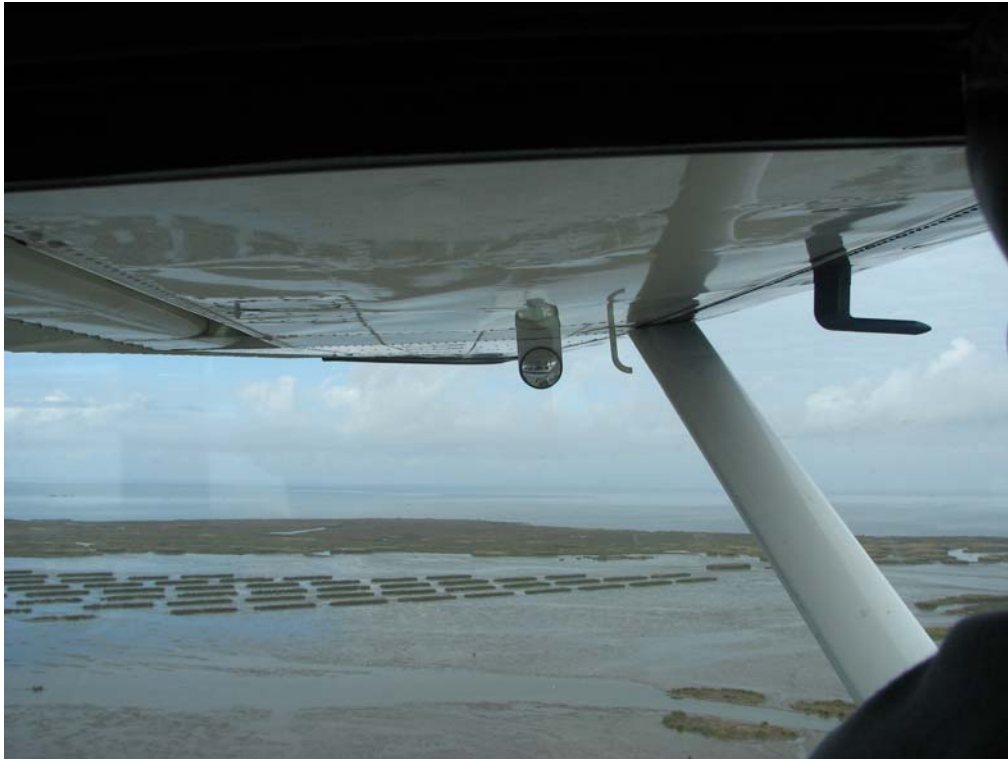
Terrace Field (View 3)

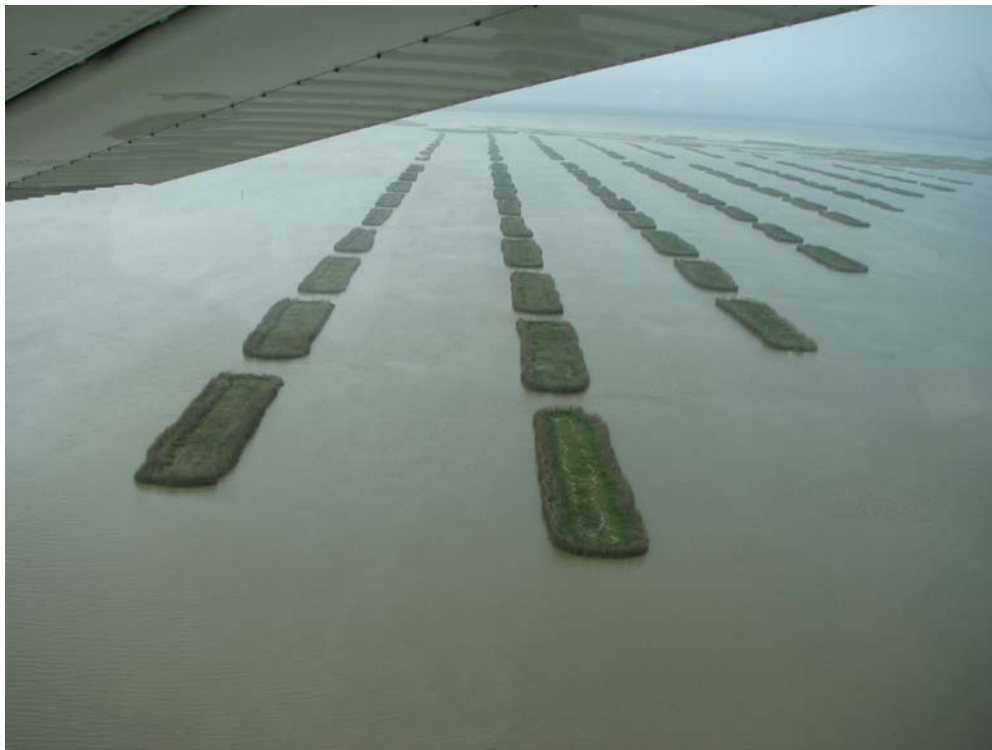
Terrace Field (View 4)

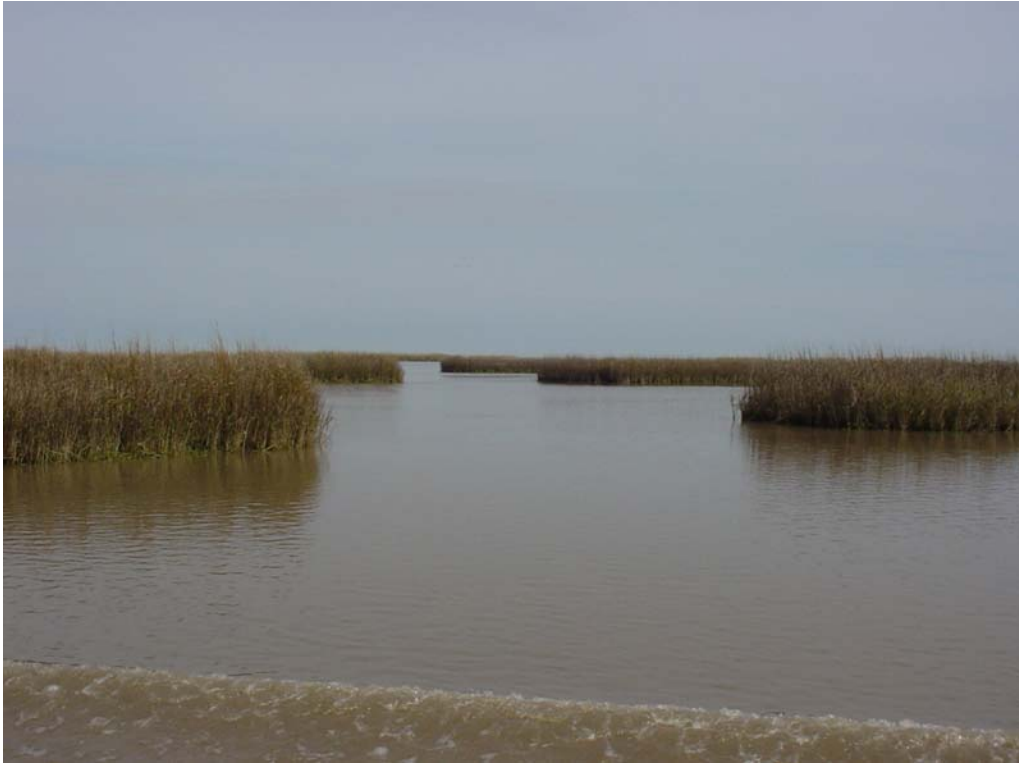
Surface View of terrace Field

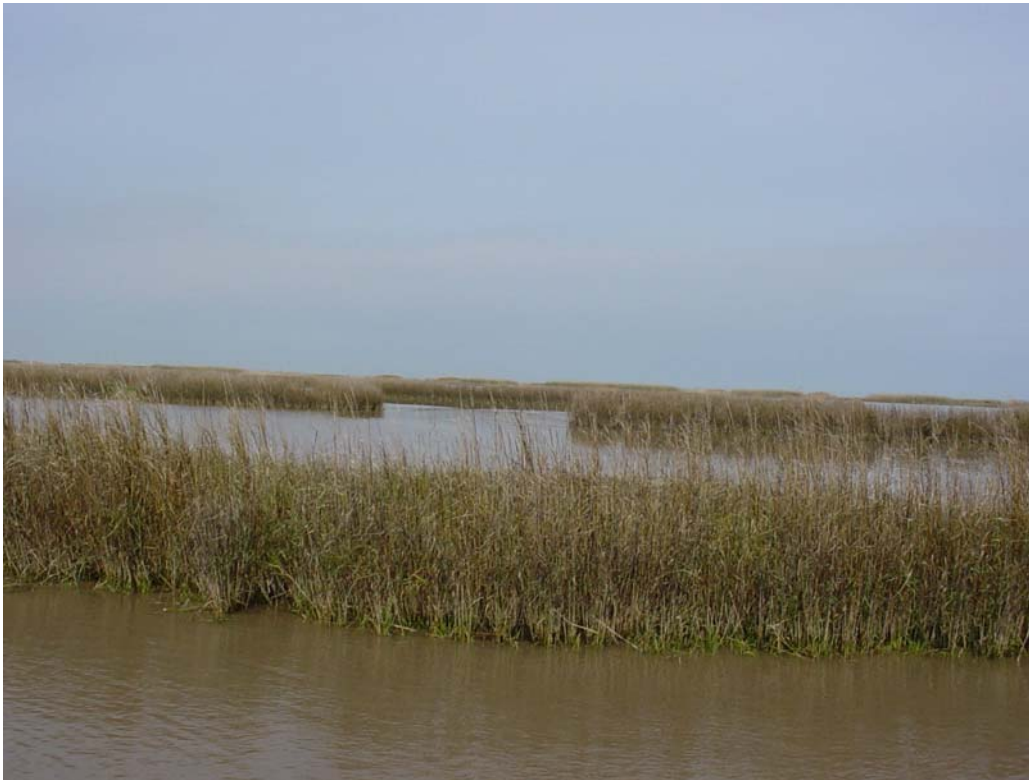
Surface View of Terrace Field

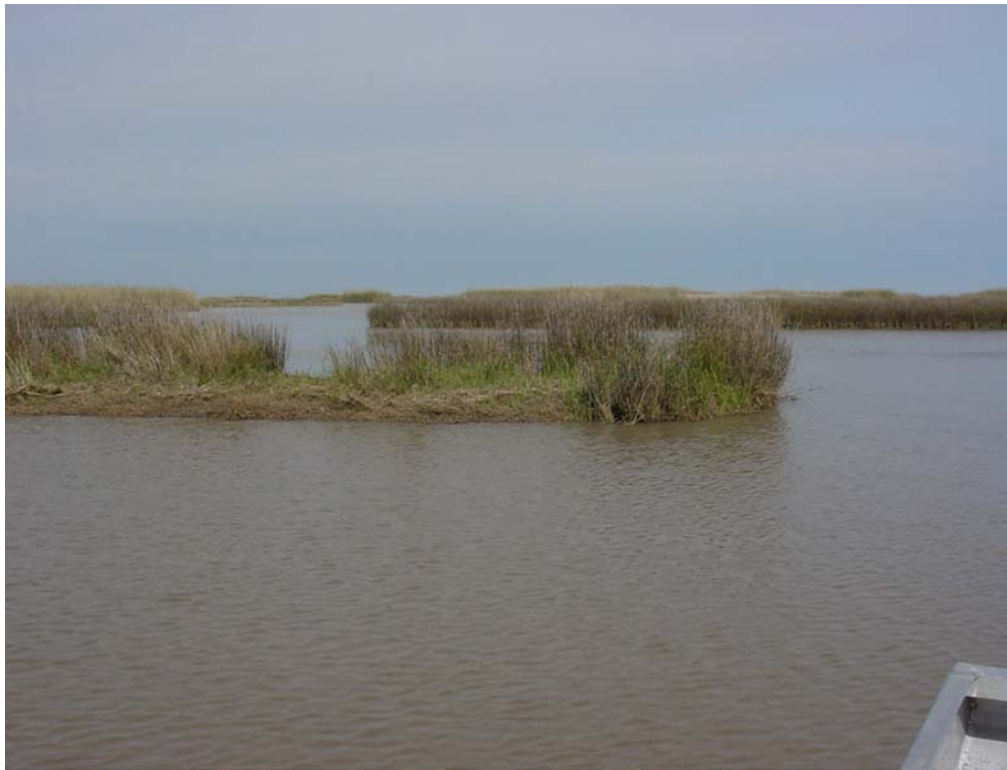
View of Terrace Slightly Eroded

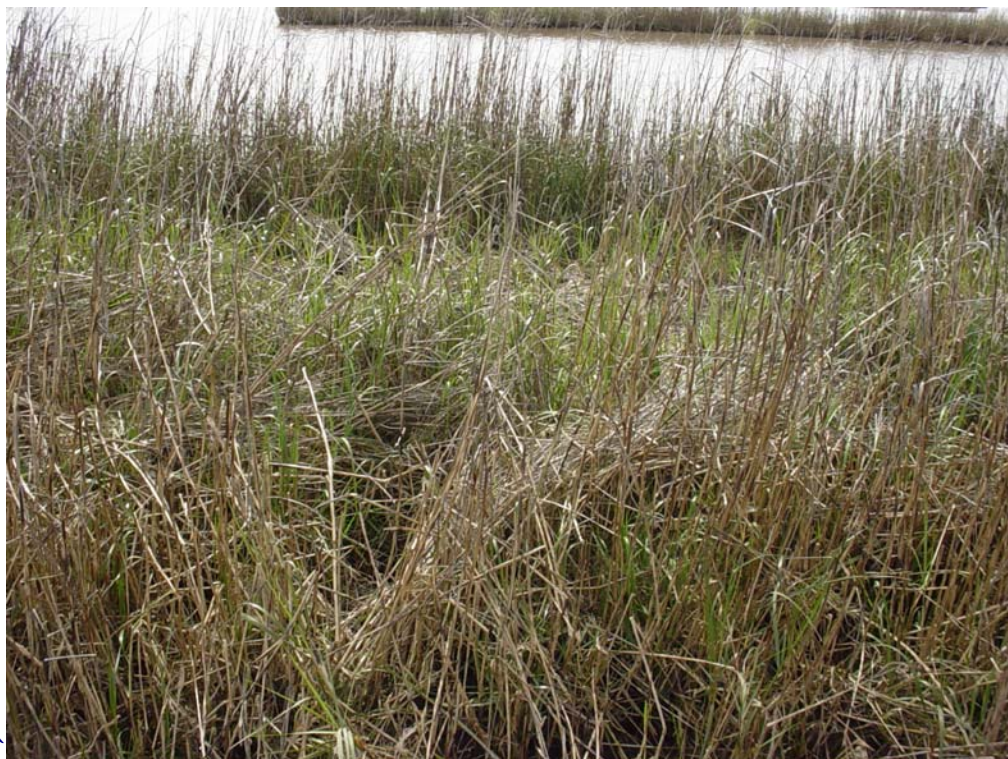
Heavy Vegetation on Terrace

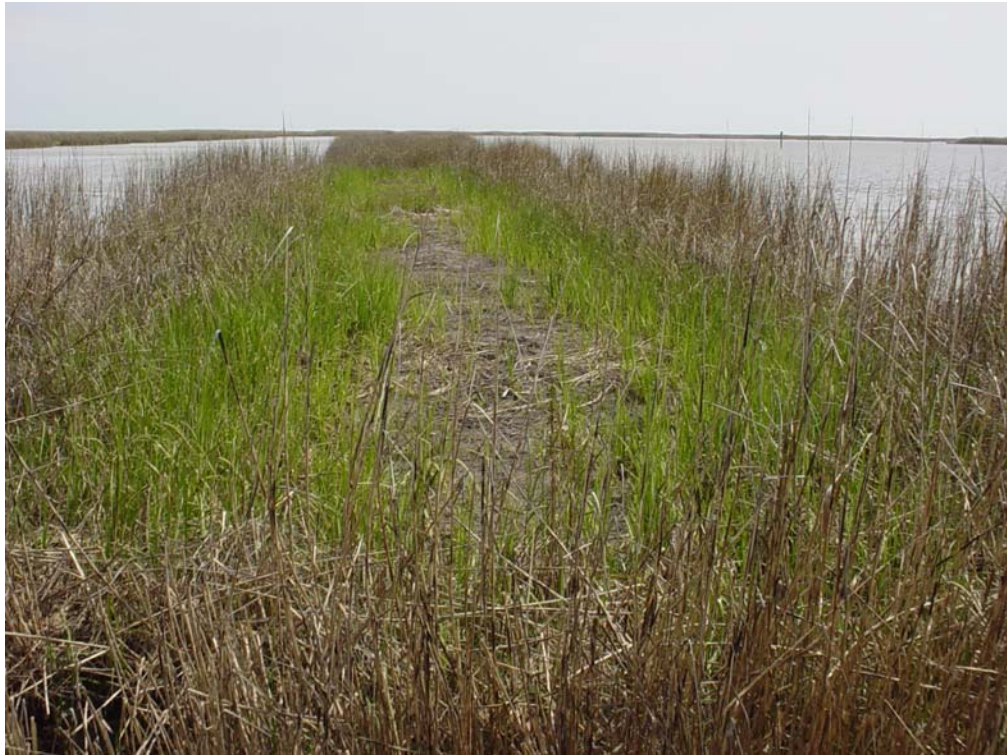
Looking Down a Heavily Vegetated Terrace

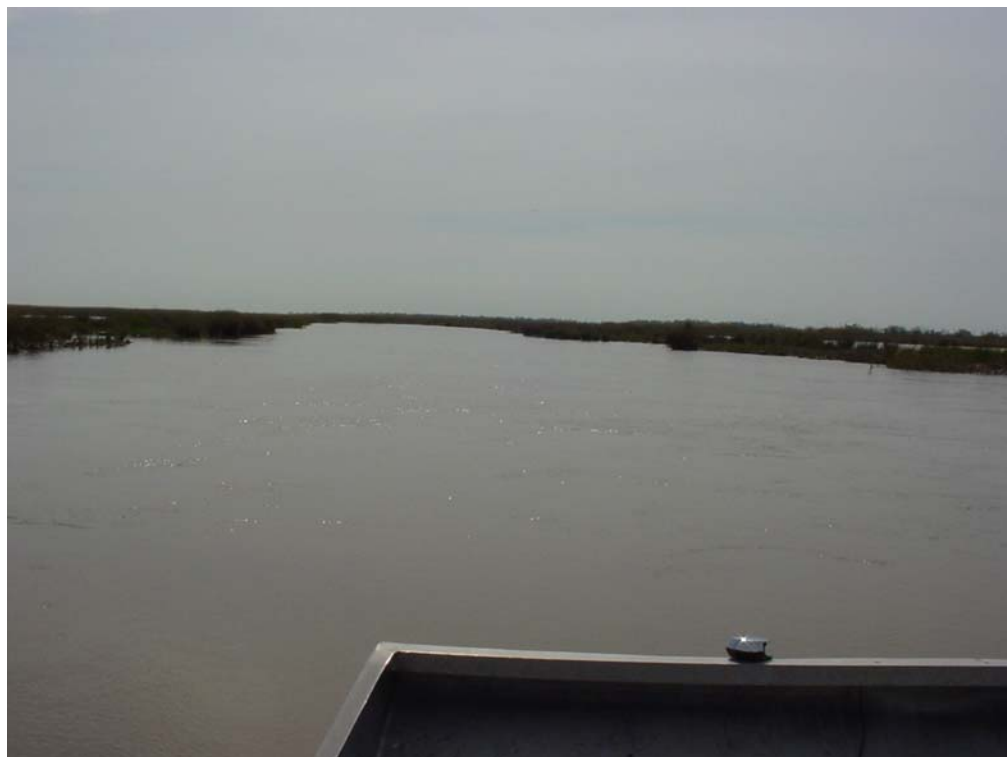
Crevasse No. 1A

- B. Crevasse No. 1A: This crevasse is the longest of all and feeds river water directly into Bay Denesse where the terraces were constructed. Currents through this crevasse were swift and appeared to be carrying plenty river sediments into the terrace area. Soundings showed good depth throughout the length of the crevasse and the crevasse spoil was well vegetated.

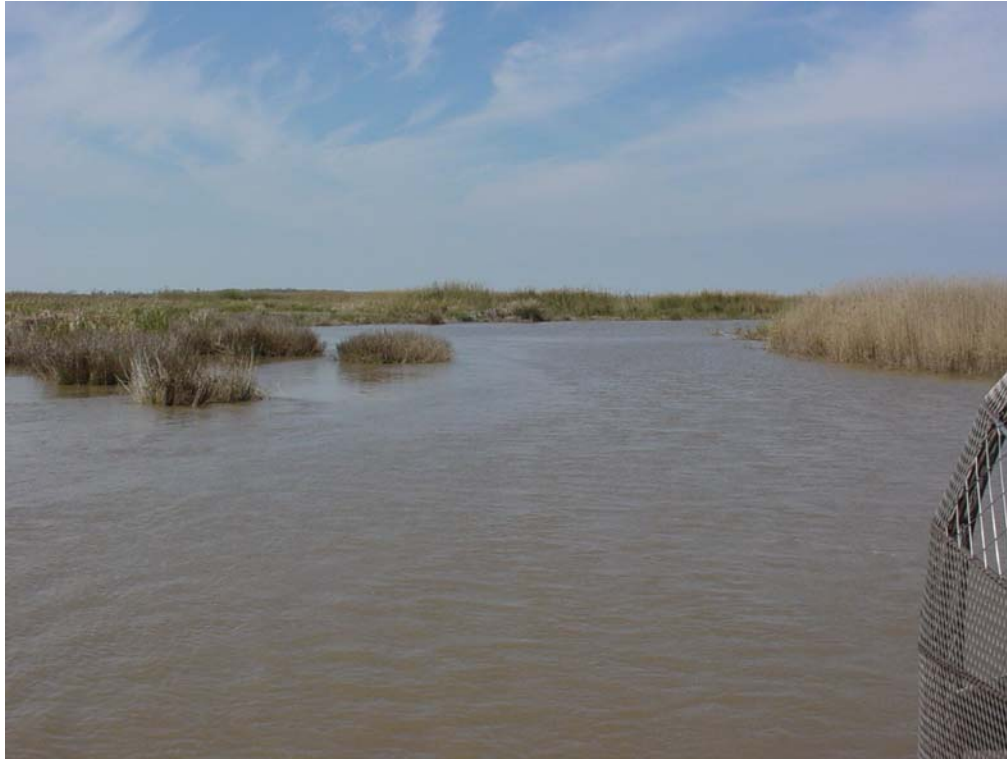
Crevasse No. 1B

- C. Crevasse No. 1B: This crevasse, which is the shortest of all, feeds a small area of marsh. Soundings through its length indicate good water depth throughout.

Currents through this cut were swift, carrying plenty river sediments. The spoil banks appeared to be very heavily vegetated.

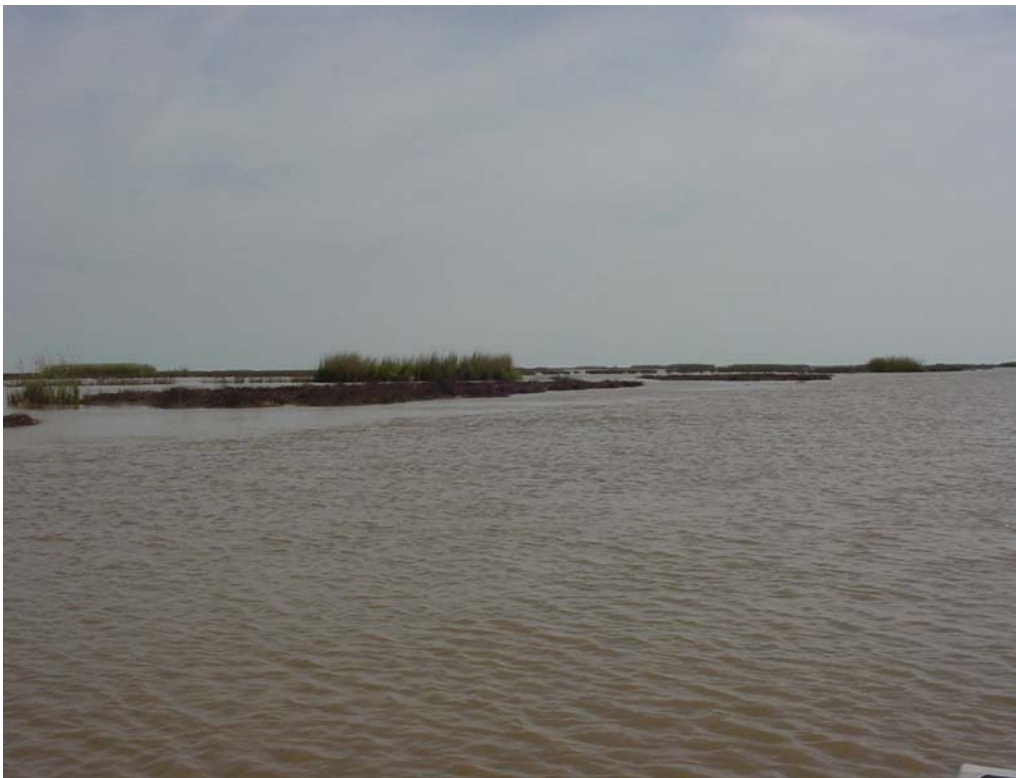
Crevasse No. 1A Spoil Area

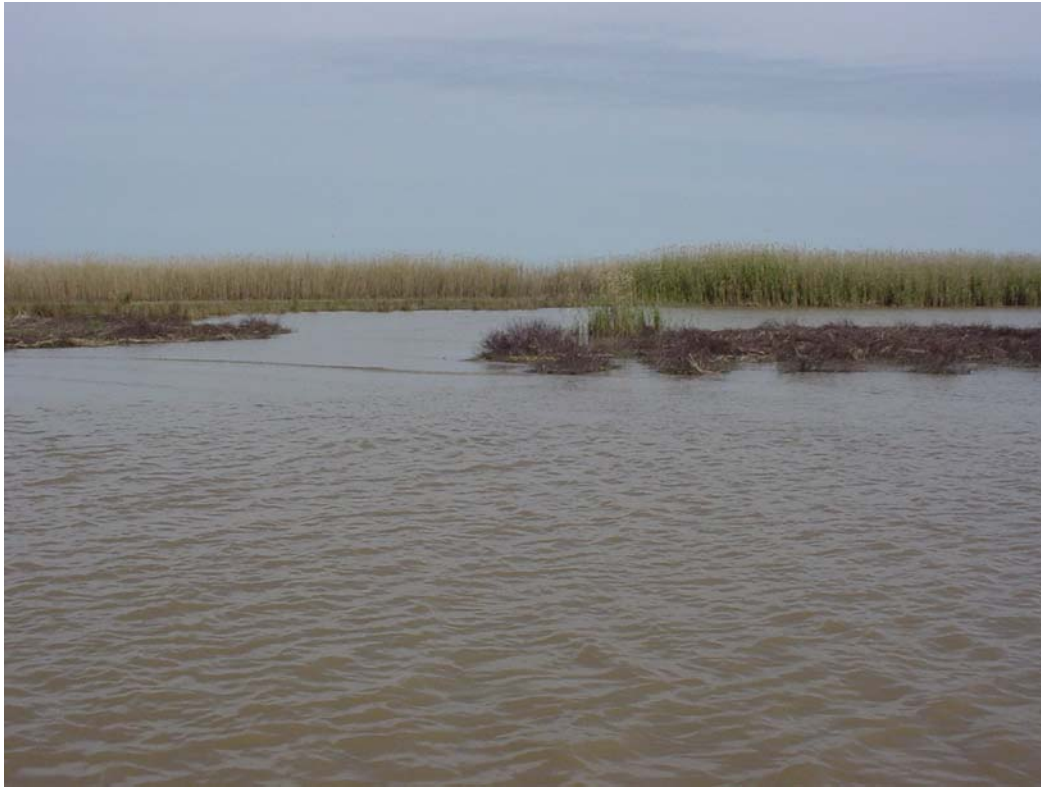
Crevasse No. 1C

- D. Crevasse No. 1C: Good flow is being maintained by this crevasse. Soundings indicate good water depth is being maintained throughout its length. Strong current is also being maintained carrying much needed river sediments into the bays. Dredge spoil from the crevasse has vegetated nicely.

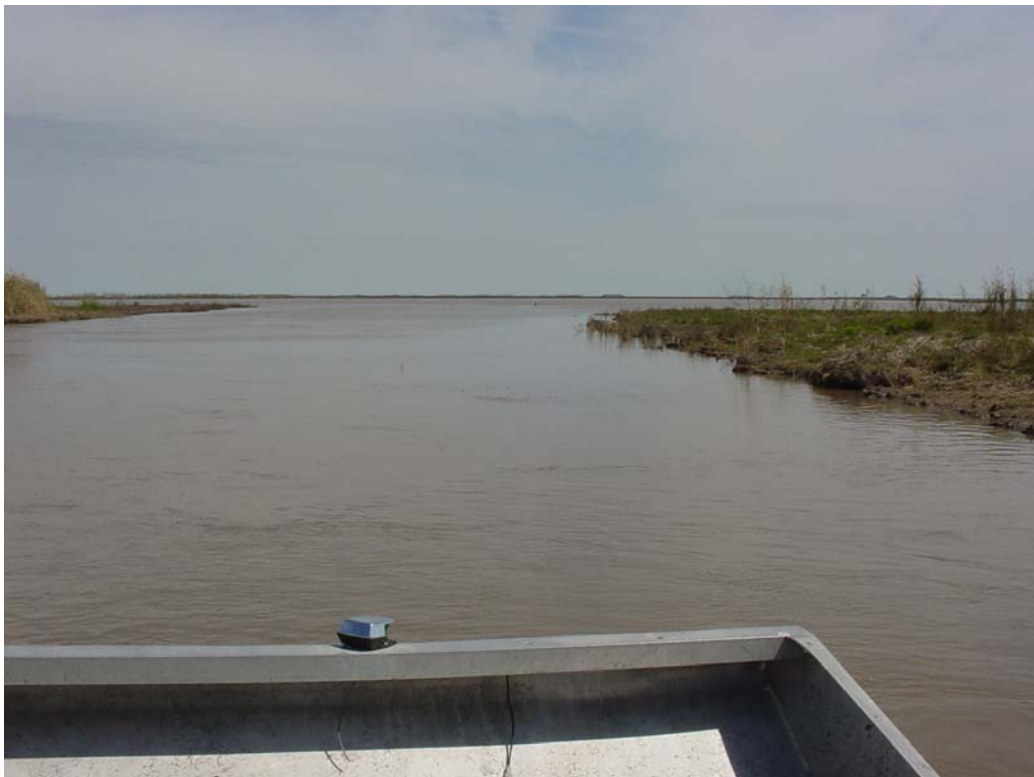
Crevasse No. 2A

- E. Crevasse No. Alt.2A: This crevasse maintains a good flow throughout its length. It has maintained its depth through along its length and appears to be carrying much needed river sediments into the interior marsh areas.

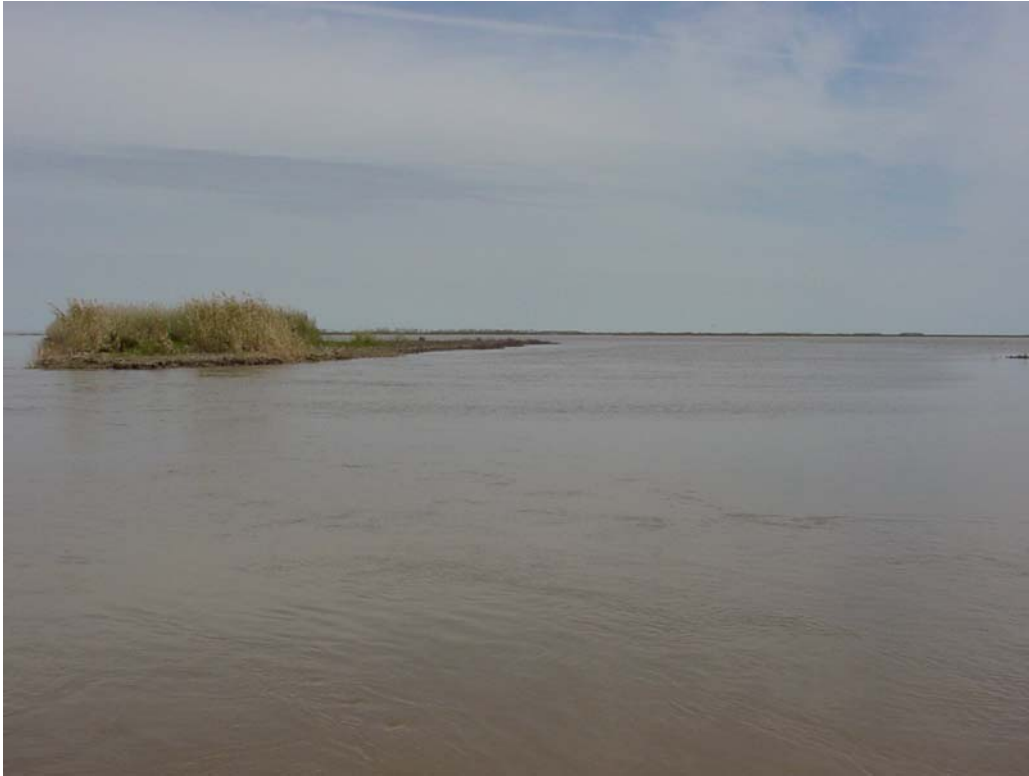
Crevasse No. 2B

- F. Crevasse No. 2B: Currents are moderate to high in this crevasse. There is obvious evidence of sediments are being carried into the marsh areas, and the spoil from the crevasse excavation has vegetated very heavily. This crevasse has also maintained it original depth throughout.

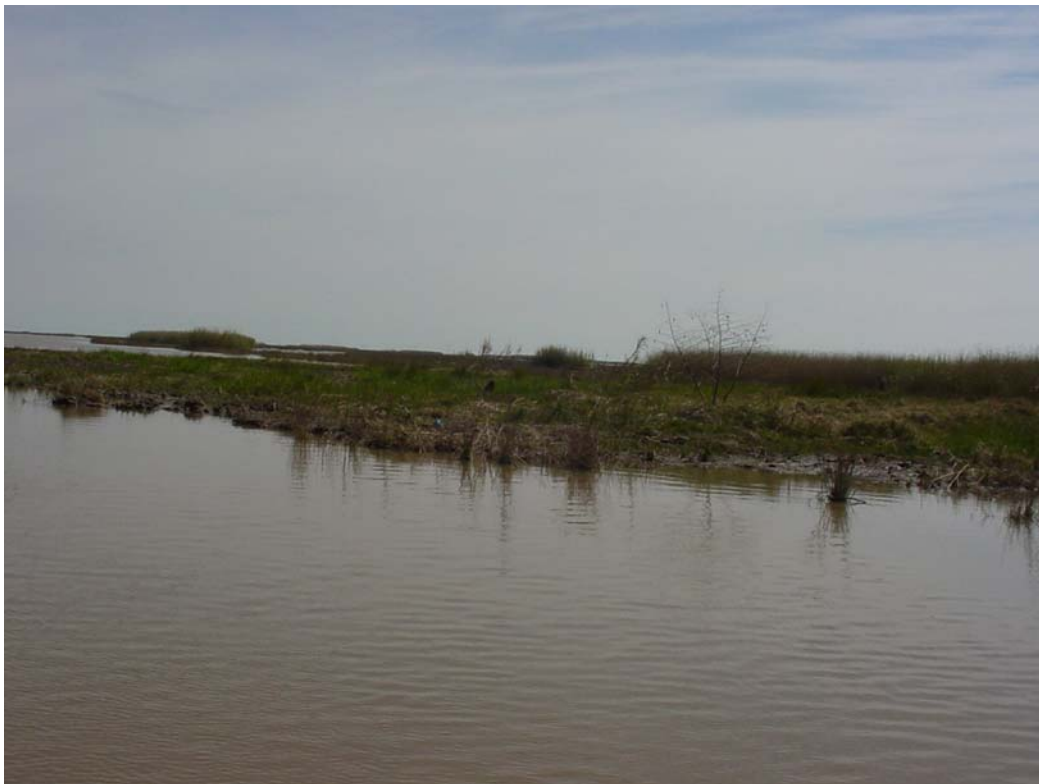
Crevasse No. 2C

- G. Crevasse No. 2C: This crevasse is also one of the longest of the project and soundings show that it has maintained its constructed depth through its length. The spoil form the crevasse excavation has vegetated very nicely and there is plenty current to carry river sediments into the interior marsh areas.
