**Coastal Protection and Restoration
Authority of Louisiana**

2008 Annual Inspection Report

**CAERNARVON OUTFALL
MANAGEMENT
(BS-03a)**

State Project Number BS-03a
Priority Project List 2

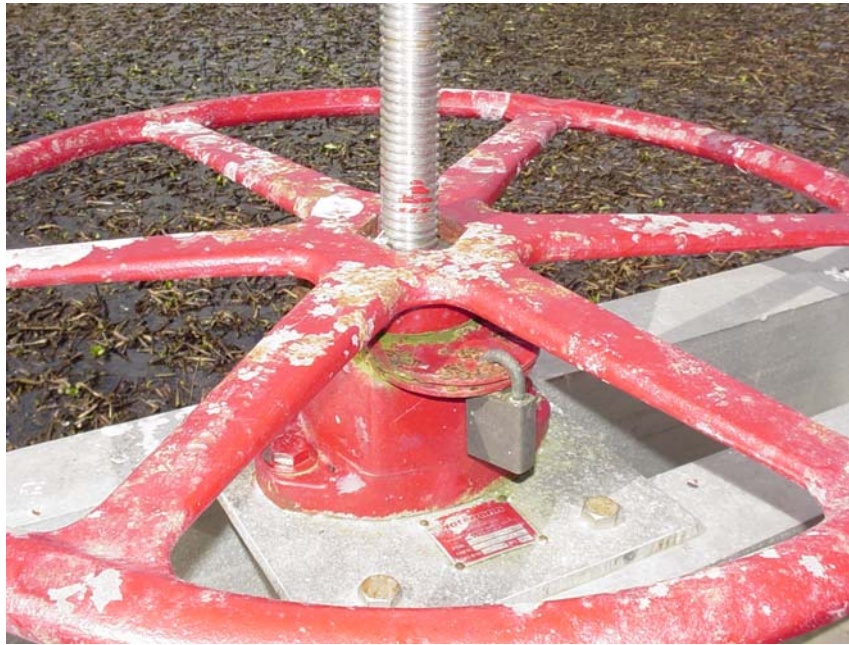
- A. **Site/Structure # 13** – The gate was in the open position at the time of the inspection. Water flow was visibly going out, possibly due to a sufficient differential head. It was evident that not much (if any) blockage remains due to storm debris. Water was rushing out of the interior where it appeared that a few rocks were displaced on the north end of the closure accented by some scouring of the embankment at the tie-in. The timber walkway has separated from its support beam at one end.

Photo # 1 Site 13 (view 1) Corrosion of locking plates caused them to separate making locking impossible.

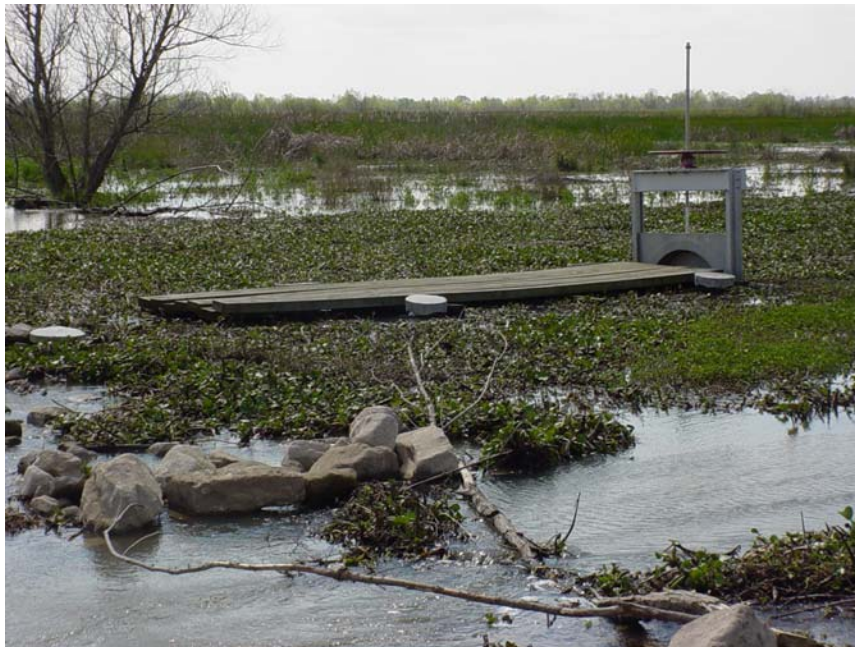
Photo # 2 Site 13 (view 2) The extent of blockage of the culvert due to storm debris is minimal. Note the high water stages in the inside, flowing out into Bayou Mandeville. Approximately ½ foot difference in water levels. (2007 Photo)

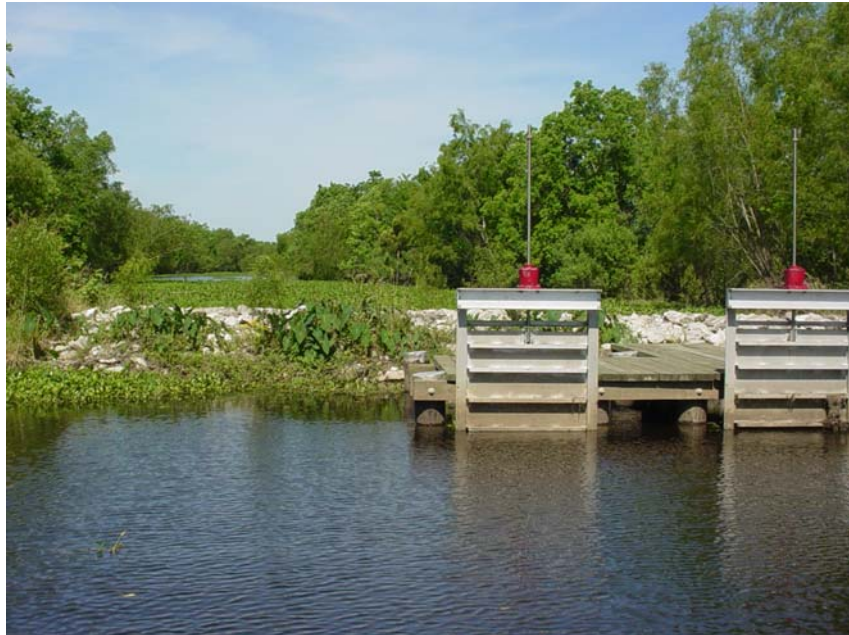
- B. **Site/Structure # 25** –The structure remains covered with small amounts of marsh debris from the storm. The gates were padlocked closed at the time of the inspection but plans are in place to open these gates in the near future. It was not evident how much (if any) blockage remains due to storm debris. Note: The structure could be accessed due to water hyacinth and debris obstructions in the N-C canal.

Photo # 3 Site 25 The structure remains covered with storm debris. Both of the gates remained closed to reduce flow to the Braithwaite area where the USACE was constructing an emergency levee contract. That contract has since been completed. This site was not accessible during the 2008 inspection.

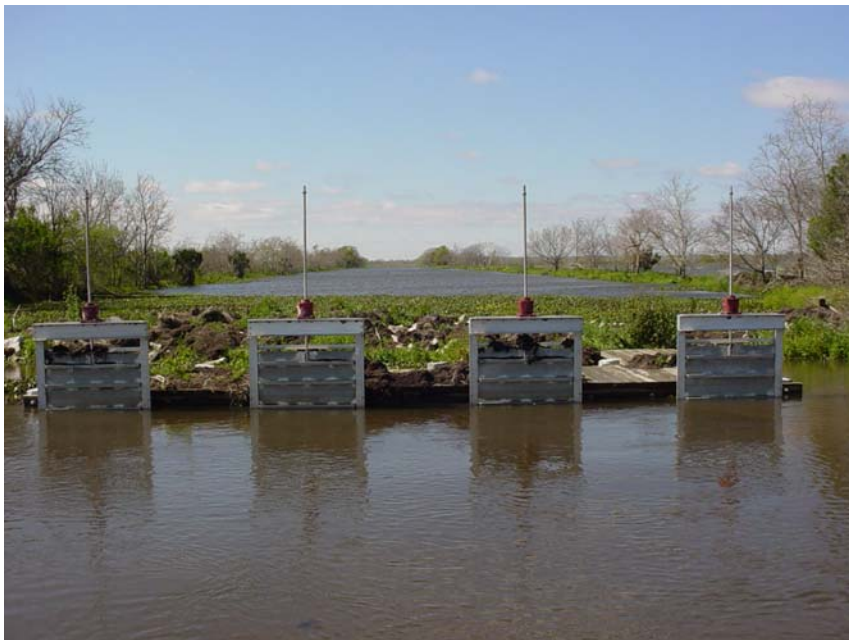
- C. **Site/Structure # 26** – The structure is still has some storm debris deposits in spots. The gates were in the open position at the time of the inspection. Water flow was slightly visible, possibly due to a lack of sufficient differential head. It was evident that not much (if any) blockage remains due to storm debris. Padlocks on all 4 gates were non-functional. Delacroix Canal is completely plugged with storm-related debris thereby eliminating a substantial portion of freshwater flow from the diversion towards this portion of the project area.

Photo #4 Site 26 The structure still has a small amount storm debris. The blockage of the culverts by storm debris has been cleared. The flow-meter, and all its attachments that were destroyed by the storm, will be replaced soon.

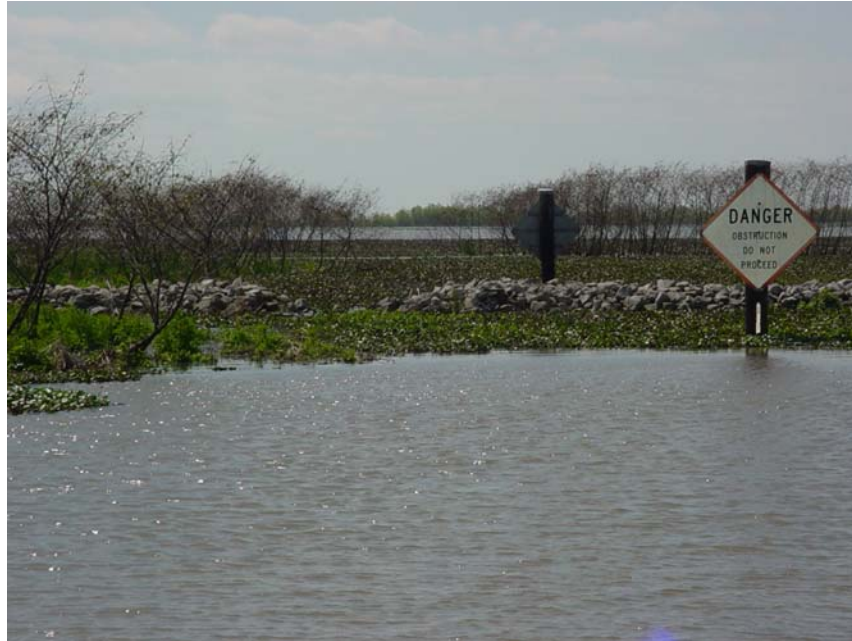
- D. **Site/Structure # 32** –Overall condition was good with the exception of the area that was vandalized in early 2003. That area was partially repaired by the 2003 inspection team; however, that repair was again vandalized to the original depth. The condition of the closure appears not to have changed; most of the storm debris is gone. This structure was constructed to keep diversion water from entering Lake Leary from the western lake rim; the storm devastated that portion of the lake rim rendering this structure ineffective. Nothing needs to be done until the Lake Leary shoreline is rebuilt.

Photo # 5 Site 32 (view 1) This structure was opened to the waterline by vandals and was partially repaired by the 2003 inspection team. Destruction of the west lake rim of Lake Lery by the storm, now makes this closure irrelevant.

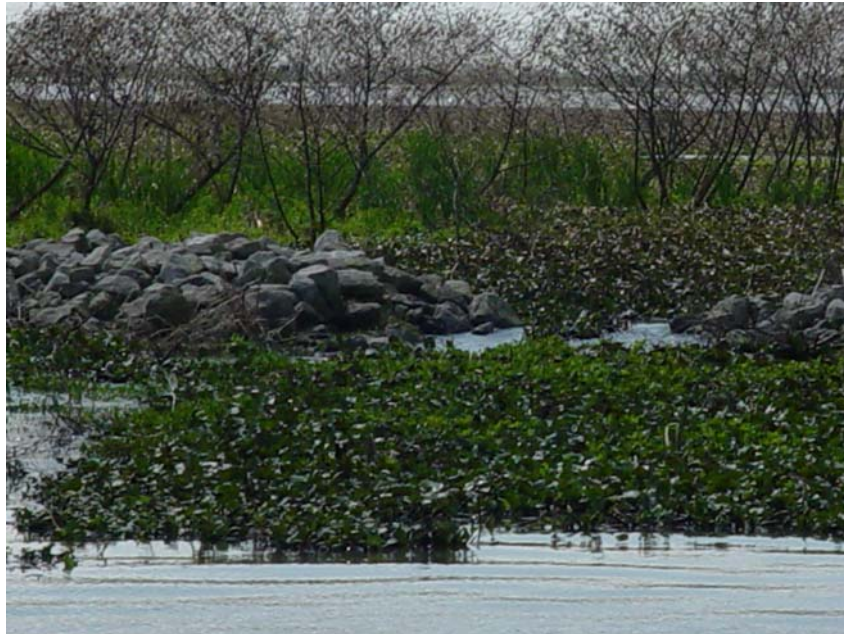
Photo # 6 Site 32 (view 2) Close up view of the vandalized area. Approximately 30% of the west lake rim was destroyed by the storms.

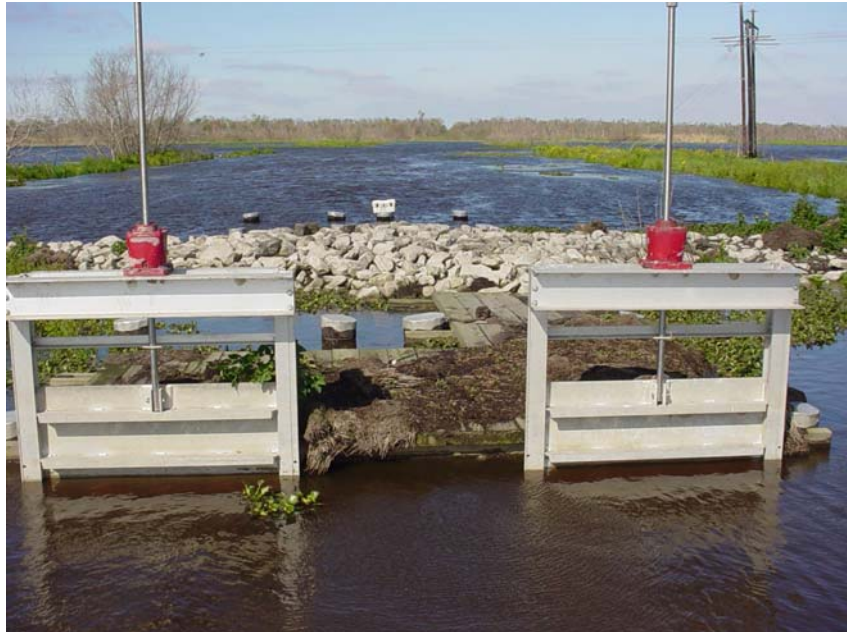
- E. **Site/ Structure # 40** – The structure is just slightly covered with storm debris. The gates were in the open position at the time of the inspection. Water flow was somewhat visible, possibly due to a lack of a large differential head. The culverts at this site was flushed out since the last inspection. The interior channel that leads to the site was relatively clear of debris and hyacinths. Padlocks on both gates were non-functional.

Photo # 7 Site 40 Small amounts of storm debris still remains on structure. The blockage of the culverts by storm debris has been cleared. The flow-meter was damaged but recovered will be replaced. Note the high water stages from the structure westward to the Plaquemines east bank hurricane levee (tree line) in the background.

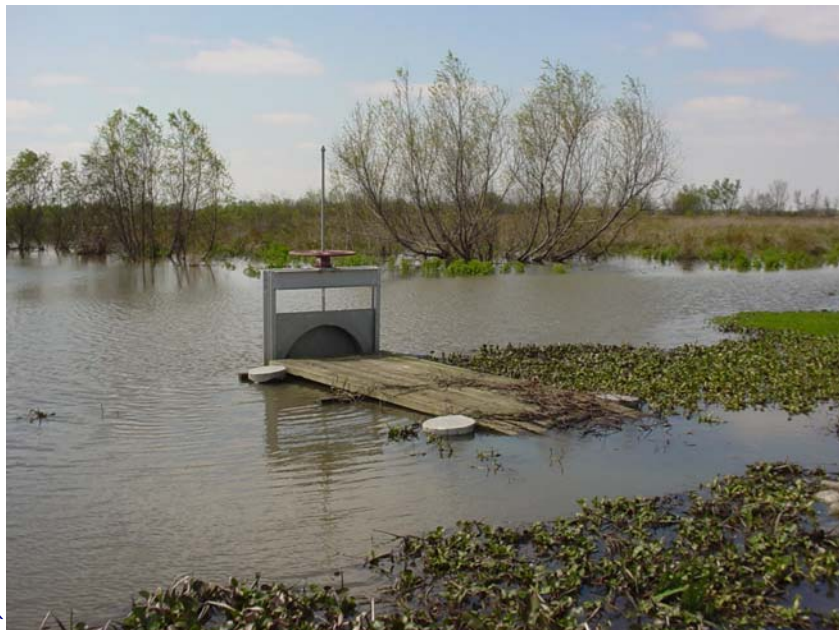
- F. **Site/Structure # 50** – The gate was in the open position at the time of the inspection. The outfall water elevations were so high that flow was visible over the entire

closure, as well as through the culvert. The timber walkway is slightly bowed. Padlock on the gate was non-functional.

Photo # 8 Site 50 The extent of blockage of the culverts by storm debris is minimal. Slight erosion was evident on both sides of the rock plug where it ties into the earthen embankment. High flows such as this, allow water to flow around the structures to flood the marsh.

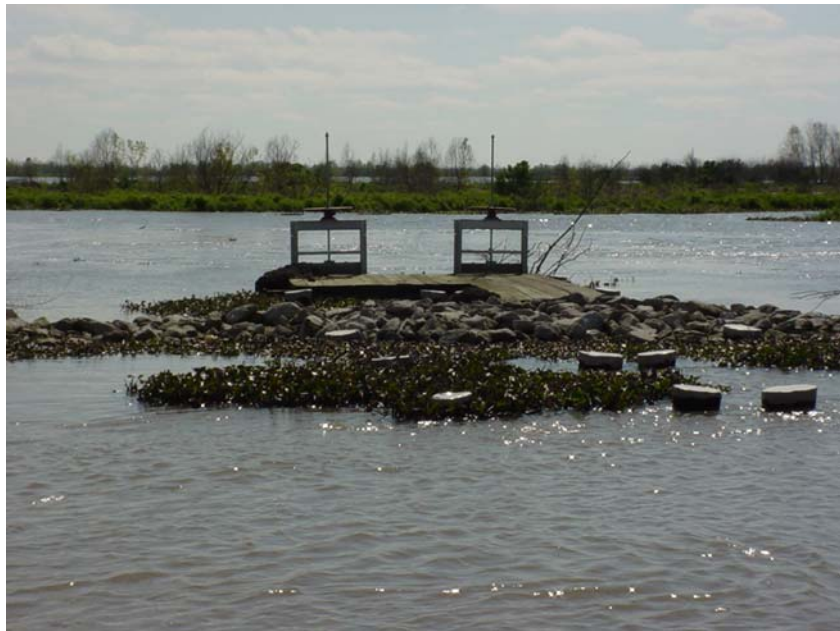
- G. **Site/Structure #52** – The gates were in the open position at the time of the inspection. There appeared to be a vortex on the water surface near the inlet of the north culvert indicating some water flow. It was evident that much blockage remains due to storm debris in the north culvert. There is a tree ball located at the end of the combination gate that keeps it from operating. There was a moderate breach of the spoil bank to the right and left of the plug allowing some flow from the canal to the marsh. It is estimated that the canal water level was from 9 to 12 inches higher than the interior, which allowed much water to flow over the spoil-bank into the marsh. The padlock on the gate was non-functional.

Photo # 9 Site 52 (view 1) Some storm debris remains on the inside of the culverts. A tree stump ball is blocking the north culvert opening on the inside. Slight erosion was evident on both sides of the rock plug where it ties into the earthen embankment.

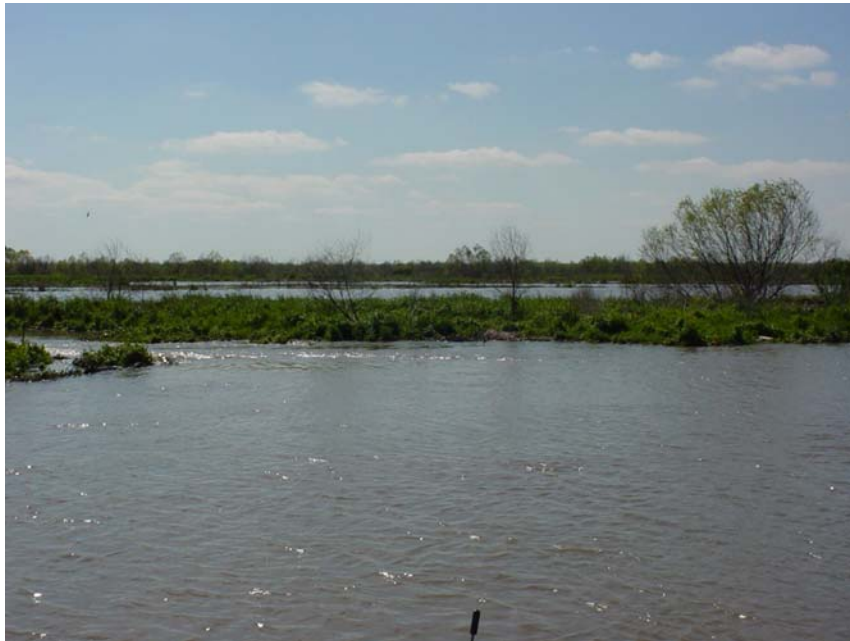
Photo # 10 Site 52 (view 2) This breach in the earthen embankment is approximately 50 yards to the west of the rock plug. Many of these breaches are evident throughout the outfall area allowing free flowage from the conveyance channels into the interior marshes.

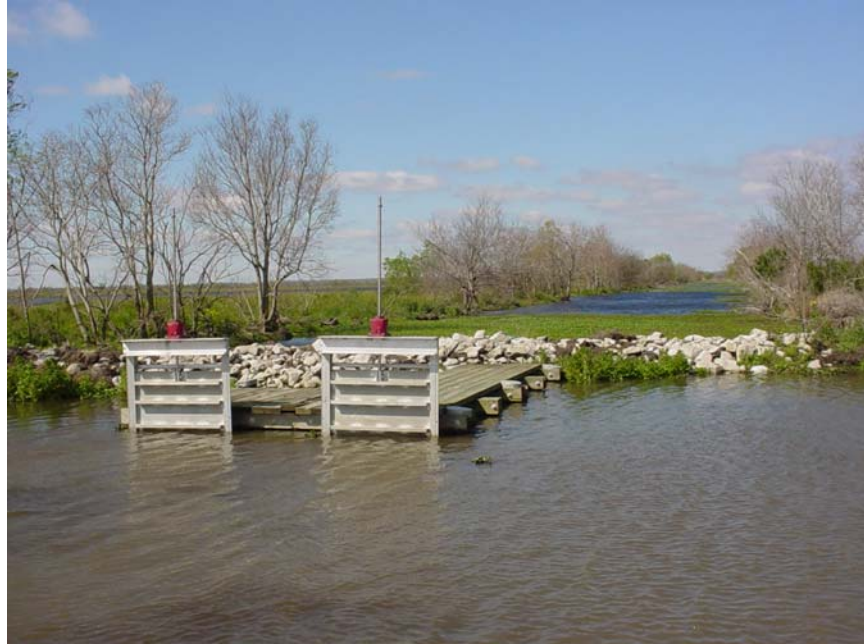
- H. **Site/Structure # 54** – The structure has been cleared of all storm debris. The gates were in the open position at the time of the inspection. Water flow was not visible, due to a lack of sufficient differential head therefore it was not evident how much blockage remains due to storm debris. The culverts at this site were flushed out since the last inspection

Photo # 11 Site 54. Structure is clear of storm debris. The blockage of the culverts from storm debris has been cleared. The flow-meter and all attachments on this structure that were destroyed by the storm will be replaced soon.

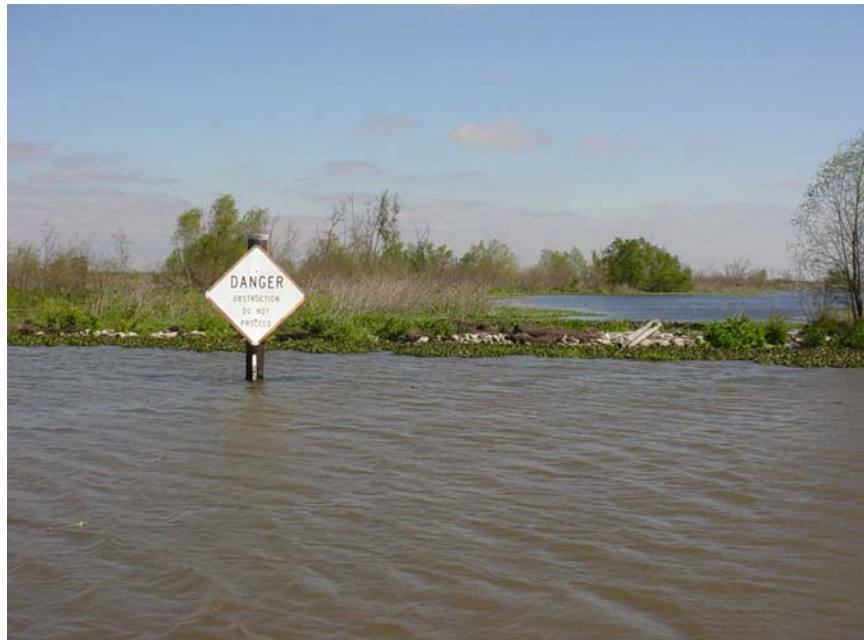
- I. **Site/ Structure # 56** - No subsidence was noted in this rock structure since the last inspection. Some storm debris remains on the entire rock closure. The warning signs that were damaged during the storm have been reset. The middle section of the plug is approx. 0.5' lower than the sides.

Photo #12 Site 56 The overall condition of the rock closure appears to be good. There is still much storm debris covering the closure. No noticeable subsidence has occurred since the last inspection.

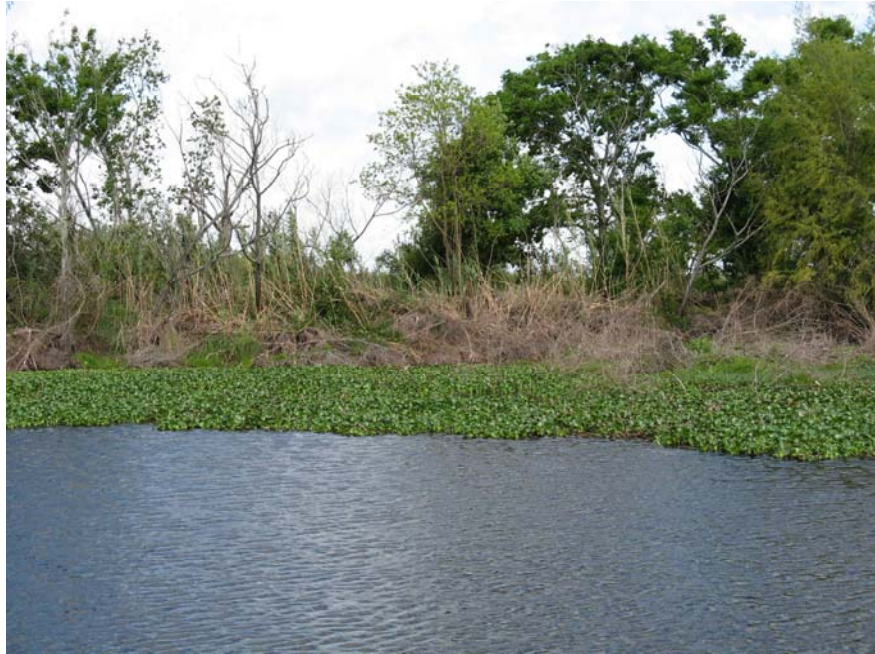
- J. **Site # 57** –It appears that the vegetation on the spoil bank along the sides of the Reggio Canal that was damaged by the storm is recovering well although many sparse areas remain. There are small breaches in the spoil-bank between structure nos. 26 and 40. One large cut (~15' wide) exists in the spoil-bank east of structure no. 54.

Photo # 13 Site 57 (view 1) Reggio Canal spoil bank. Storm damage is still evident, but vegetation is rapidly recovering.

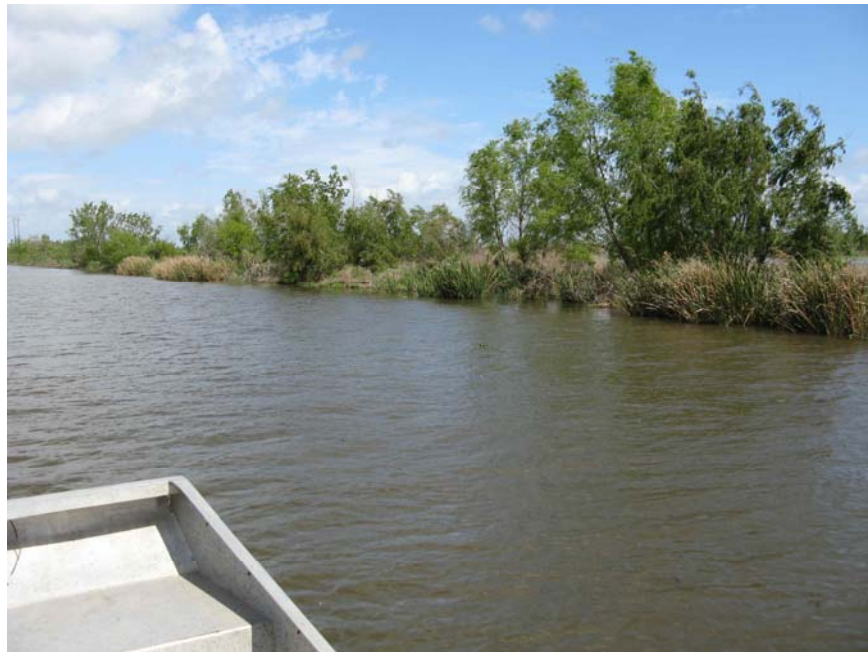
Photo # 15 Site 57(view 2) Reggio Canal spoil bank. More recovering vegetation. Note the gaps on the spoil bank caused by the storms.

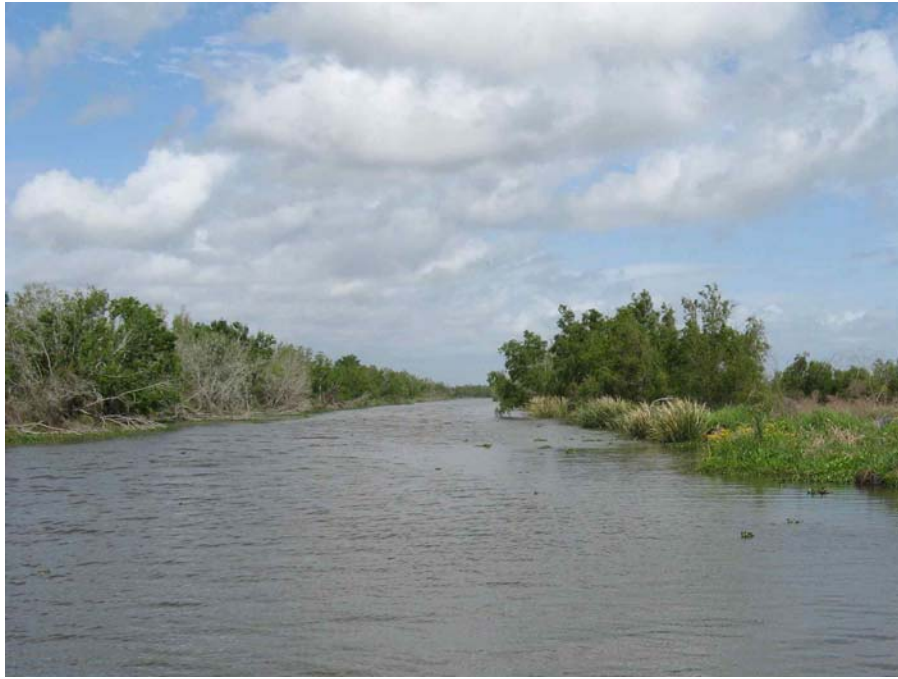
Photo # 16 Site 57 (view 4) Reggio Canal spoil bank. More recovering vegetation.

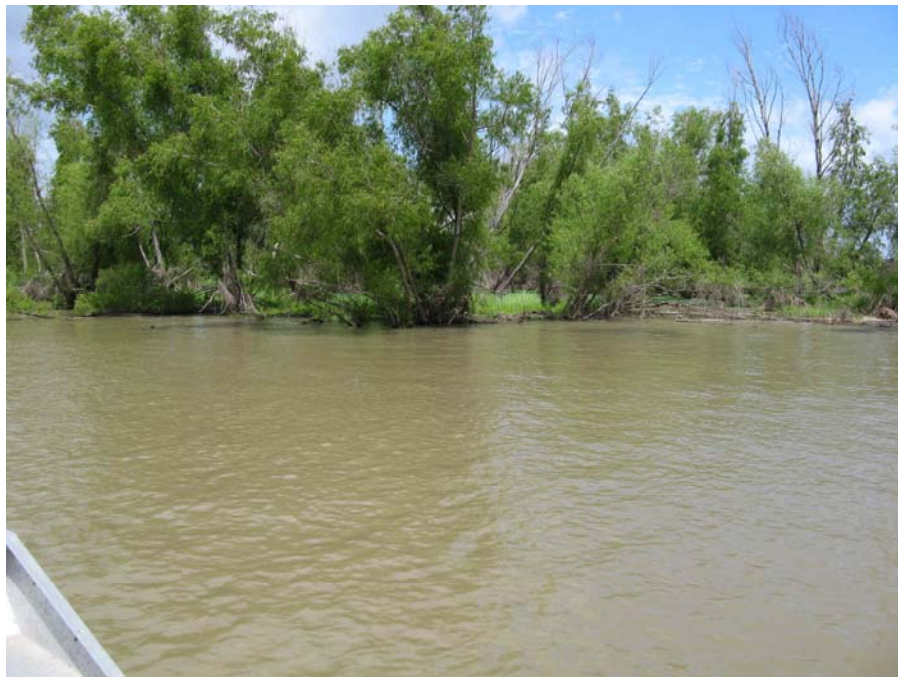
- K. **Site # 58** –The vegetation on the spoil bank along the sides of the Bayou Mandeville that was damaged by the storm is recovering although many sparse areas remain.

Photo # 17 Site 58 Bayou Mandeville spoil bank. Many damaged trees along the bank line. Embankment is again heavily vegetated.

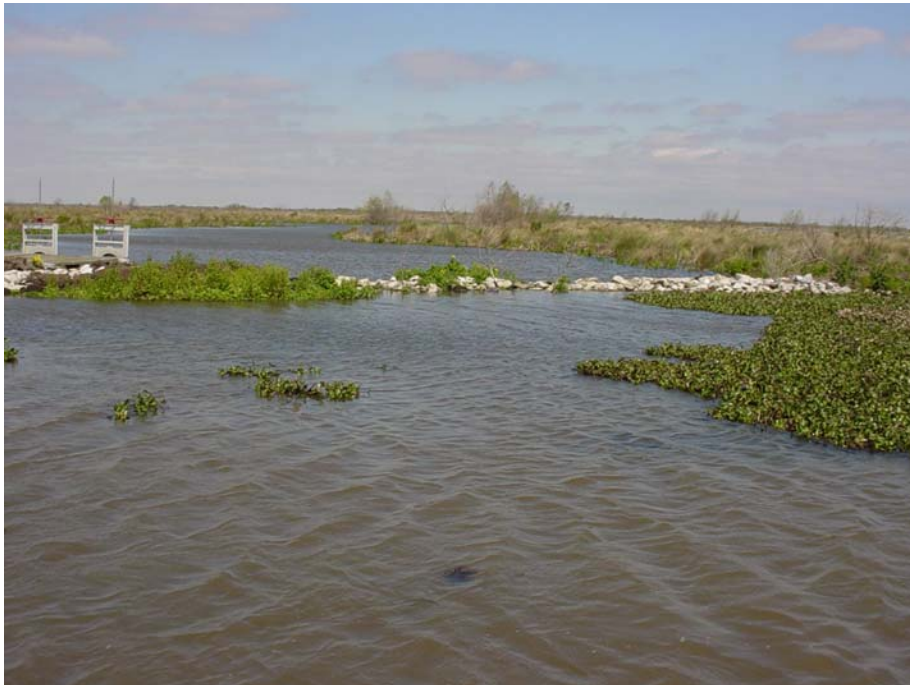
- L. **Site/Structure # 60** – The gate structure is completely cleared from any storm debris. The gates were in the open position at the time of the inspection. Water flow was slightly visible; therefore, not much blockage remains due to storm debris. The culverts at this site were flushed out since the last annual inspection. The high water stage makes the rock closure on the east wing-wall appear to have subsided since the last inspection; however, the closure still is functioning as designed.

Photo # 19 Site 60(view 1) Slightly more subsidence is noticed in the center part of the rock closure..

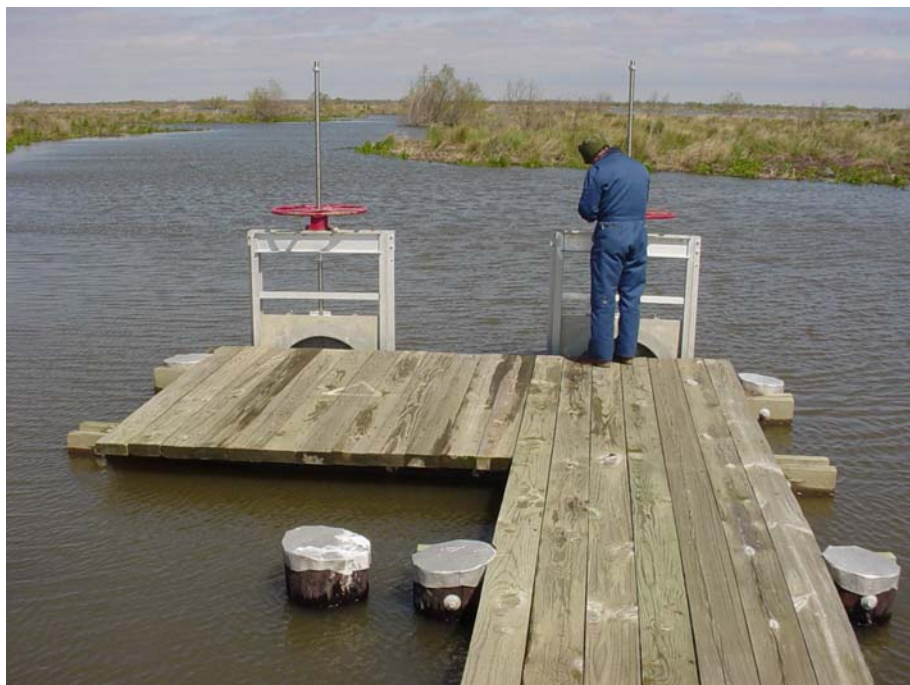
Photo # 20 Site 60 (View 2) Structure is clear of all storm debris. The blockage of the culverts due to storm debris has been cleared. Some flow was visible through the culverts.
