2008 Annual Inspection Report

DELTA WIDE CREVASSES (MR-09)

State Project Number MR-09
Priority Project List 6

March 12, 2008
Plaquemines Parish

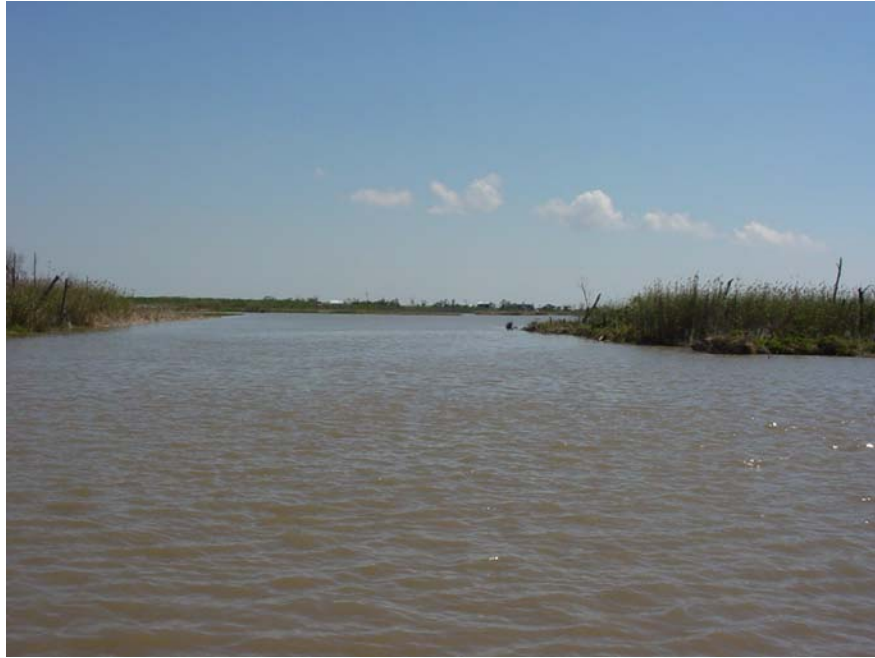
- A. Crevasse No. NC-1: (1,000 ft. X 100 ft. X -8.0 ft. NAVD 88) This newly dredged crevasse is in good to excellent condition. Soundings indicated that it has retained most of its originally constructed depth. River water is flowing very well through the channel and the spoil from the dredging of the crevasse has vegetated throughout the deposited bay area.

Crevasse No. NC-1, (view 1) Looking into crevasse from Pass-a-Loutre, notice camps in rear of photo.

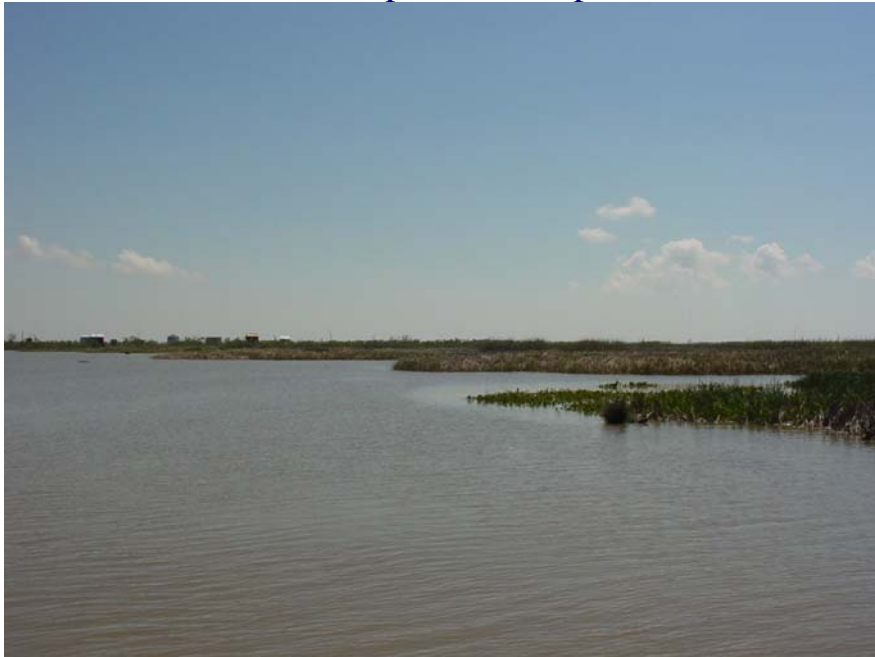
Crevasse No. NC-1, (view 2) Midway into crevasse looking towards vegetated spoil area.

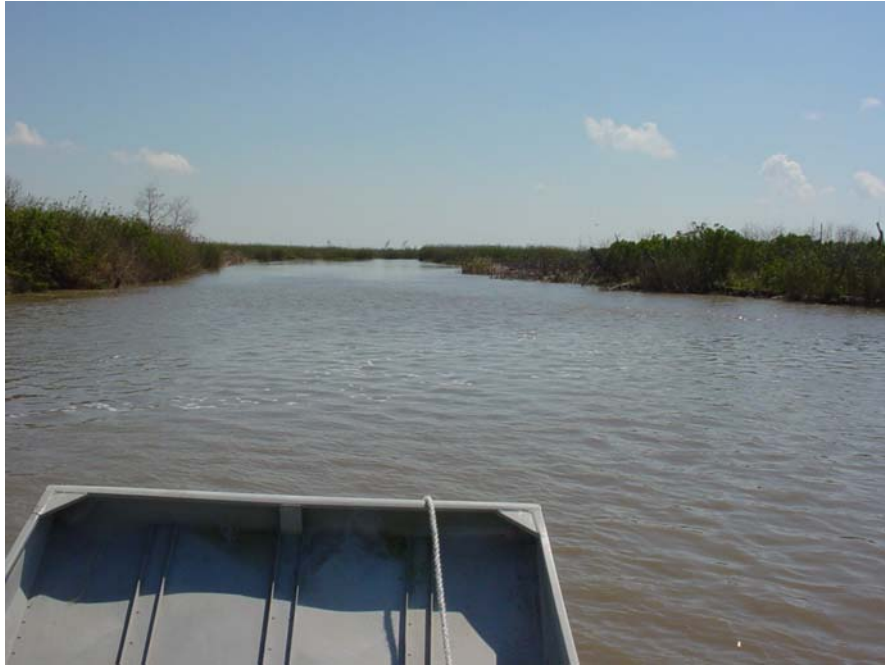
- B. Crevasse No. NC-3: (1,400 ft. X 100 ft. X -8.0 ft. NAVD 88) This is the second of the two new crevasses, functioning very well and flowing with a very swift current bringing much needed sediments into the interior bays. The crevasse is maintaining a good depth throughout its channel but has lost a little depth near the upstream opening. This minor deficiency in depth; however, does not seem to be affecting the amount of flow that is entering the crevasse.

Crevasse No. NC-3, (view 1) Looking into crevasse from South Pass.

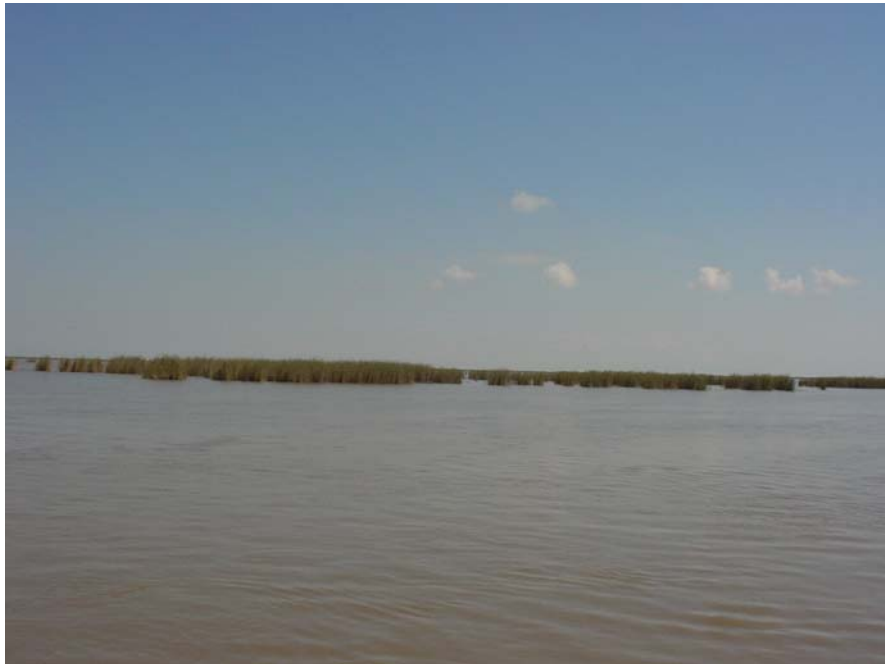
Crevasse No. NC-3, (view 2) Vegetated crevasse dredging spoil in bay area.

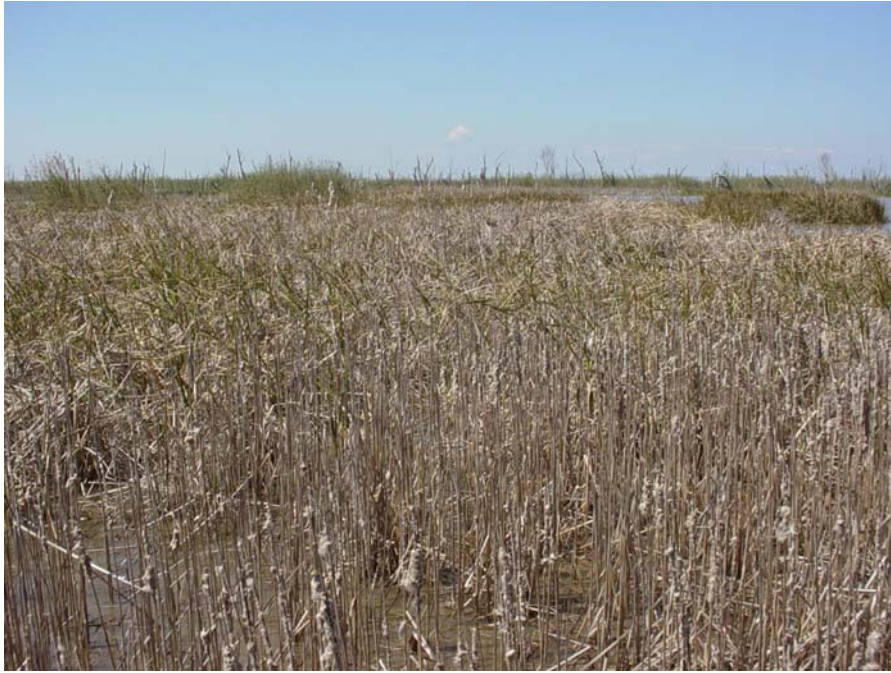
- C. Crevasse No. 9: (2,200 ft. X 75 ft. X -8.0 ft. NAVD 88) Good flow is being maintained in this dog-leg shaped previously dredged crevasse (1999). Its location allows for swift currents during high river stages. The spoil deposition from this cut is very heavily vegetated and appears to have kept its constructed height above the bays.

Crevasse No. 9, (view 1) In bay area, vegetated spoil from crevasse dredging.

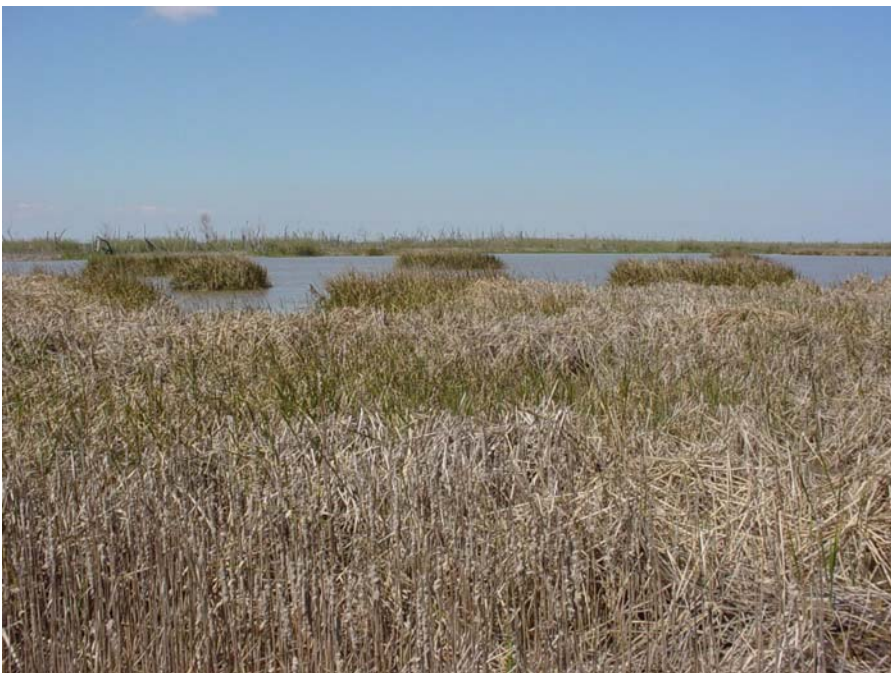
Crevasse No. 9, (view 2) Vegetated spoil deposition in bay area.

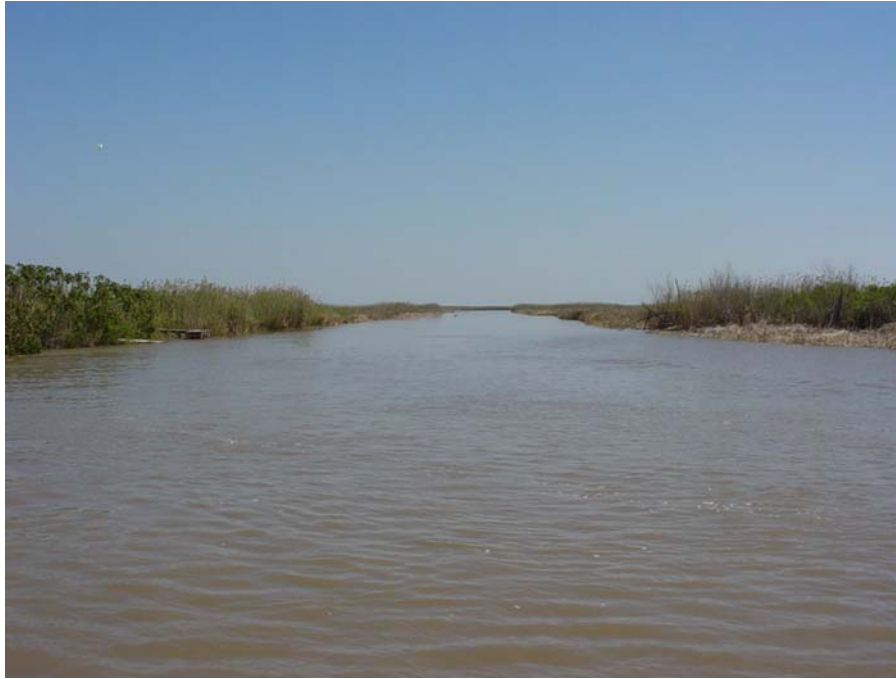
- D. Crevasse No. 11: (2,600 ft. X 100 ft. X -8.0 ft. NAVD 88) This re-dredged crevasse (1999) has maintained a good flow throughout its length. It has maintained its depth throughout and the current in this cut is more than adequate. All of the spoil deposited in the inner lagoon areas has vegetated very heavily and appears to be in excellent condition.

Crevasse No. 11, (view 1) From Pas-a-loutre looking into Crevasse.

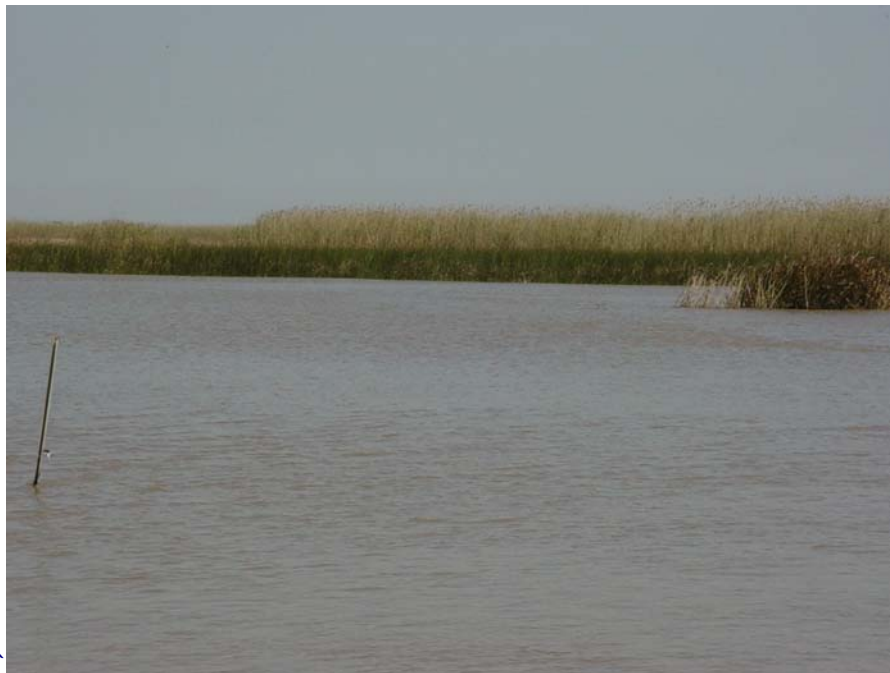
Crevasse No. 11, (view 2) Crevasse end looking at spoil area vegetation.

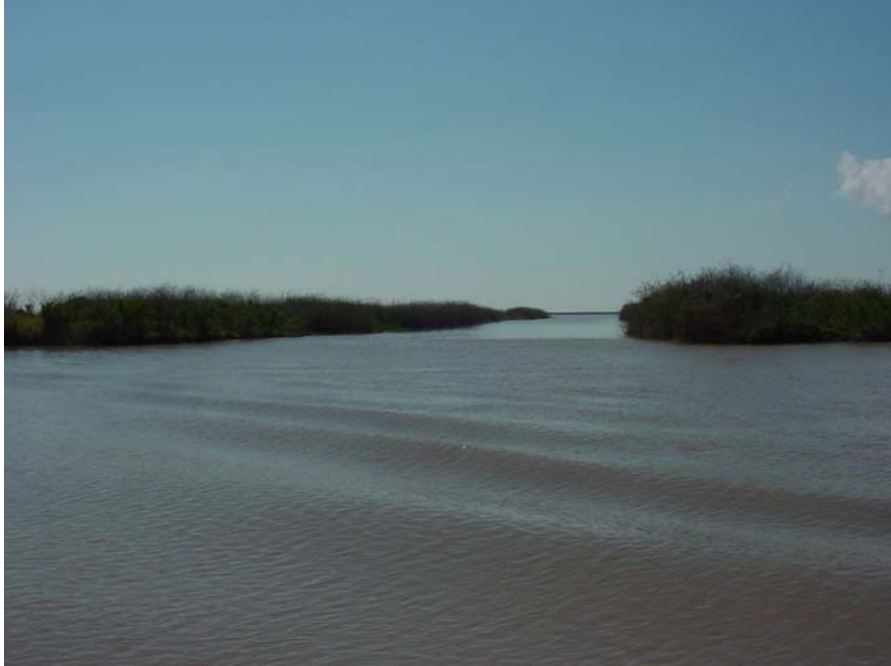
- E. Crevasse No. 12: (2,000 ft. X 75 ft. X -8.0 ft. NAVD 88) Despite being located off of the main channel, this crevasse appears to be functioning very well. There is sufficient current to carry sediments to the inner section of the bays and lagoons and the spoil from the dredging is heavily vegetated. Soundings indicate good depth throughout the cut. This crevasse also had been previously dredged (1999).

Crevasse No. 12, (view 1) Inside bay looking out into crevasse.

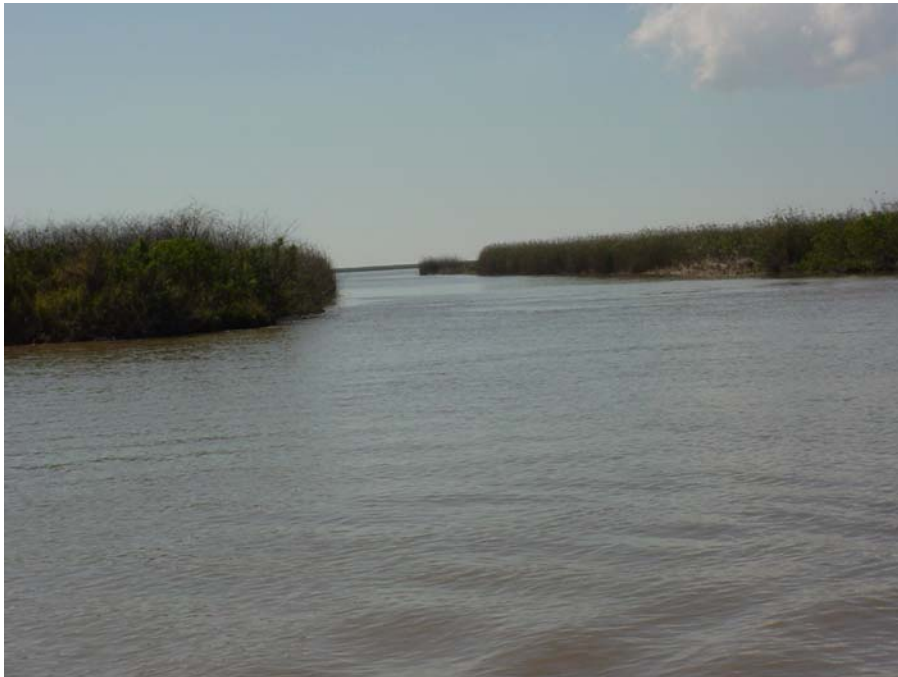
Crevasse No. 12, (view 2) Outside crevasse looking into bay.

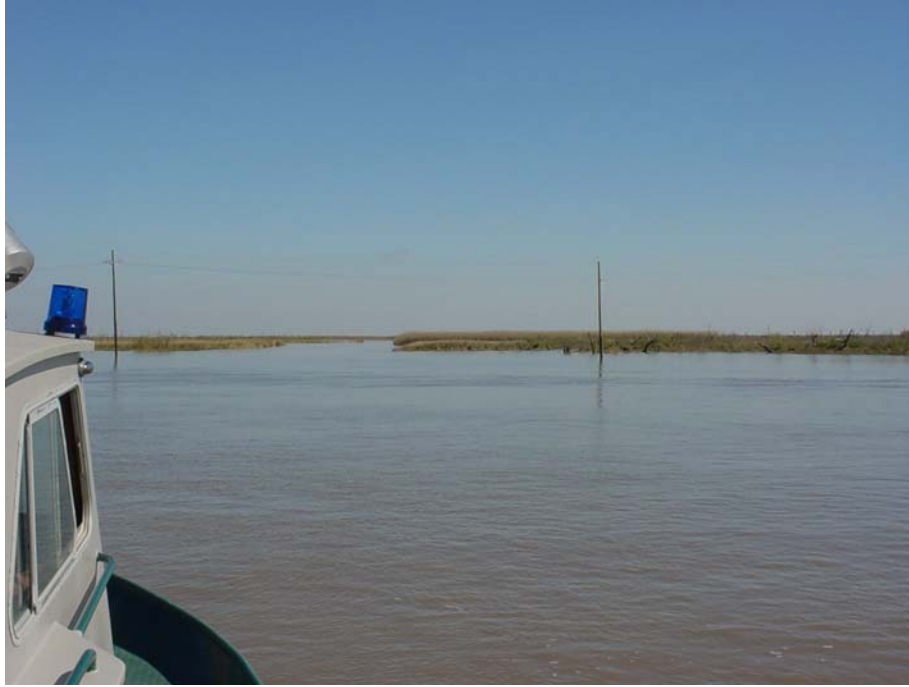
- F. Crevasse No. 81: (1,200 ft. X 100 ft. X -8.0 ft. NAVD 88) This crevasse is located off of Baptiste Colette in the Delta Wildlife Management Area. The current in the crevasse is strong, since it is located in close proximity to the Mississippi River. Soundings show that the mouth of this crevasse has silted up

from the large amounts of sediments that is carried into the cut by the river currents. It is estimated that there is only 3 to 4 feet of draft that exists at the mouth of the crevasse.

Crevasse No. 81, (view 1) Looking into crevasse from Baptiste Collette channel. Notice power line at Crevasse entrance.

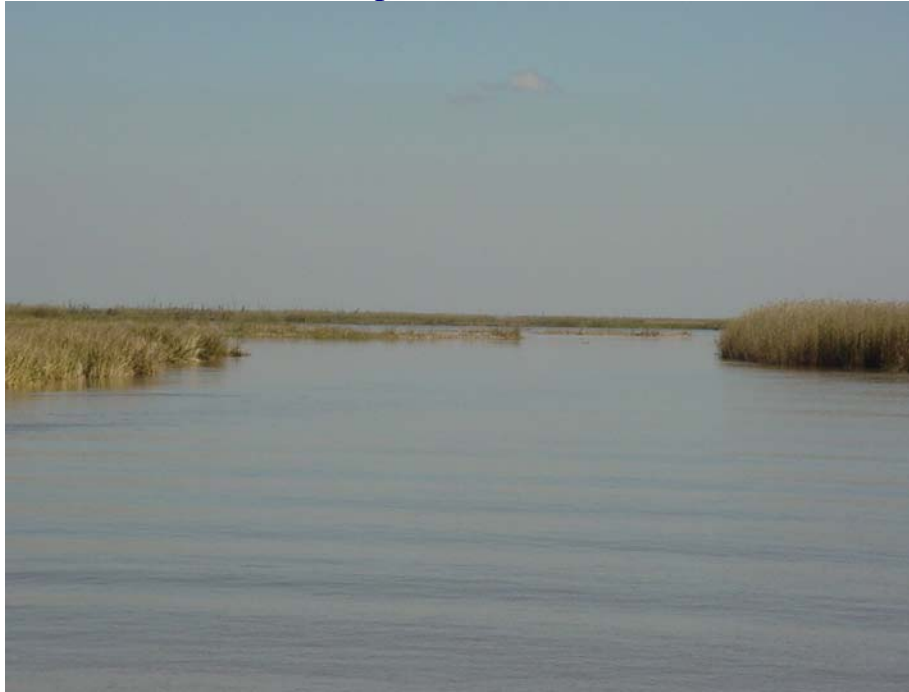
Crevasse No. 81, (view 2) Inside crevasse looking toward vegetated spoil area.
