2008 Annual Inspection Report

Bayou Chevee Shoreline Protection

State Project Number PO-22
Priority Project List 5

July 13, 2009
Orleans Parish

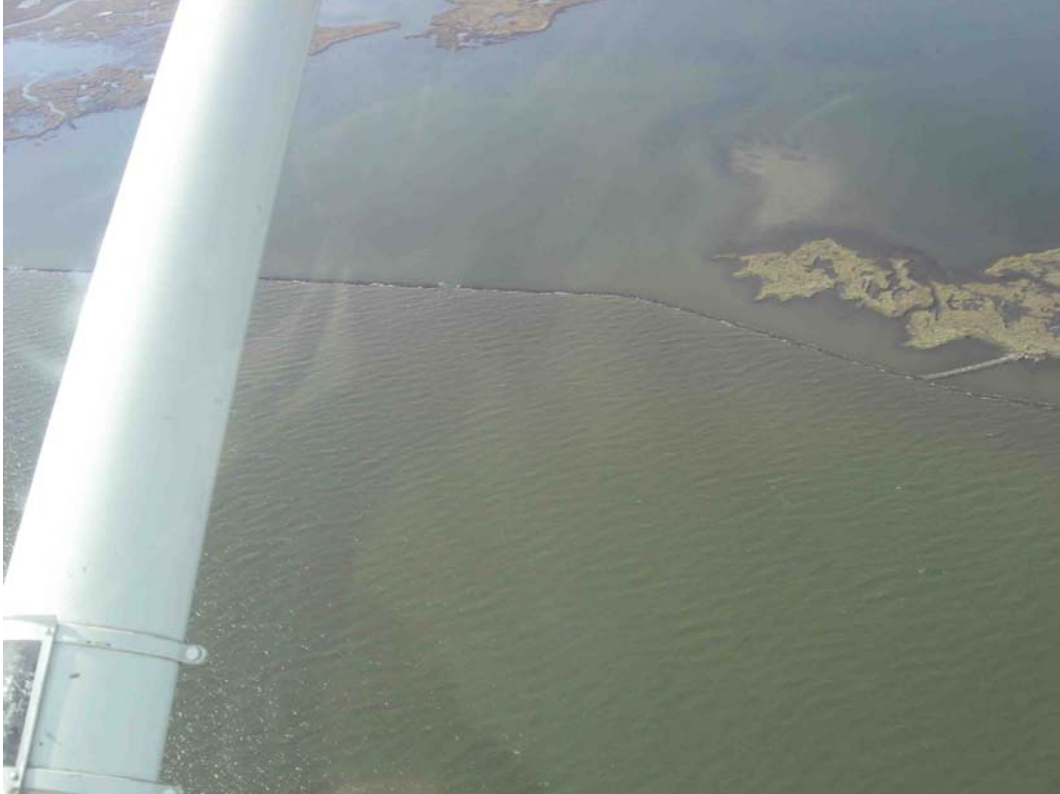
Photo #1 – North Cove Rock Dike.

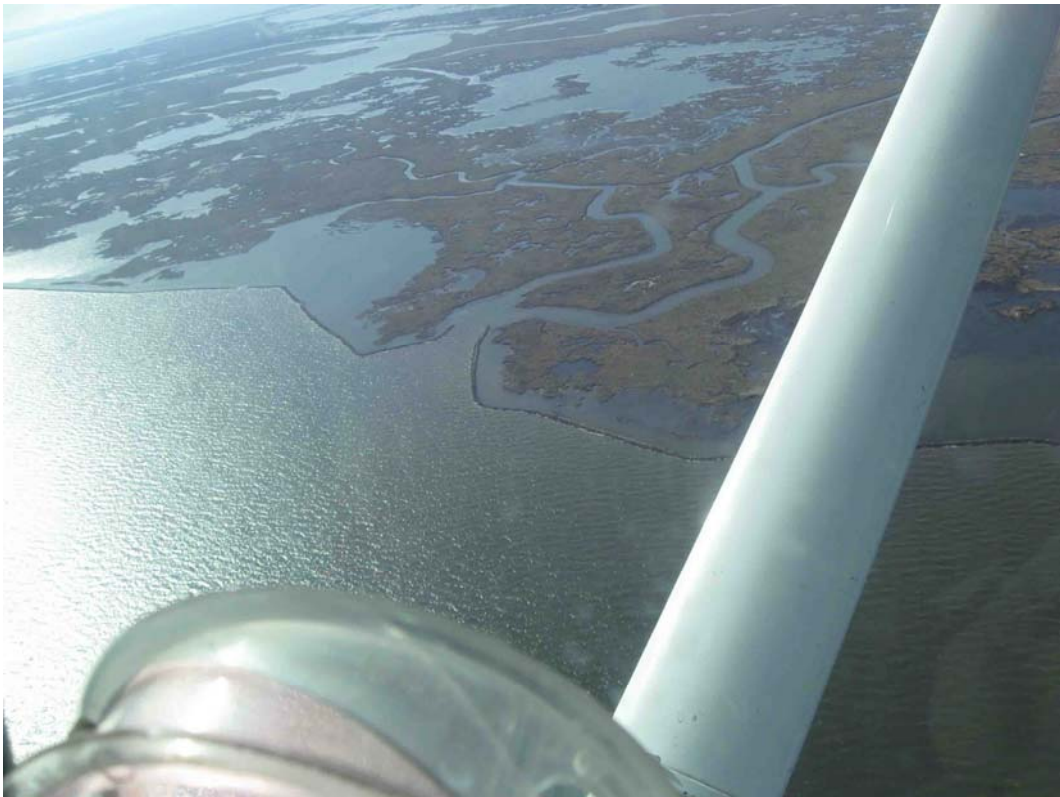
Photo #2 – Bayou Chevee Rock Dike.
