**State of Louisiana  
Department of Natural Resources  
Coastal Restoration Division**

**2006 Annual Inspection Report**

**Jonathan Davis Wetland Protection**

State Project Number BA-20  
Priority Project List 2

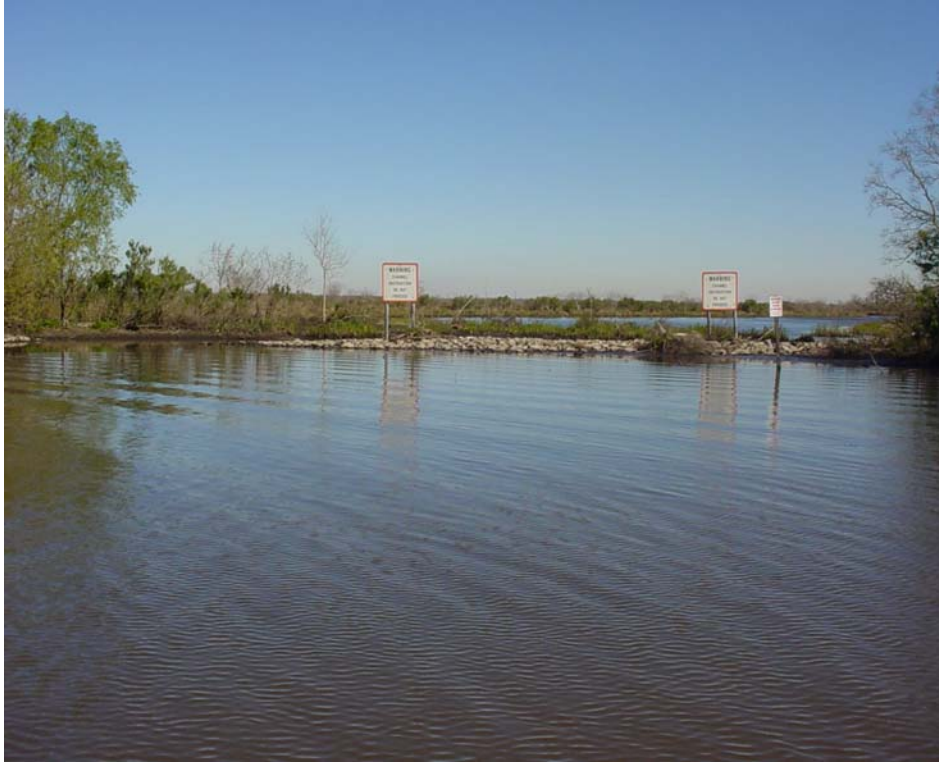
Upon a visual inspection, we noticed a large breach on the west side of the structure (Photo #1). Due to poor soil conditions, this structure has experienced significant settlement problems since the time it was constructed. Several attempts were made during construction to stabilize the structure by placing several lifts of rock, but the structure continued to settle. The maintenance work for this structure will be performed during the construction of Construction Unit 4 (CU 4).

**Photo #1**  
**Structure #14, Notice low spot on left of picture.**

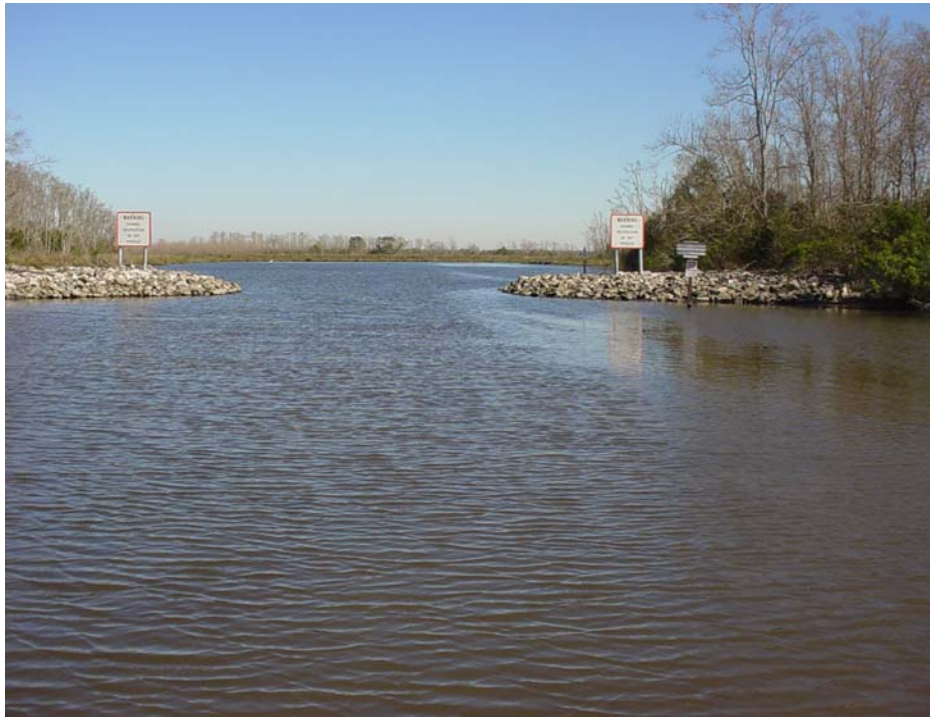
**Photo #2**  
**Structure #15**

Structure 15 appeared to be in good condition at the time of the inspection with little or no noticeable settlement of the rock weir (Photo #2). Signs and supports were also in good condition. The original design of this structure was modified to include a boat bay to accommodate oilfield activities and navigation on the interior marsh of the structure. During the construction of CU 4, this structure will be modified so that it represents the original design more accurately.

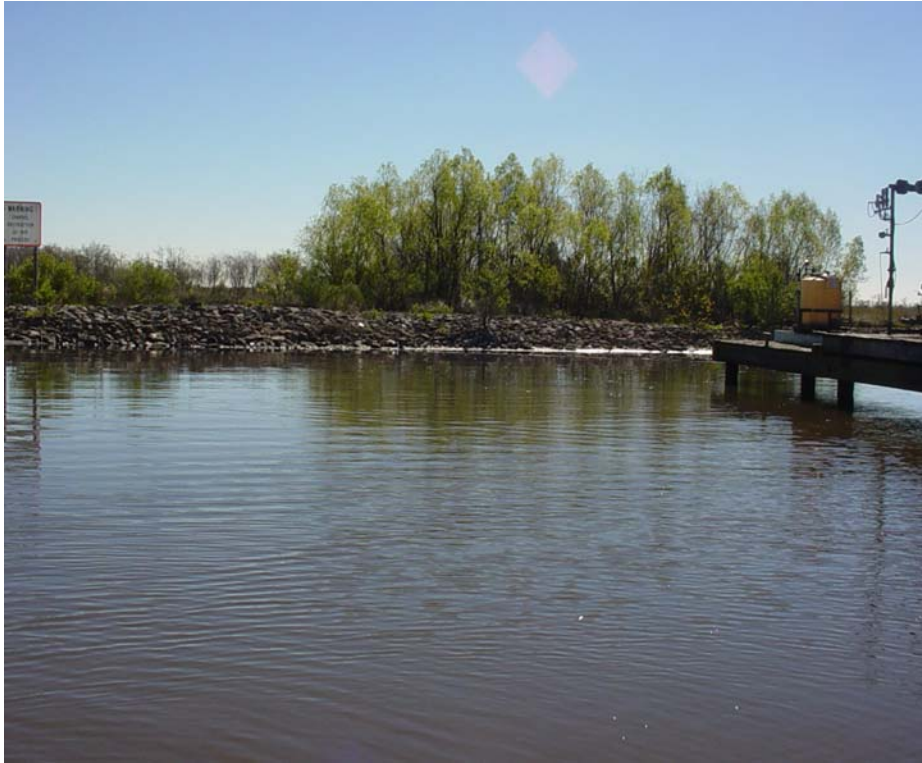
Structure 16 appeared to be in good condition with exception of a low area on the south side of the channel plug (Photo #3). The maintenance work for this structure will be performed during the construction of CU4.

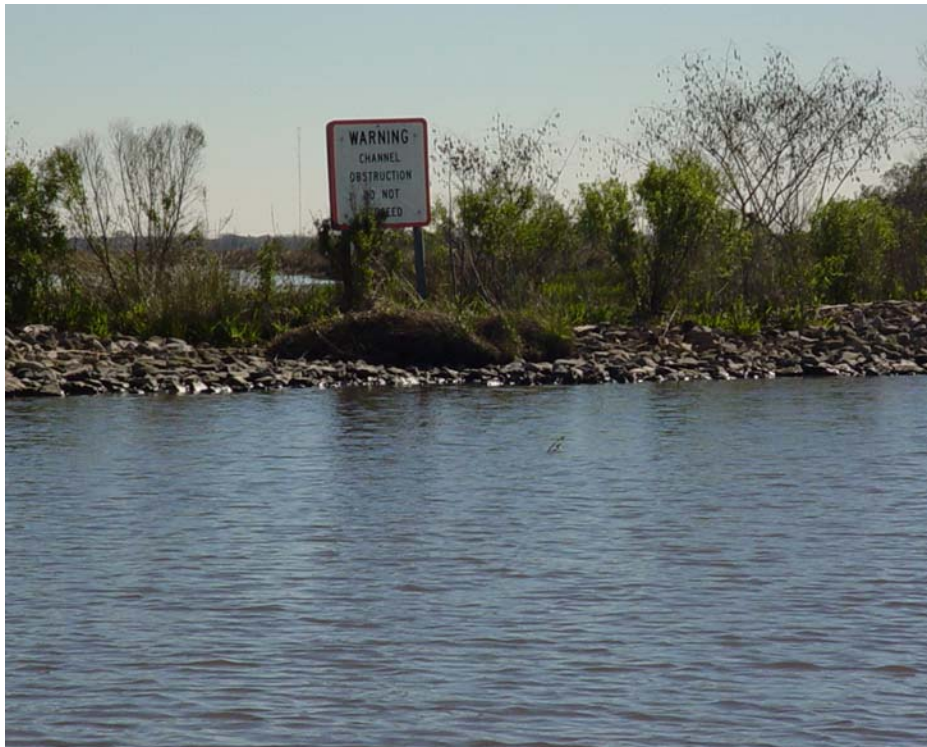
During the inspection, we observed significant settlement near the warning sign on the south side of the structure and just east of the warning sign on the north side of the structure (Photo #4). The maintenance work for this structure will be performed during the construction of CU 4.

**Photo #4**  
**Low spot on Structure #17**

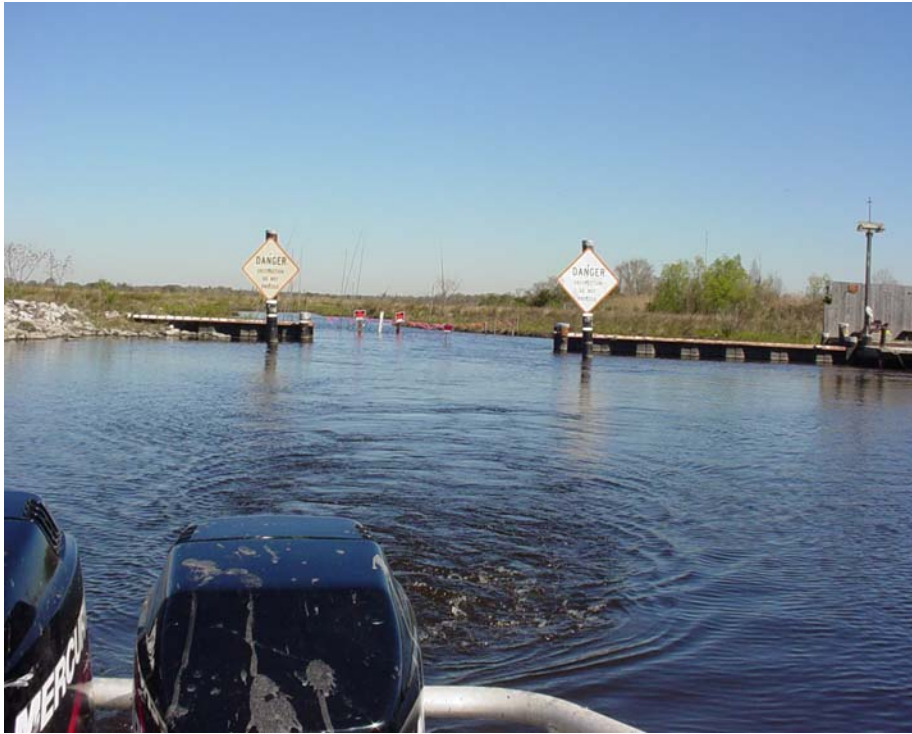
**Photo #5**  
**Structure #22**

The structure itself appears to be in good condition along with the signs, supports, and sheet pile caps (Photo #5). There is however a safety concern. NRCS was contacted by two of the adjacent landowners about people going over the structure in boats even though there are signs warning of a shallow obstruction. LDNR and NRCS agree that there will be no action taken on this because there is adequate warning signage and little that could be done to remedy the problem without permitting/land rights issues.

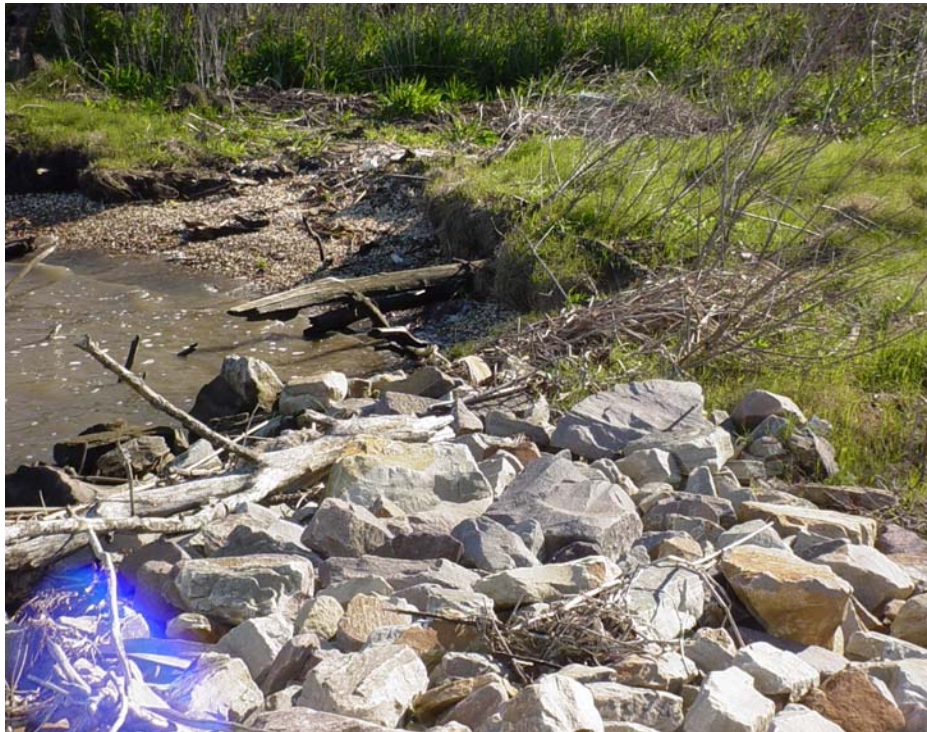
The Bayou Perot Bank Stabilization looks good. There was some slight erosion noticed at the western most portion of the West Reach of the structure (Photo #6). There was also some settlement noticed between Sta. 90+00 and 92+00. The maintenance work for this structure will be performed during the construction of CU4. The erosion problem will be discussed further with NRCS.

**Photo #6**  
**Erosion at west end on CU3.**
