**State of Louisiana  
Department of Natural Resources  
Coastal Restoration Division**

**2006 Annual Inspection Report**

**Barataria Bay Waterway East  
Bank Protection**

State Project Number BA-26  
Priority Project List 6

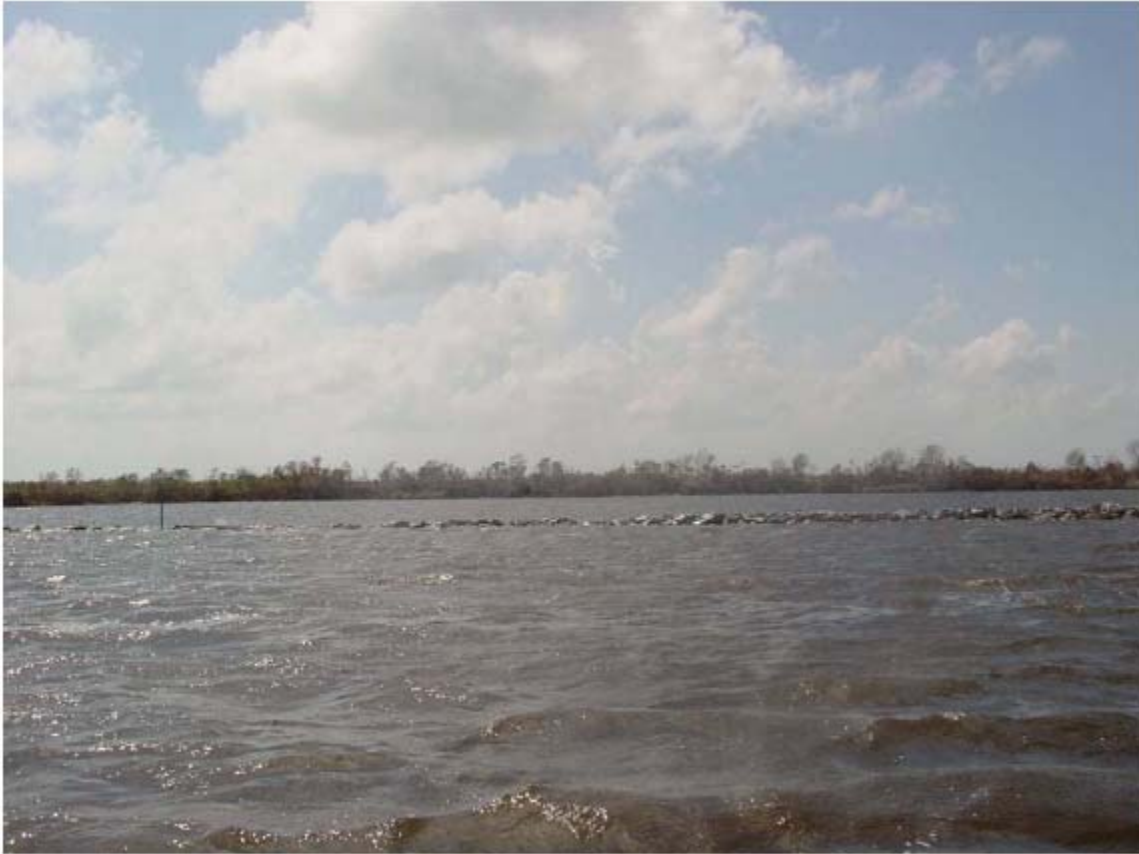
There was no noticeable damage to the rock structure due to the Hurricanes Katrina and/or Rita (Photo #1). Prior to the Hurricanes, some settlement had been noticed in the structure which was still present at the time of the inspection. In December, 2005, a contract to raise these structures was awarded and resulted in the placement of 17,417 tons of rock riprap on the settled sections of the structure. The work was completed on January 24, 2006 (Photo #2).

**Photo #1 – Shoreline Protection.** Before Maintenance Project.

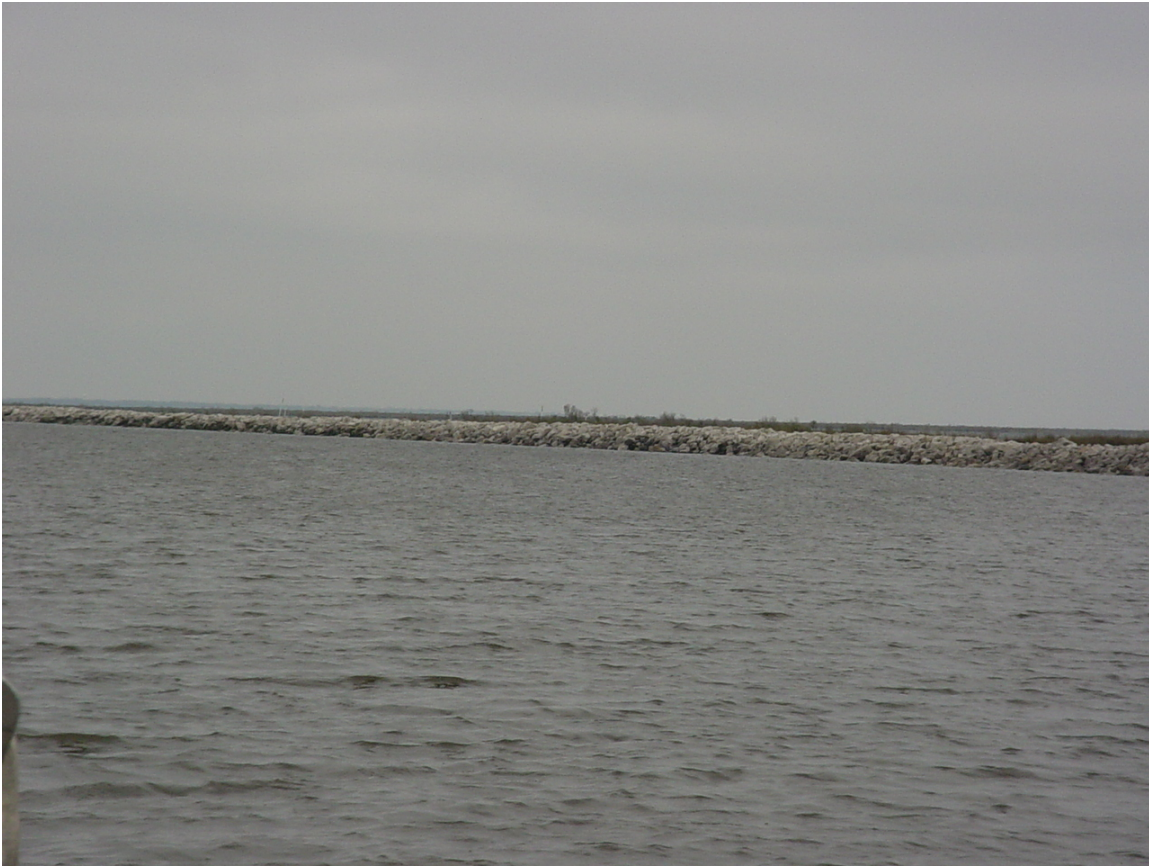
The Barataria Bay Waterway East Protection Project (BA-26) is performing as intended. The rock dike is protecting the existing marsh as designed. The recently completed maintenance lift raised the elevation of the settled sections of foreshore rock dike back to the original designed elevation. This should ensure that the structure performs adequately through the next programmed maintenance lift in 2011.

**Photo No. 2 – Shoreline Protection.** After Maintenance Project.
