Coastal Protection and Restoration Authority of Louisiana

2008 Annual Inspection Report

GIWW/CLOVELLY HYDROLOGIC RESTORATION

State Project Number BA-02
Priority Project List 1

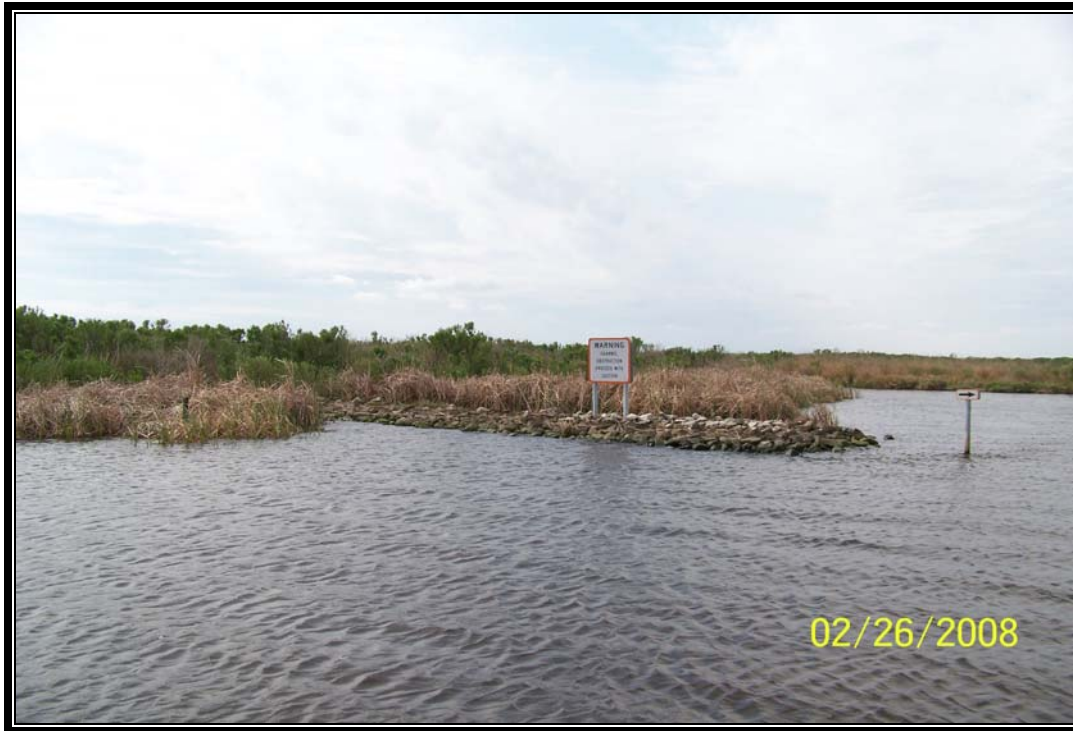
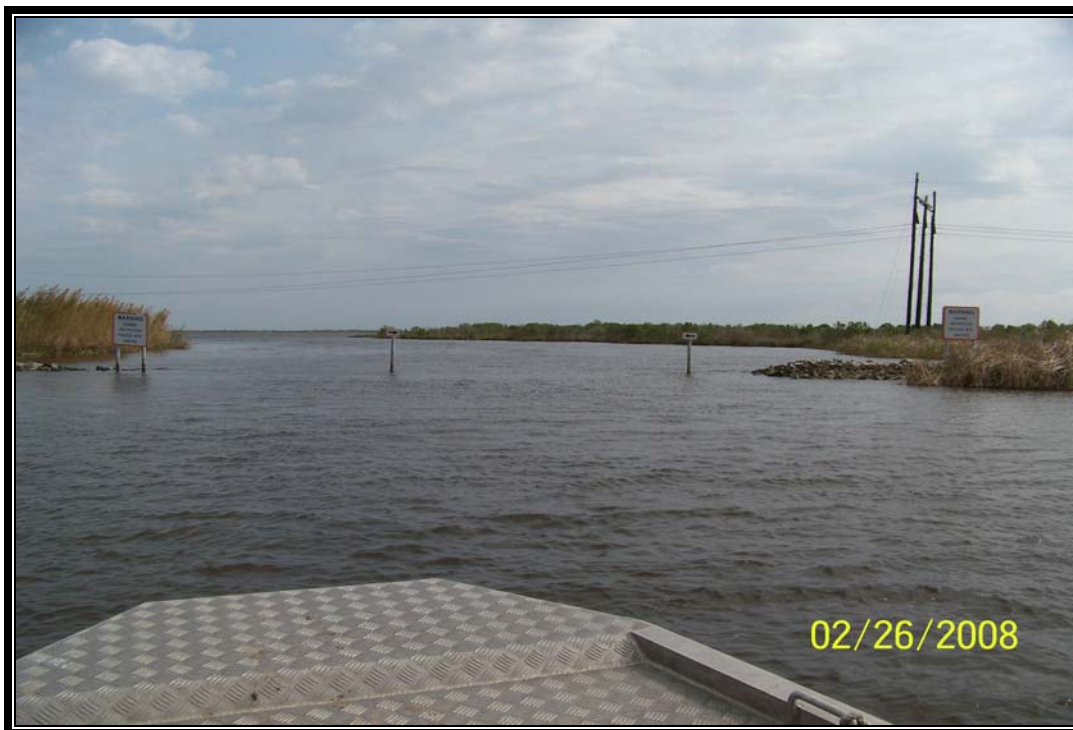
The rock weir appeared to be in fair condition with moderate settlement on the north side of the structure. The north section of the rock weir was at or below the water level which was estimated to be approximately +1.0' NAVD 88 at the time of the inspection. From as-built drawings, the fixed crest section on the north and south side of the boat bay was constructed to an elevation of +2.3' NAVD 88 and the boat bay to -5.1' NAVD 88. Measurements taken with a hand held fathometer at the center of the boat bay indicated a depth of 7.0' above the rock channel liner. It is estimated that the fixed crest section on the north side and the rock channel liner beneath the boat bay has settled approximately 1.3' and 1.0', respectively. Minor settlement was noted along the fixed crest section on the south side of the boat bay. All signs and supports were in good condition. (Appendix B: Photos 1-2).

Moderate settlement was noted along the fixed crest section on the north side of the structure and the rip rap channel lining at the bottom of the canal. It is recommended that rock riprap be installed on the north side and channel bottom to re-establish designed crest elevations. Although the method of repair is relatively simple, access to the structure may present challenges. Shallow depths along the shoreline of Bay L' Ours near the mouth of the channel where the structure is located may prevent rock barge from accessing the site. Temporary access dredging will be required from the structure to deeper waters in Bay L' Ours. The maintenance costs outlined in Appendix C reflect these conditions.

Photo No. 1 (0792) – the south side of rock weir with boat bay (Structure 2) located along the west bank of Bay L' Ours.

Photo No. 2 (0793) – view of rock weir with boat bay (Structure 2) and signage looking east.

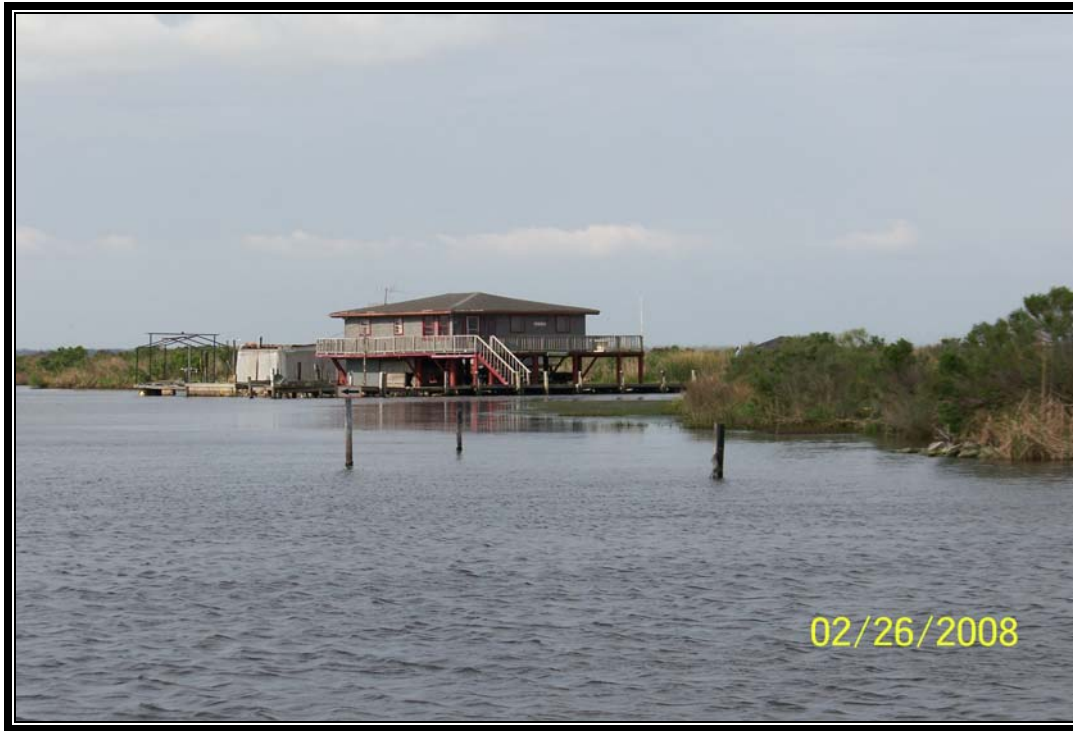
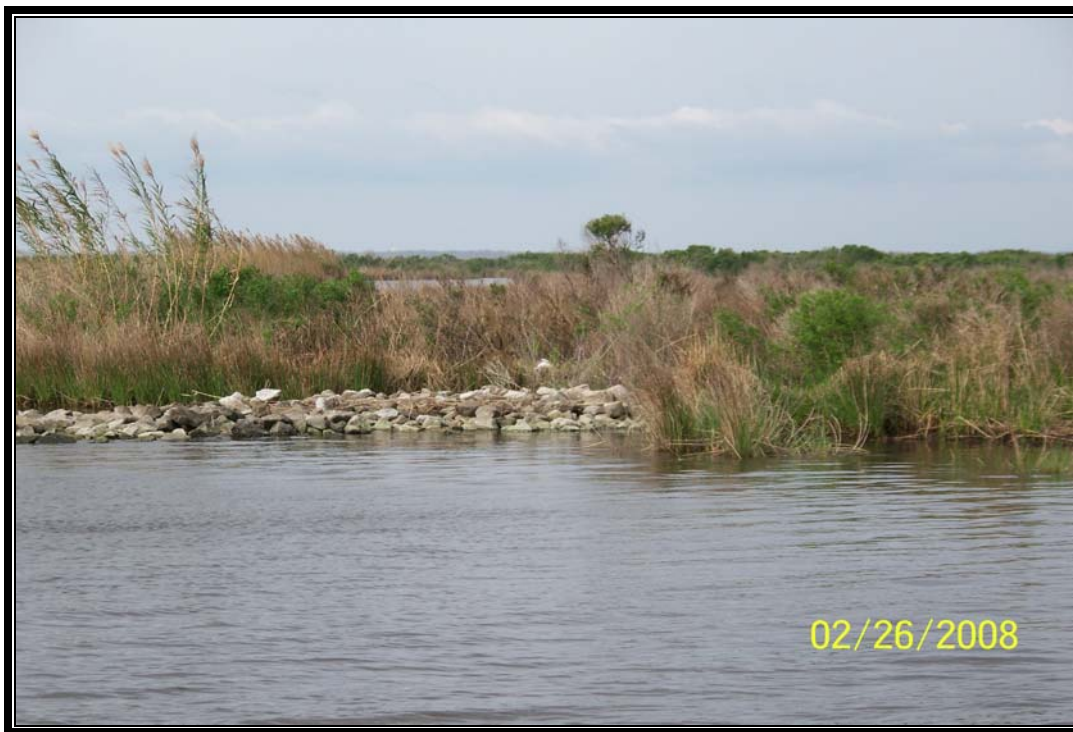
A visual inspection of Structure 4 revealed moderated to severe settlement of the fixed crest rock weir. Severe settlement was noted on the north side of the structure where the rock weir had subsided below the water line estimated at +1.0 NAVD 88 at the time of the inspection. The south side appeared to have settled slightly with the top portion of the rock weir exposed above the water line. Measurements were taken with a hand-held fathometer at the center of the boat bay where it was determined, based on estimated water levels, that the elevation of the rock rip-rap channel liner was approximately -4.5' NAVD 88. Comparing the as-built elevation (-3.9 NAVD 88) with the measured depths, it is estimated that the boat bay section of the structure has settled over 0.5'. According to the as-built drawings, the north and south fixed crest sections were constructed to an elevation of 2.4' NAVD 88. Comparing the as-built elevations with visual observations in the field, we estimate that the fixed crest weir section has settled over a foot on the south side and approximately 2' on the north. The warning sign on the north side of the structure is missing. After reviewing photos from previous inspections prior to the storm, we are confident that this warning sign was destroyed during Hurricane Katrina. Replacement of this sign shall be included in the project plan for the upcoming maintenance event. (Appendix B, Photos 3-4)

Structure No.4 was found to be in fair to poor condition with severe settlement on the north side of the structure and moderate to minor settlement of the boat bay and rock weir section on the south side. The warning sign on the north side of the structure was also missing. Recommendation for refurbishing this structure includes installation of rock riprap along the entire structure to raise the crest to design elevations and replacement of the missing warning sign. As in the case of Structure No.2, temporary access dredging may be required to complete maintenance of this structure. Detailed cost estimates to complete these repairs are shown in Appendix C.

Photo No.3 (0790) – the north side of the rock weir (Structure 4) located along the west bank of Bay L’ Ours.

Photo No.4 (0791) – the south side of the rock weir (Structure 4) located along the west bank of Bay L’ Ours.

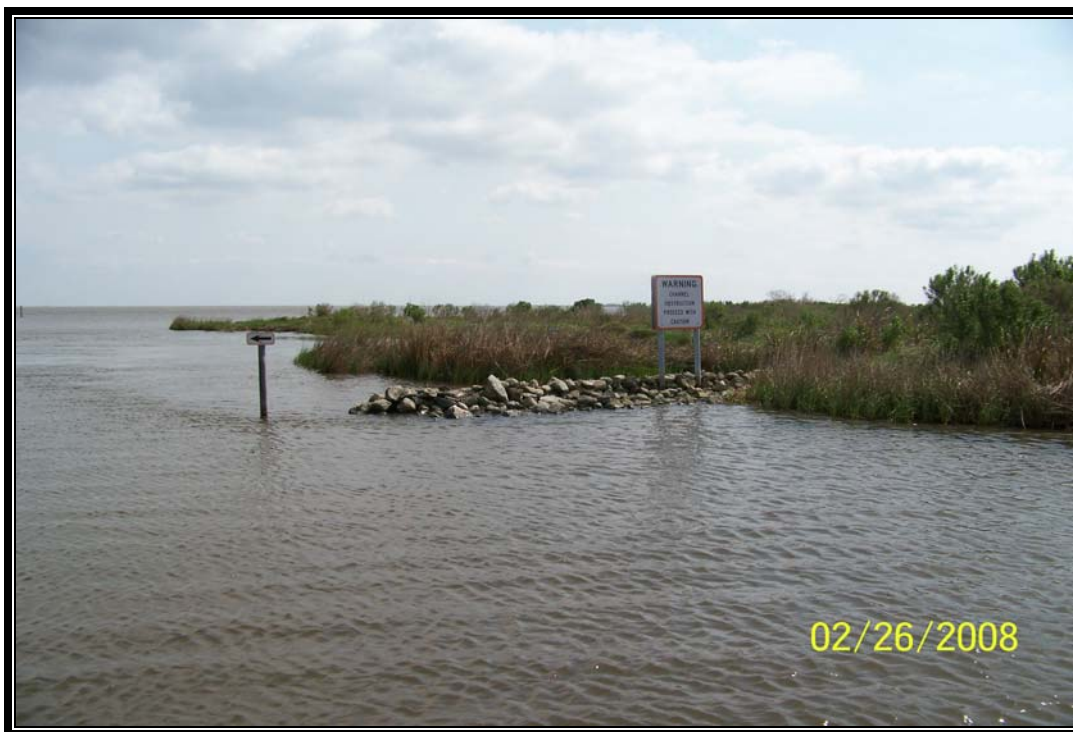
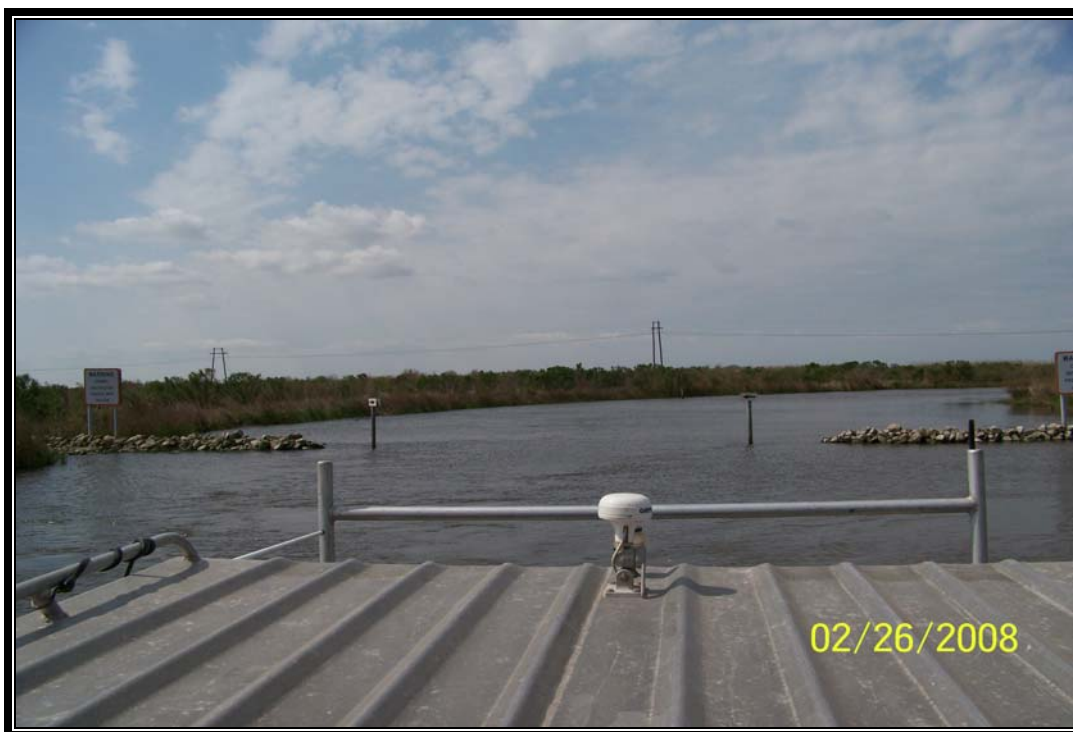
Structure No.7 appeared to be in good condition with no apparent settlement of the fixed crest rock sections. The as-built drawings indicate that the fixed crest rock weir was constructed to elevations of -4.4 NAVD 88 at the boat bay and +2.4' NAVD 88 on the north and south sides. From visual observations, minor settlement is suspected on the north side of the structure. Field measurements using a hand-held fathometer revealed a depth of 6.4' at the center of the boat bay. Based on as-built elevations, we estimate that the rock lined boat bay is currently at an elevation of -5.4' NAVD 88, which indicates settlement of approximately 1.0'. All signs, supports and earthen embankment tie-ins appear to be in good condition. (Appendix B: Photos 5-6)

Photo No. 5 (0825) – the south side of the rock weir section (Structure 7) located looking east toward Little Lake.

Photo No. 6 (0826) – view of fixed crest rock weir with boat bay (Structure 7) looking west.

Item	Condition	Physical Damage	Corrosion	Photo #	Observations and Remarks
Signage /Supports	Good			5 thru 6	Observation: The north side of the rock weir has experienced slight settlement since placement of rip-rap. Overall, the rock weir was in good condition with only minor settlement noted. The signs and supports were also in good condition. No maintenance will be required at this time.
Eathern Embankment	Good				
Rock Weir	Fair				
Construction Unit No. 1					
Structure Description: 200 linear ft. rip-rap fixed crest weir with a 20 ft. boat bay located south of Clovelly Canal, west of Little Lake and north of Site 4 in Bayou De La Gauche. The crest of the weir is set at and elevation of 2.4 ft. The invert of the boat bay is set at and elevation of -4.4'. Aluminum warning signs are located in the center of the rock weir sections.					
Marsh Level: +1.42'

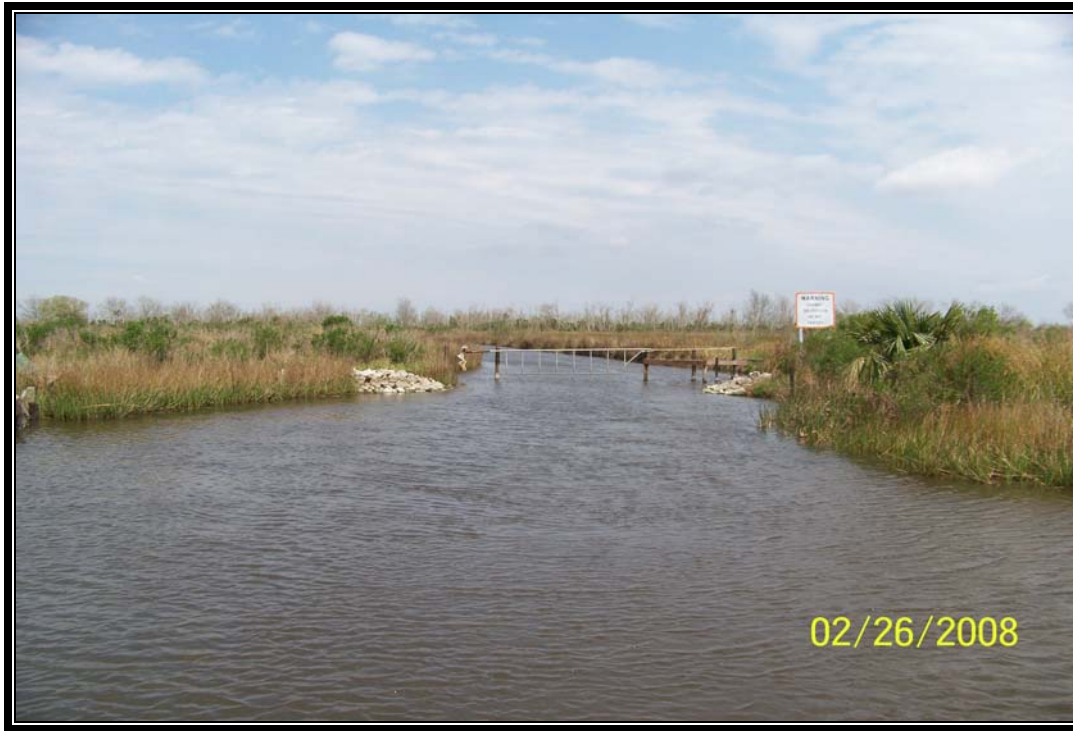
The small rock weir with boat bay and steel gate closure located at the mouth of a small marsh channel adjacent to Structure 7 appears to be in very good condition. The warning sign, steel gate and earthen embankment tie-ins are in good condition. (Appendix B: Photo 7)

Photo No. 7 (0827) – view of rock weir and gate (Structure 8) looking north.

Item	Condition	Physical Damage	Corrosion	Photo #	Observations and Remarks
				7	Observation: The small rock weir adjacent to Structure No.7 was in good condition with no indication of damage or settlement. The gate and signage was also in good condition. No maintenance required at this time.
Signage /Supports	Good				
Eathern Embankment	Good				
Rock rip rap weir	Good				
Construction Unit No.1					
Structure Description: 65 linear ft. rock rip-rap fixed crest weir with a 8' wide boat bay located in a pipeline channel south of the Clovelly Canal and west of Little Lake. The crest of the weir was set at +1.0 ft. AML (above marsh level). Marsh level was determined to be 1.8 ft. The invert of the boat bay was constructed at an elevation of -3.5 ft. Aluminum warning signs supported by galvanized pipes are located at the entrance of the pipeline canal.					
Marsh Level: +1.8'

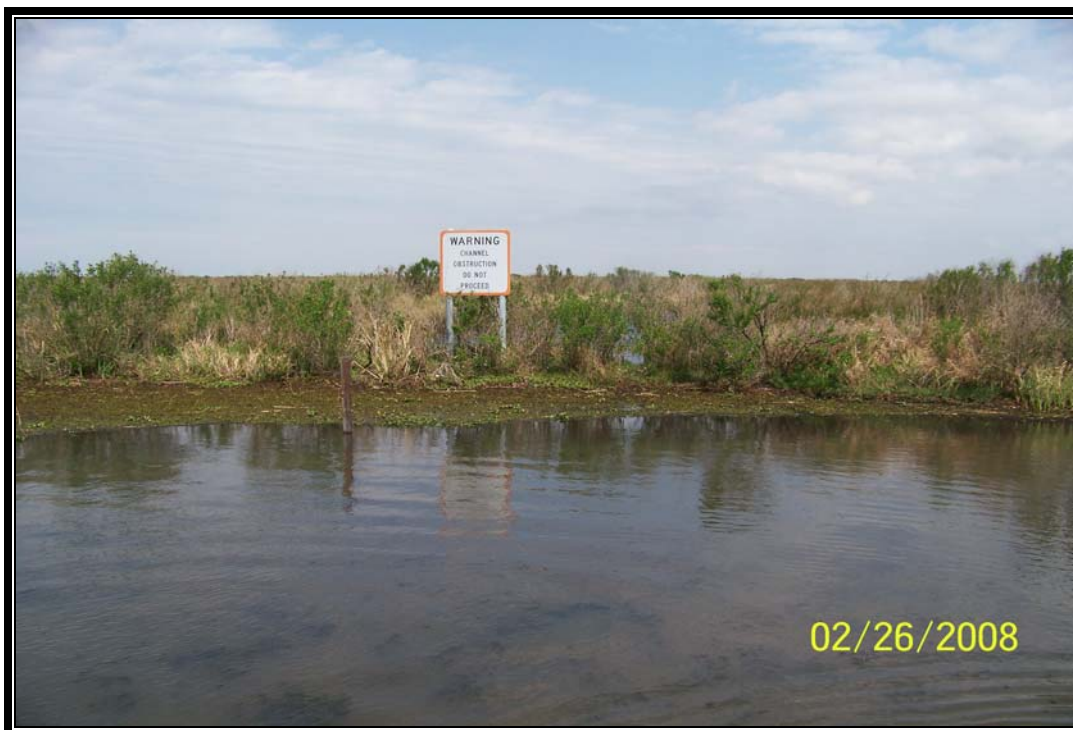
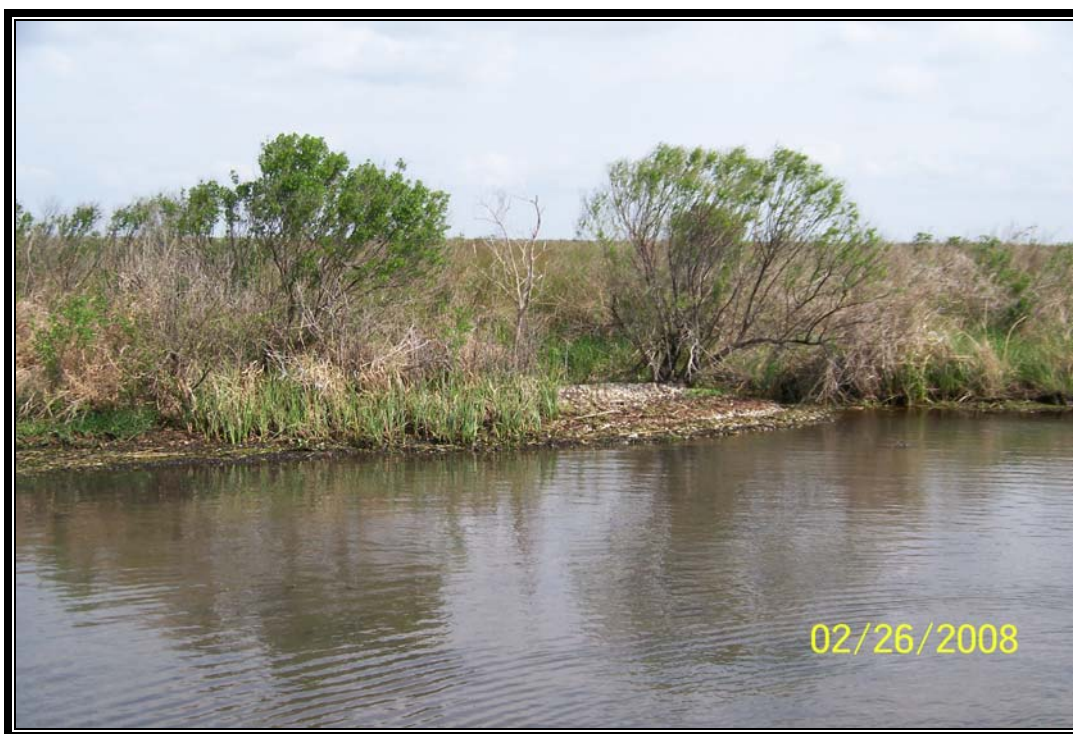
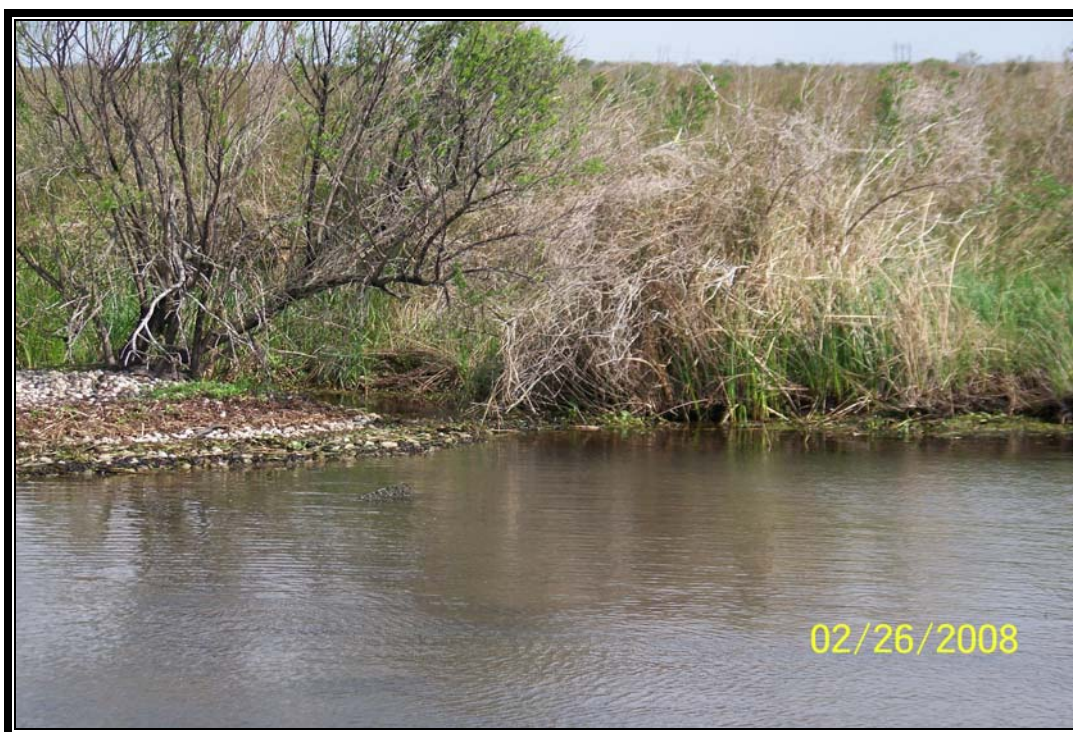
As indicated on previous inspection reports, there is a 5 to 7 ft. wide shallow breach in the embankment on the east side of the structure. It appeared that the breach has not increased in width or depth from previous inspections. It is possible that water may by-passes the structure on high tides since the crest of the structure is only slightly above the existing marsh. The crest of the weir plug was originally constructed to an elevation of +2.45' NAVD 88. At this time, we do not recommend maintenance to close the small breach. The OCPR will re-evaluate the condition of Structure 43 on future site visits. (Appendix B: Photos 8-10)

Photo No. 8 (0822) – rock plug (Structure 43) looking north.

Photo No. 9 (0823) – the east side of Structure 43 looking northeast.

Photo No. 10 (0824) – a view of the shallow area on the east side of the rock plug (Structure 43).

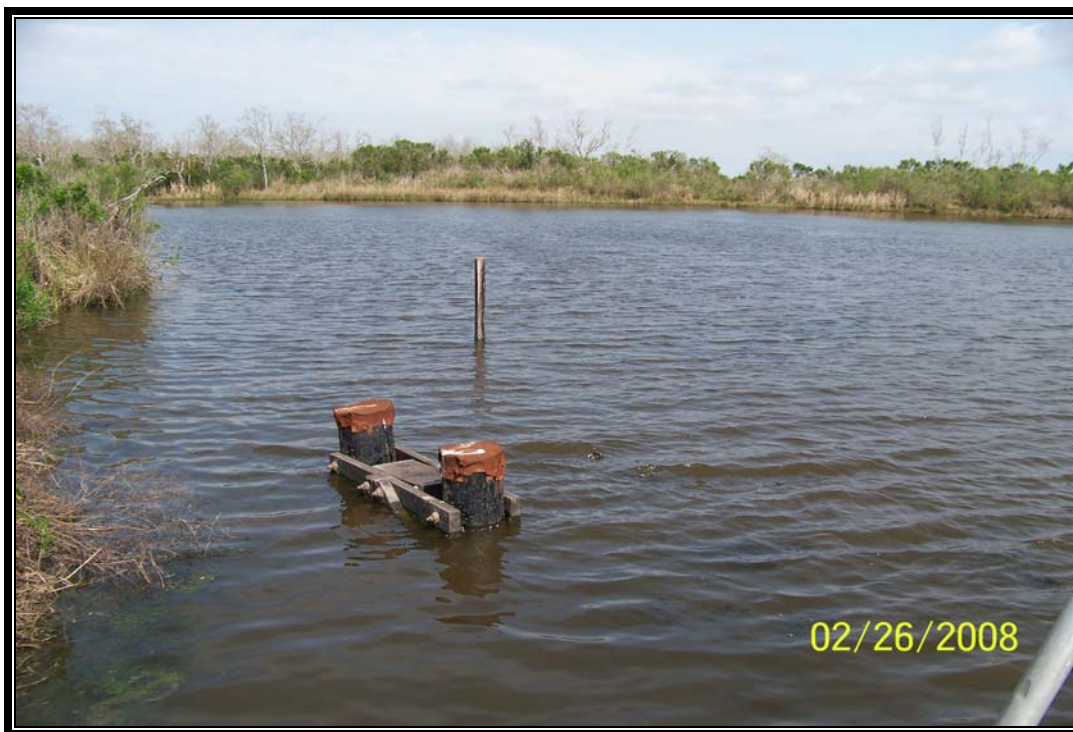
timber supports and earthen embankments were also in good condition. The sheet metal covering the tops of the timber piles supporting the corrugated metal pipe were rusted and corroded. Although corrosion was present, we did not observe any deterioration of the tops of the timber piles. We did notice excessive barnacle growth in and around the flap-gated structure below the waterline. The barnacle growth does not appear to be having an adverse affect on gate operations. (Appendix B: Photo 11)

Photo No. 11 (0816) – a view of timber supports and flap gate at Structure 91.

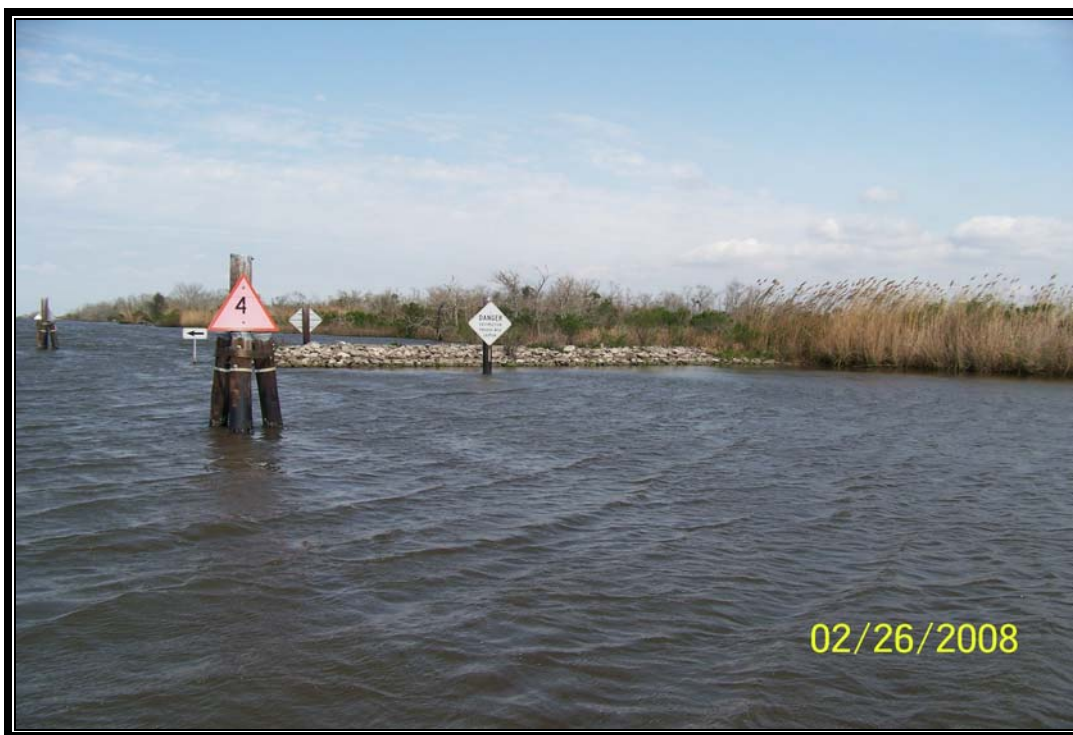
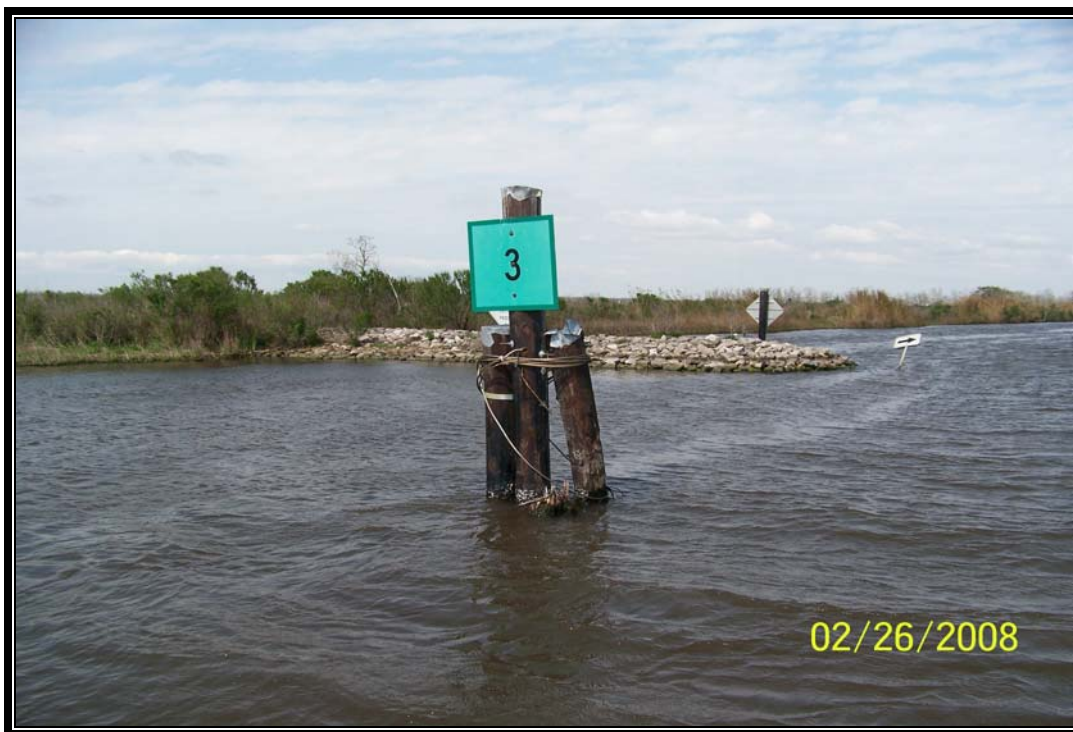
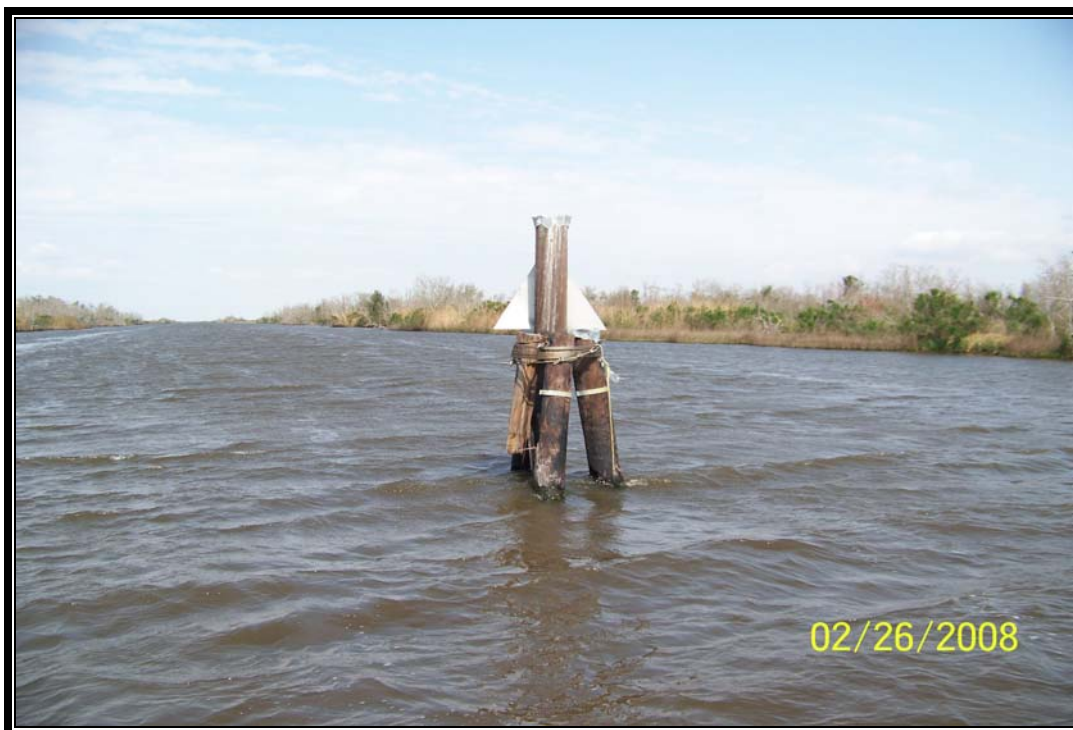
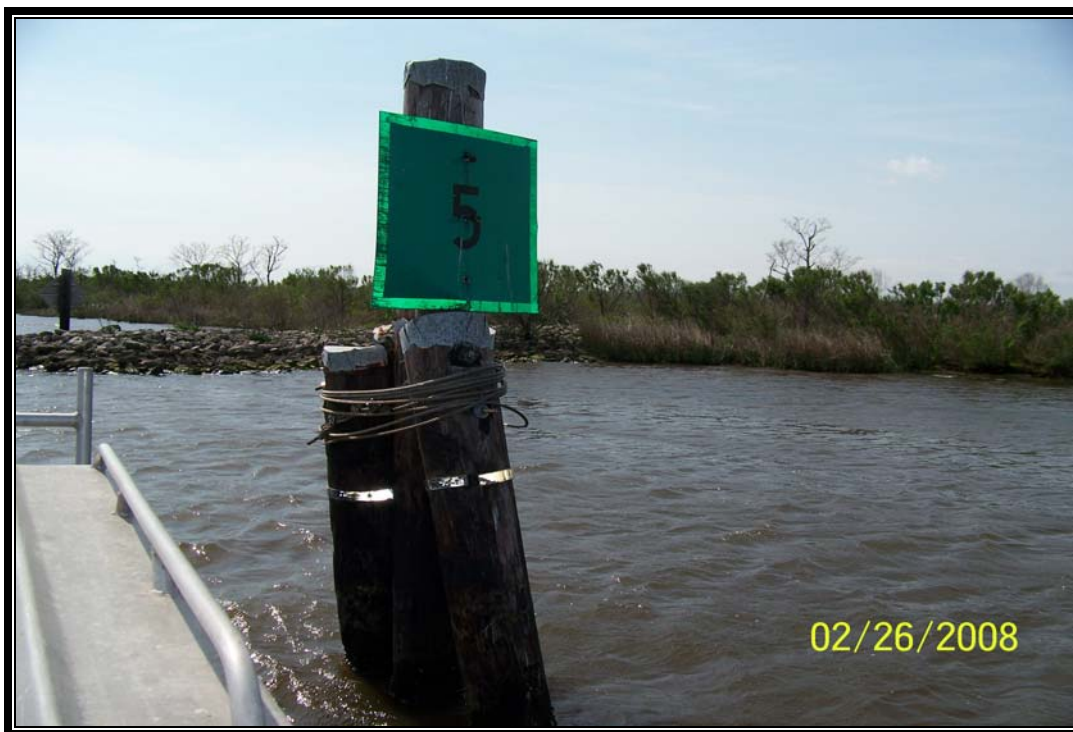
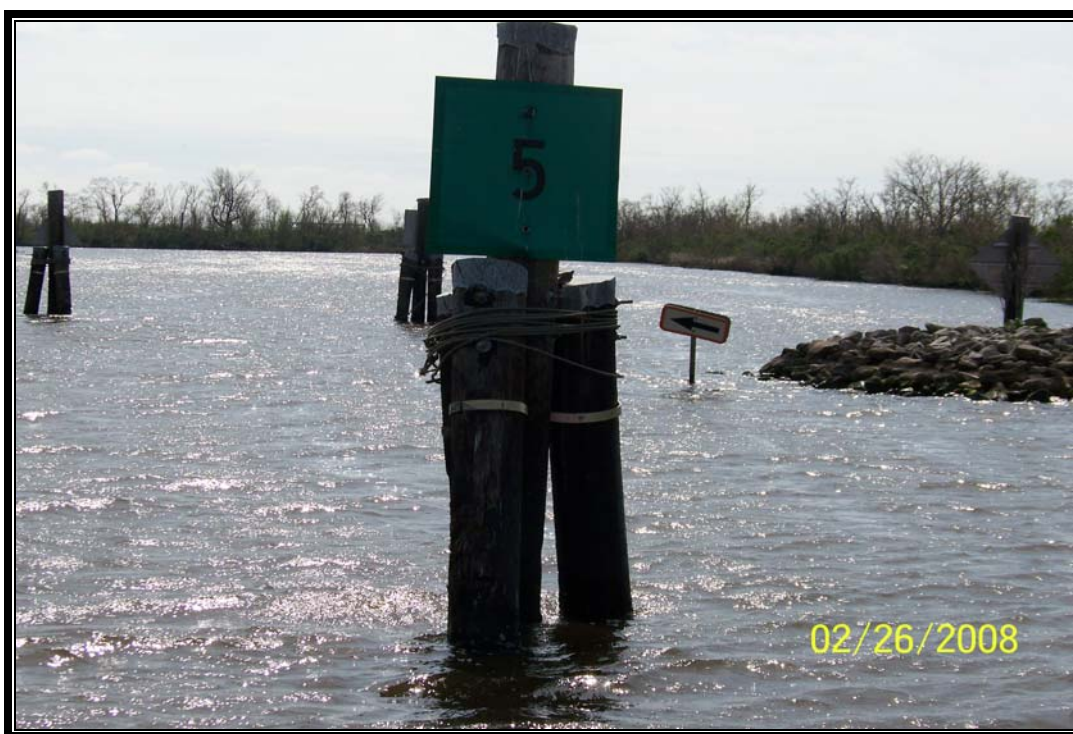
The rock weir with barge bay was in good condition with no apparent settlement. The rock weir was constructed to a -6.4' NAVD 88 at the barge bay and +4.0' NAVD 88 along the crest on each side of the structure. Staff gauge readings from a CRMS station just north of the structure indicated a water elevation of 0.8' NAVD 88 at the time of the inspection. Using the water elevation, we estimated that the rock weir section on both sides of the structure to be approximately +3.5' to 4.0' NAVD 88 reinforcing our observations that no settlement has occurred. Over the years, we have noticed increasing damage to the timber piles supporting the warning signs at the entrance to the barge bay. Several vertical piles are split, the batter piles are off center and the surface of all the piles are worn or scarred from vessels rubbing the timbers while accessing the barge bay. Although visible damage is evident on the surface of the piles, we do not believe that structural failure of the timber dolphin system is imminent. The OCPR will continue to monitor the condition of the timber pile supports and pursue corrective action if needed. (Appendix B: 12-16)

Photo No. 12 (0817) – northeast section of rock weir with barge bay (Structure 1).

Photo No. 13 (0818) – timber dolphin support and signage on southwest side of Structure 1.

Photo No. 14 (0819) – timber dolphin support and sign on northeast side of Structure 1.

Photo No. 15 (0820) – timber dolphin and sign on northwest side of Structure 1.

Photo No. 16 (0821) – the timber dolphin and sign on northwest side of Structure 1.

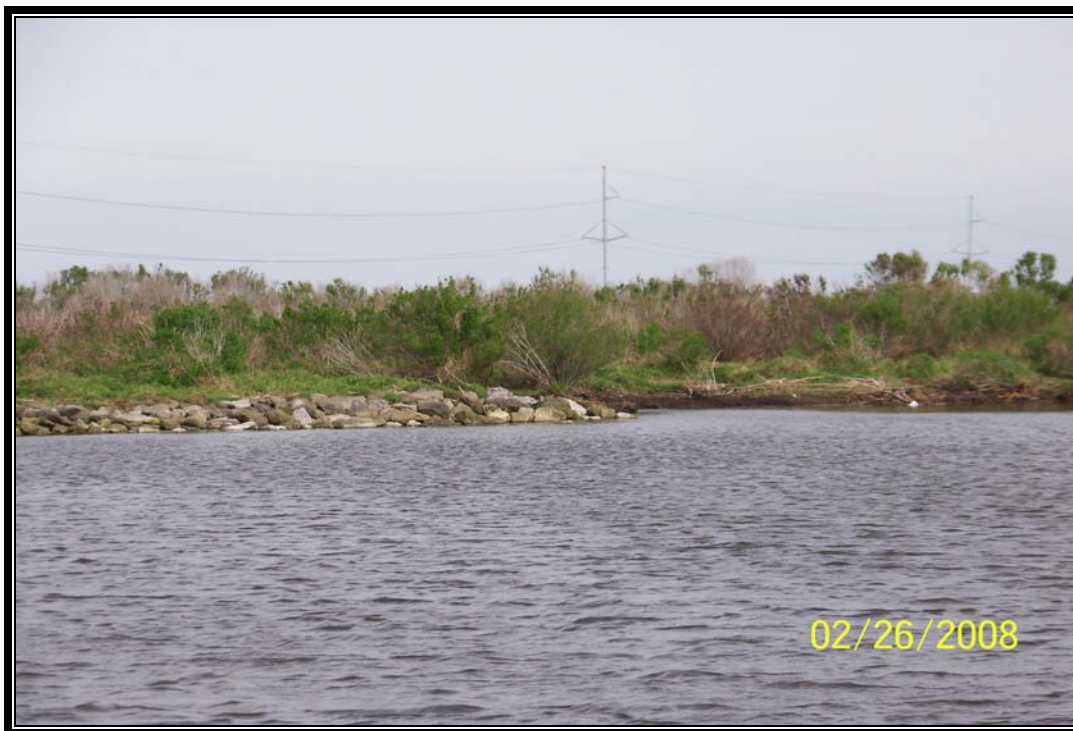
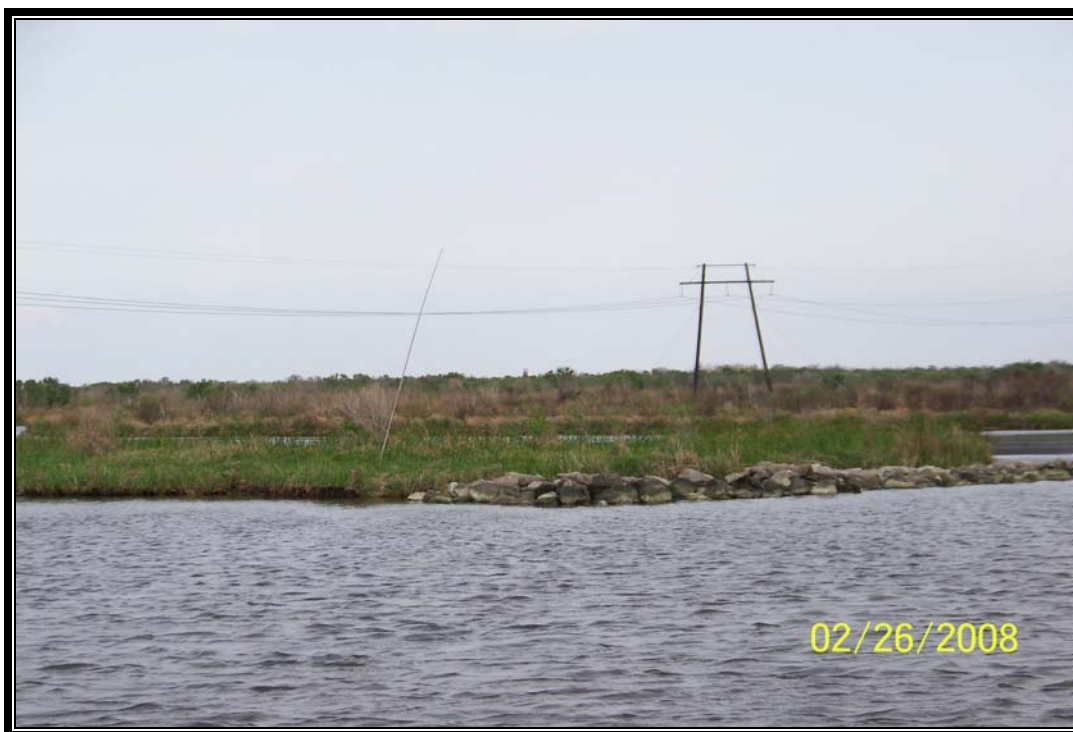
Structures 4A & 4B appeared to be in fair condition with no noticeable settlement of the rock riprap plug. We did observe significant erosion on both sides of the structure near the marsh tie-ins. Moderate erosion was present on the north side of the structure with visible cut banks along the face of the existing shoreline. We are hoping that erosion on the north side of the structure will stabilize due to the abundance of marsh shrubs (Baccharis) in the area protecting exposed organic marsh material. The area of most concern is the south side of the structure where the rock plug meets the existing marsh. The remaining shoreline in this area was very thin with only a small trip of marsh material remaining between Little Lake and the adjacent interior marsh channel. This is due in large part to Hurricanes Katrina and Rita which eroded a large section of marsh from the intersection of Bayou Des Amoreax at the mouth of Little Lake to the south side Structures 4A & 4B. The potential for breaching in this area remains very high. (Appendix B: Photos 17-18)

The rock plug structures appeared to be in good condition with no visible settlement. The critical areas of concern associated with this structure are the tie-ins where the rock terminates near the existing marsh on both sides of the structure. The existing marsh in this area sustained high erosion rates from Hurricanes Katrina and Rita and is very thin, exposing the structure to potential breaching. Due to very little marsh remaining between the Bay L' Ours shoreline and Bayou Des Amoreaux, we recommend that the rock plug be extended approximately 200' on the south side and 100' on the north side, to a location where the marsh is stable. It is anticipated that access dredging will be required to complete this work. Detailed cost estimates for extending the rock plug are outlined in Appendix C.

Photo No. 17 (0787) – marsh tie-in on the north side of Structures 4A and 4B showing some marsh erosion where the rock plugs meet the existing marsh.

Photo No. 18 (0788) – the marsh tie-in on the south side of Structures 4A and 4B showing a thin strip of marsh remaining behind the structure.
