Coastal Protection and Restoration Authority of Louisiana

2008 Annual Inspection Report

GIWW/CLOVELLY HYDROLOGIC RESTORATION

State Project Number BA-02
Priority Project List 1

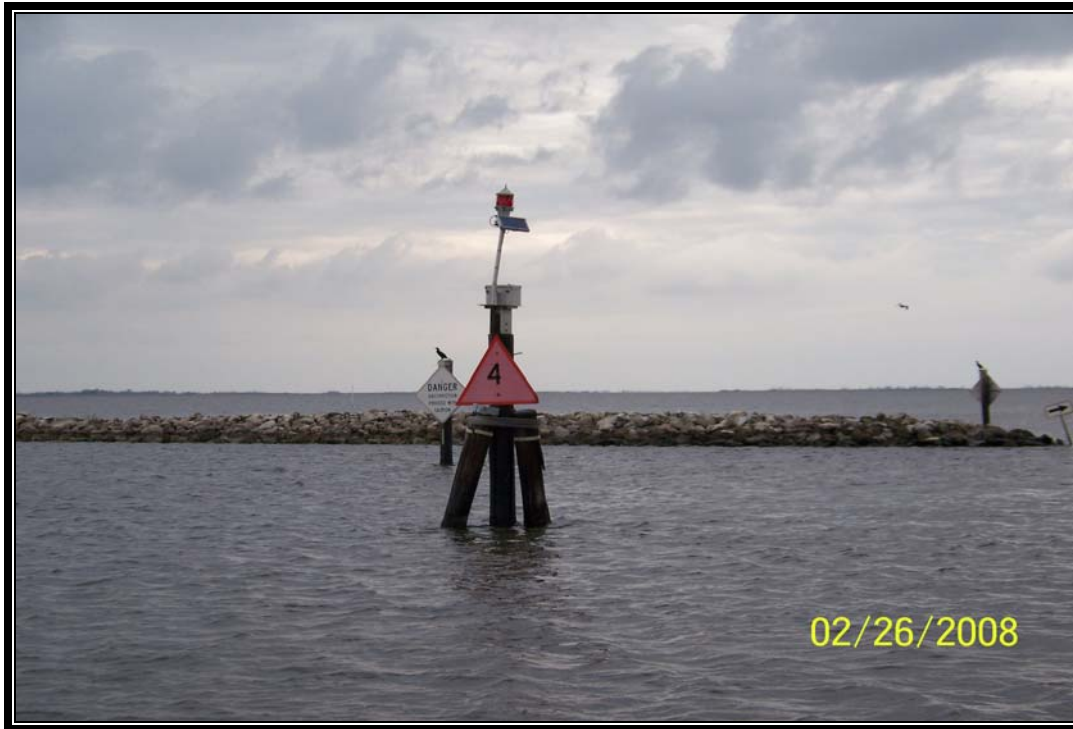
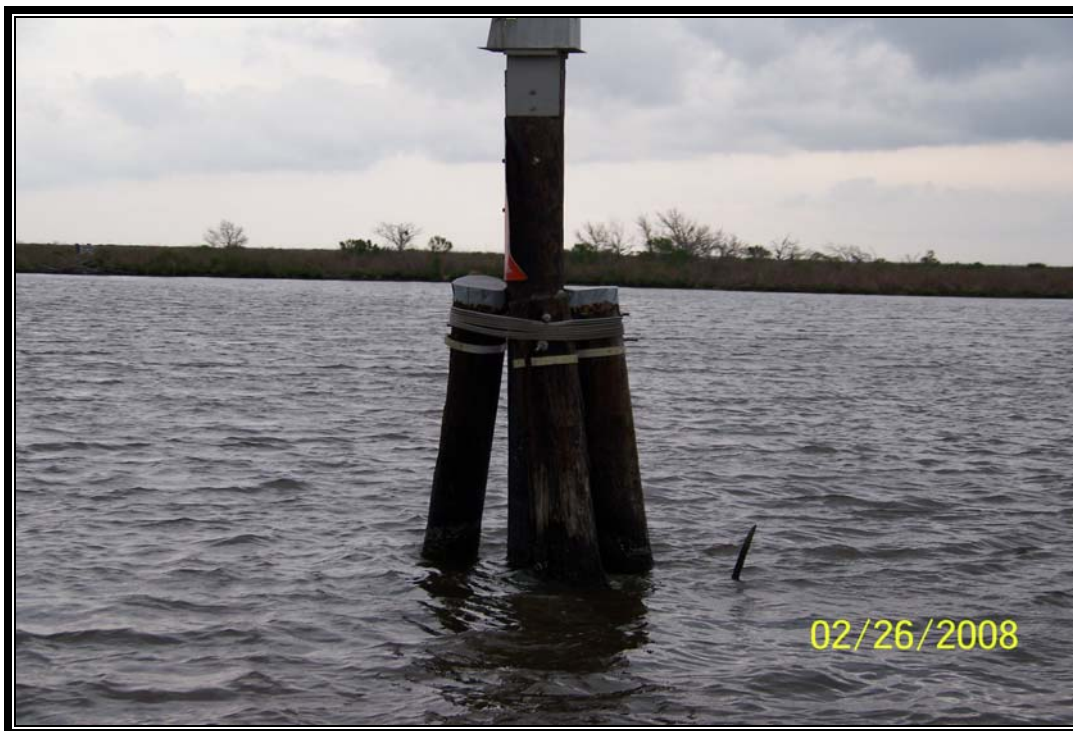
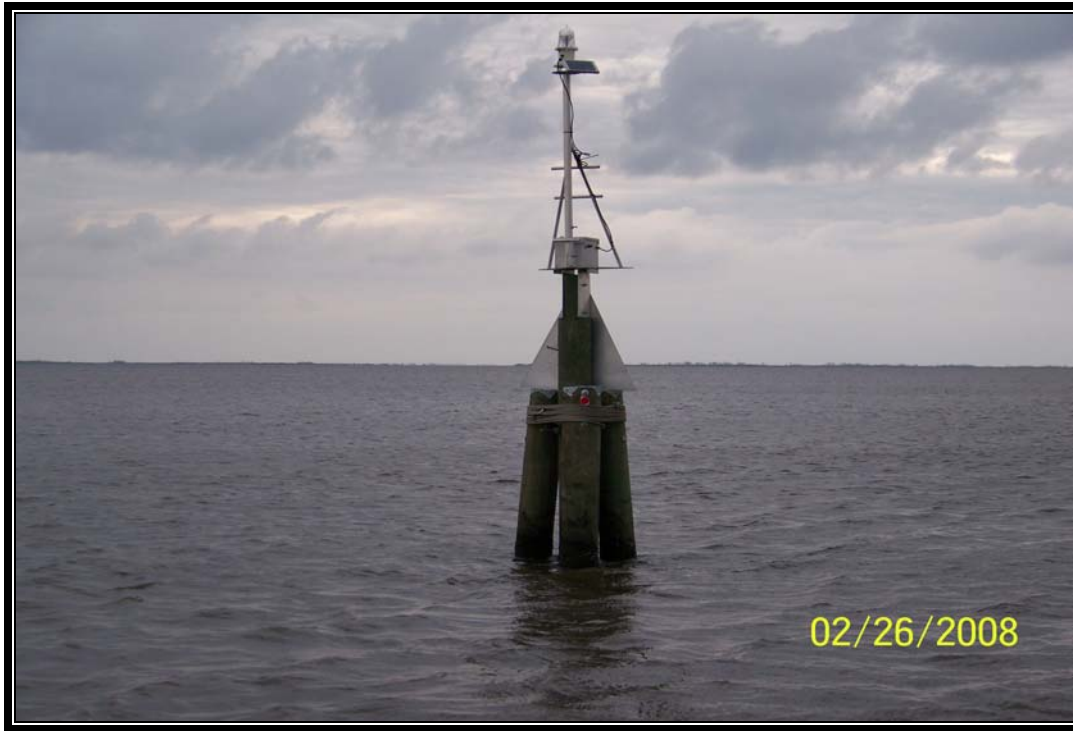
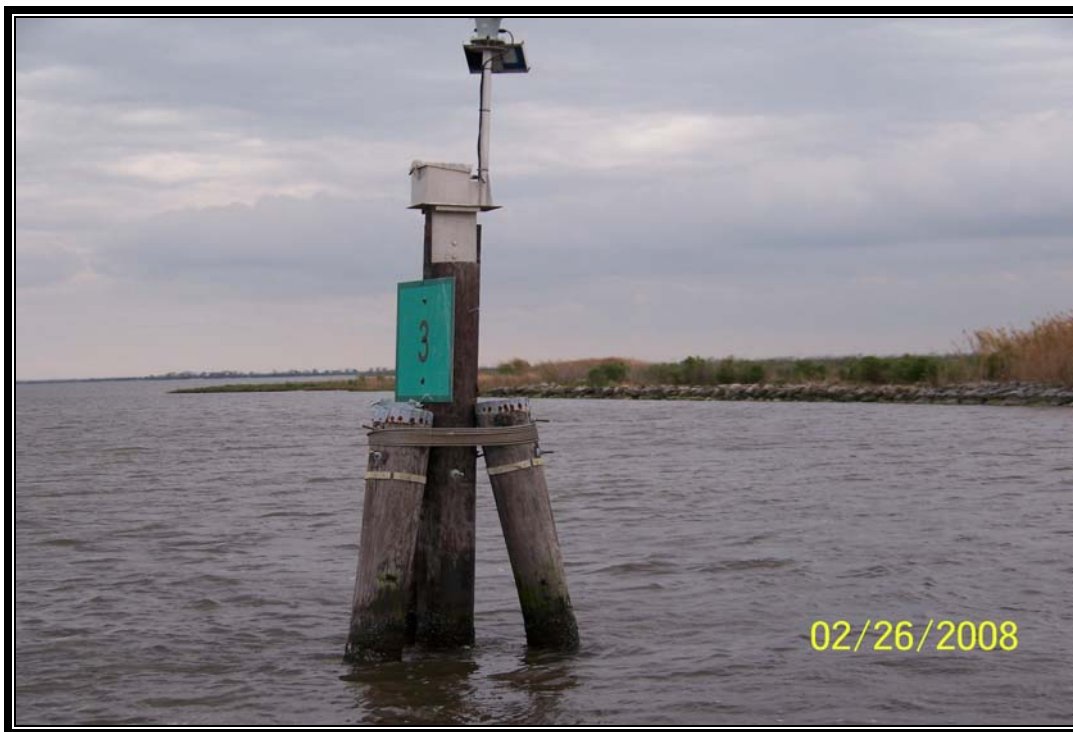
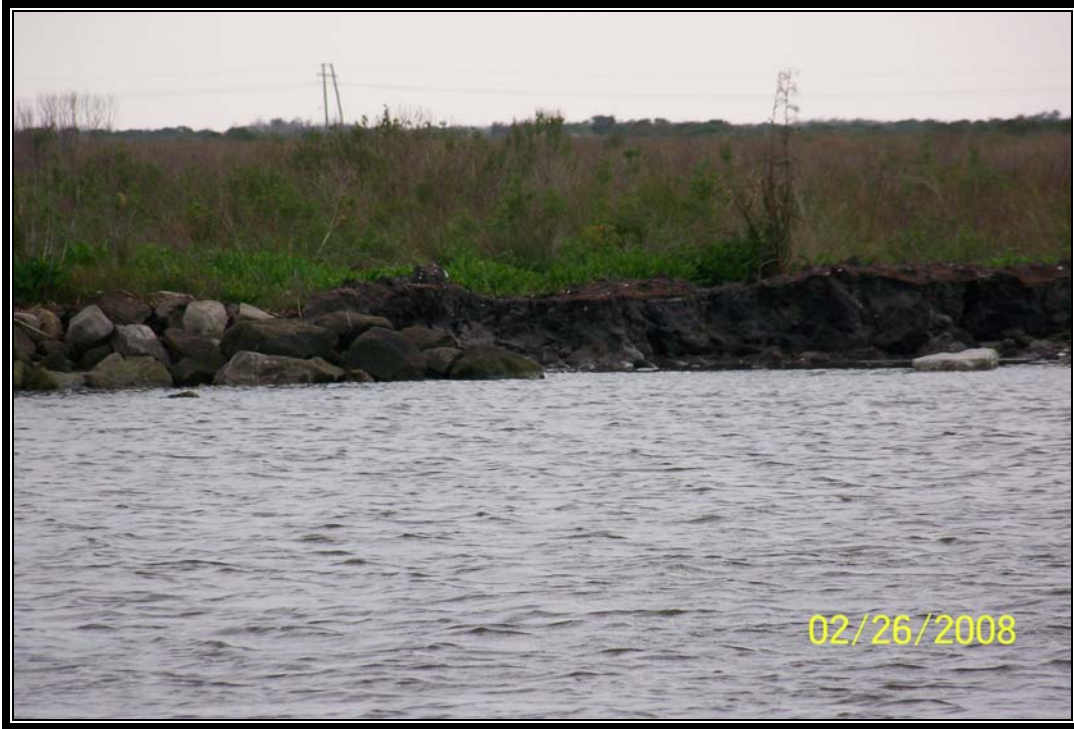
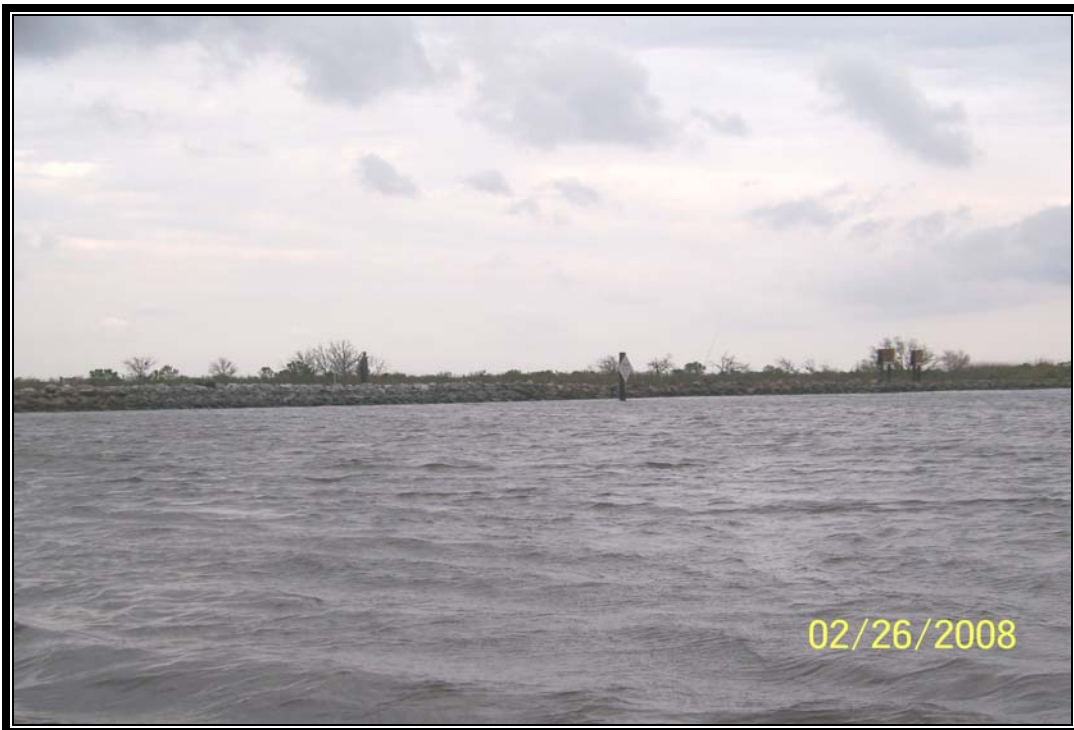
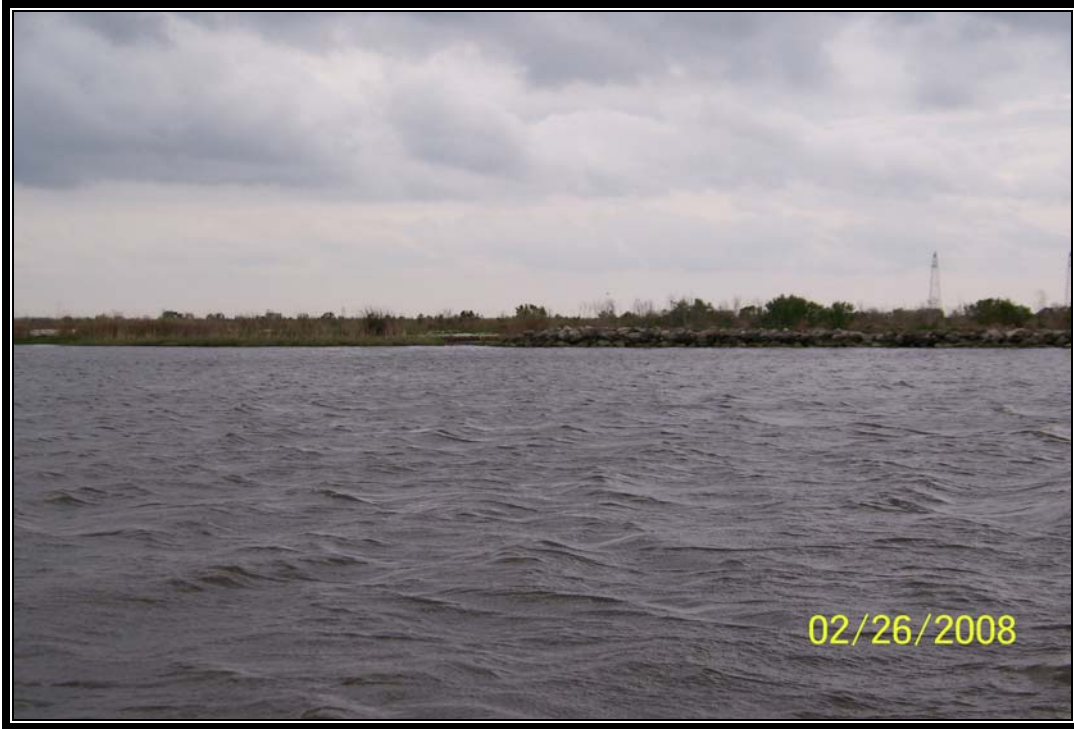
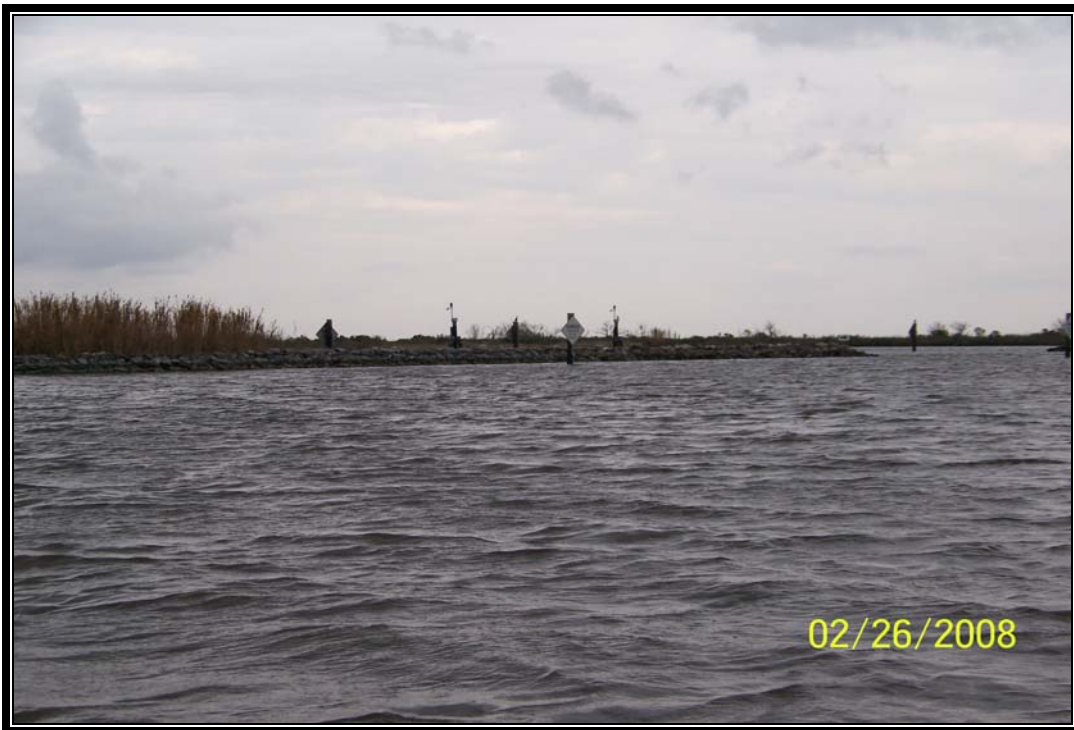
The fixed crest weir with barge bay was in good condition with no apparent settling or displacement of rock rip-rap. Based on initial reports from the landowner and NRCS regarding erosion problems on the south side of the structure, we focused our inspection on these locations. We found that the shoreline in this location had eroded back past the internal toe of the rock weir as indicated in a field trip report prepared by NRCS on June 19, 2006. Although erosion is prevalent, it appears that there is no immediate threat of breaching which would compromise the hydrology of the project. However, to slow future erosion in this area,

NRCS has recommended that planting additional smooth cordgrass on the lake side to buffer the wave action along the shoreline. The OCPR agrees that this is the most logical and cost effective method of protecting the shoreline in this area. A copy of NRCS's inspection report and assessment of erosion along the shoreline of Little Lake dated June 19, 2006 is provided in Appendix E. The timber navigational aid supports were in fair condition with visible damage on the northwest support structure. Longitudinal cracks, scrapes and abrasions were noted on the face of the timber dolphin on the northeast side of the structure. There is no indication that the structural integrity of the timber dolphin is compromised by the existing damage. Inspection, diagnostic testing and maintenance of the navigational lights at Structure 14A have been contracted to Automatic Power, Inc. of Larose through the OCPR which began in January 2007. (Appendix B: Photos 19-26)

Photo No.19 (0769) – timber dolphin and navigational aid located on the northwest side of rock weir with boat bay (Structure 14A).

Photo No.20 (0770) – timber dolphin and navigational aid located on the southwest side of the rock weir with boat bay (Structure 14A).

Photo No.21 (0771) – timber pile cluster and navigational aid located on the northeast side of Structure 14A repaired in 2006.

Photo No.22 (0772) – timber dolphin and navigational aid located on the southeast side of Structure 14A.

Photo No. 23 (0774) – earthen embankment tie-in located on the north end of Structure 14A.

Photo No. 24 (0775) – rock weir north of barge bay along Structure 14A looking northeast

Photo No. 25 (0776) - the southern earthen embankment tie -in along the rock weir with boat bay (Structure 14A)

Photo No. 26 (0777) - the southern section of the rock weir with barge bay (Structure 14A).

Item	Condition	Physical Damage	Corrosion	Photo #	Observations and Remarks
Timber Piles / Timber Wales	Fair	Damage to timber dolphin system NW side		19 thru 26	Observation: Rock weir with barge bay was in good condition with no apparent settlement along the length of the structure.
Galv. Pile Caps					
Cable / Hardware etc.	Fair	Loss cables on several dolphins			The timber pile dolphin supporting the navigational aids on the northwest side of the structure was damaged. The timber batter pile is split vertically with visible scapes or abrasions on the surface of the piling. The steel cable wraps were loose from an apparent collision from a barge vessel accessing the barge bay.
Signage / Supports	Good				The damage appears to be superficial with no indication that the structure integrity of the structure is compromised.
Eathem Embankment	Fair	moderate erosion both sides of the rock dike			Large cut banks were noted on the north side of the structure where the rock dike ties into the existing marsh. The marsh appears to be stable in this area with no breaching.

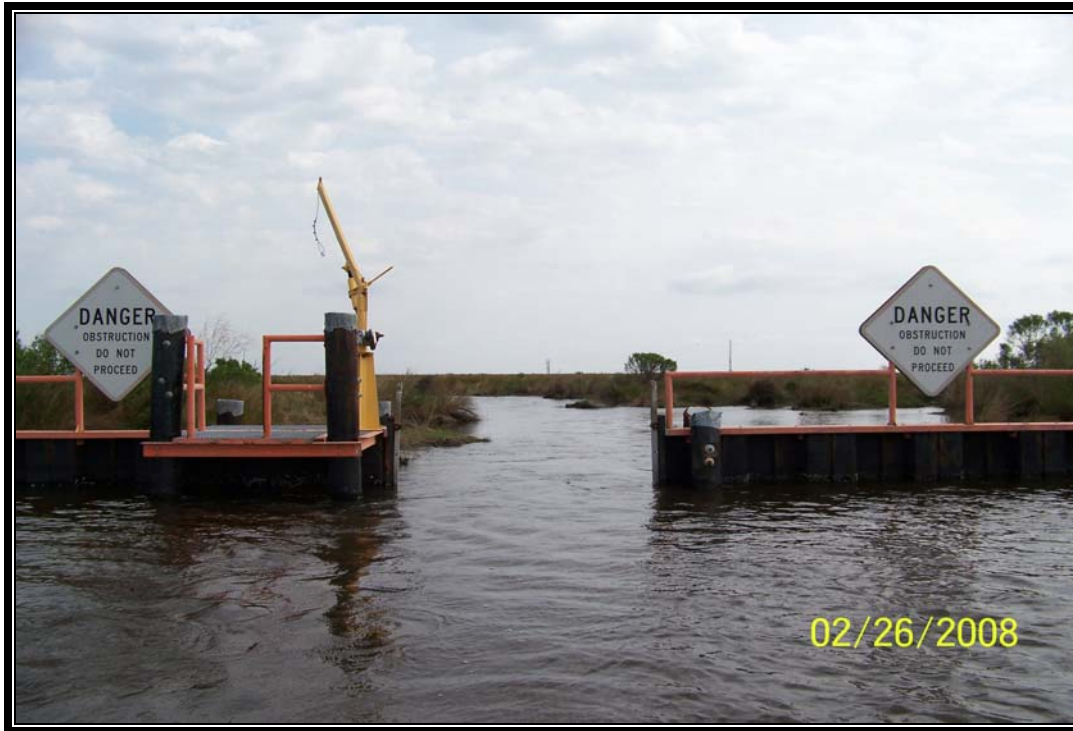
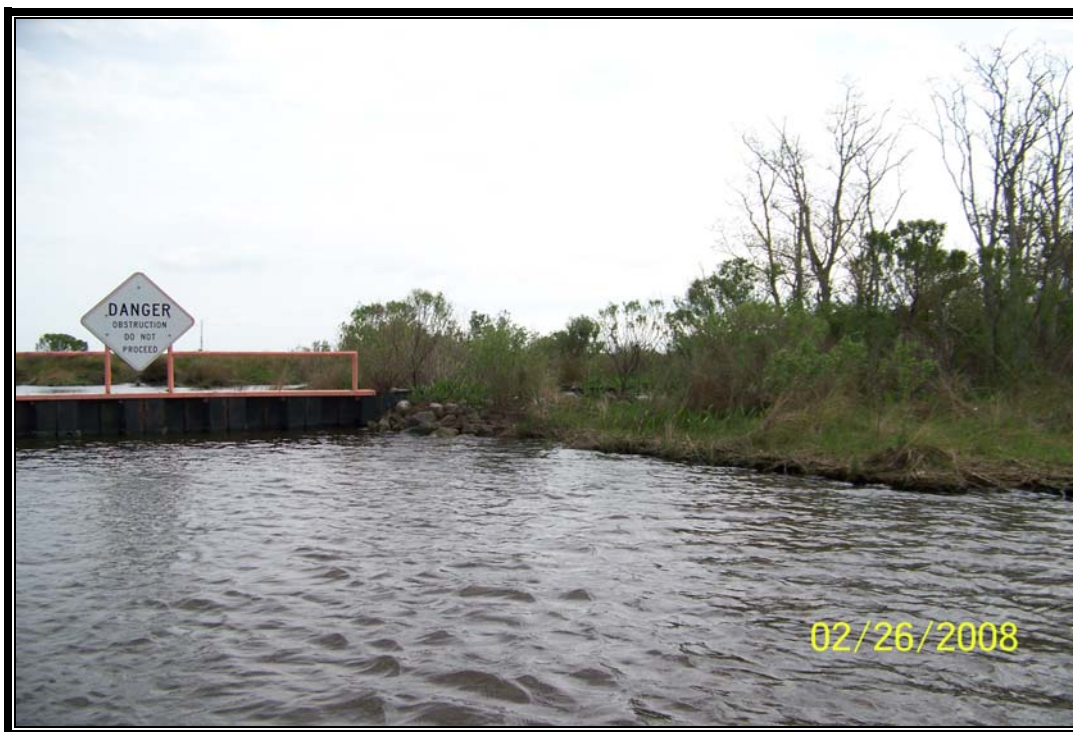
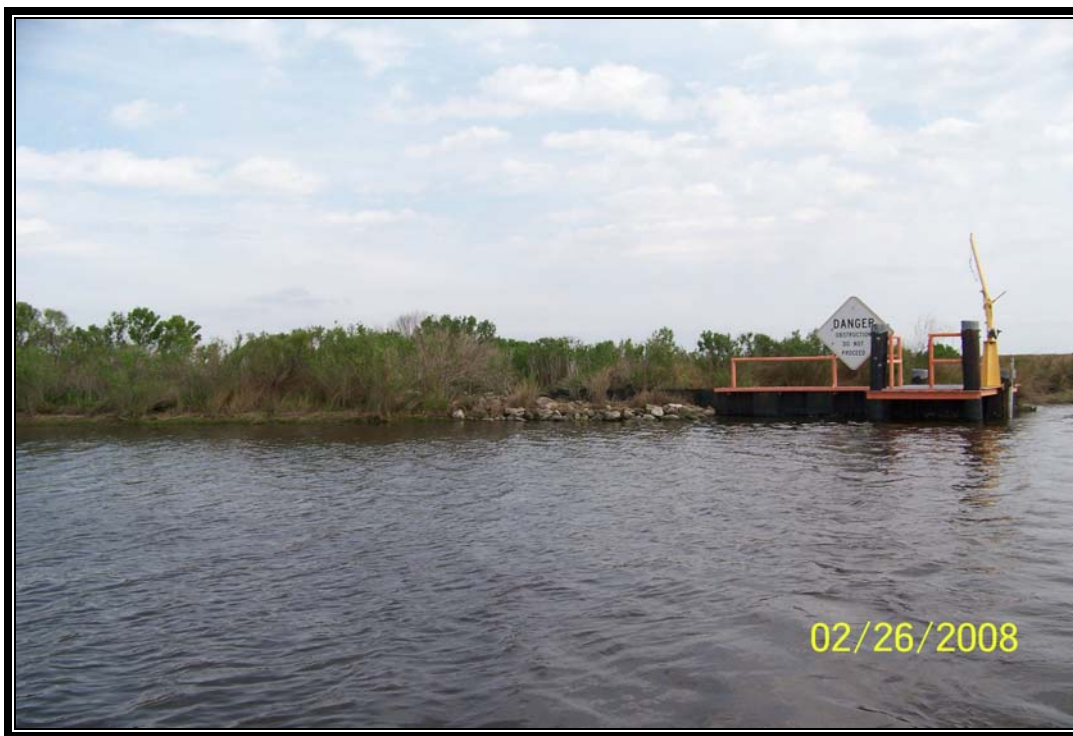
Other than minor corrosion and paint chipping along the channel cap of the bulkhead, handrails and movable boom deck, the structure was in good condition. The stop logs, cables, signs, supports and other hardware appear to be operable and in good condition. The stop logs were installed in the variable crest weir section in November 2007. From September 2005 to November 2007, the structure operations were suspended due to a large marsh mat that had floated against the structure during Hurricane Katrina, blocking the water exchange to the interior marsh. Over this time period, the marsh material had dissolved or decayed, sinking to the bottom of the channel, allowing the flow of water through the structure to resume. The operations of the water control structure will continue to be contracted through OCPR's indefinite delivery contracts (Appendix B: Photos 27-29)

Photo No. 27 (0806) - variable crest weir structure (Structure 35) located on north bank of the first location canal along Brenton Canal from Bay L' Ours.

Photo No. 28 (0807) – the south bank tie-in of Structure 35 looking northeast.

Photo No. 29 (0808) – the north bank tie-in of Structure 35 looking northeast.

Item	Condition	Physical Damage	Corrosion	Photo #	Observations and Remarks
Steel Bulkhead / Caps	Good	None	Minor Paint Chipping	27 thru 29	Structure 35 appeared to be in good condition with only superficial paint chipping and corrosion of channel caps, handrails, bulkhead and walkways. The lifting boom to raise the stop logs were also in good condition.
Stop Logs	Good	None			
Handrails			Minor Paint Chipping		The channel on the interior marsh leading to the structure that was clogged with floating marsh debris following the hurricanes of 2005 has worked loose leaving a small, but adequate, channel for water flow. With the opening of this channel, normal structure operations resumed in November 2007.
Grating	Good				
Hardware etc.					
Timber Piles / Timber Wales	Good				
Galv. Pile Caps					
Cable / Hardware etc.	Good				
Signage / Supports	Good				
Eathem Embankment	Good				
Construction Unit No.2

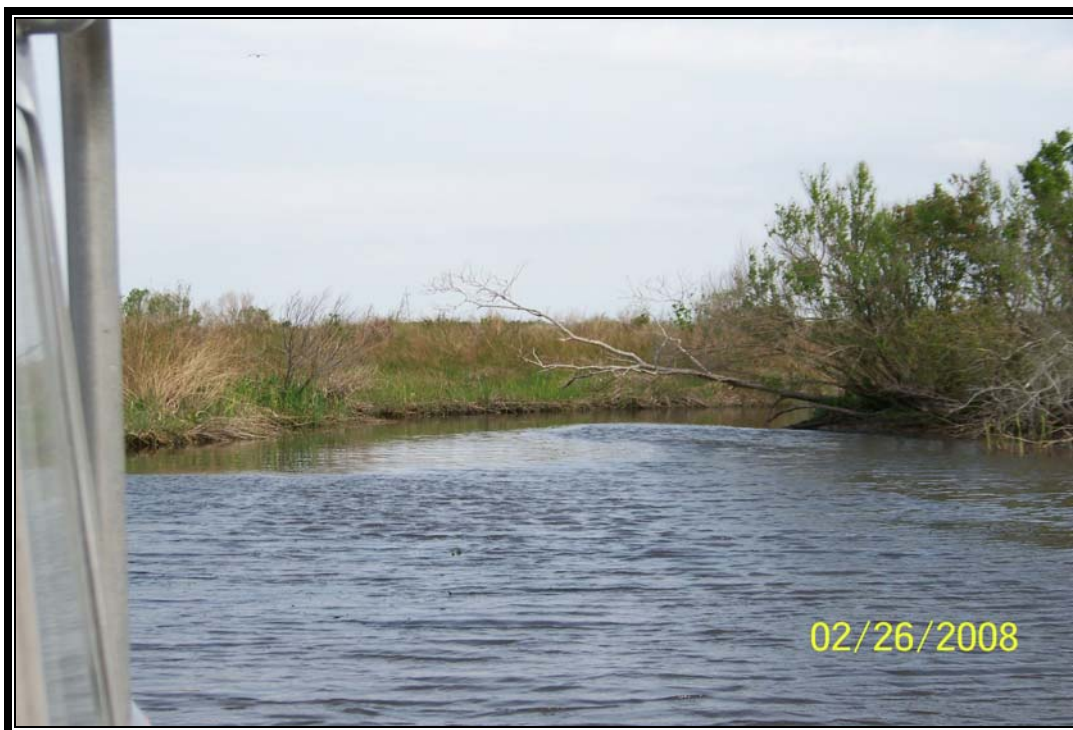
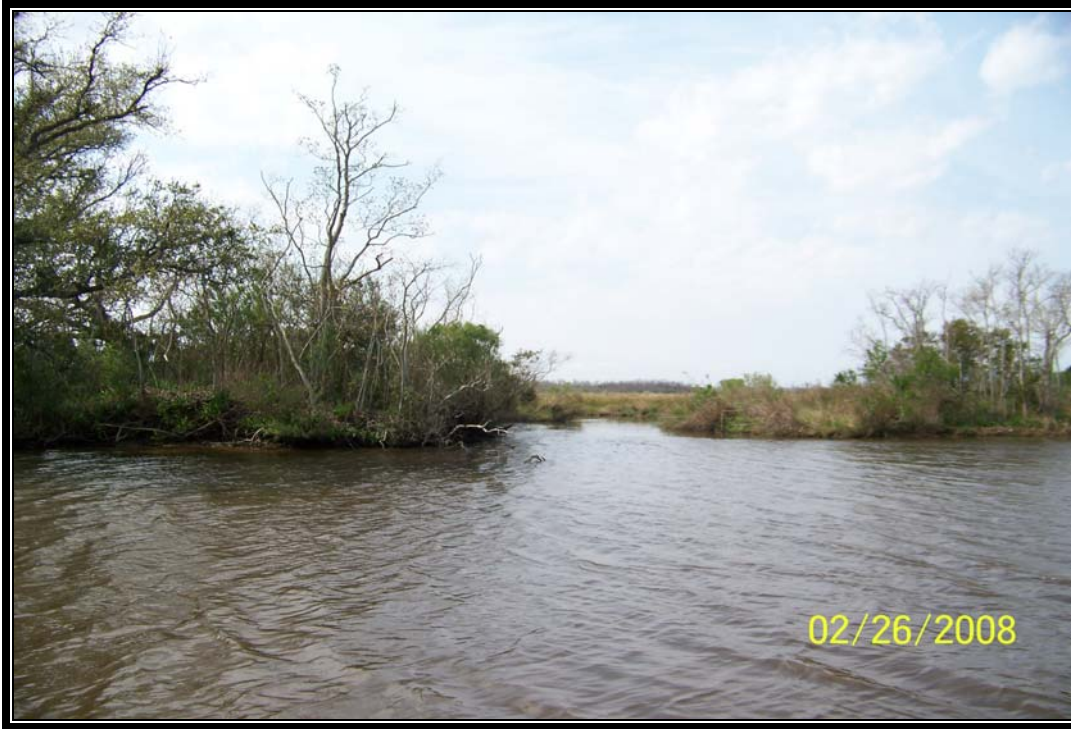
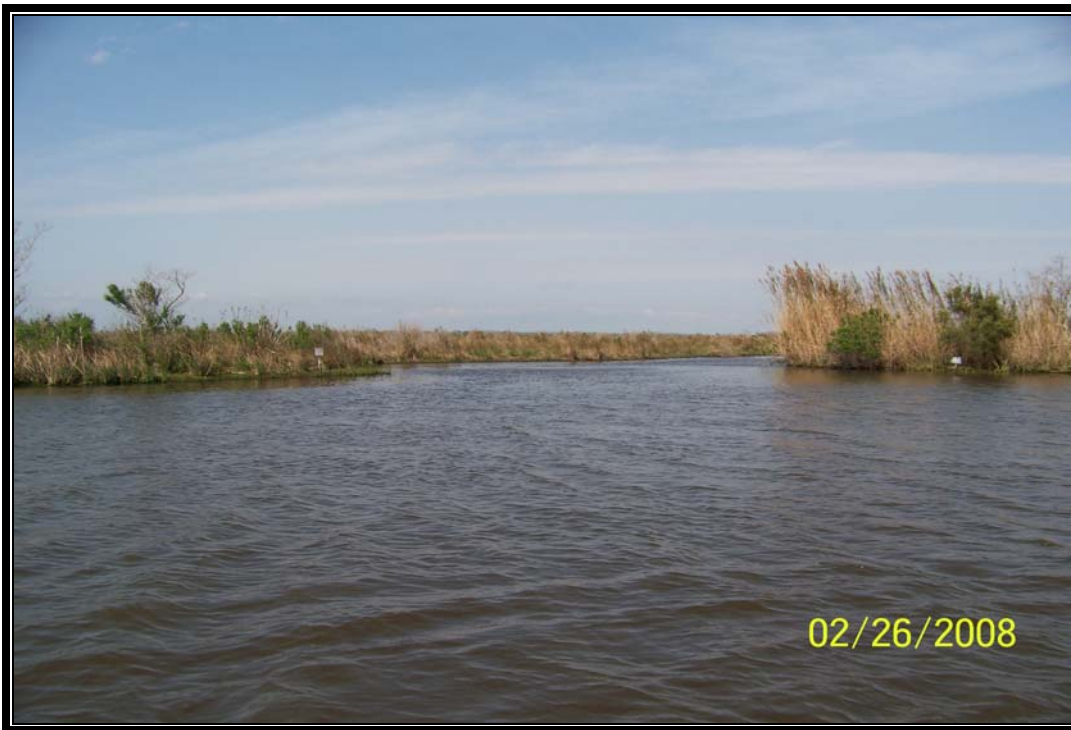
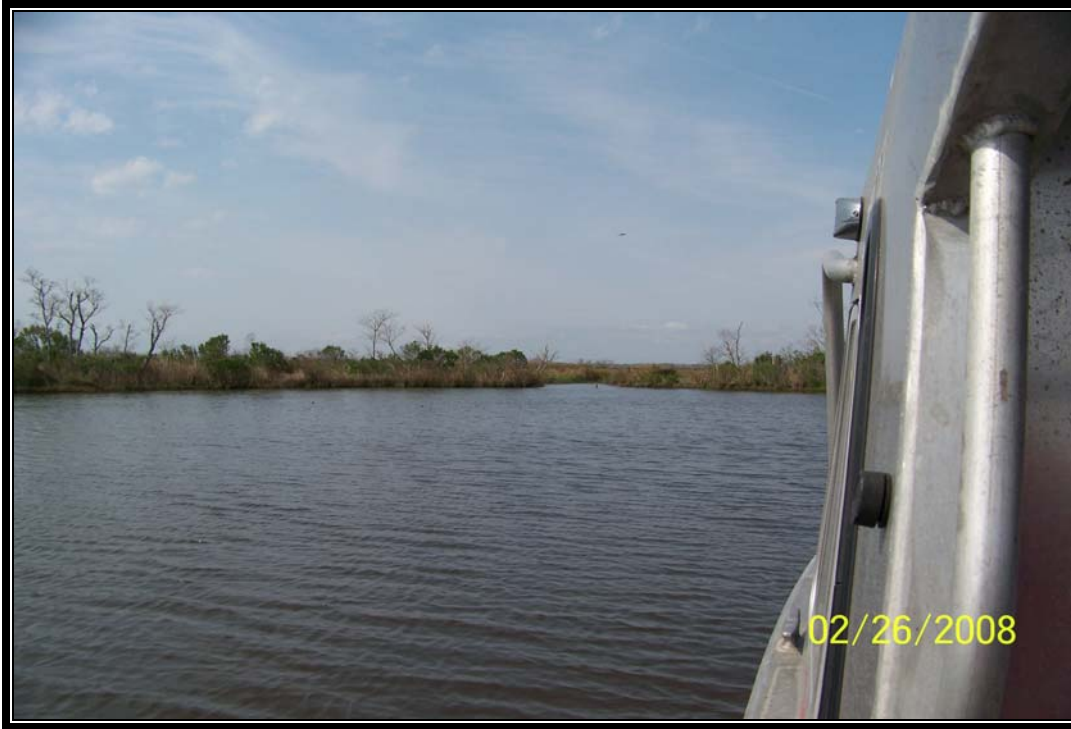
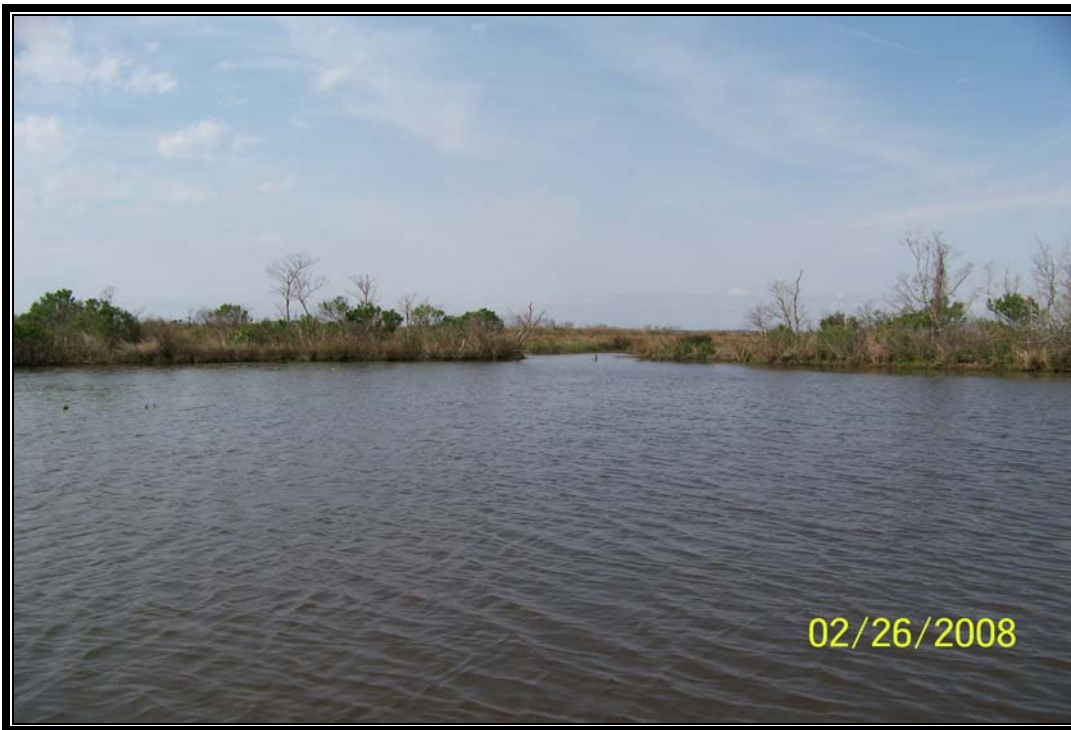
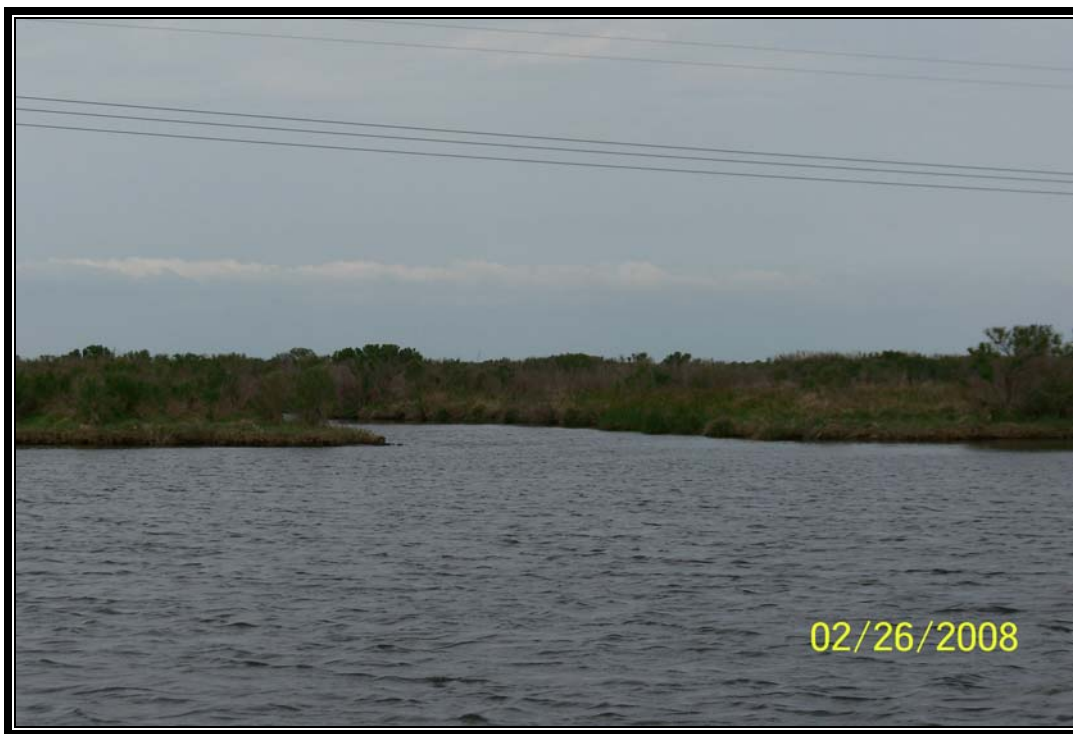
The earthen embankments located near the southern boundary of the project appear to be in a similar condition as observed during the 2007 inspections. There are six (6) breaches identified for repairs and/or refurbishment during the next maintenance cycle. Breach 1 is

Photo No. 38 (0810) – breach 1 located on the north bank of the second location canal off of Breton Canal from Bay L' Ours.

Photo No. 39 (0811) – breach 3 located along the south bank of the second location canal off of Breton Canal from Bay L' Ours.

Photo No. 40 (0813) – breach 4 located along west bank of location canal that intersects Superior Canal east of Structure 1.

Photo No. 41 (0814) – Breach 6 at the end of the first dead end canal on the left that intersects Superior Canal east of Structure 1.

Photo No. 42 (0815) - Breach 6 at the end of the first dead end canal on the left that intersects Superior Canal east of Structure 1.

Photo No. 43 (0789) – breach 5 consists of a large opening in the shoreline along the west bank of Bay L'Ours south of Structures 4A & 4B.

In all, six (6) breaches ranging from 10' to 30' wide were identified within the project area which will require refurbishment. A map showing the location of these breaches is shown in Appendix F. It is recommended that breaches 1 through 4 and 6 be constructed to design elevations utilizing available insitu material from adjacent channel bottoms. Breach 5 is approximately 30' wide and is located along the shoreline of Bay L' Ours. Due to its location, where wave intensities and shoreline erosion are high, it is recommended that a rock riprap plug be constructed across the breach to provide adequate protection along the shoreline in this area. It is anticipated that access dredging will be required to close Breach 5.

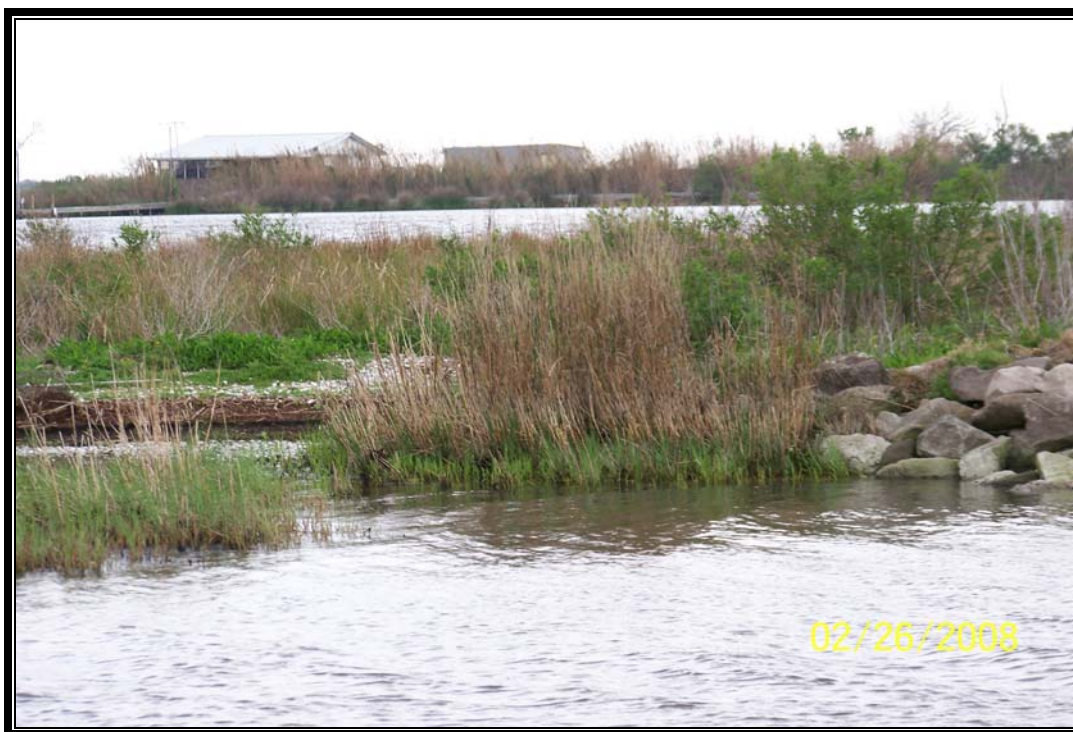
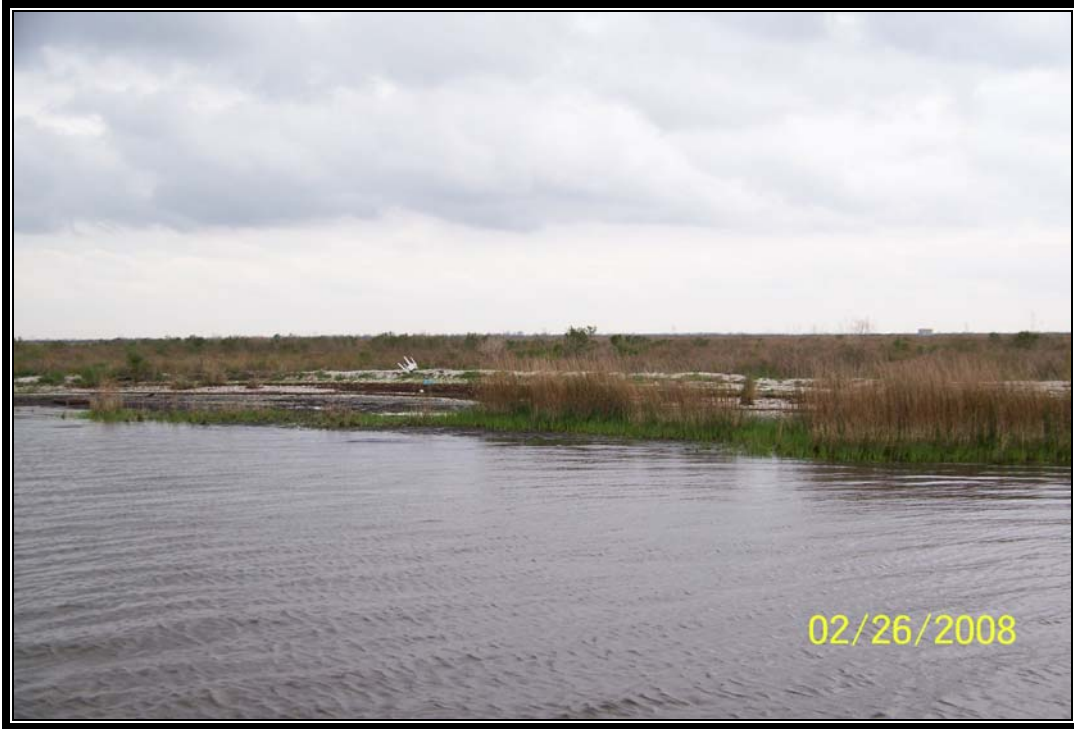
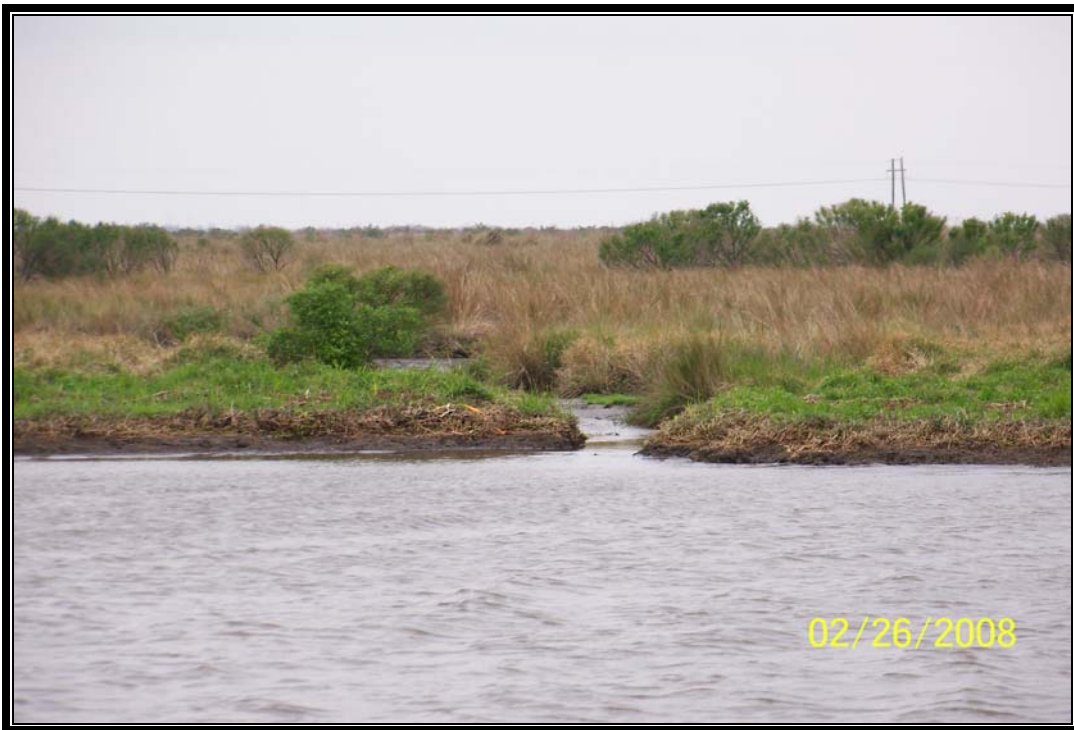
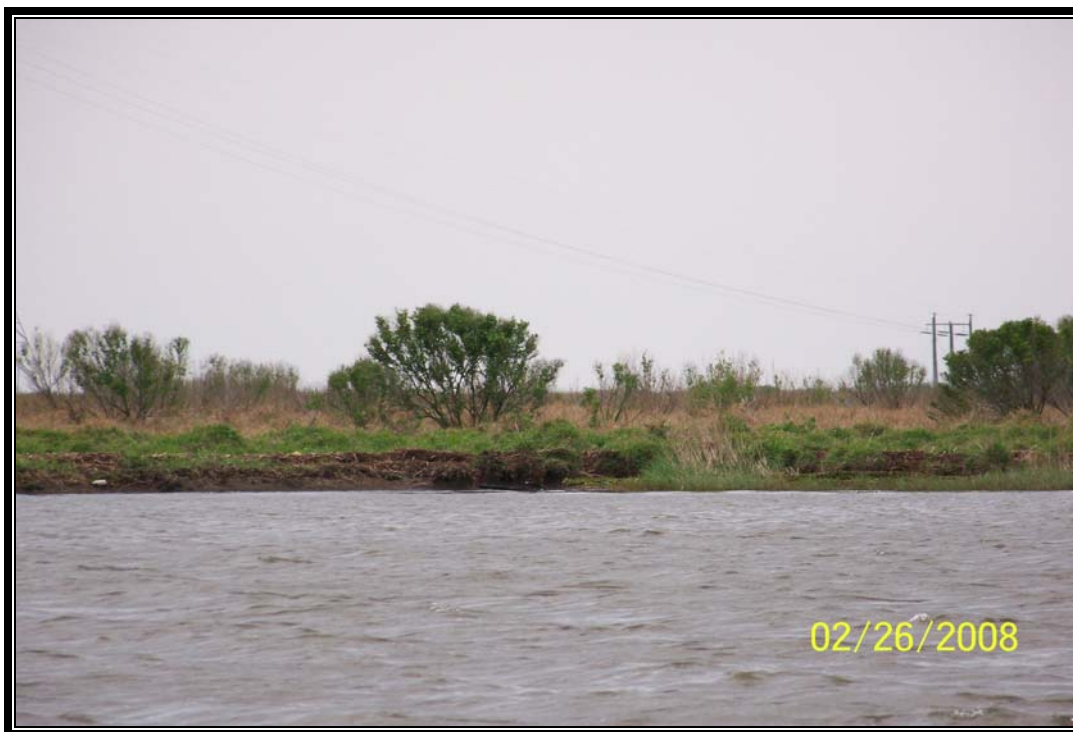
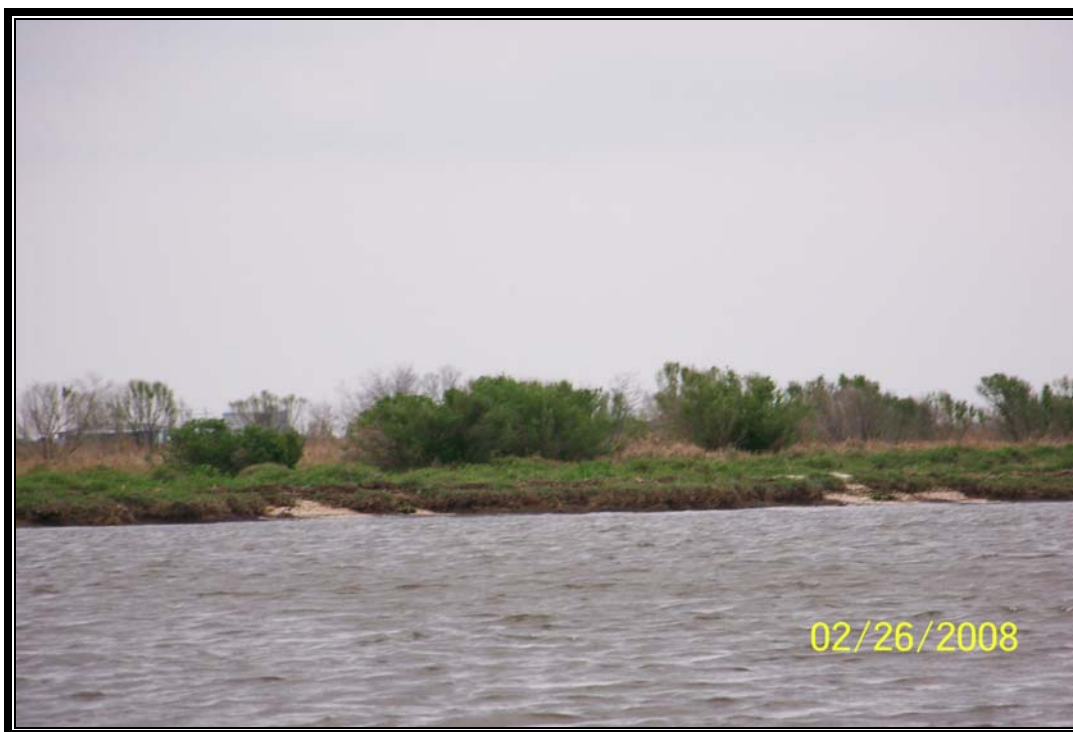
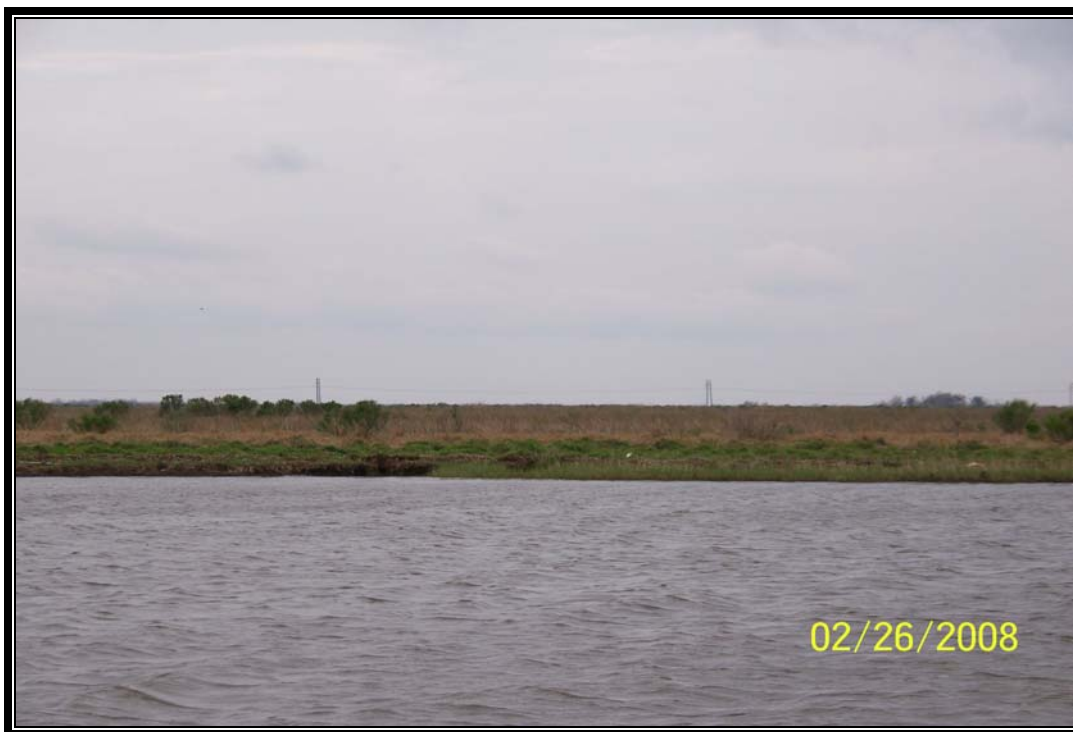
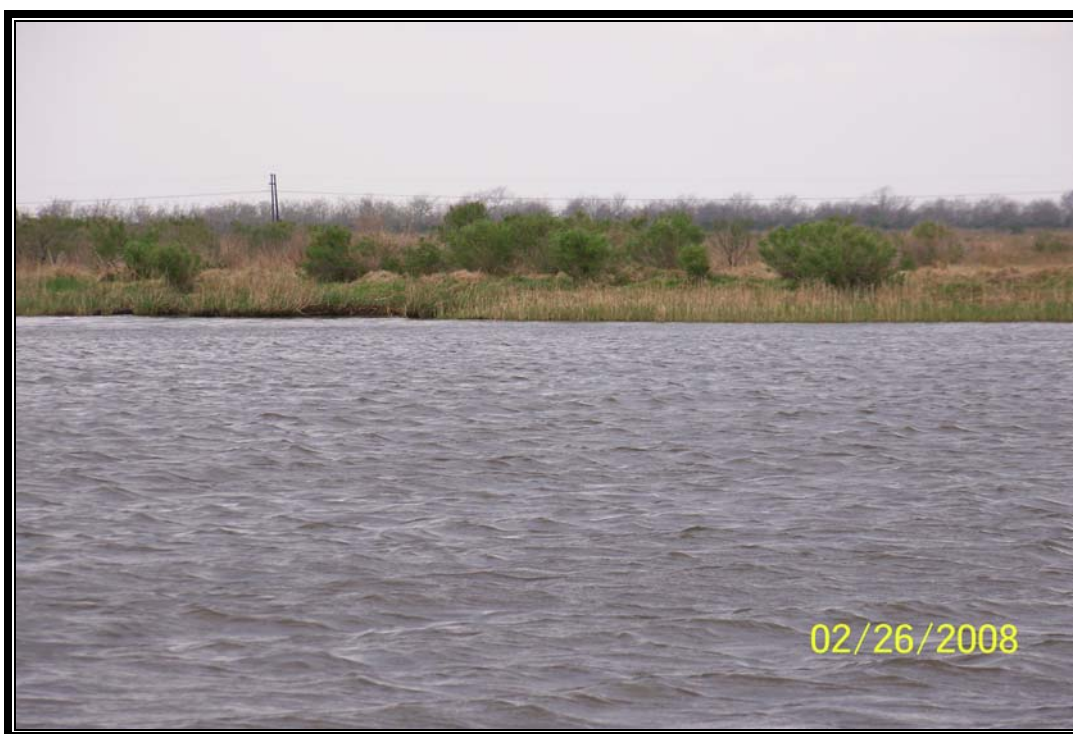
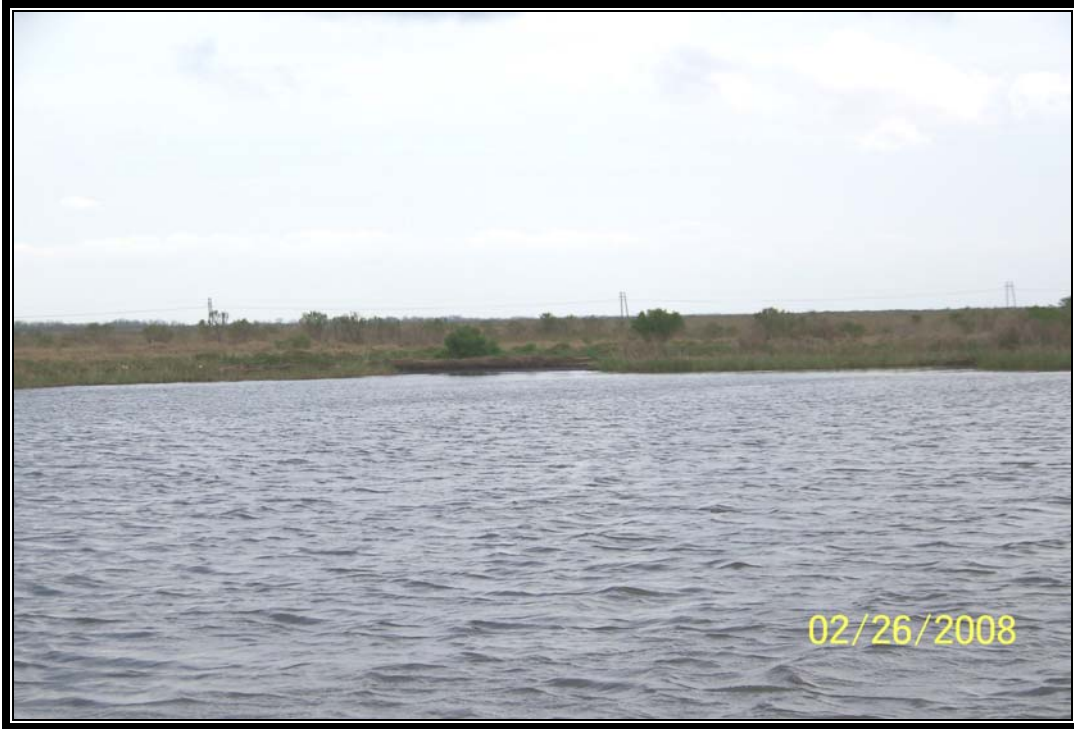
Photo No. 44 (0778) - erosion noted on the southern of the Structure 14A where the rock dike tie-ins to the existing marsh.

Photo No. 45 (0779) – erosion of the marsh along the shoreline of Little Lake on the southern end of Structure 14A.

Photo No. 46 (0784) - small breach along the shoreline of Little Lake north of Structure 8.

Photo No. 47 (0781) – erosion of the marsh along the shoreline of Little Lake. This type of erosion is typical along the shoreline in areas south of Structure 14A.

Photo No. 48 (0782) – erosion along the shoreline of Little Lake south of Structure 14A.

Photo No. 49 (0783) – erosion along the shoreline of Little Lake between Structures 14A and 8.

Photo No. 50 (0785) – erosion along the shoreline of Little Lake between Structures 14A and 8.

Photo No. 51 (0786) – an area of erosion along the shoreline of Little Lake between Structures 14A and 8.

Other deficiencies noted during this inspection included moderate erosion and large cut banks along the shoreline of Little Lake south of Structure 14A. Since there are no major breaches in the shoreline, that is currently jeopardizing the internal hydraulics of the project, we are not recommending any improvements or maintenance at this time. However, OCPD will assist NRCS in facilitating a possible plantings project along the shoreline in critical locations where plantings are favorable. The inspection team will closely monitor the shoreline in this area on future site visits to determine if conditions have changed.

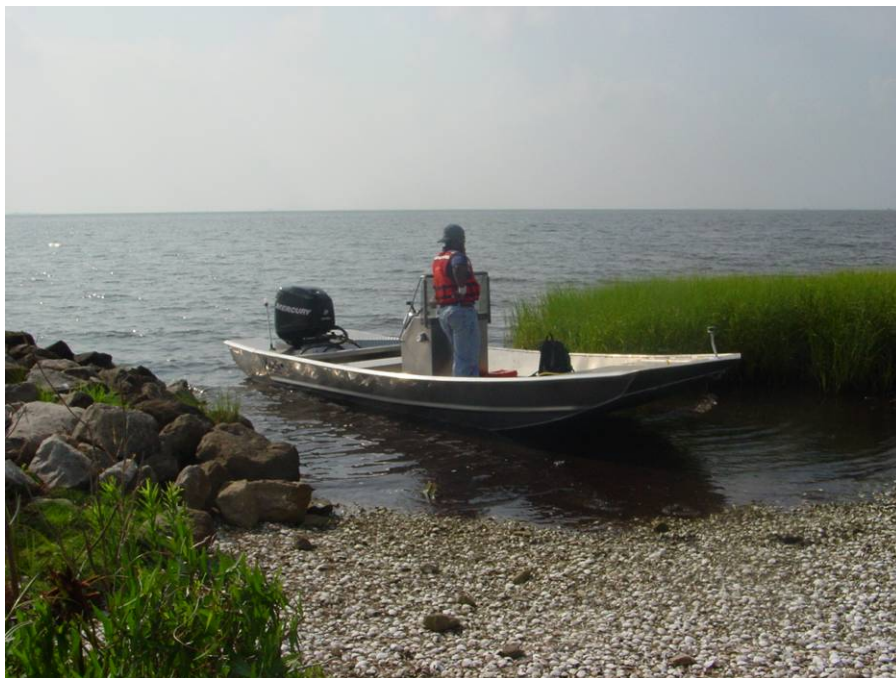
Figure 2. Area A. Southern terminus of Structure 14A where shoreline has receded past the interior toe of the structure.
